SUBJECT: Quad Cities Station Units 1 and 2
Service Test Results for 250V DC Batteries
NRC Docket Nos. 50-254 and 50-265

ATTACHMENT

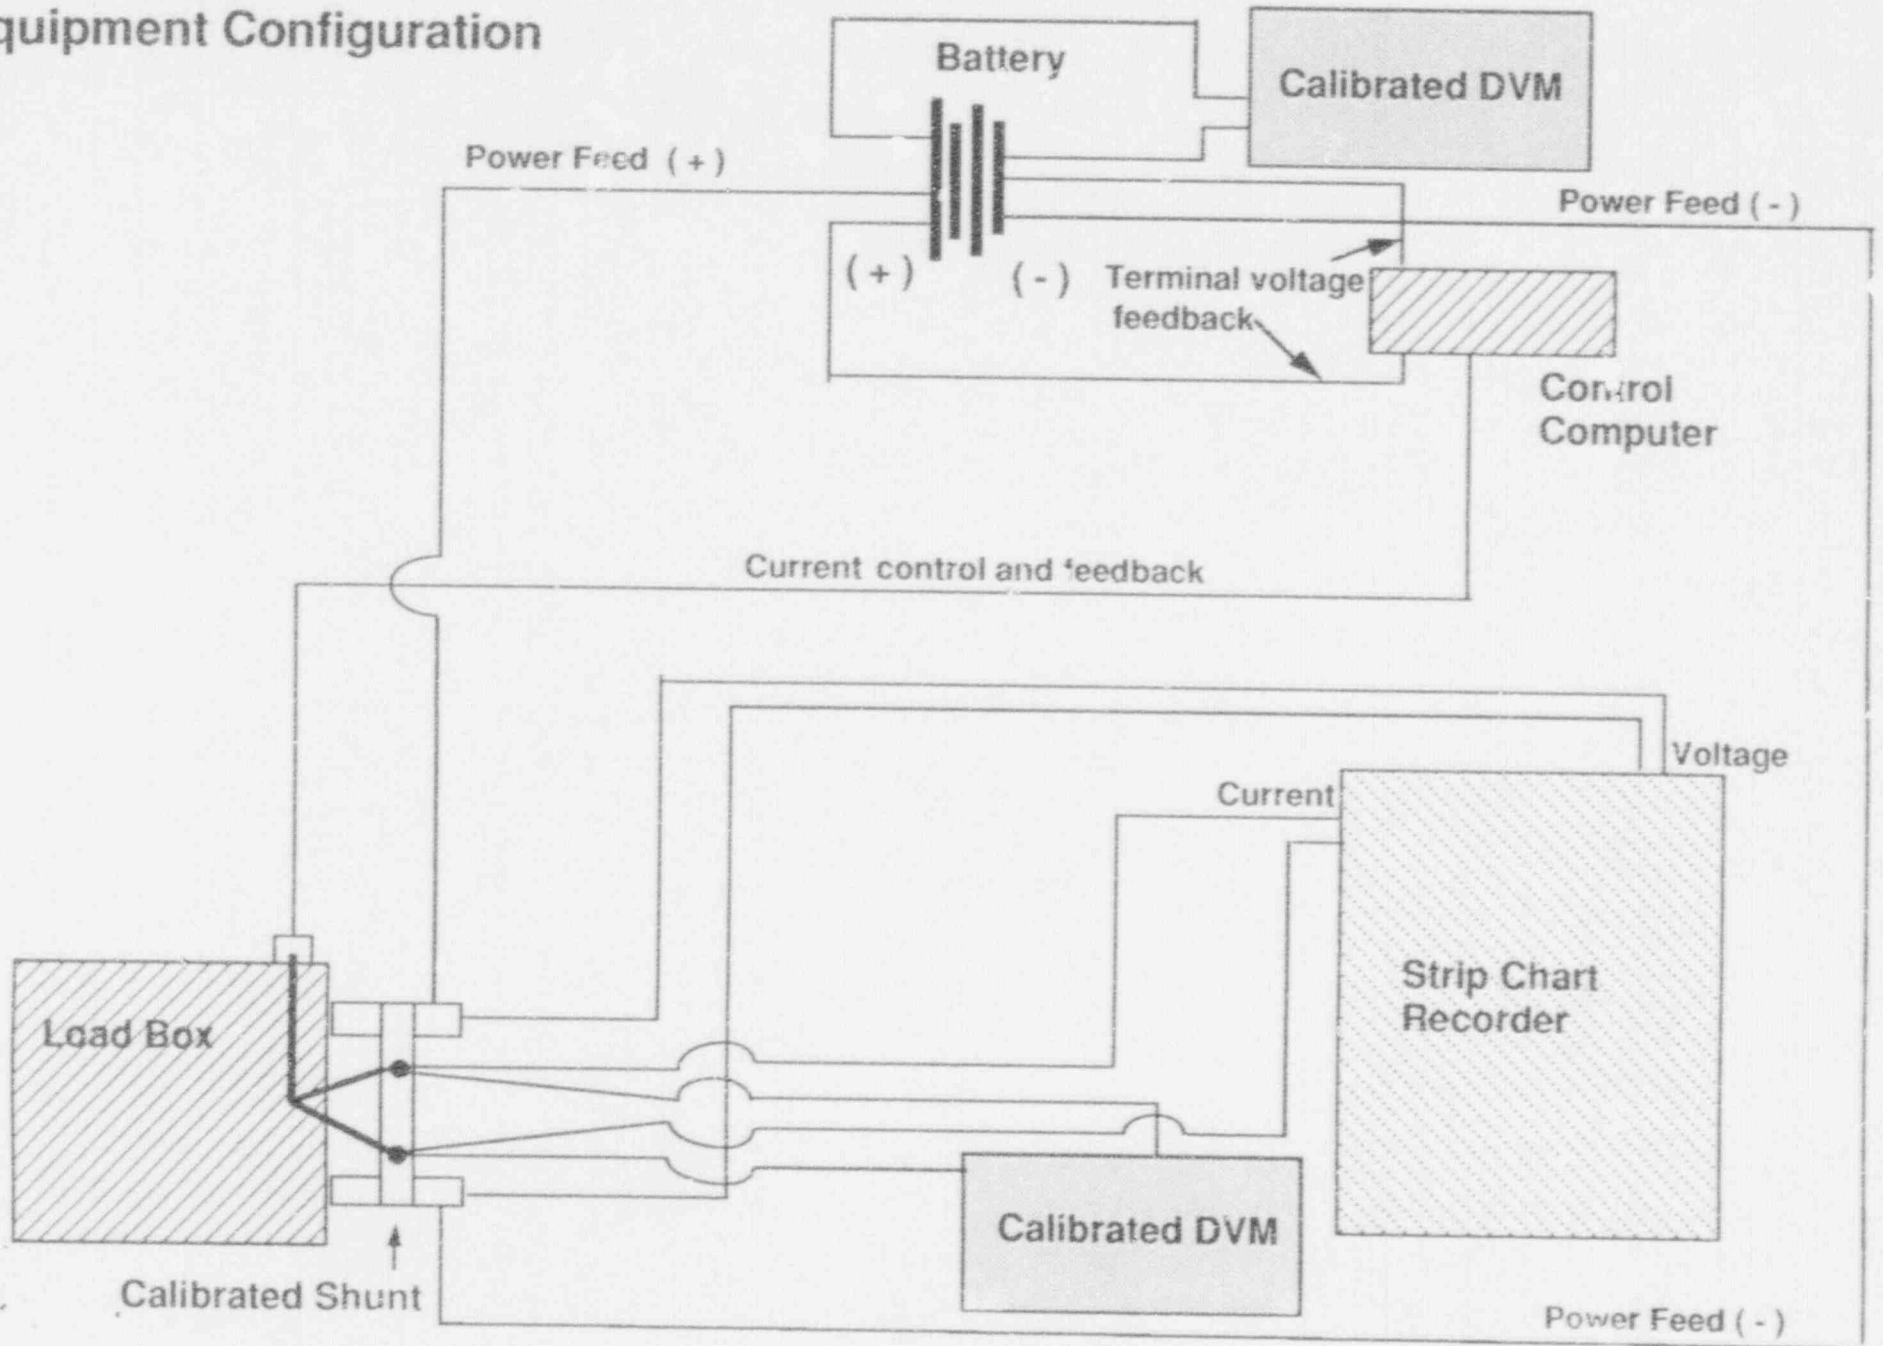
Figure 1
Service Test
Equipment Configuration

The configuration of the test equipment used during the service test is shown in Figure 1. This configuration is summarized below.

1. The required load (as defined by the load profile) was automatically sequenced onto the battery at 15 second intervals using a load box and control computer

2. The acceptability of the service test was determined by continuously monitoring the battery terminal voltage with a calibrated digital voltmeter (DVM), and verifying that the voltage remained above 210 volts for the duration of the service test.

3. The discharge current (the load placed upon the battery by the load box/control computer) was monitored with a second calibrated DVM and calibrated shunt (1200A/100 mV). Voltage across the shunt was monitored with the DVM and then converted to current through use of the current/voltage ratio. In addition to monitoring the discharge current, the calibrated shunt also provided electrical signals to the load box/control computer in order to establish the proper load; and a strip chart recorder to provide an uncalibrated indication of voltage and current.

The service test was conducted utilizing three engineers for monitoring and control of the test. An engineer was stationed at the DVM/shunt equipment to ensure that the delivered load from the load box/control computer met the load profile requirement. If the delivered load did not meet the requirement within the first ten seconds of the applicable time period, this engineer was required to notify a second engineer, who was stationed in the battery room, to switch the control computer to a manual mode and adjust the load to meet the required load profile. The first engineer would then verify that the delivered load met the requirement for the applicable time period. A third engineer (also stationed in the battery room) continuously monitored the DVM which was monitoring the terminal voltage to verify acceptable performance.
