LA SALLE COUNTY STATION  
UPDATED FINAL SAFETY ANALYSIS REPORT

FIGURE 9.1-1  
NEW FUEL STORAGE

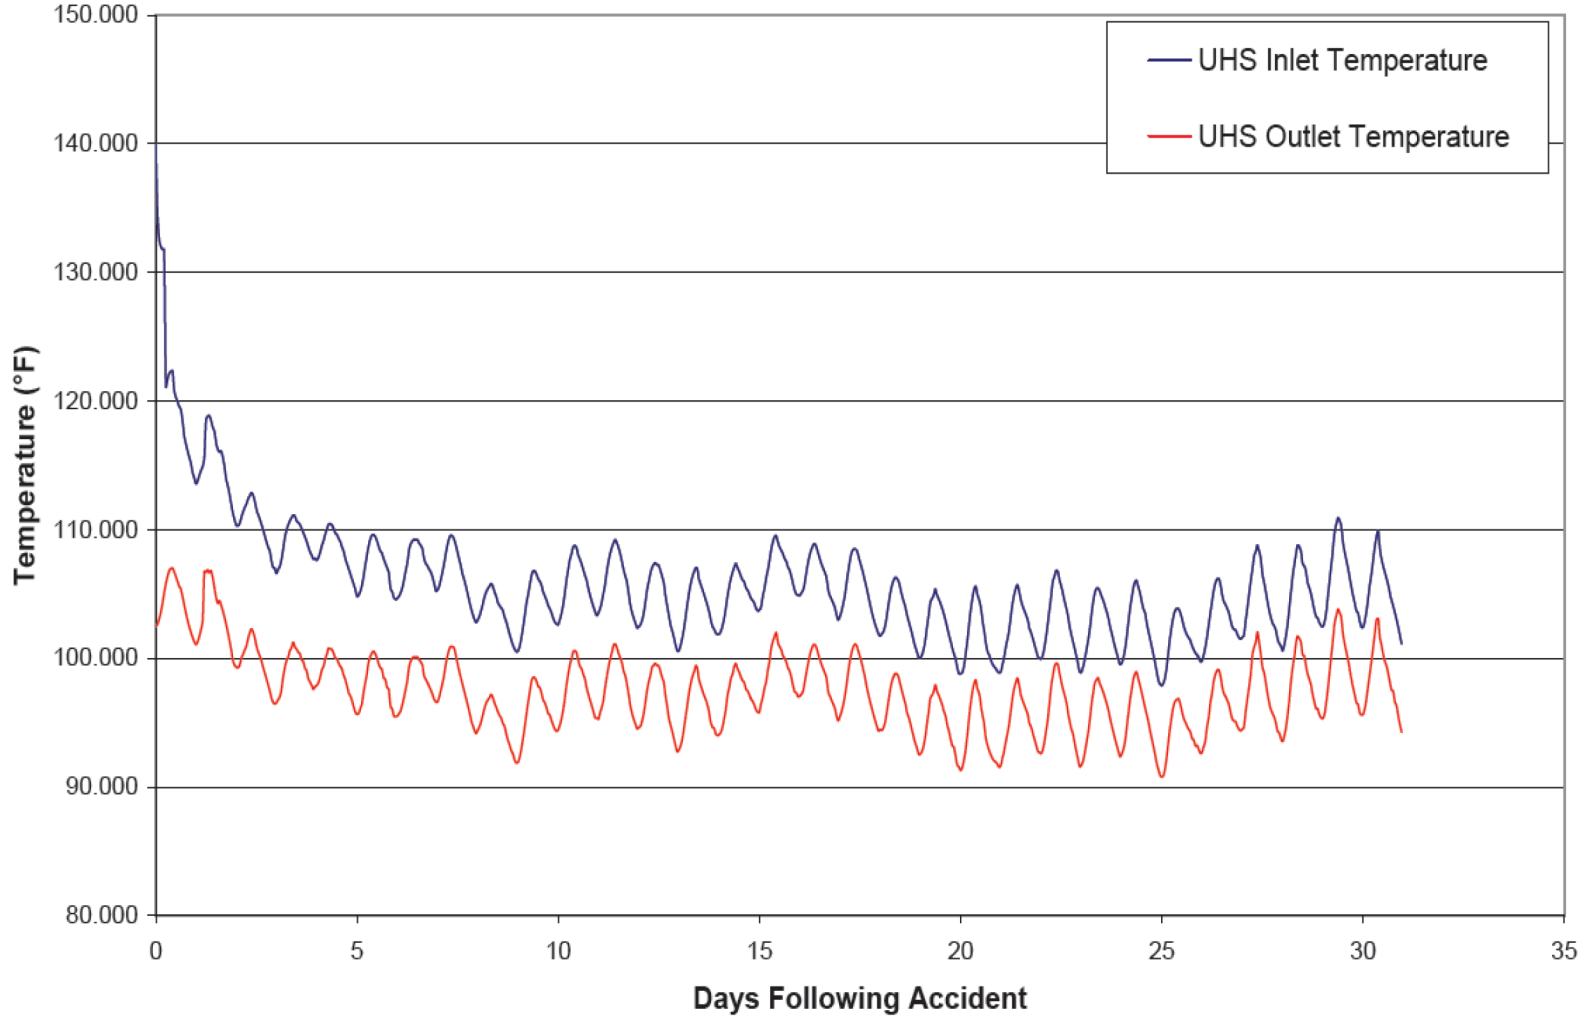
FIGURE 9.2-2

UHS TEMPERATURE RESPONSE TO LOCA  
WORST 31-DAY TEMPERATURE CONDITIONS

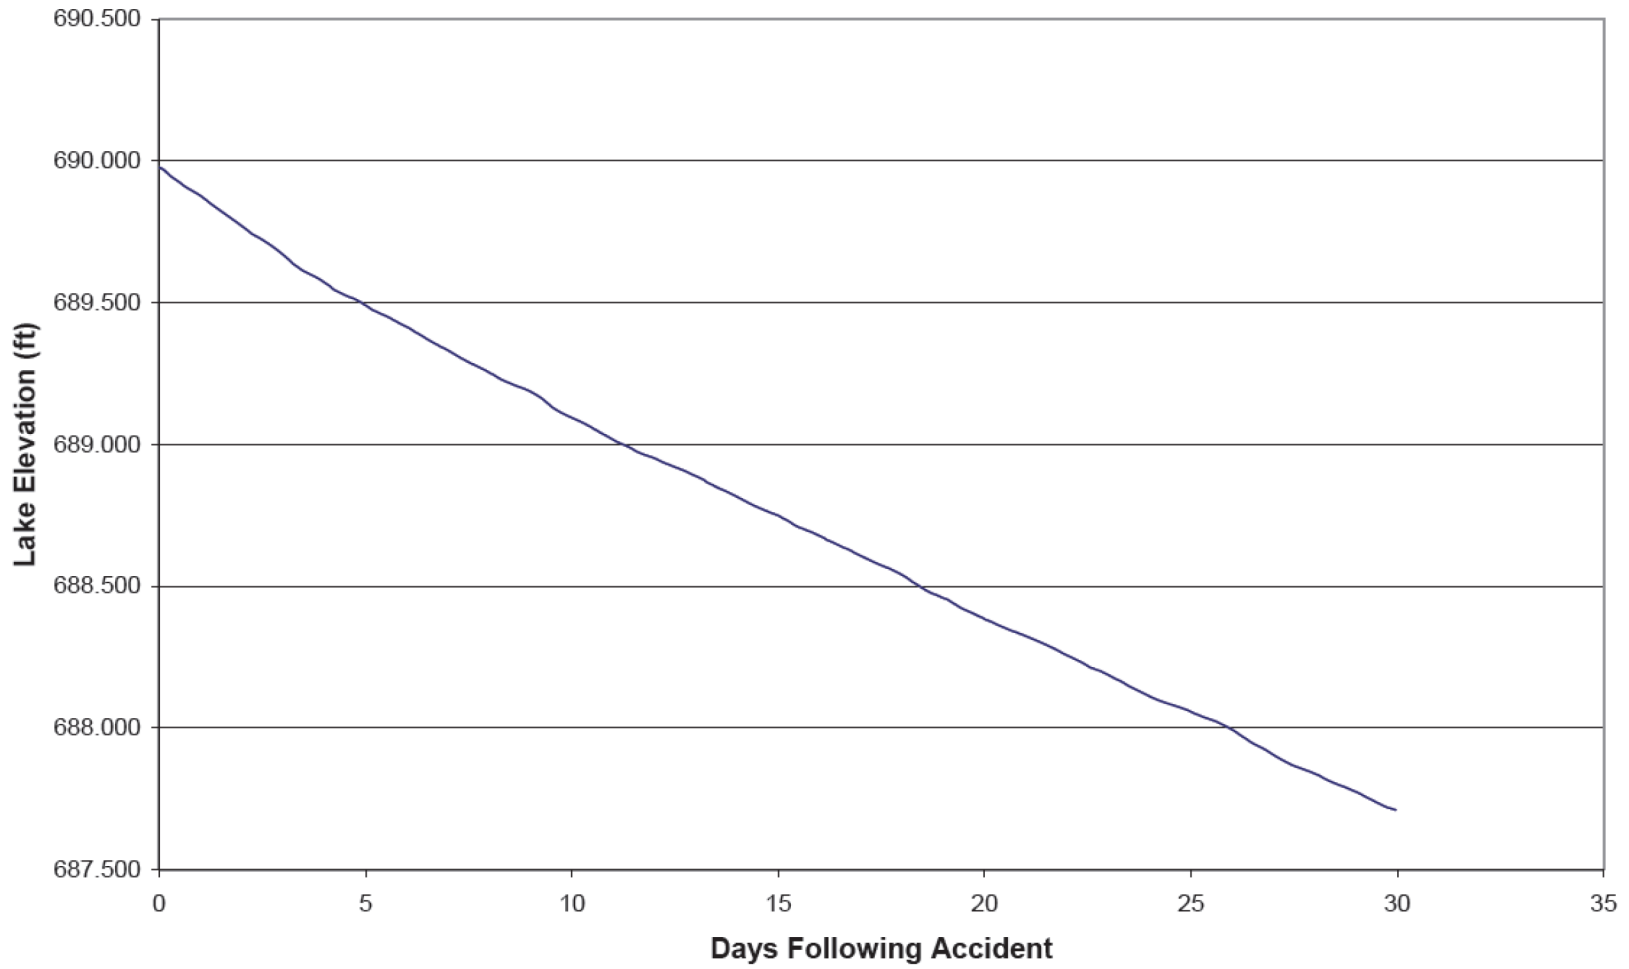
LASALLE COUNTY STATION UPDATED FINAL SAFETY ANALYSIS REPORT
FIGURE 9.2-3 UHS TEMPERATURE RESPONSE TO LOCA WORST 30-DAY EVAPORATION CONDITIONS

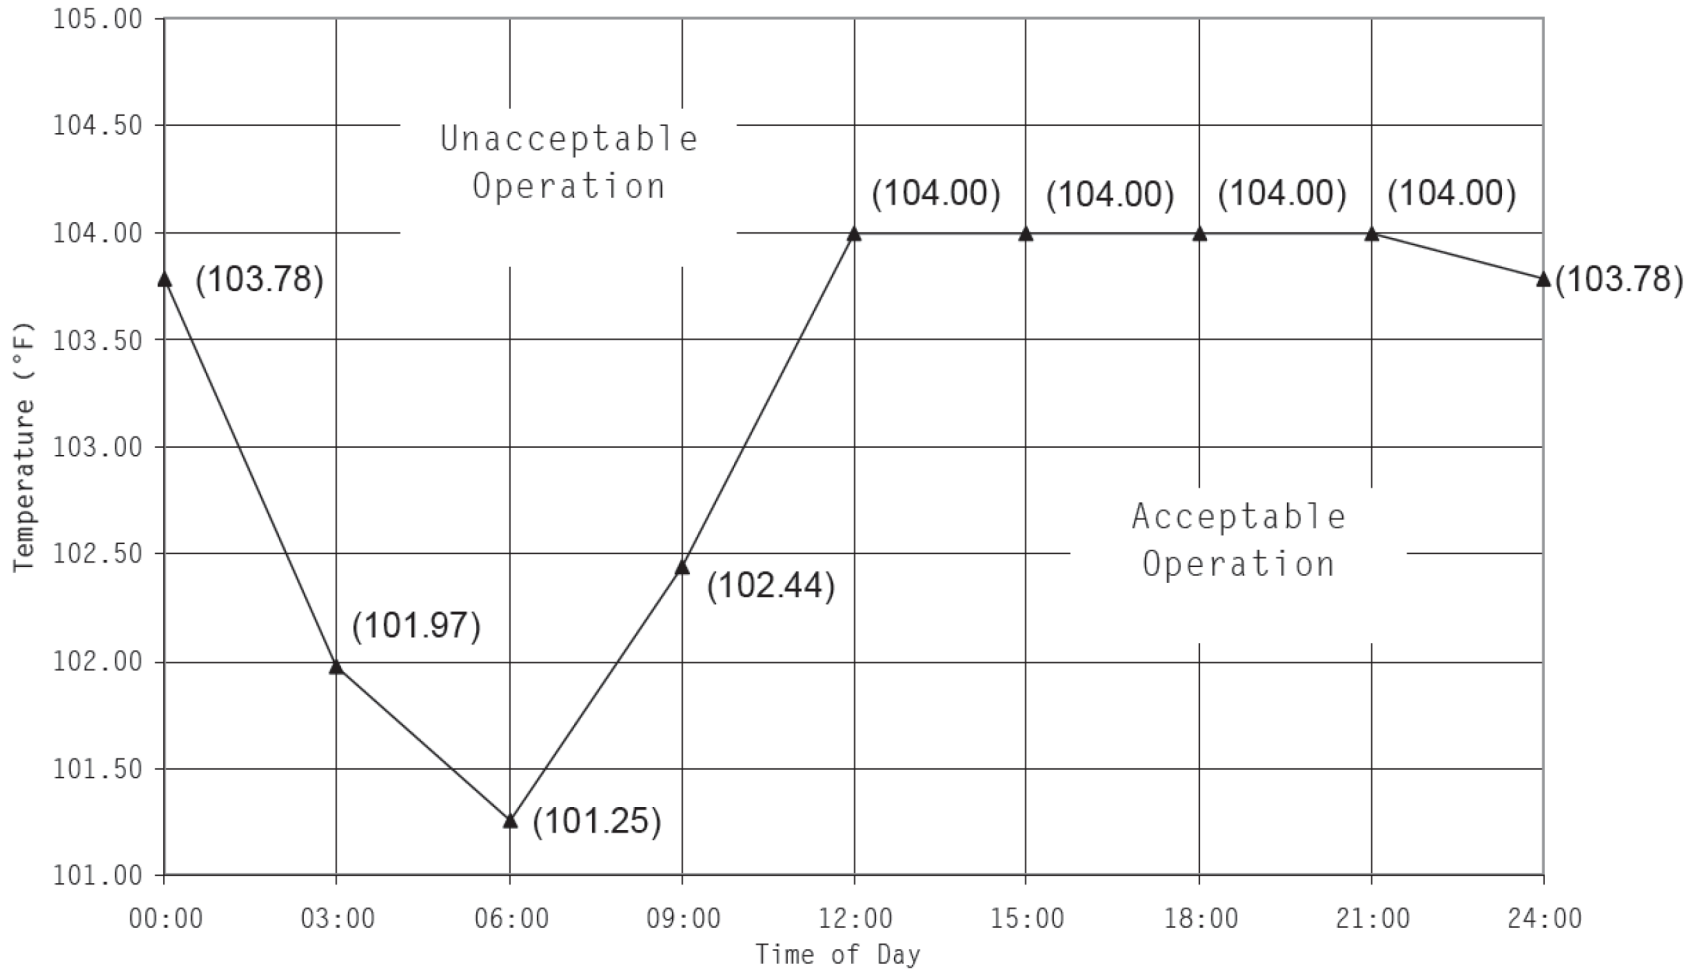
FIGURE 9.2-8

UHS TECHNICAL SPECIFICATION  
TEMPERATURE LIMIT

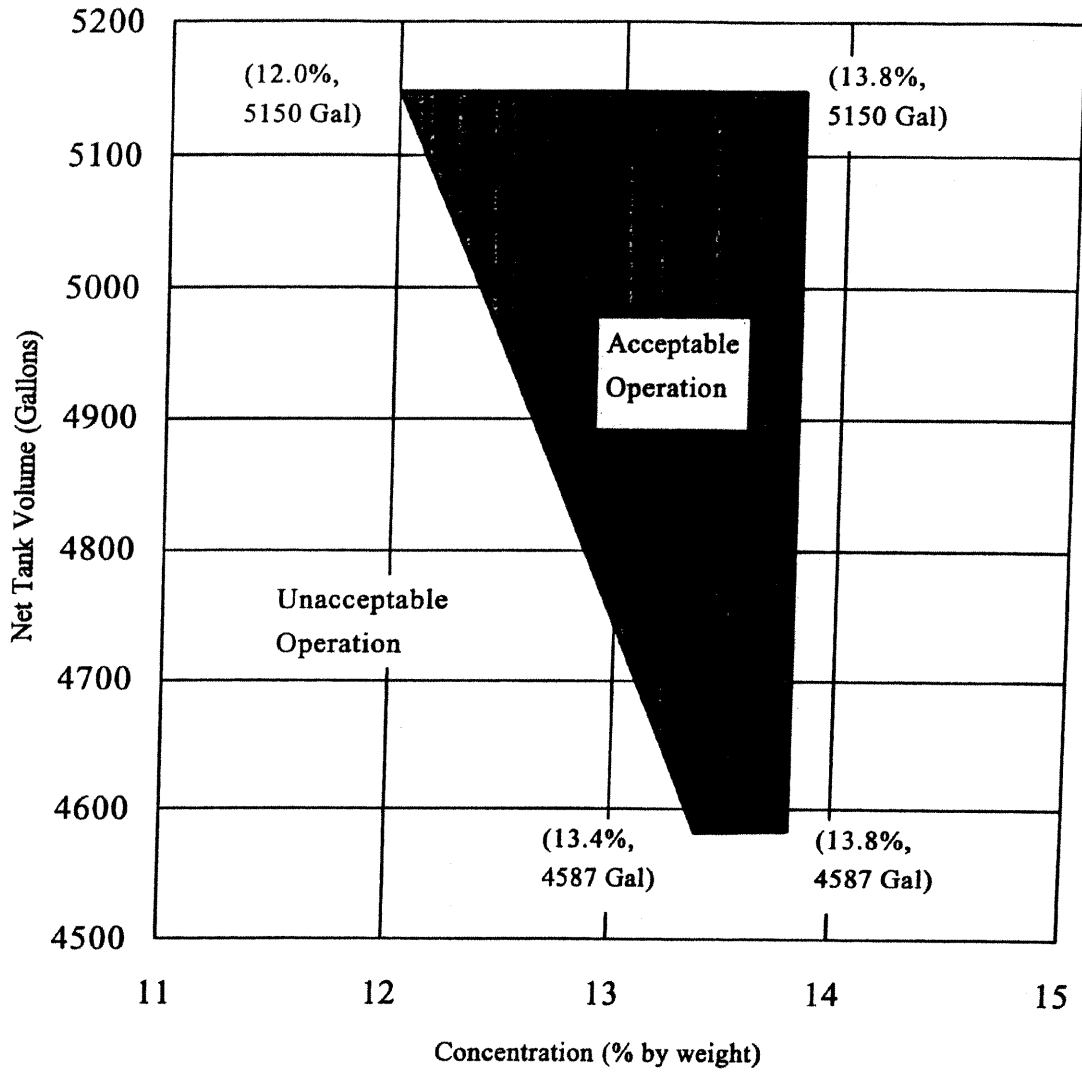
FIGURE 9.3-1

SODIUM PENTABORATE VOLUME  
CONCENTRATION REQUIREMENTS
