RADIOLOGIC AND ENGINEERING ASSESSMENT

DOE ID NO.: GJ-18587-VL
ADDRESS: 2245 NORTH 15TH STREET

JULY 1985

URANIUM MILL TAILINGS REMEDIAL ACTION PROJECT OFFICE

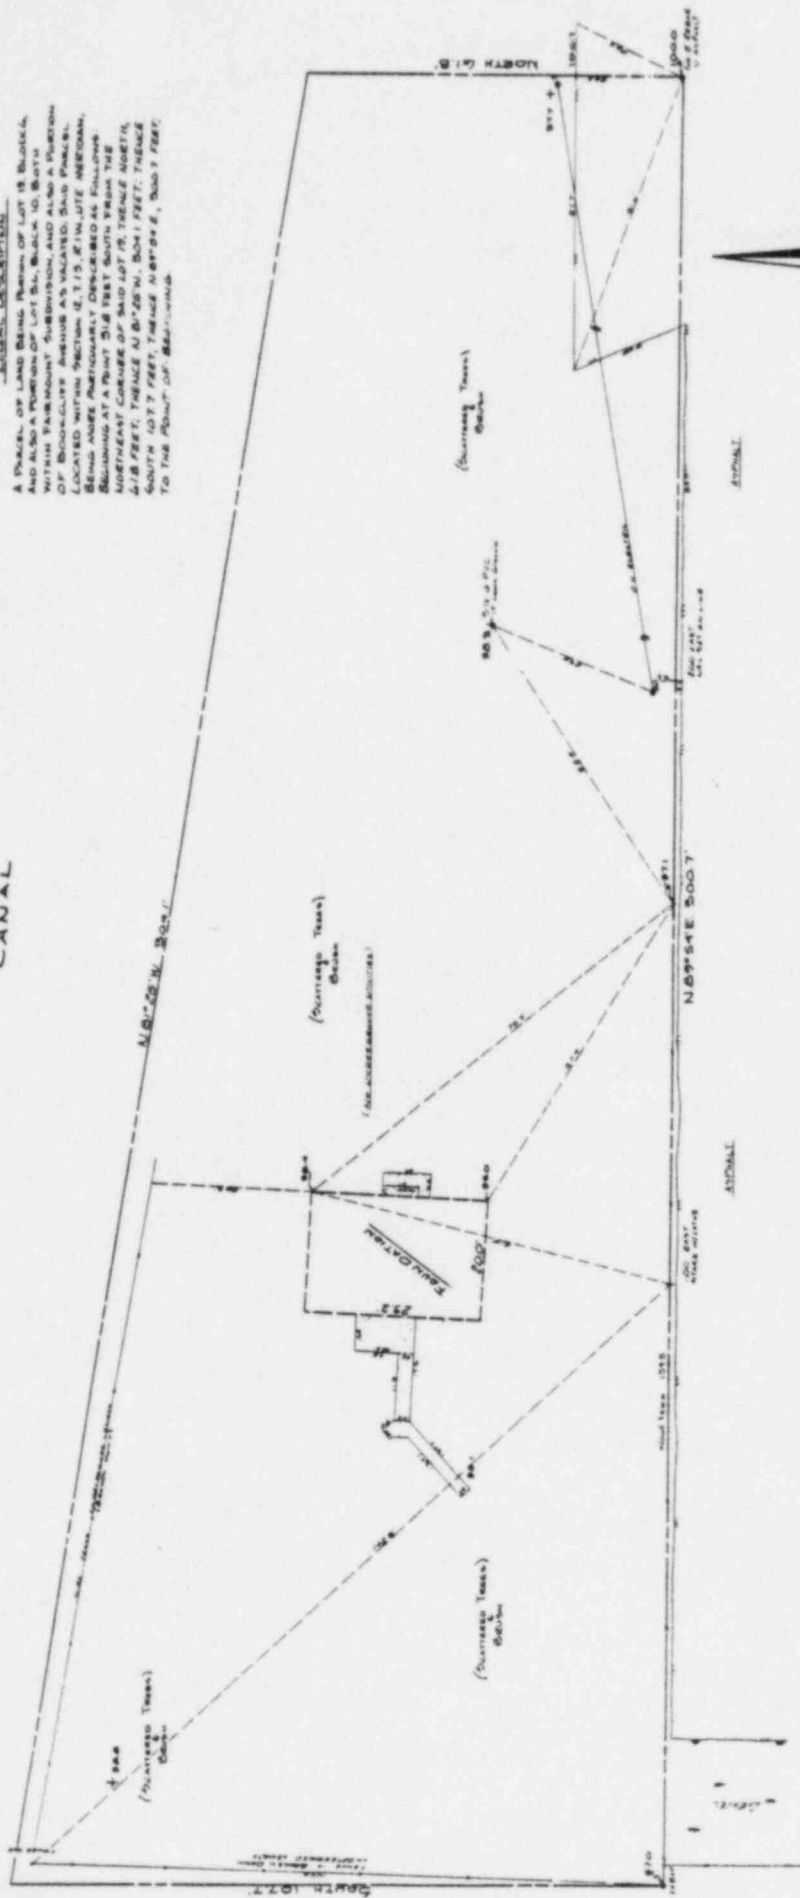
FIGURE 2.2 SITE PLAN

Utilities: Utility locations are shown in Appendix Figure 2.2.

Electrical:	Overhead (abandoned)
Gas:	None
Telephone:	None
Sewer:	None
Water:	None
Cable TV:	None

There are numerous trees throughout this property. Structures, utilities, landscaping, and other special features of this property are included in Appendix Figure 2.2.

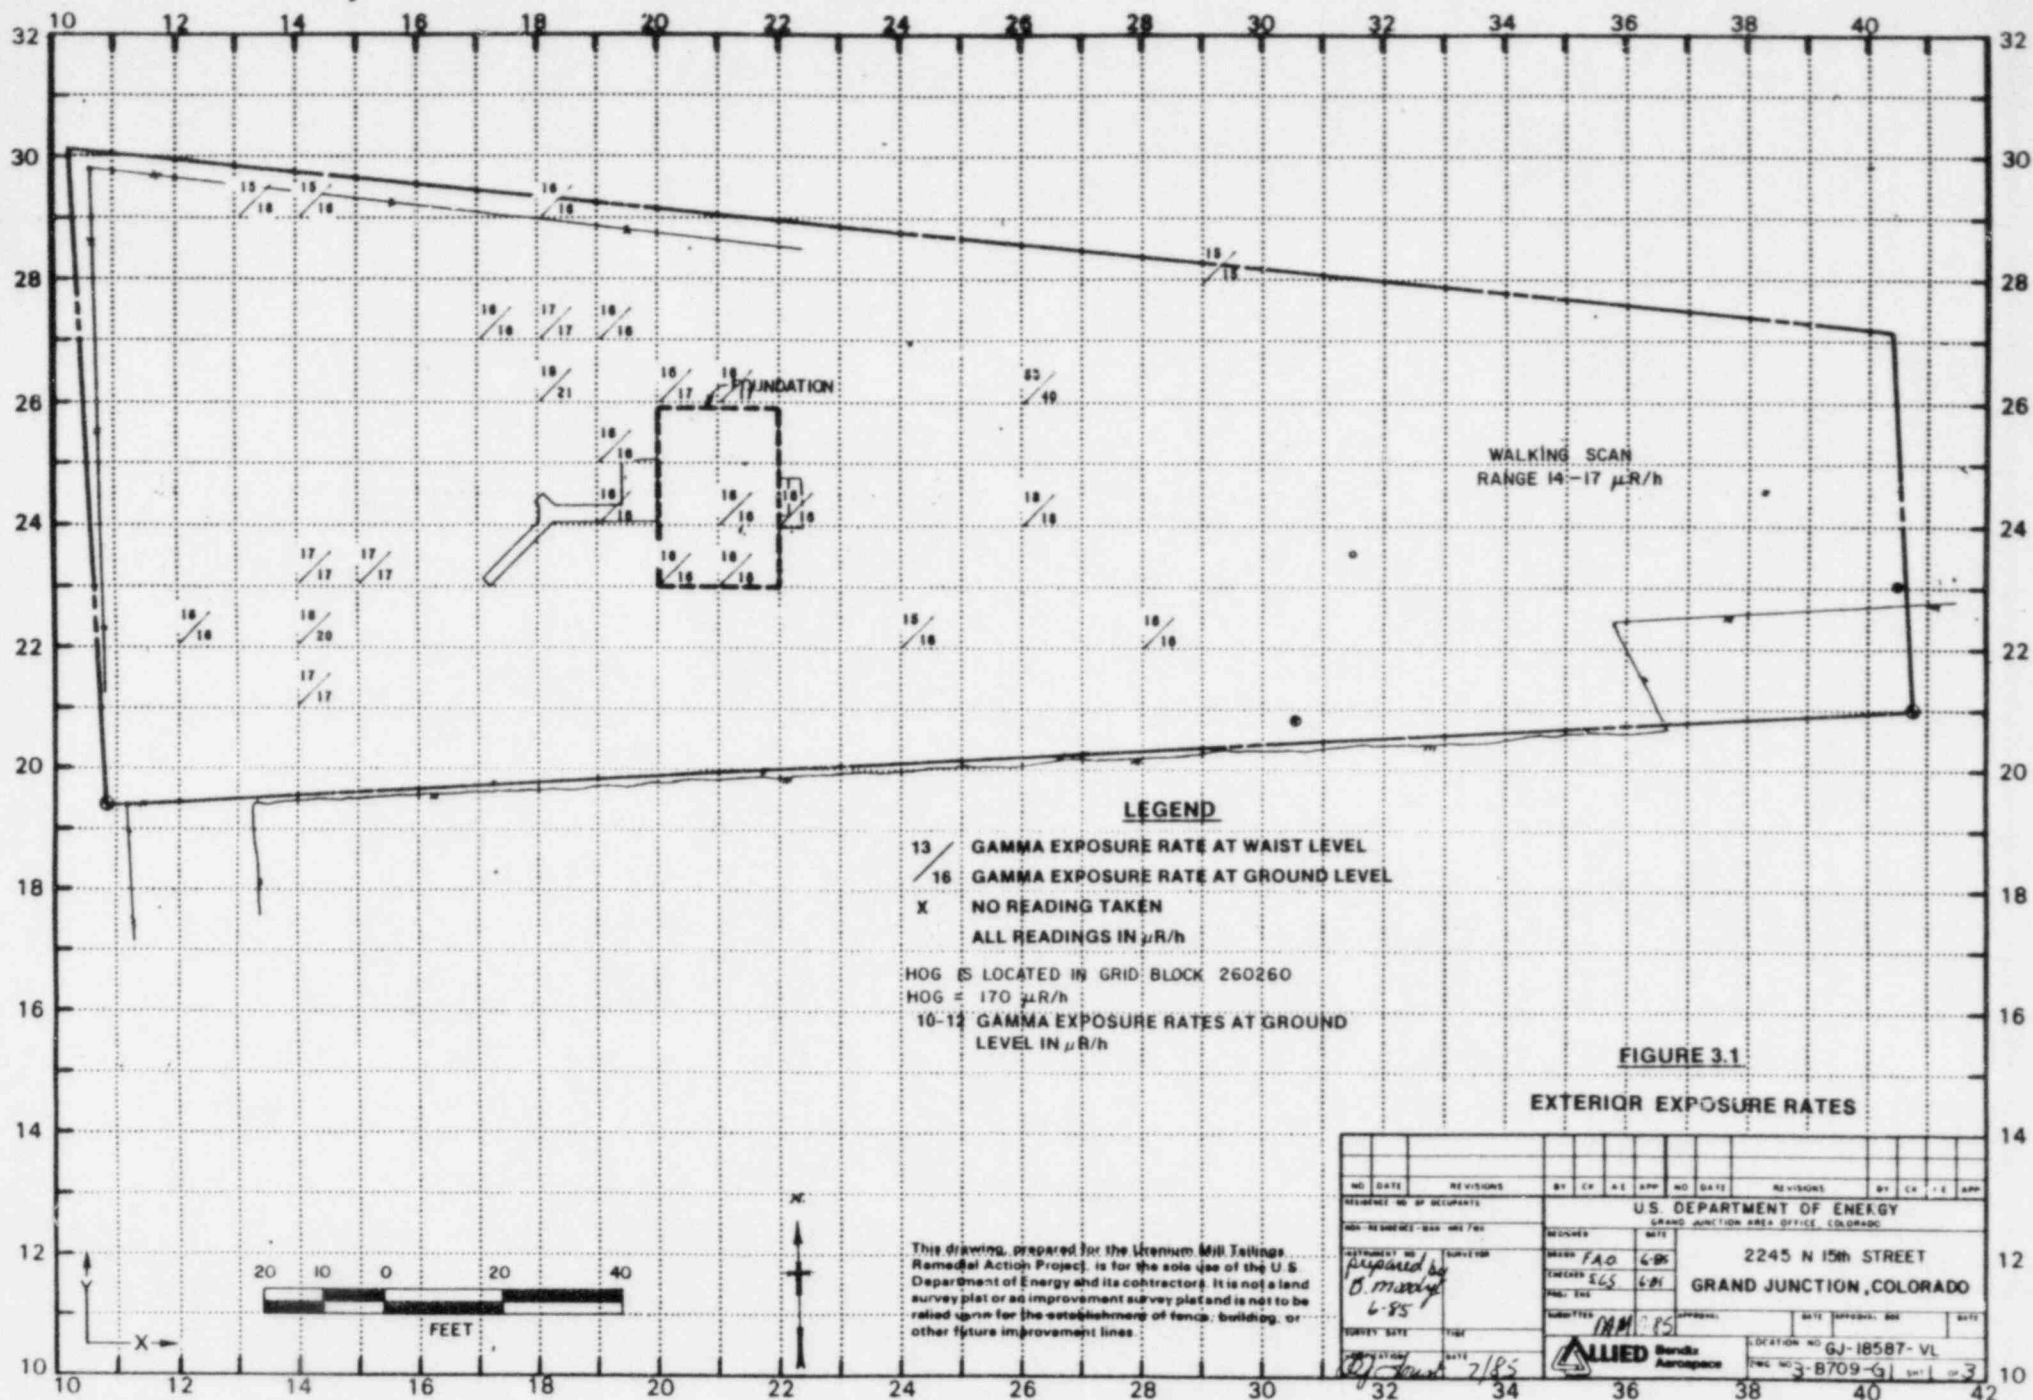
Background Readings: 14 to 17 uR/h
Highest Outside Gamma Reading (HOG): 170 uR/h

Exterior radium-concentration measurements are presented in Appendix Table 3.1. Grid-point survey and gamma scan results are shown in Appendix Figure 3.1.

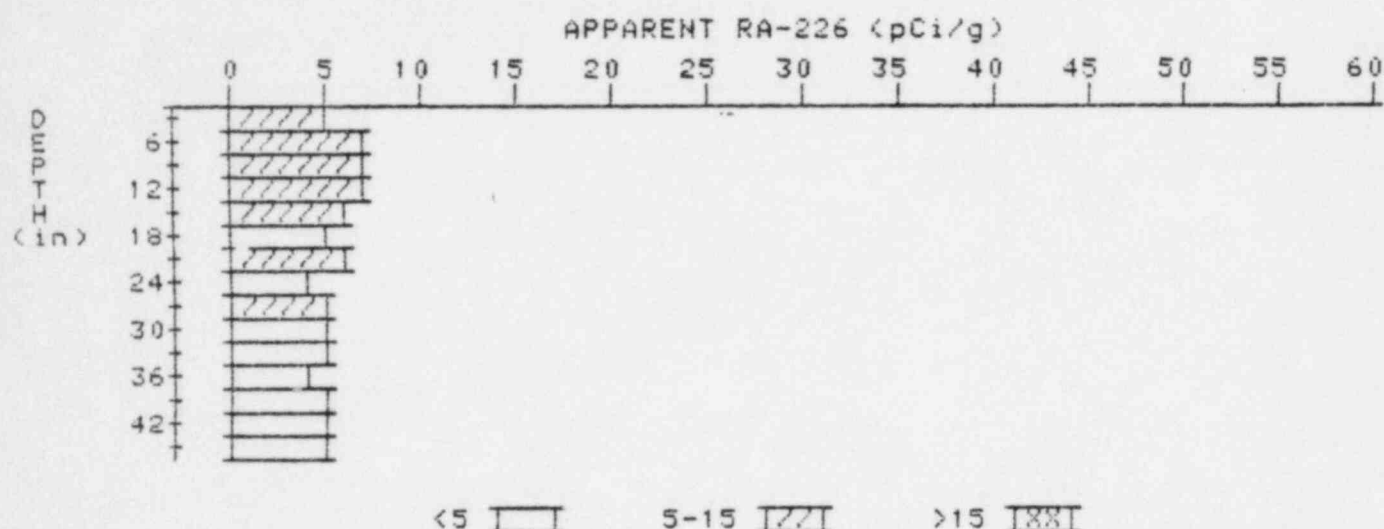
APPARENT RADIUM-226 CONCENTRATION DECONVOLUTION GRAPH

HOLE NUMBER: 2

LOCATION: 140220

Depth (in)	Apparent Radium-226 (pCi/g) Undeconvolved	Apparent Radium-226 (pCi/g) Deconvolved
3	5.2	5.2
6	6.1	7.0
9	6.5	7.4
12	6.4	7.1
15	5.9	5.7
18	5.5	5.0
21	5.4	5.9
24	5.0	4.5
27	4.9	5.1
30	4.7	4.5
33	4.6	4.6
36	4.5	4.3
39	4.5	4.5
42	4.5	4.5
45	4.5	4.5

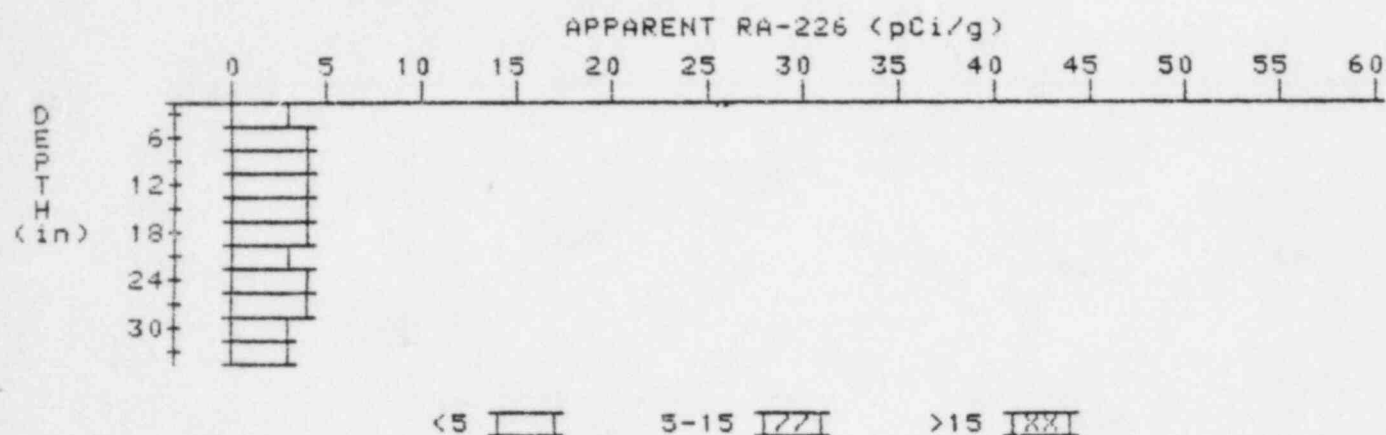
APPARENT RADIUM-226 CONCENTRATION DECONVOLUTION GRAPH

HOLE NUMBER: 3

LOCATION: 170200

Depth (in)	Apparent Radium-226 (pCi/g) Undeconvolved	Apparent Radium-226 (pCi/g) Deconvolved
3	3.4	3.4
6	3.6	3.8
9	3.7	3.9
12	3.7	3.7
15	3.7	3.7
18	3.7	3.9
21	3.6	3.4
24	3.6	3.8
27	3.5	3.5
30	3.4	3.2
33	3.4	3.4

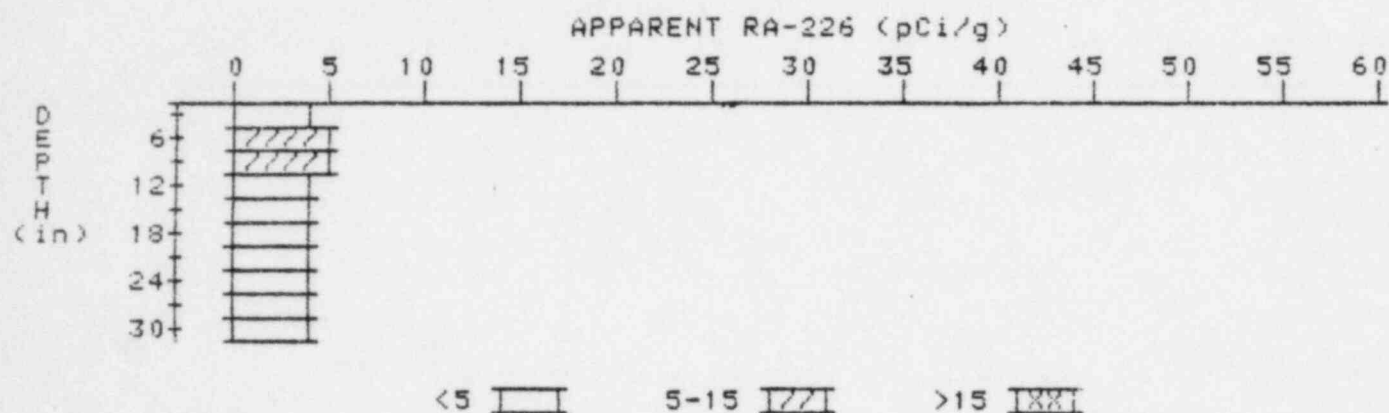
APPARENT RADIUM-226 CONCENTRATION DECONVOLUTION GRAPH

HOLE NUMBER: 6

LOCATION: 225239

Depth (in)	Apparent Radium-226 (pCi/g) Undeconvolved	Apparent Radium-226 (pCi/g) Deconvolved
3	3.8	3.8
6	4.3	5.0
9	4.4	5.1
12	4.1	3.9
15	3.9	3.7
18	3.8	3.6
21	3.8	4.0
24	3.7	3.5
27	3.7	3.9
30	3.6	3.6

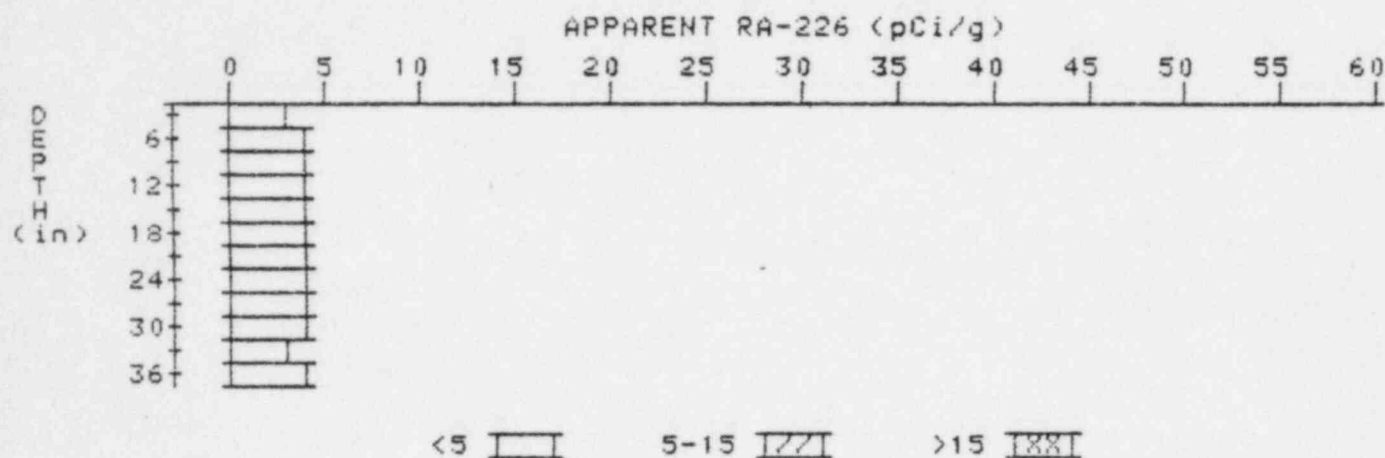
APPARENT RADIUM-226 CONCENTRATION DECONVOLUTION GRAPH

HOLE NUMBER: 7

LOCATION: 230270

Depth (in)	Apparent Radium-226 (pCi/g) Undeconvolved	Apparent Radium-226 (pCi/g) Deconvolved
3	3.1	3.1
6	3.6	4.1
9	3.8	4.2
12	3.8	3.6
15	3.9	4.3
18	3.8	3.6
21	3.8	3.8
24	3.8	4.0
27	3.7	3.7
30	3.6	3.6
33	3.5	3.3
36	3.5	3.5

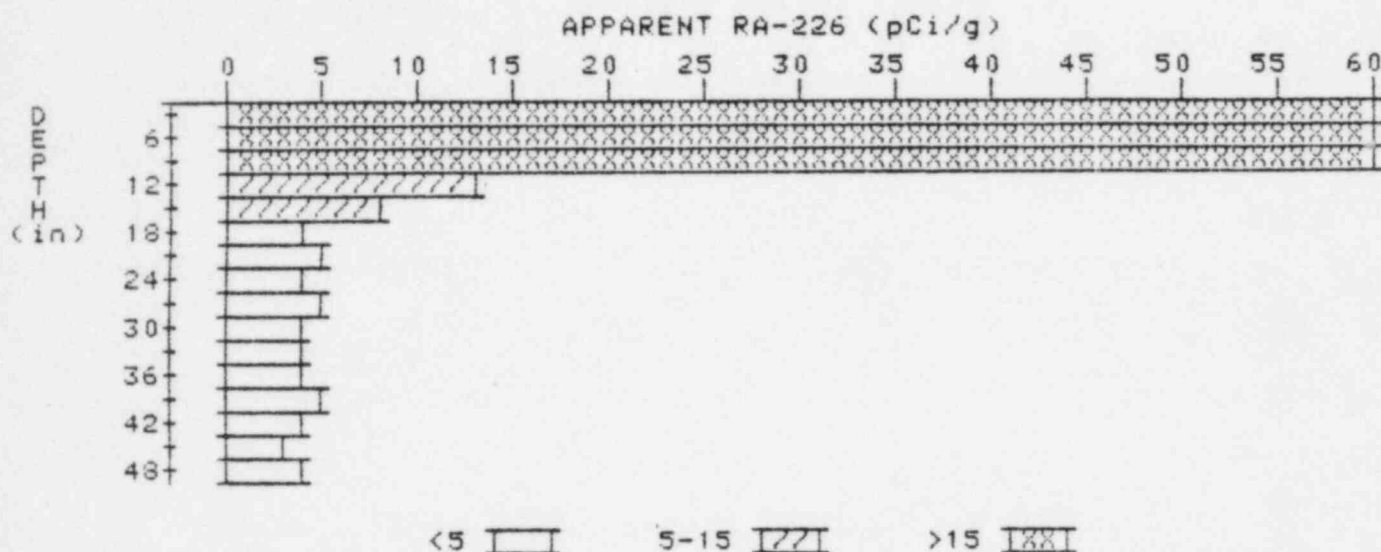
APPARENT RADIUM-226 CONCENTRATION 12 DECONVOLUTION GRAPH

PROPERTY NUMBER: GJ-18587-VL
HOLE NUMBER: 12
LOCATION: 271264

Depth (in)	Apparent Radium-226 (pCi/g) Undeconvolved	Apparent Radium-226 (pCi/g) Deconvolved
3	64.6	64.6
6	67.2	100.6
9	51.0	60.2
12	29.6	13.4
15	17.3	7.7
18	10.4	3.6
21	7.3	4.8
24	5.6	3.8
27	4.9	4.5
30	4.4	3.9
33	4.2	3.8
36	4.2	4.0
39	4.3	4.8
42	4.1	4.1
45	3.9	3.2
48	4.1	4.1

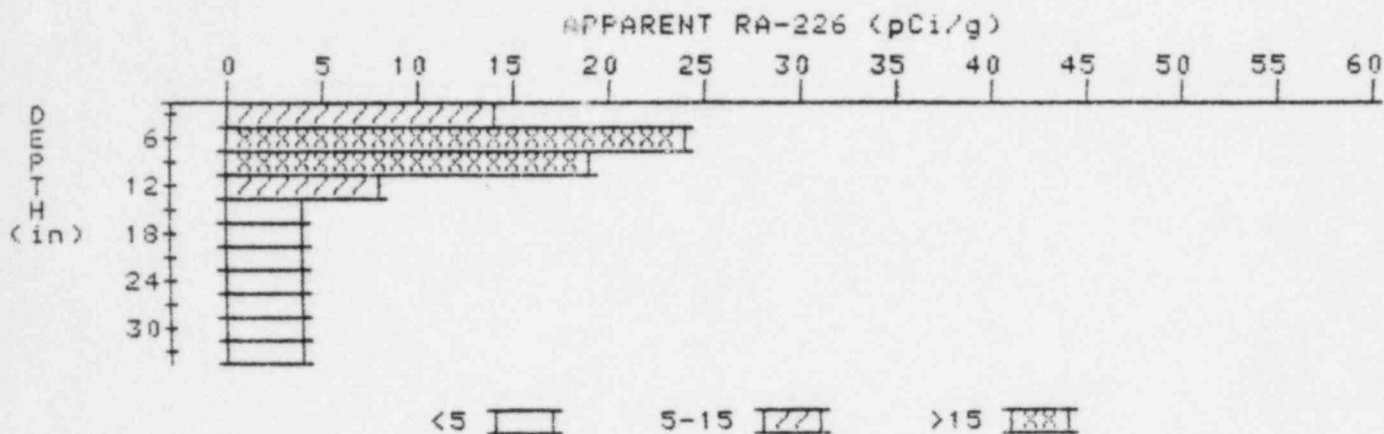
APPARENT RADIUM-226 CONCENTRATION 13 DECONVOLUTION GRAPH

PROPERTY NUMBER: GJ-18587-VL
HOLE NUMBER: 13
LOCATION: 290218

Depth (in)	Apparent Radium-226 (pCi/g) Undeconvolved	Apparent Radium-226 (pCi/g) Deconvolved
3	13.6	13.6
6	16.3	24.3
9	14.5	19.1
12	10.1	8.0
15	6.9	3.9
18	5.4	4.0
21	4.7	4.2
24	4.3	4.1
27	4.0	3.6
30	3.9	3.7
33	3.9	3.9

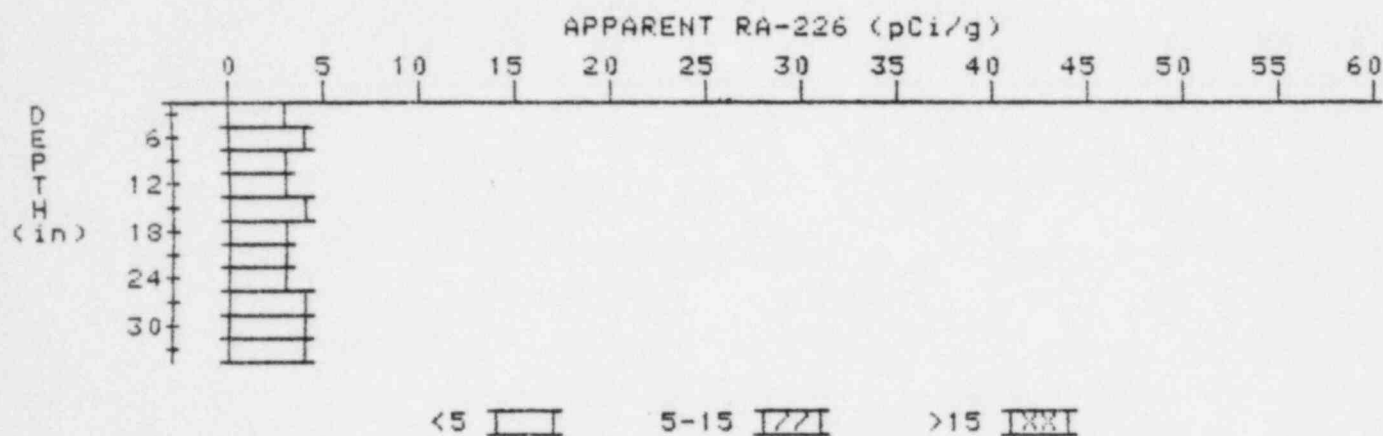
APPARENT RADIUM-226 CONCENTRATION 14 DECONVOLUTION GRAPH

PROPERTY NUMBER: GJ-18587-VL
HOLE NUMBER: 14
LOCATION: 290240

Depth (in)	Apparent Radium-226 (pCi/g) Undeconvolved	Apparent Radium-226 (pCi/g) Deconvolved
3	2.9	2.9
6	3.2	3.6
9	3.3	3.5
12	3.3	3.1
15	3.4	3.6
18	3.4	3.4
21	3.4	3.4
24	3.4	3.2
27	3.5	3.5
30	3.6	3.8
33	3.6	3.6

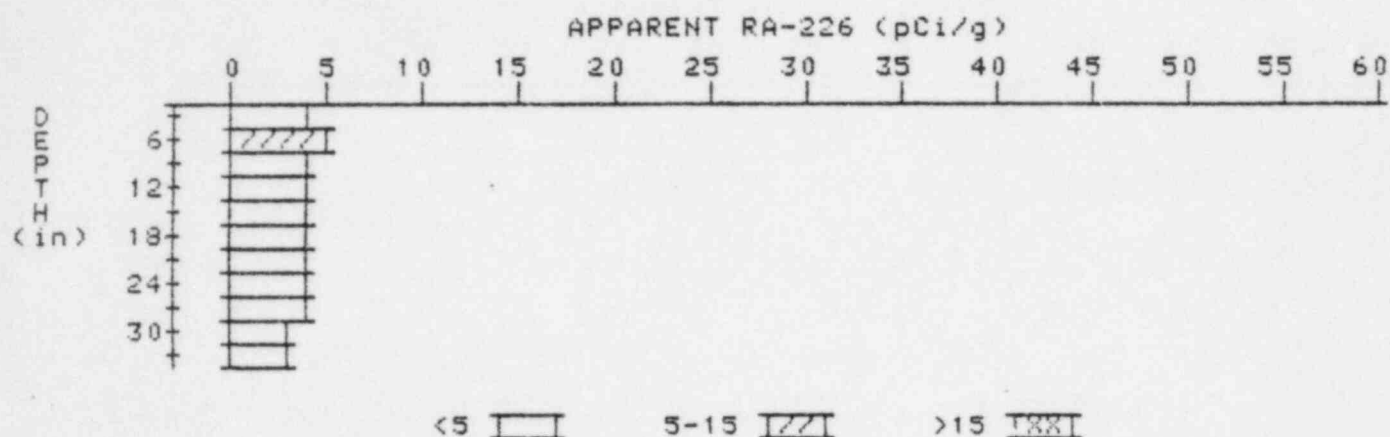
APPARENT RADIUM-226 CONCENTRATION 15 DECONVOLUTION GRAPH

HOLE NUMBER: 15

LOCATION: 290260

Depth (in)	Apparent Radium-226 (pCi/g) Undeconvolved	Apparent Radium-226 (pCi/g) Deconvolved
3	4.3	4.3
6	4.5	5.4
9	4.2	4.2
12	3.9	3.5
15	3.8	3.8
18	3.7	3.5
21	3.7	3.9
24	3.6	3.6
27	3.5	3.5
30	3.4	3.2
33	3.4	3.4

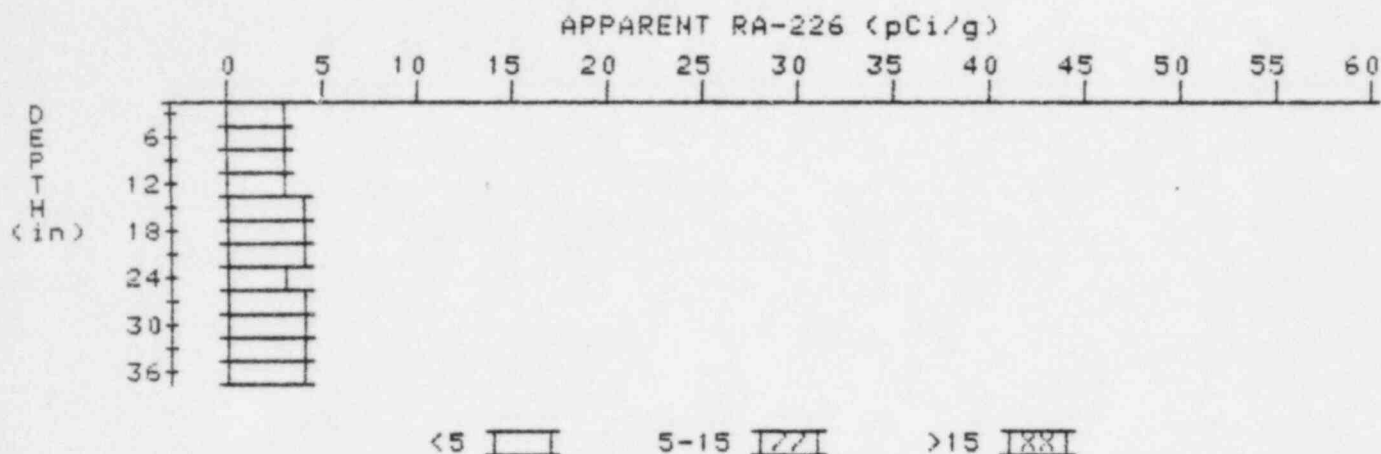
APPARENT RADIUM-226 CONCENTRATION 16 DECONVOLUTION GRAPH

PROPERTY NUMBER: GJ-18587-VL
HOLE NUMBER: 16
LOCATION: 290282

Depth (in)	Apparent Radium-226 (pCi/g) Undeconvolved	Apparent Radium-226 (pCi/g) Deconvolved
3	2.5	2.5
6	2.9	3.3
9	3.1	3.1
12	3.3	3.3
15	3.5	3.9
18	3.5	3.5
21	3.5	3.5
24	3.5	3.3
27	3.6	3.8
30	3.6	3.6
33	3.6	3.6
36	3.6	3.6

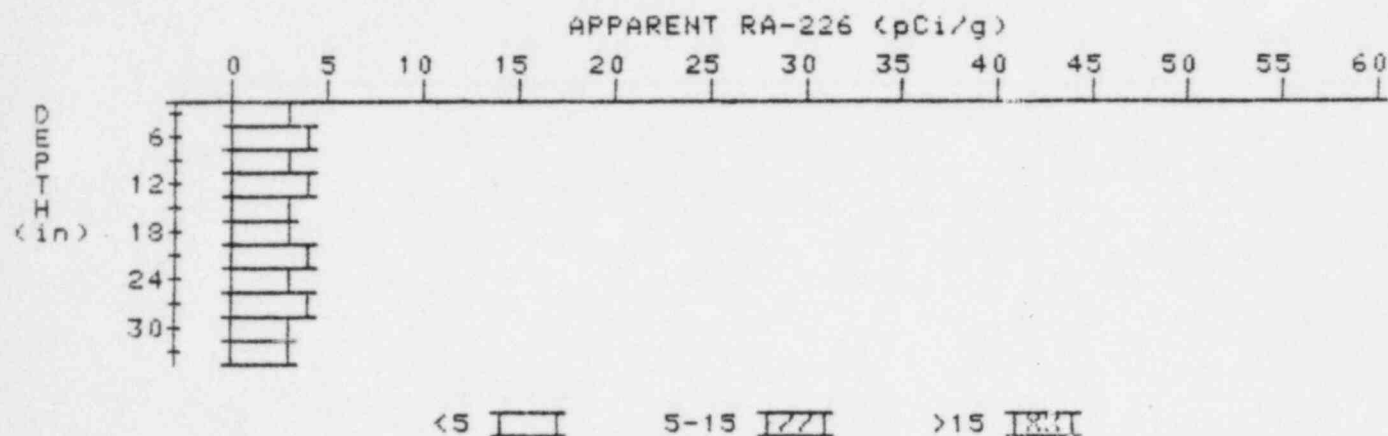
APPARENT RADIUM-226 CONCENTRATION 17 DECONVOLUTION GRAPH

PROPERTY NUMBER: GJ-18537-VL
HOLE NUMBER: 17
LOCATION: 360230

Depth (in)	Apparent Radium-226 (pCi/g) Undeconvolved	Apparent Radium-226 (pCi/g) Deconvolved
3	3.2	3.2
6	3.4	3.8
9	3.4	3.2
12	3.5	3.9
15	3.4	3.2
18	3.4	3.2
21	3.5	3.9
24	3.4	3.0
27	3.5	3.9
30	3.4	3.2
33	3.4	3.4

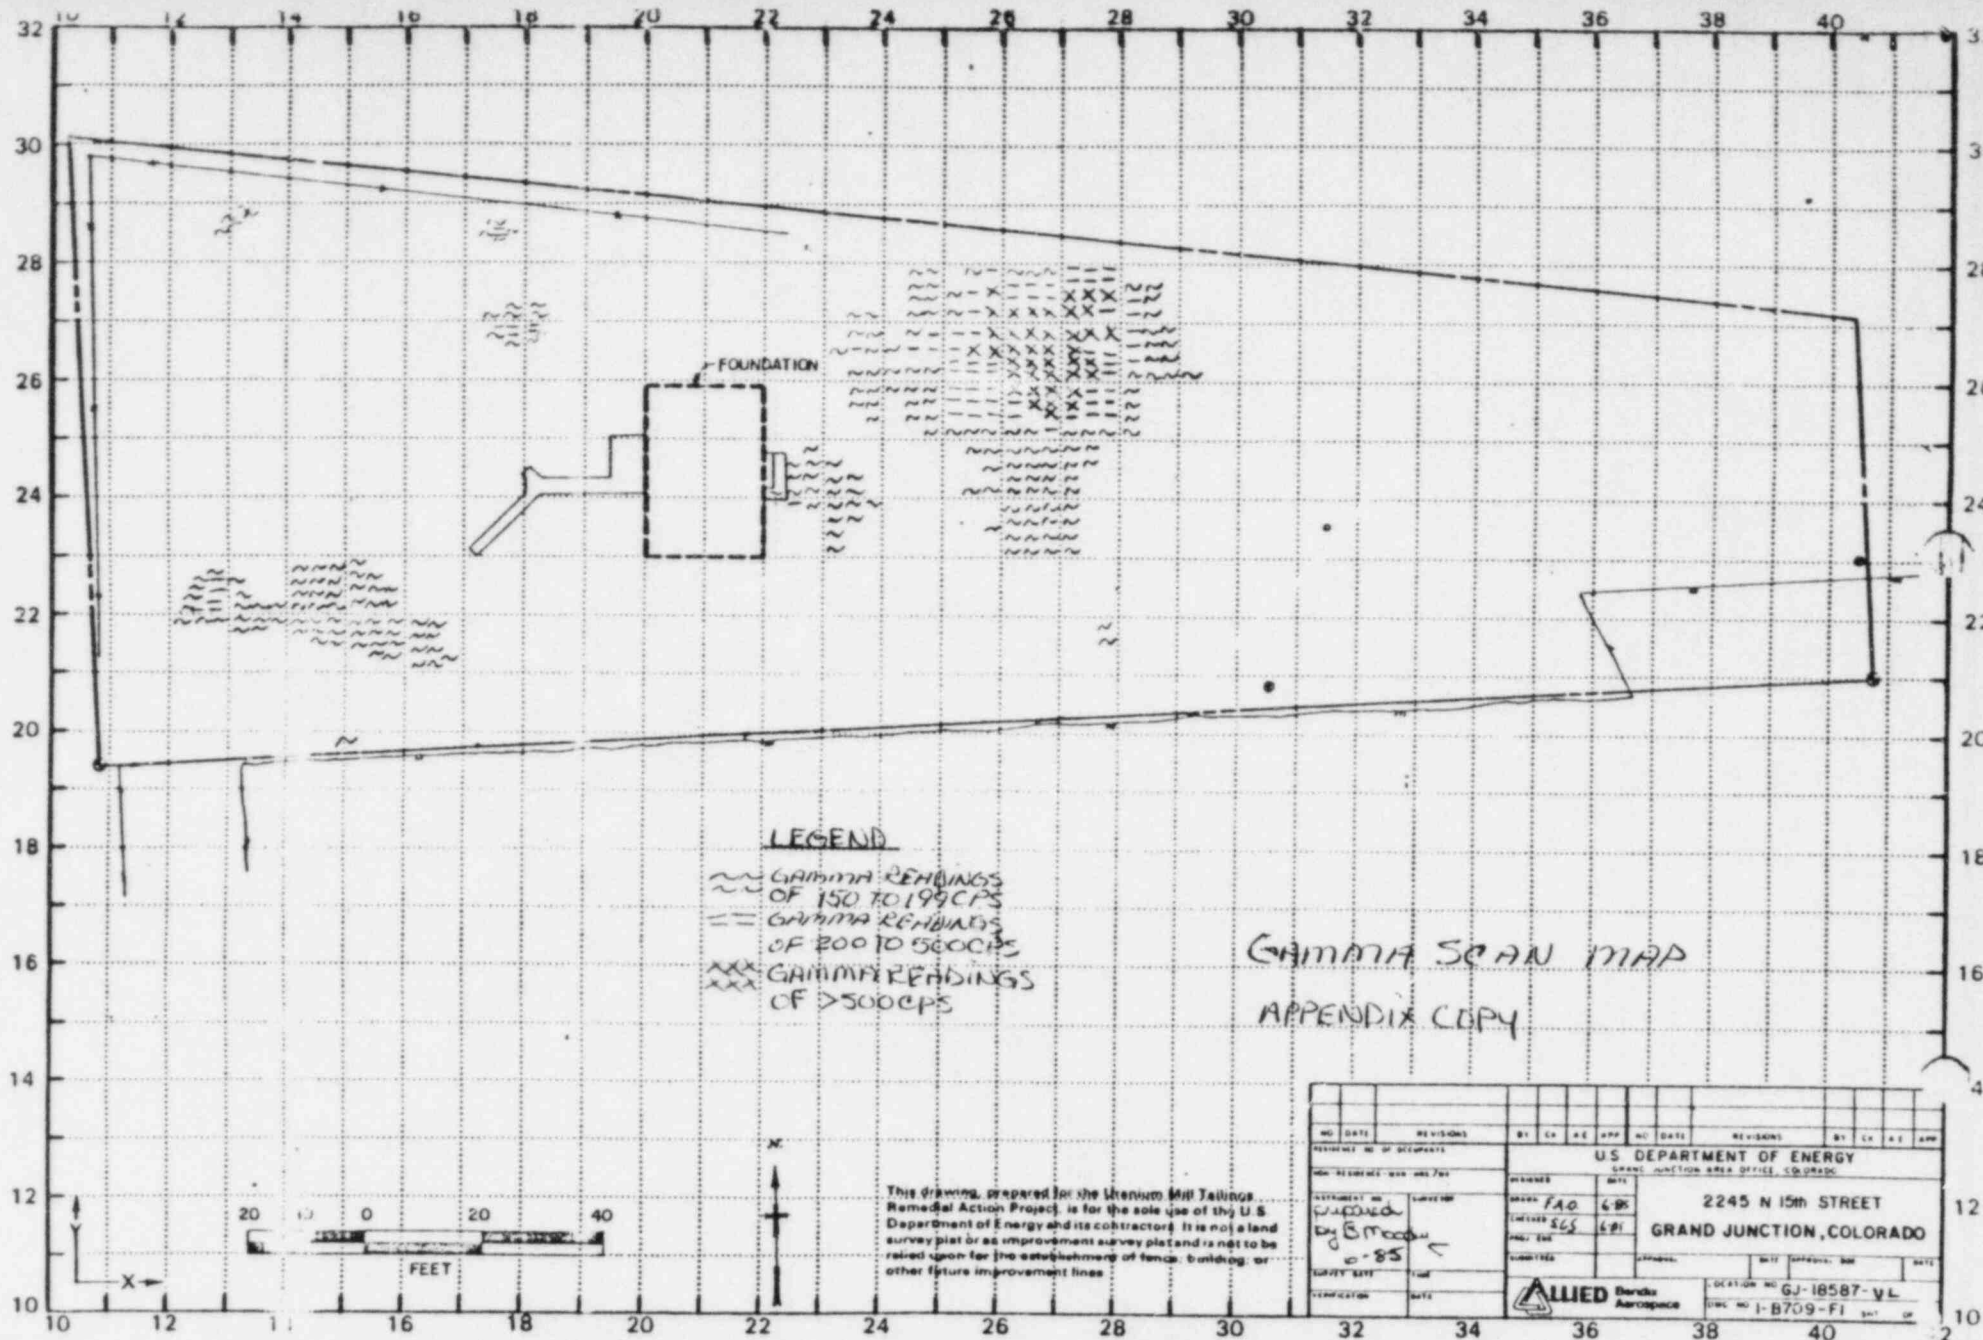
A complete walking scan was performed. The elevated readings shown on the scan map were investigated.
