SIR-86-002
Revision 0
Project: GPC0-07-1
March, 1986

EVALUATION OF IGSCC FLAW INDICATIONS
AND WELD OVERLAY DESIGNS FOR
PLANT E. I. HATCH UNIT 1 - FALL 1985
MAINTENANCE/REFUELING OUTAGE

Structural Integrity Associates

Georgia Power Company

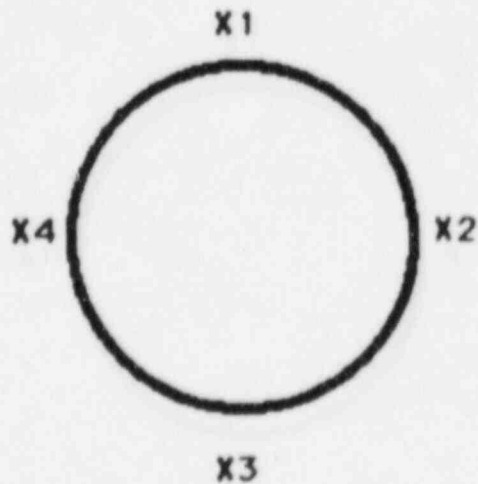
Figure 6-3. Measurement of Weld Overlay Shrinkage

**SECTION A-A
PUNCH MARKS AT 4 AZIMUTHAL LOCATIONS
(90° APART)**

1. PLACE PUNCH MARKS BEFORE BEGINNING WELDING.
2. MEASURE DISTANCE BETWEEN EACH PAIR (UPSTREAM/DOWNSTREAM) OF MARKS BEFORE AND AFTER WELDING
