Results of Foliar  
Survey for winter  
of 1984-1985  
attached.

Subject: EPP Annual Operating Report  
Appendix B to Facility License No. NPF-11 and No. NPF-18

Fog and Rime Ice Monitoring Program Summary  
LaSalle County Generating Station

RESULTS OF POLIAR SURVEY OF THE  
LASALLE COUNTY GENERATING STATION FOR RIME  
ICE DEPOSITION DAMAGE

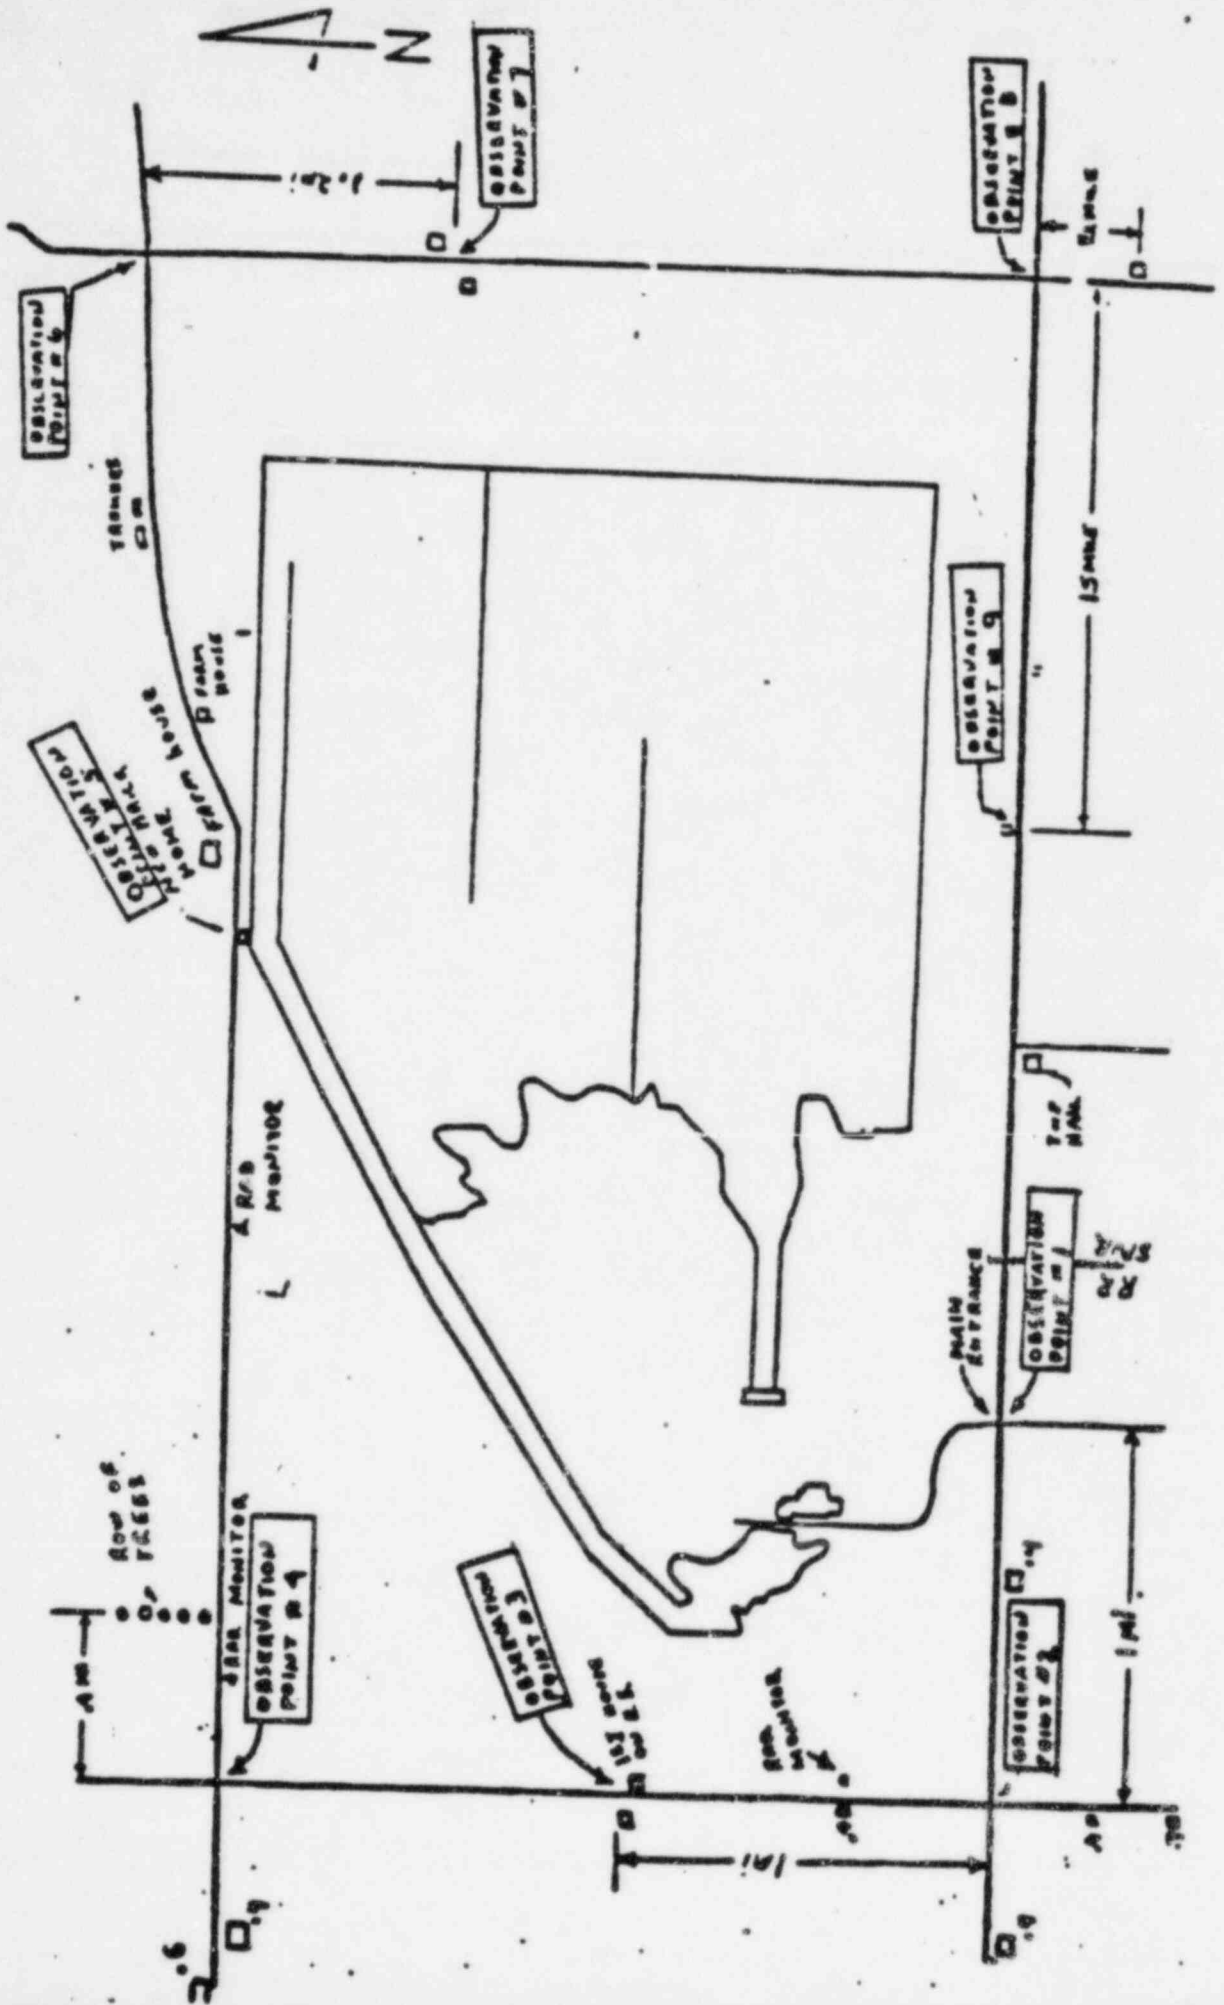
Obs.Pt.	Dir. Span	Obs.Pt.	Dir. Span	Obs.Pt.	Dir. Span
1	305°- 82°	4	90°-161°	7	197°-339°
2	27°- 85°	5	90°-240°	8	278°-351°
3	65°-112°	6	188°-262°	9	286°- 67°

(See Map on Reverse Side)
