NUREG/CR-4597
Volume 1
ORNL-6282/V1

Aging and Service Wear of Auxiliary Feedwater Pumps for PWR Nuclear Power Plants

Volume 1. Operating Experience
and Failure Identification

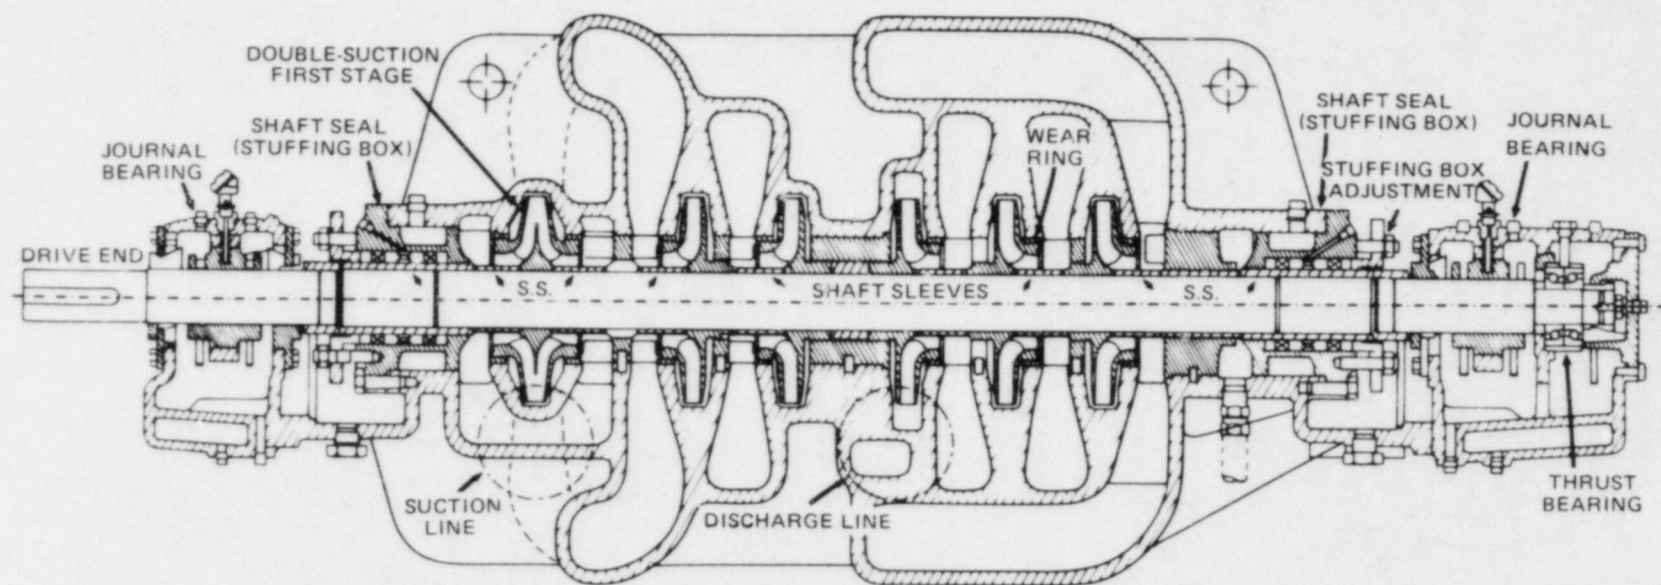
ORNL-DWG. 86-4224 ETD

Fig. 1. Double-suction, opposed-impellers AUXFP.

More specific details of configuration vary considerably from vendor to vendor. Even within the array of available designs from a single manufacturer, there can be a considerable variety of construction details. The main factor that determines these more specific configuration details is the design approach used in handling the very large axial thrust forces on the rotor, which arise as a natural by-product in HHPS centrifugal pumps. A second factor is the design approach used to avoid cavitation in the inlet (suction), that is, single-suction (Figs. 2 and 3) or double-suction (Fig. 1) inlet stage.

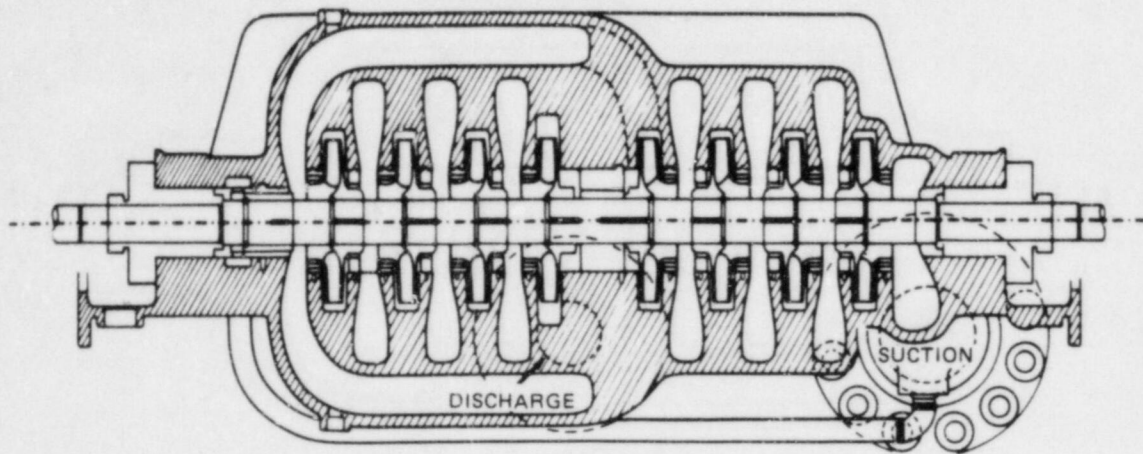
ORNL-DWG. 86-4225 ETD

Fig. 2. Single-suction, opposed-impellers AUXFP.

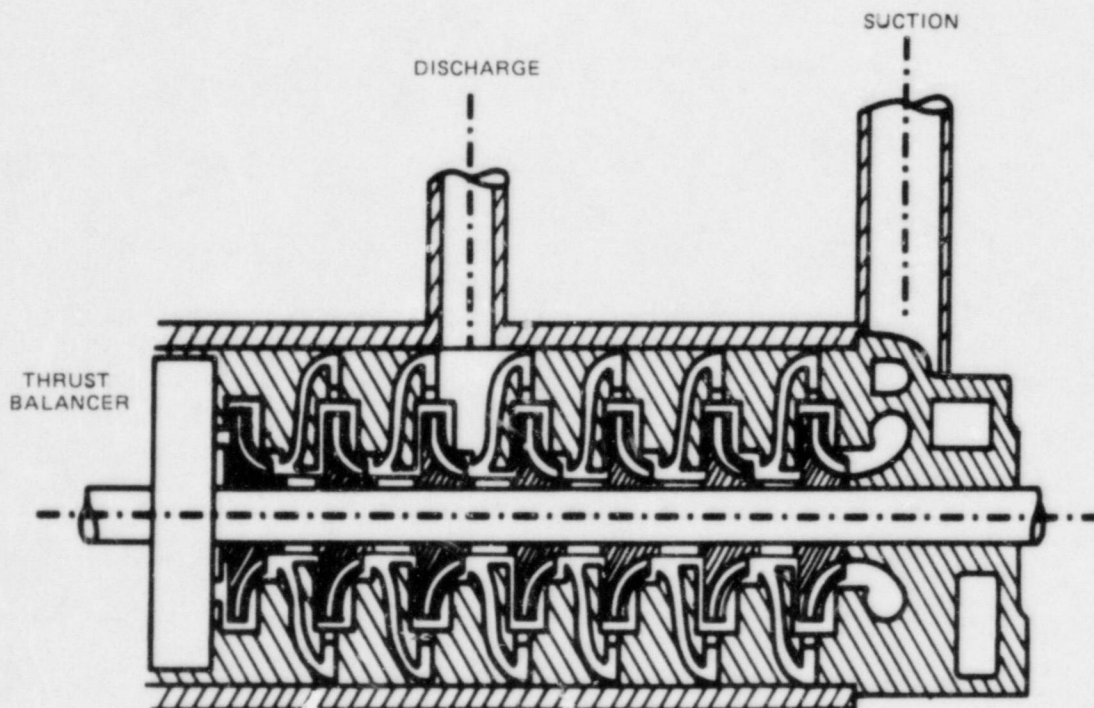
Fig. 3. Single-suction, in-line-impellers AUXFP.

Some manufacturers use a configuration with all stages positioned in the same axial direction (Fig. 3, called "in-line" type). Other manufacturers use a configuration with the stages on one-half of the shaft axially opposed to those on the other half of the shaft (Figs. 1 and 2, called "opposed" type) for thrust cancellation. The basic difference between these two configurations involves the previously referenced different design approaches to handling the very large axial thrust loads inherent in multistage HHPS centrifugal pumps. Opposed type configurations (i.e., thrust cancellation approach) are often designed with only a thrust bearing. In-line type configurations are always designed with an additional thrust balancer of either "balancing drum" type or "balancing disk" type (see Appendix D).

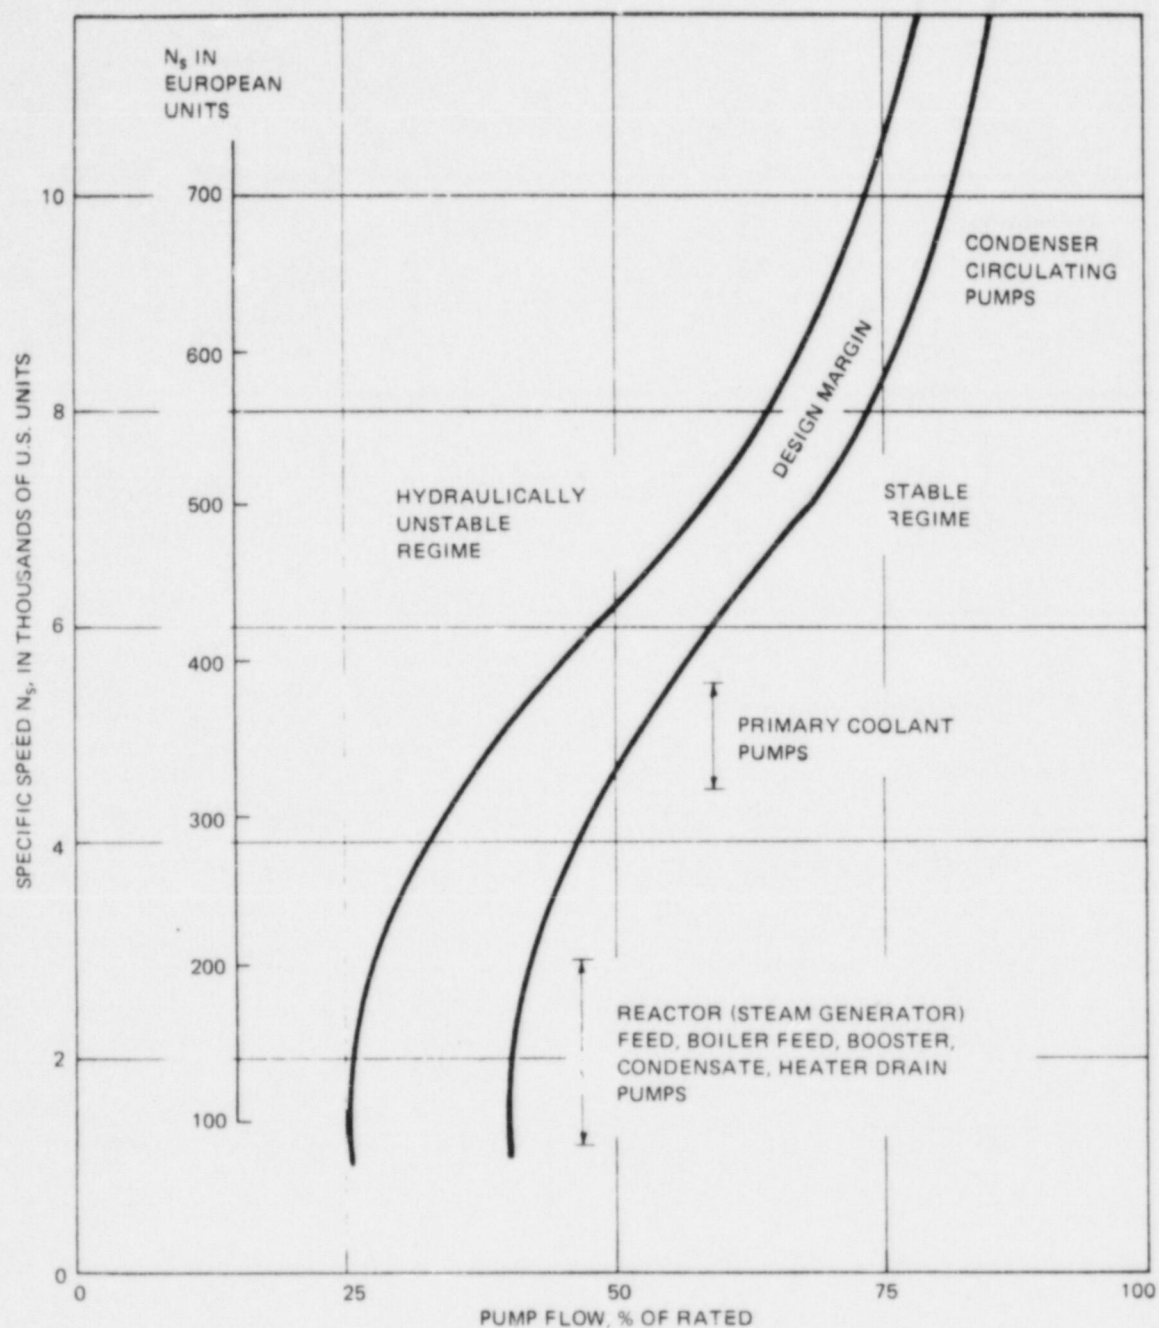
ORNL-DWG. 86-4227 ETD

Fig. D.1. Anticipated useful operating ranges for pumps used in large nuclear and fossil power generating units. (Inner line of design margin area is preferred; if hydraulic instability occurs at higher flows various pump and system problems can be expected.) Source: E. Makay and O. Szamody, *Survey of Feed Pump Outages*, EPRI FP-754, Electric Power Research Institute, April 1978.

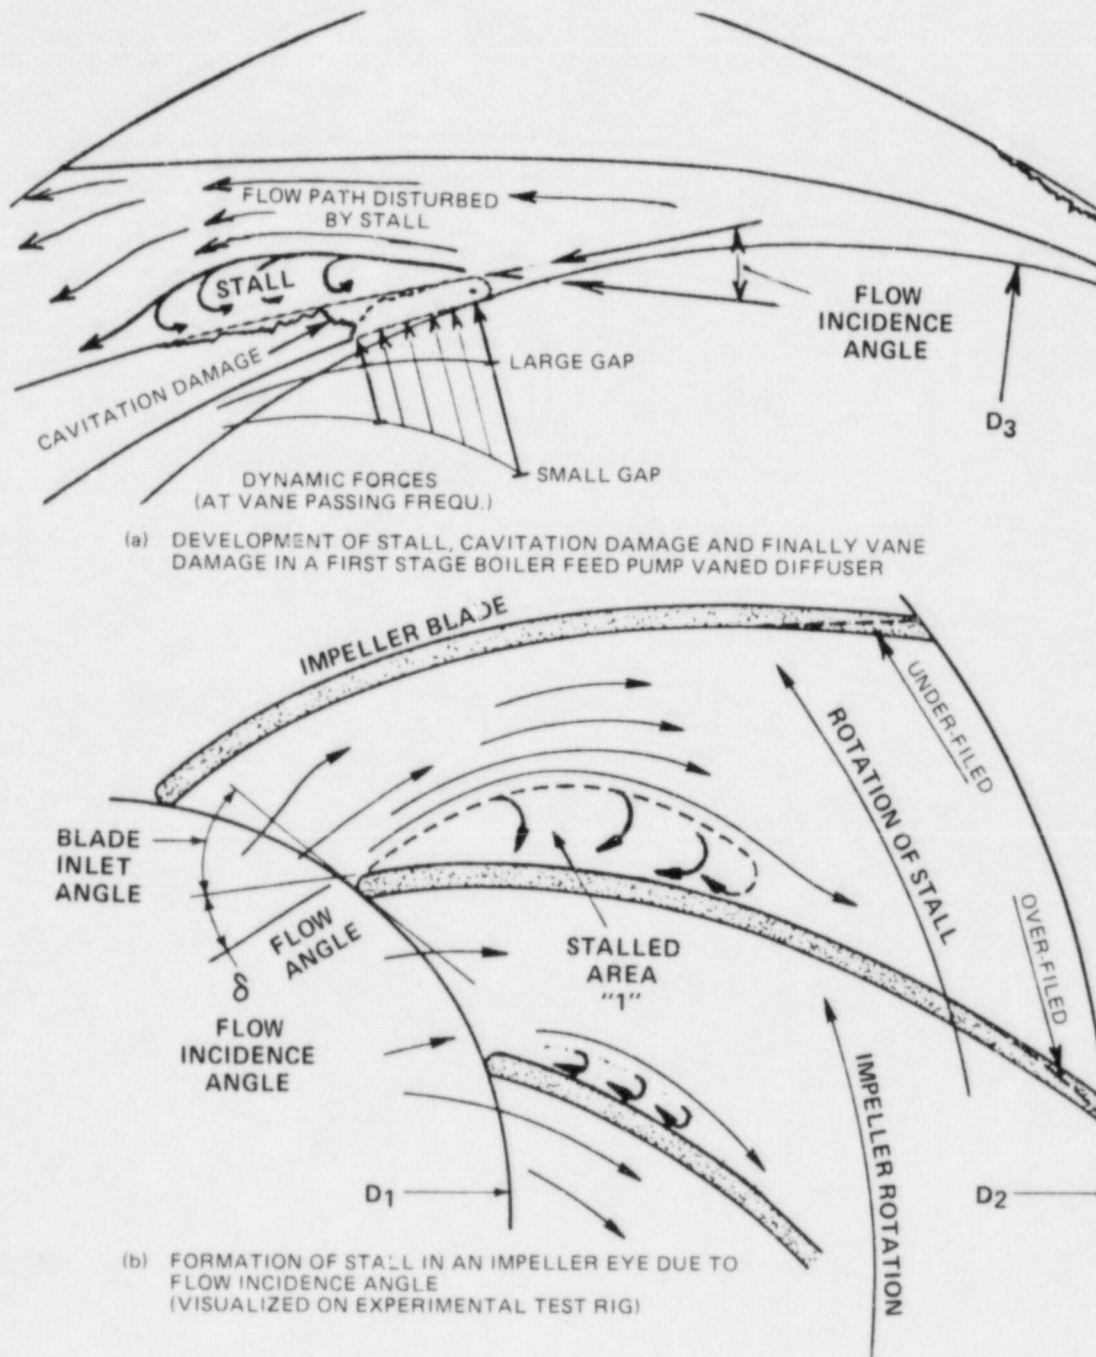
Fig. D.2. Formation of stall (a) in diffuser and (b) in eye of impeller. Source: E. Makay and O. Szamody, *Recommended Design Guidelines for Feedwater Pumps in Large Power Generating Units*, EPRI CS-1512, Electric Power Research Institute, September 1980.

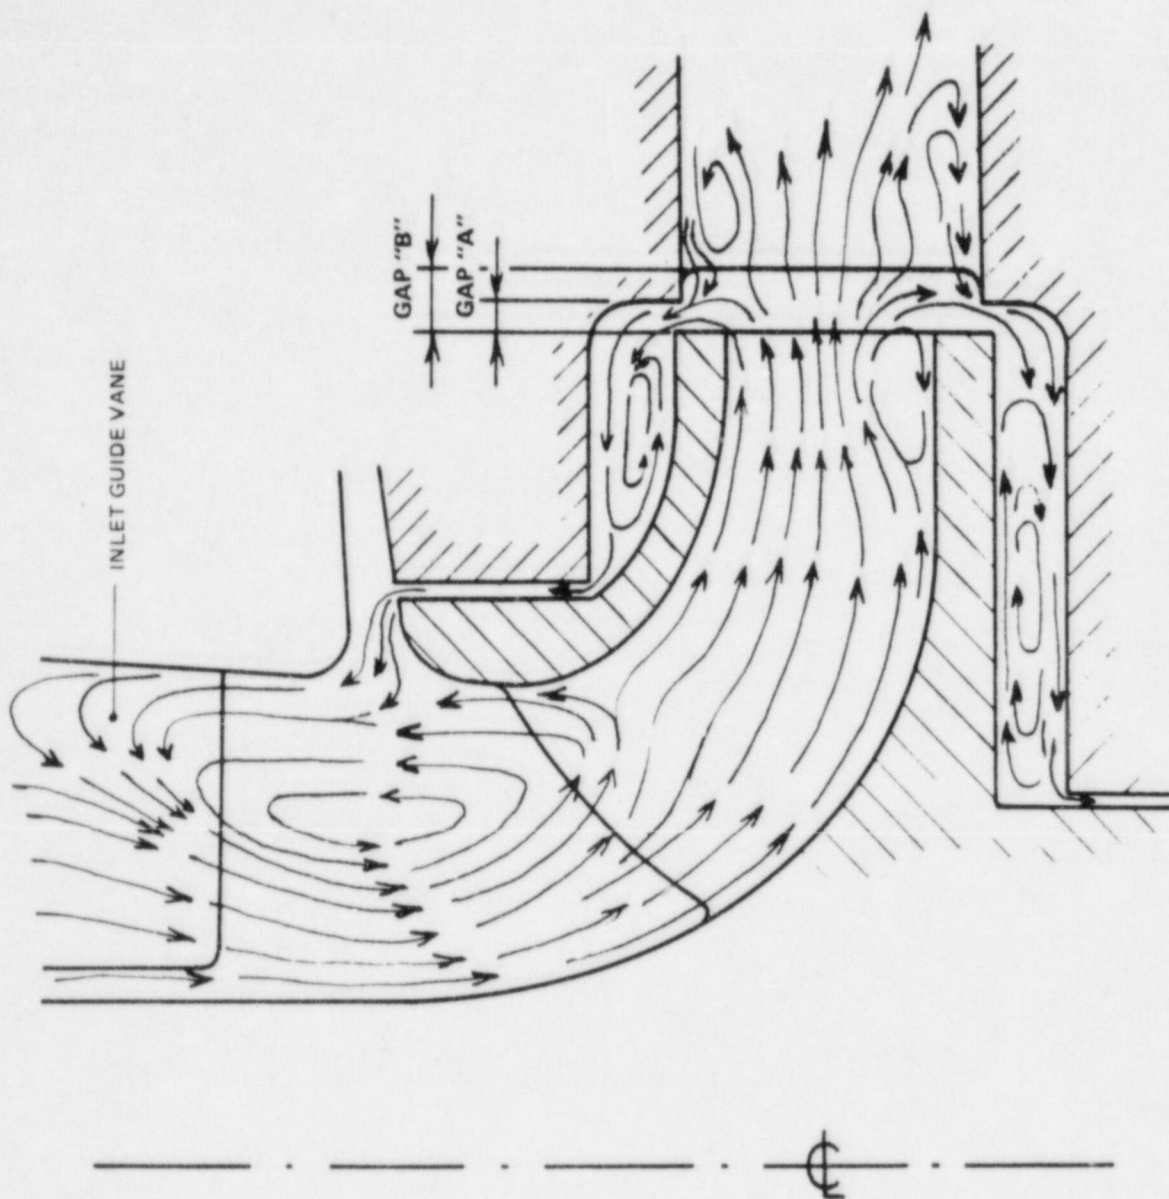
ORNL-DWG. 86-4229 ETD

Fig. D.3. Secondary flow pattern in and around pump impeller stage at off-design flow operation. Source: E. Makay and O. Szamody, *Survey of Feed Pump Outages*, EPRI FP-754, Electric Power Research Institute, April 1978.

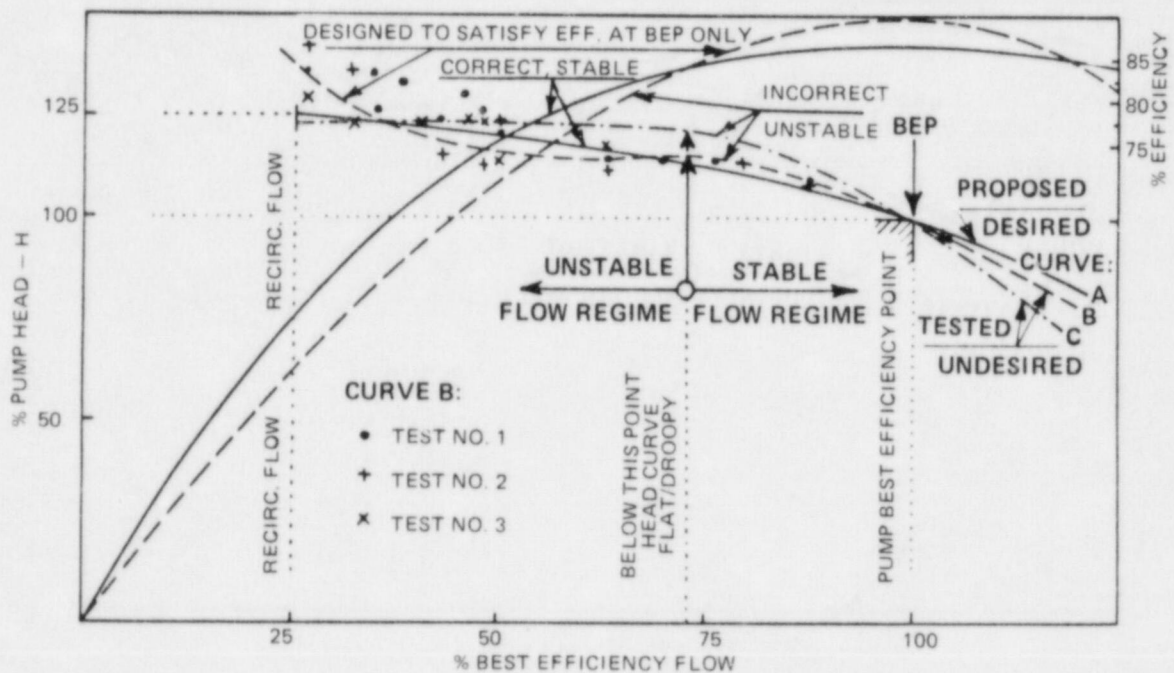
ORNL-DWG. 86-4230 ETD

Fig. D.4. Head-capacity characteristics of multistage boiler feed pumps. Curve "A" is correct and desired for stable system operation. Curve "B" represents hydraulically unstable impeller-diffuser design. Parallel- as well as single-pump operation is difficult in the unstable flow regime. Curve "C" shows design with flat head curve at part load resulting in control system malfunctioning. Single-pump operation is possible in unstable regime. Designs "B" and "C" are not acceptable for utility applications. *Source: E. Makay and O. Szamody, Survey of Feed Pump Outages, EPRI FP-754, Electric Power Research Institute, April 1978.*

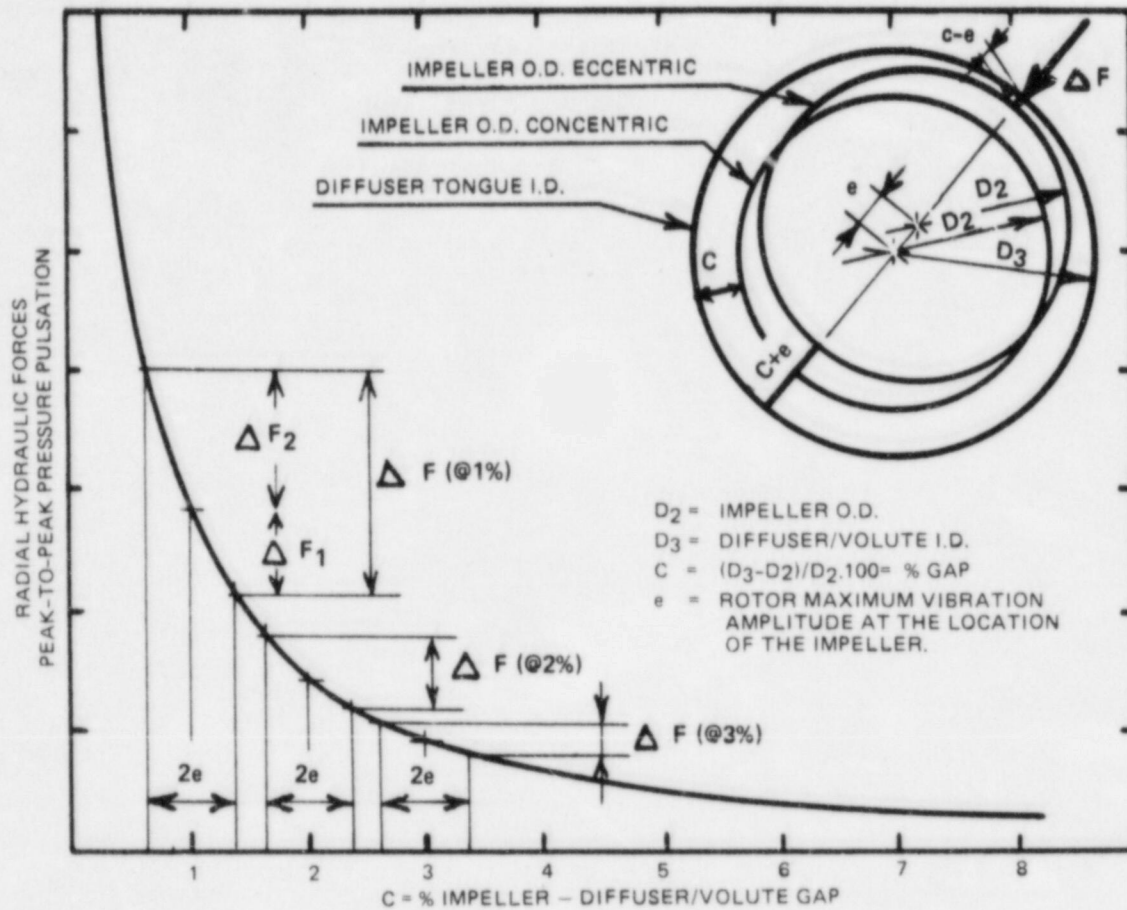
ORNL-DWG. 86-4231 ETD

Fig. D.5. Influence of pump impeller to diffuser/volute radial gap on pressure pulsation at blade-passing frequency and rotor deflection caused radial forces. Source: R. Makay and U. Szamody, *Survey of Feed Pump Outages*, EPRI FP-754, Electric Power Research Institute, April 1978.

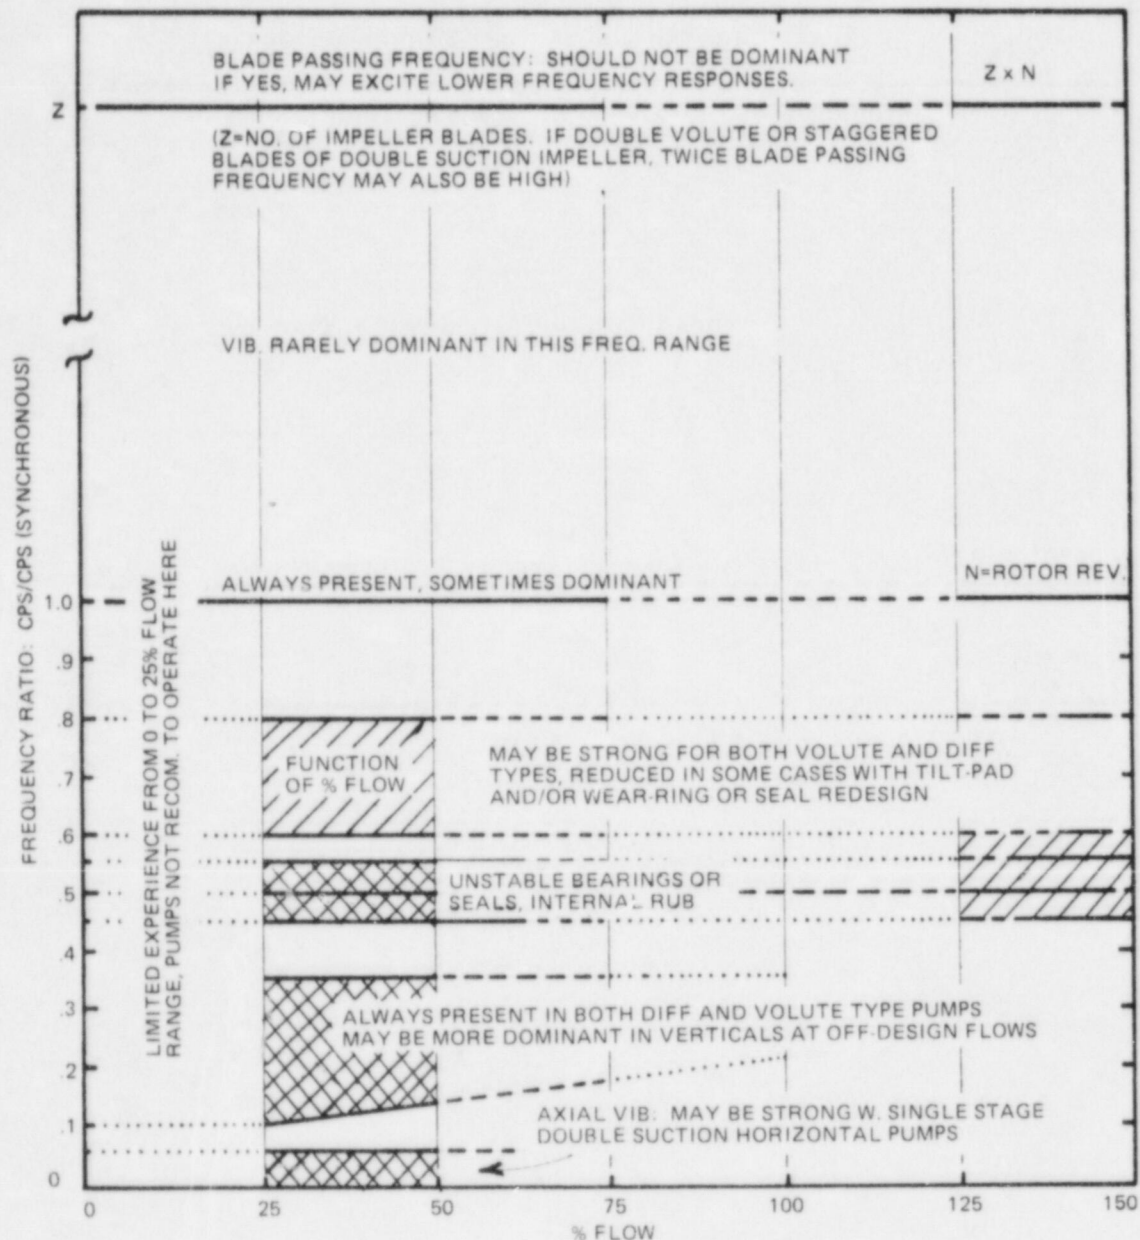
Fig. D.6. Frequencies of hydraulically induced dynamic forces acting on the rotor of a centrifugal pump. Source: E. Makay and O. Szamody, *Survey of Feed Pump Outages*, EPRI FP-754, Electric Power Research Institute, April 1978.

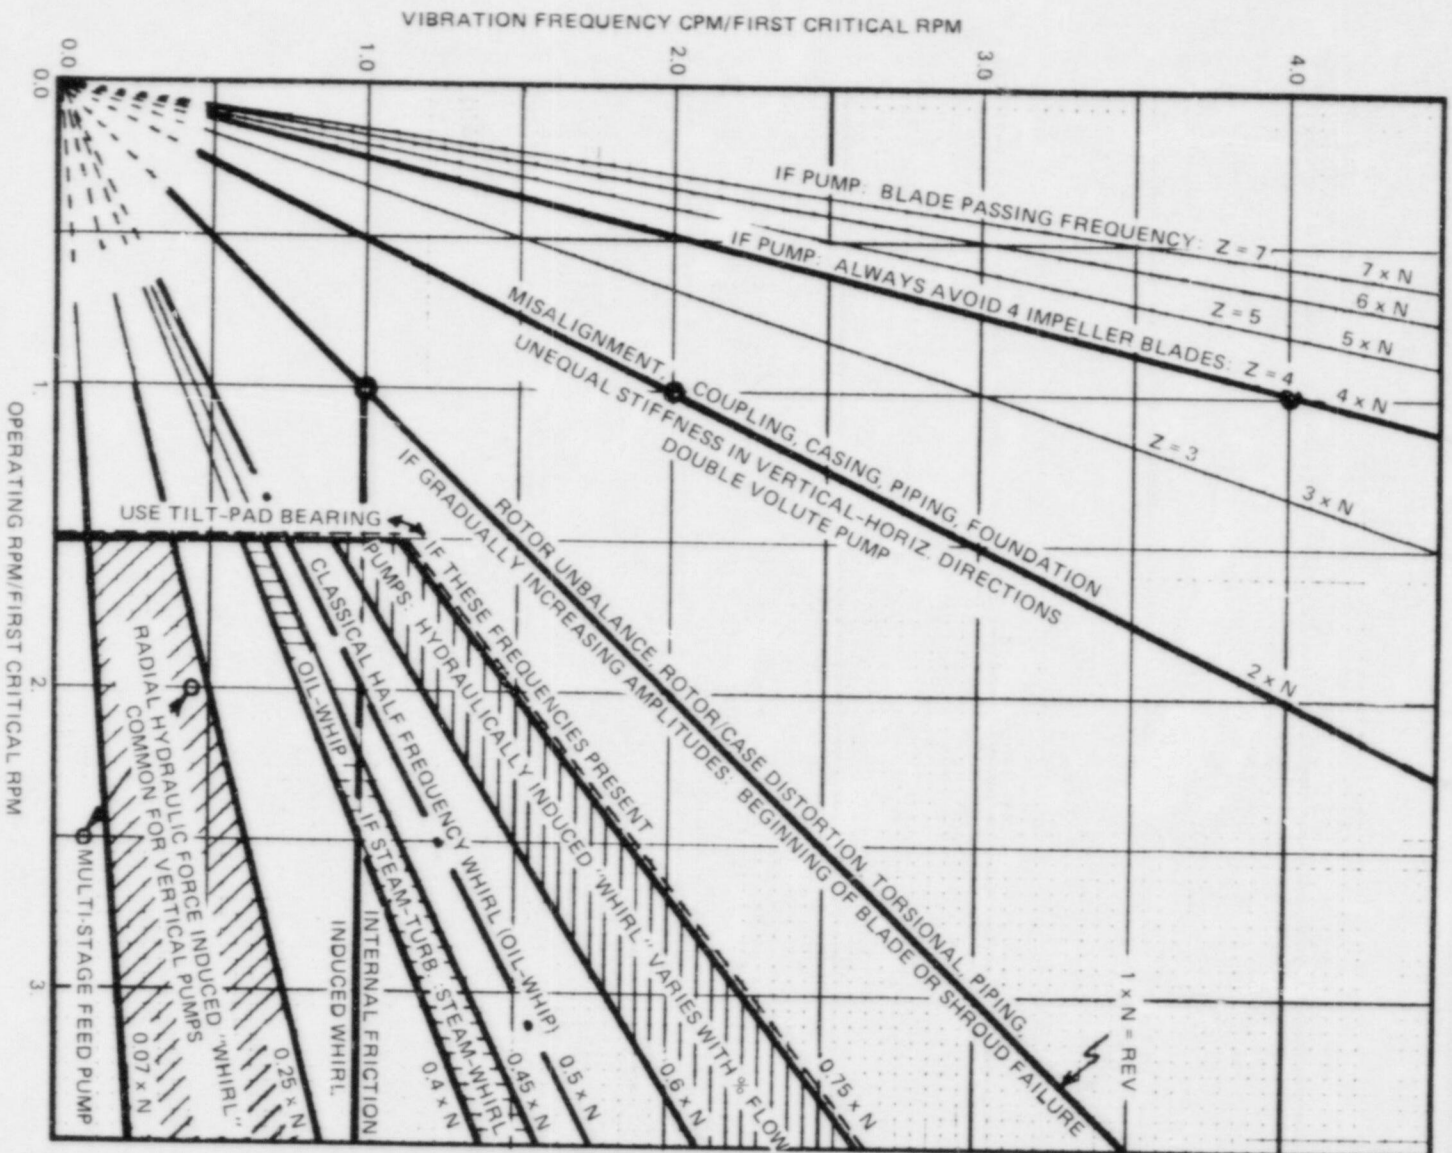
Fig. D.7. Vibration frequency vs speed. Causes and cures of common vibration problems of centrifugal pumps, steam and gas turbines, fans and blowers, compressors, and other centrifugal equipment. Source: E. Makay and O. Szamody, *Survey of Feed Pump Outages*, EPRI FP-754, Electric Power Research Institute, April 1978.

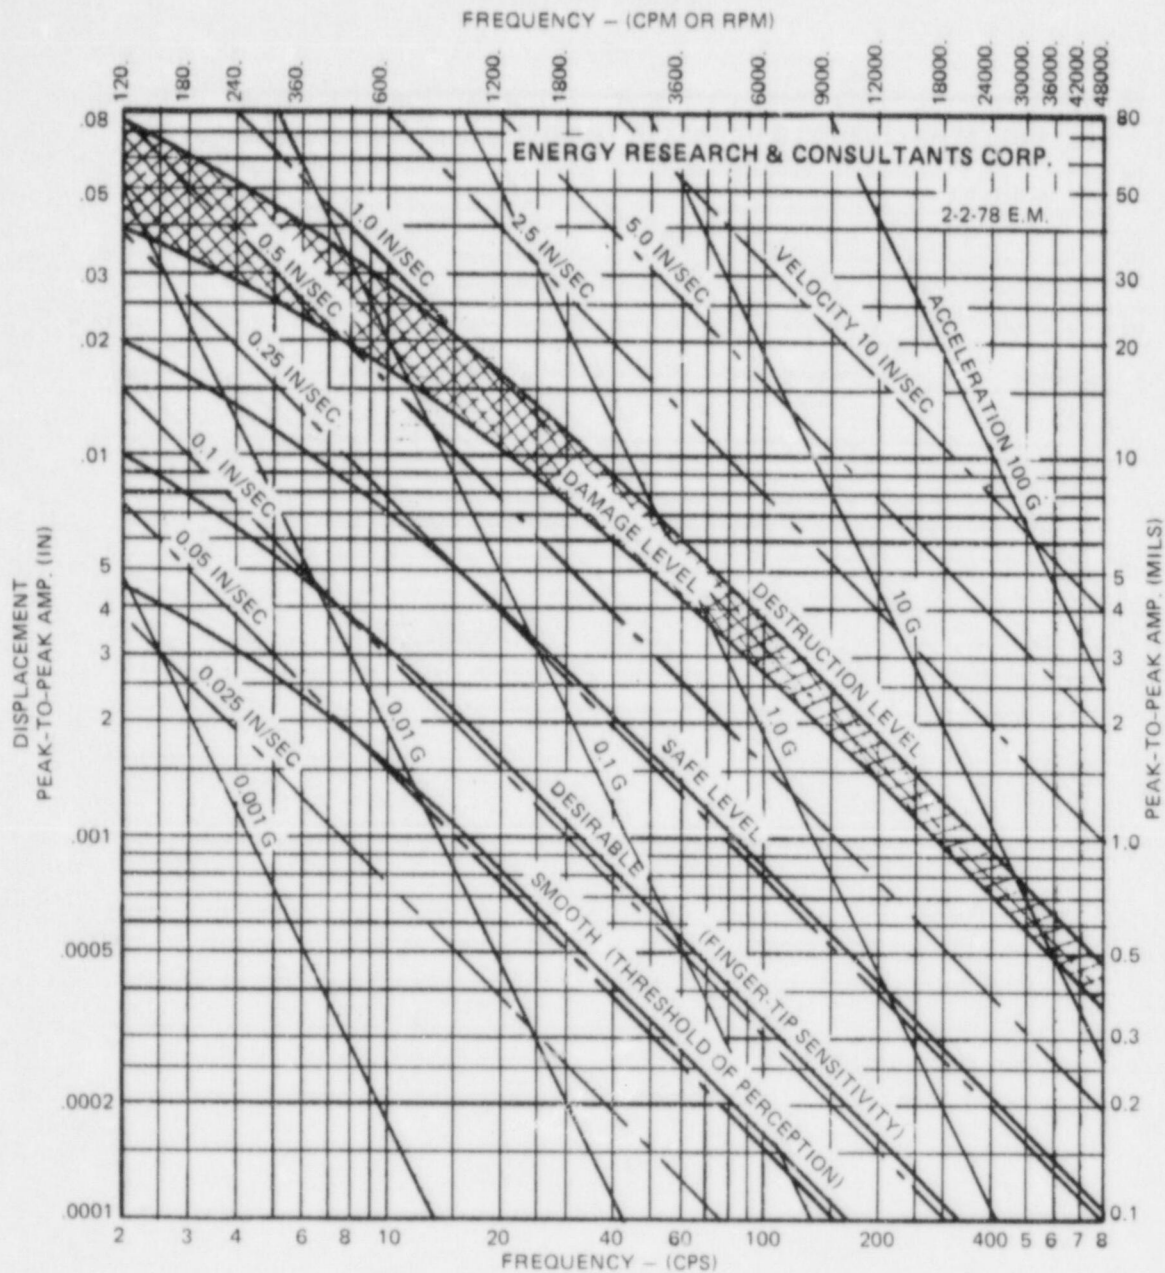
Fig. D.8. Allowable rotor vibration levels measured relative to bearing cap. (Values shown are filtered readings at that particular RPM or frequency; experimental standards). Source: E. Makay and O. Szamody, *Survey of Feed Pump Outages*, EPRI FP-754, Electric Power Research Institute, April 1978.

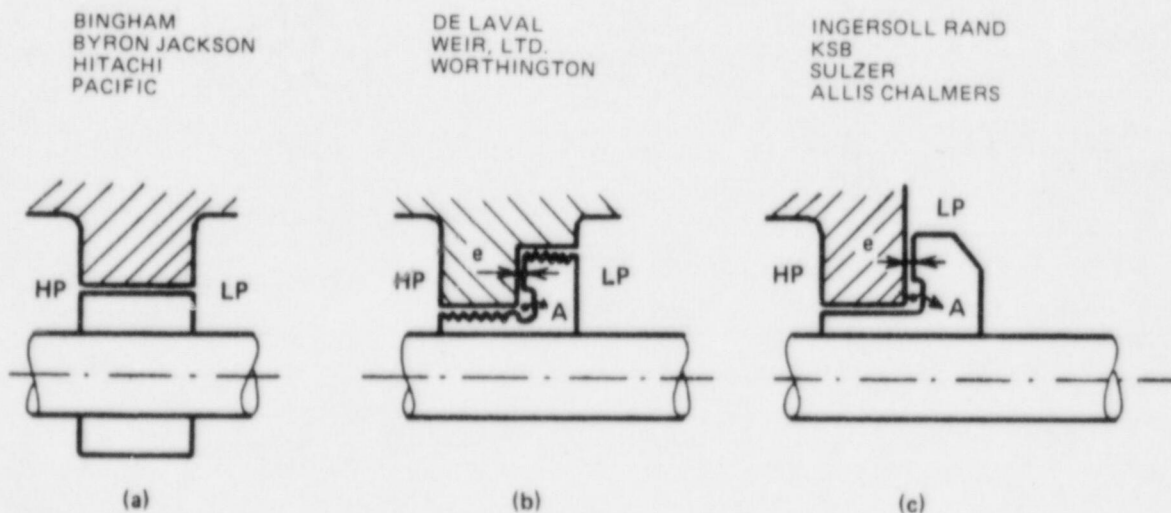
ORNL-DWG. 86-4235 ETD

Fig. D.9. Customary axial balancing devices for high-pressure multistage boiler feed pumps. (a) Balance drum (b) and (c) balance disk. Source: E. Makay and O. Szamody, *Survey of Feed Pump Outages*, EPRI FP-754, Electric Power Research Institute, April 1978.

A balance drum is basically a rotating piston that has the characteristics of an ineffective water-lubricated radial bearing, so it influences the dynamic behavior of the rotor (Fig. D.9). The balance disk, on the other hand, is basically a water-lubricated hydrostatic thrust bearing, Figs. D.9 and D.10. The small gap "e" controls the pressure and consequently the thrust balancing pressure in cavity "A." If the gap "e" becomes too small or closes entirely, the faces will touch and destruction of the mating parts results. Introduction of a small taper between faces is an effective design improvement successfully recommended in numerous plants. It is the relative taper angle "alpha," and not the orientation of the faces, that is important. Figure D.10 shows the parallel and the tapered face designs. Also shown is a force balance diagram, clearly indicating the superior behavior of the tapered disk design. The disk force counterbalances the forces produced by the impellers, transmitted to the disk through the shaft. This force can easily have a magnitude over 100,000 lb and is responsible for internal damage in many pumps. Figure D.10 shows the force T_0 , which is the force when the disk is closed. It is vital that the forces produced by the impellers can never be higher than T_0 , otherwise failure results. Many

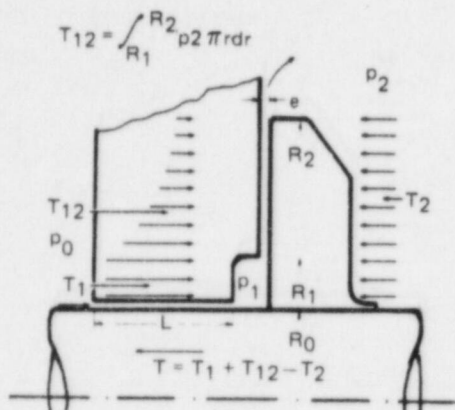
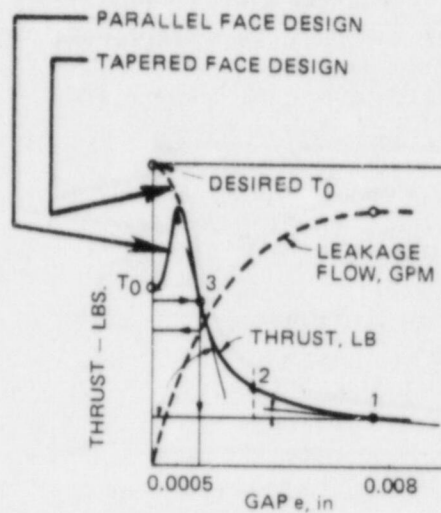
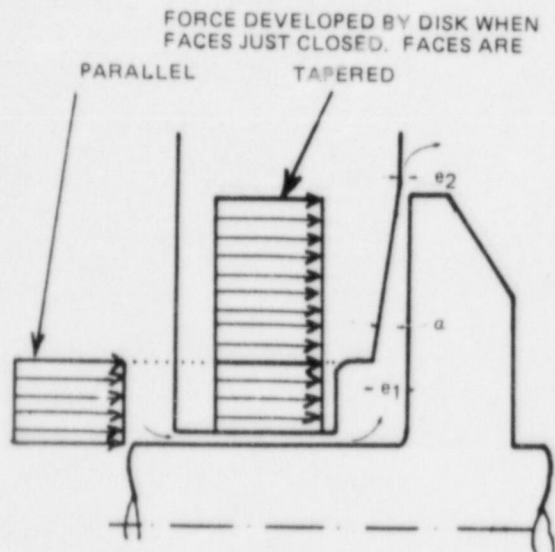
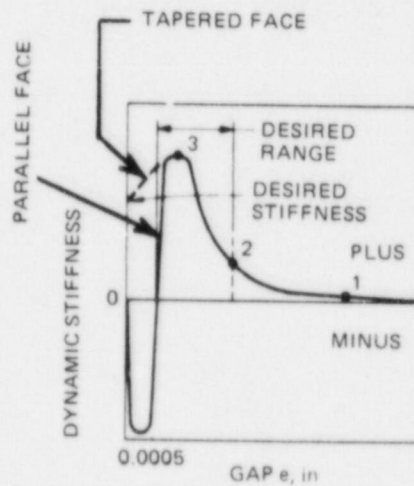
ORNL-DWG. 86-4236 ETD

(a) BALANCE DISK WITH PARALLEL FACES. FORCE EQUILIBRIUM IS SHOWN WHEN DISK IN NORMAL OPEN POSITION.

(c) BALANCE DISK THRUST CARRYING CAPABILITY AND LEAK-OFF FLOW.

(b) TAPERED FACE BALANCE DISK.

(d) DYNAMIC STIFFNESS OF BALANCE DISK.

Fig. D.10. Parallel and tapered face balance disk designs.
Source: E. Makay and O. Szamody, *Survey of Feed Pump Outages*, EPRI FP-754, Electric Power Research Institute, April 1978.

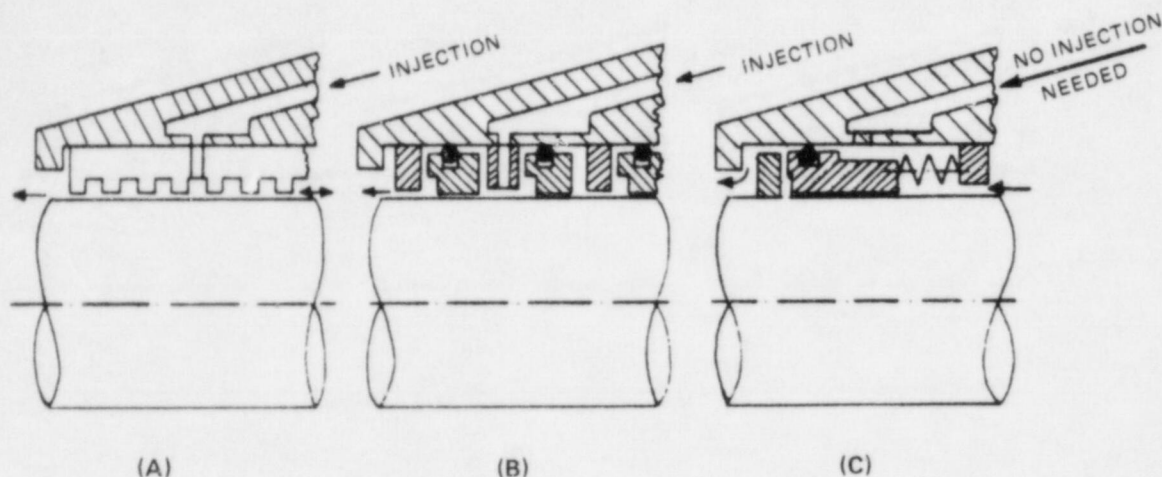
Fig. D.11. Shaft seal types used in boiler feed, nuclear feed, and feedwater booster pumps. (a) Labyrinth, (b) floating ring seals with single injection, and (c) mechanical seal. Source: E. Makay and O. Szamody, *Survey of Feed Pump Outages*, EPRI FP-754, Electric Power Research Institute, April 1978.

Shaft seals have the highest failure rate for any component in boiler feed pumps. Figure D.11 shows the three seal designs used for boiler and nuclear feedwater pump services with single injection. Double injection is used for high-temperature applications to avoid flashing in the seal area. Injection water can be regulated by temperature or pressure control. Low-speed booster pumps may employ packing; however, high-speed applications (3600 rpm or above) are exempt from that seal application with the exception of AUXFPs. The majority of failures occur with seal designs other than labyrinth types. Labyrinth seals are the least demanding "work horses" of utility pumps.

Floating-ring type or mechanical seals have the highest failure rate among all pump component failures. When in good condition, the mechanical seals have lower leakage rate than the labyrinth or packing types but obviously are more prone to wear and failure. After some wear, the seal leakage increases rapidly, especially with the floating-ring type. This then requires excessive maintenance that results in lower pump, hence unit, availability or if not repaired, rapidly decreasing pump delivered capacity. Considering the high cost of unit down time to replace failed seals and the high repair cost with the mechanical or floating-ring seal types, it becomes obvious that the best seal type for large feed pumps is the labyrinth type. Several utilities report successful conversions to labyrinth seals after a long history of failures with the other seal types.

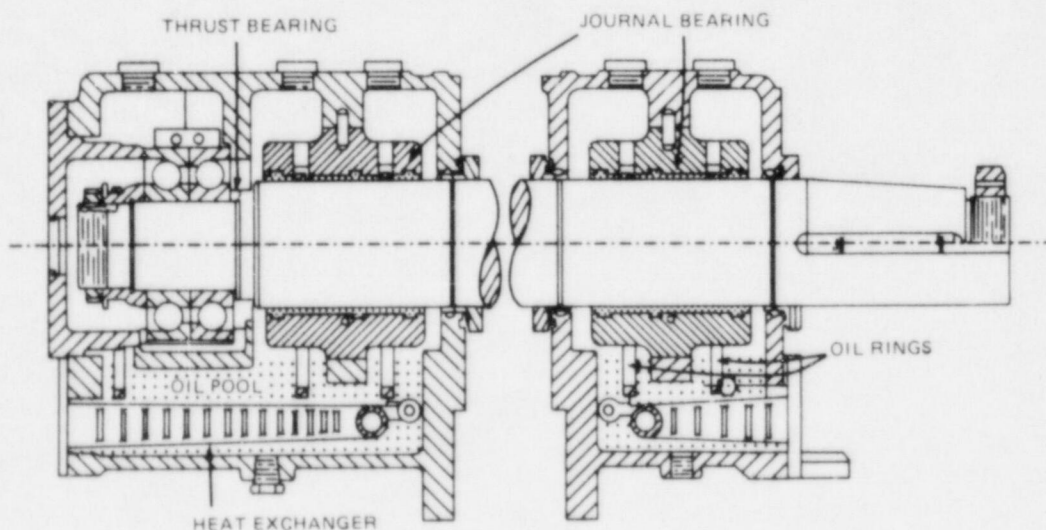
ORNL-DWG. 86-4238 ETD

Fig. D.12. Typical AUXFP bearing system.

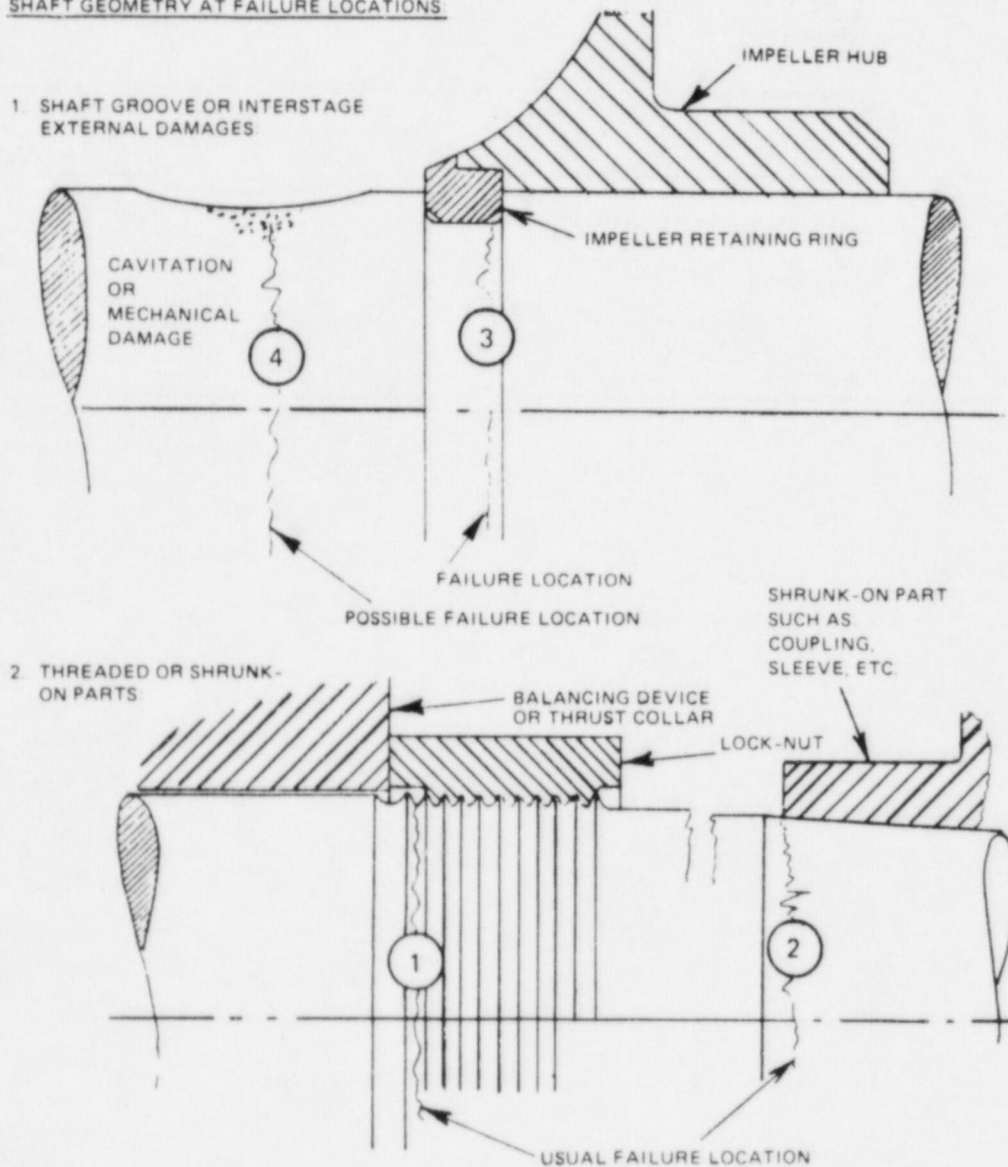
ORNL DWG 86-4239 ETD

SHAFT GEOMETRY AT FAILURE LOCATIONS

Fig. D.13. Typical multistage centrifugal pump shaft failure locations. The four most frequent locations are shown in order of failure frequency. Source: E. Makay and O. Szamody, *Recommended Design Guidelines for Feedwater Pumps in Large Power Generating Units*, EPRI CS-1512, Electric Power Research Institute, September 1980.

extended period of time. Frequent failures are a result of overloading the shaft by the high hydraulic forces acting on the axial balancing device. If the retaining mechanism of the disk (or drum) or the fitting of it is not proper on the shaft, very high cyclic forces result, accelerating fatigue failure (see Fig. D.13).
