PEACH BOTTOM ATOMIC POWER STATION
 UNITS 2 AND 3
 UPDATED FINAL SAFETY ANALYSIS REPORT

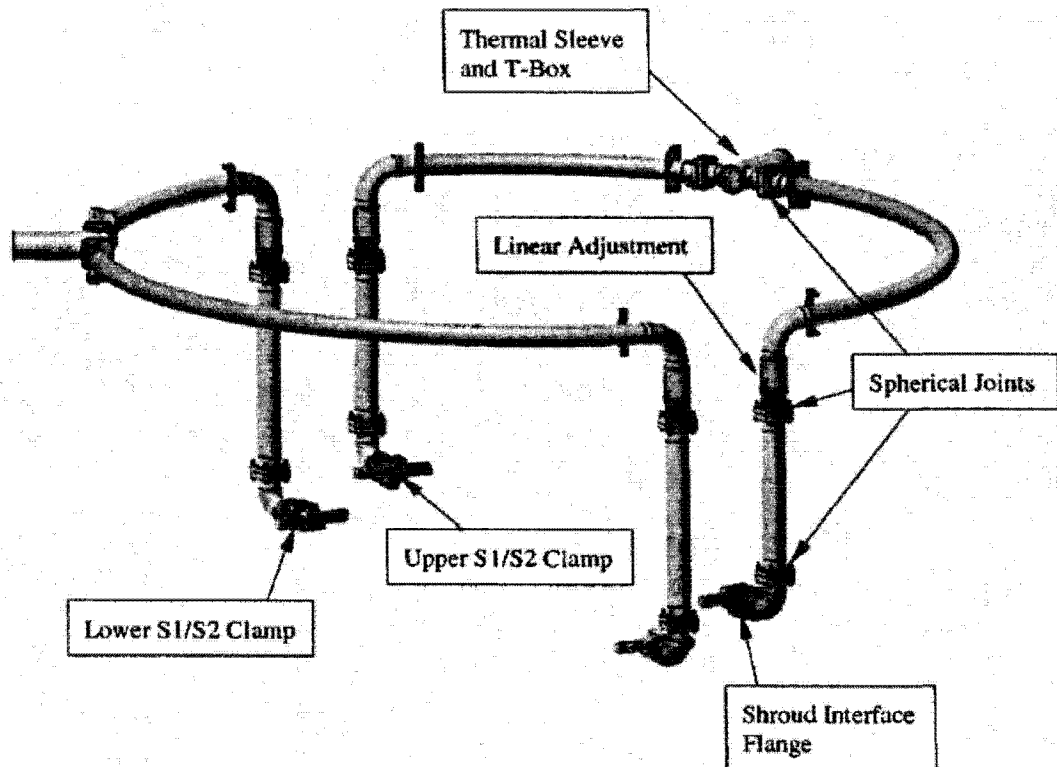
Clamps installed on the replacement core spray sparger pipes structurally replacing welds at each of the four sparger T-box locations
