**Annual Performance Report
April 2019 Through March 2020
for the Shiprock, New Mexico,
Disposal Site**

August 2021

U.S. DEPARTMENT OF
ENERGY

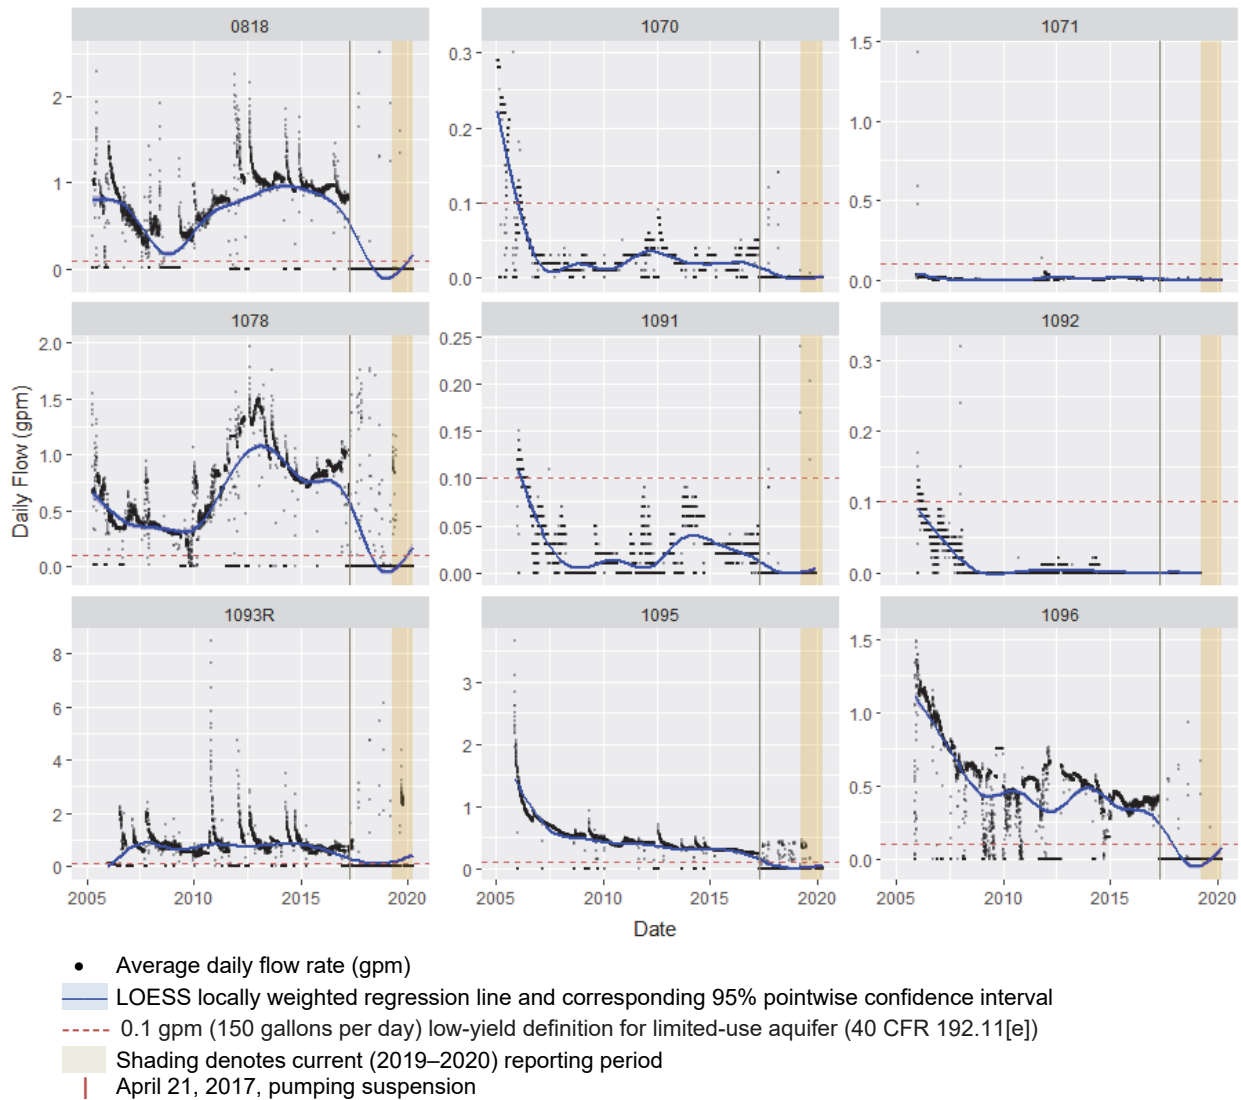
Figure 4. Historical Pumping Rates in Terrace Extraction Wells: 2005–2020

Notes: Data plotted are since the inception of the System Operation and Analysis at Remote Sites (SOARS) system in 2005–2006. *y*-axis scales are unique for each well to allow better resolution of the recent low values. As such, the plots are not directly comparable.

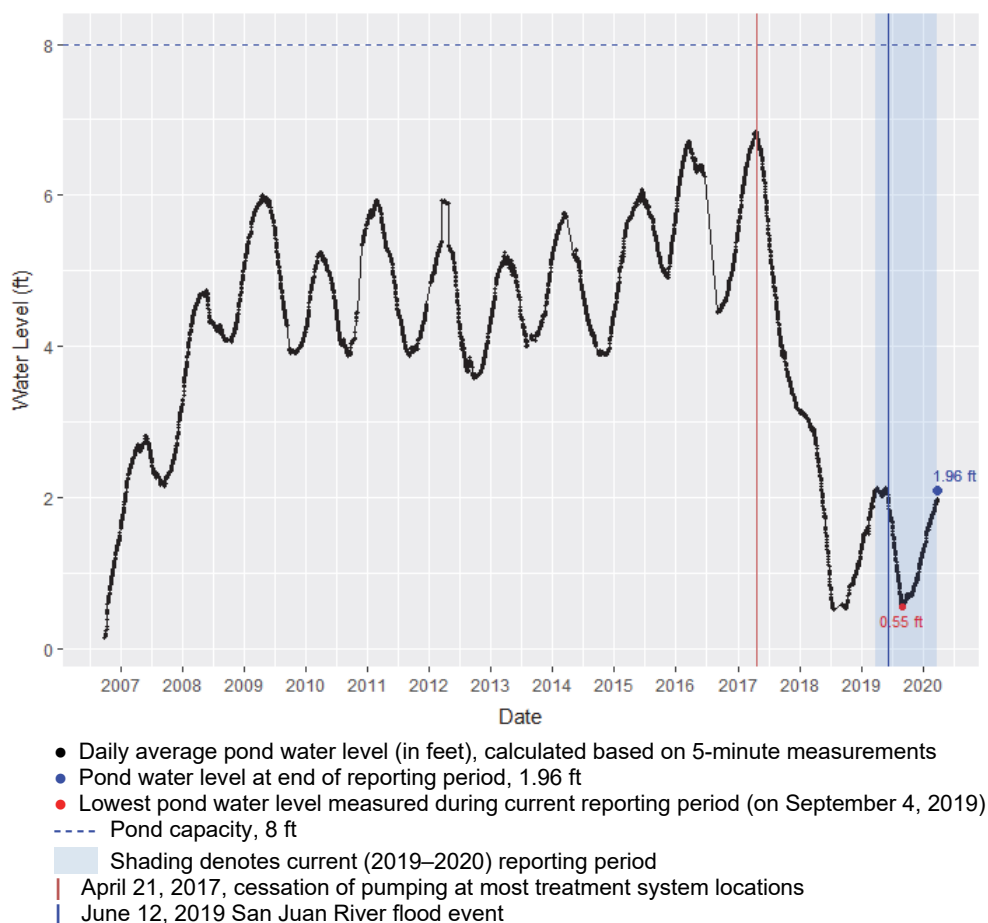
Figure 6. Water Levels in Evaporation Pond, 2006–March 2020

¹ Allowing pond water levels to decline to this low level was intentional, to inform LM’s decisions regarding (1) the time required for complete evaporation and (2) whether or not enhanced evaporation would be needed prior to pond decommissioning. (Based on LM’s observations, enhanced evaporation would not be necessary.)

The selected method for handling groundwater from the interceptor drains and extraction wells is solar evaporation. Contaminated groundwater is pumped to an 11-acre lined evaporation pond in the south part of the radon-cover borrow pit area (Figure 1). Figure 6 plots daily average pond water levels measured since September 2006. At the close of this reporting period (March 31, 2020), the water level in the evaporation pond was 1.96 ft, measured as the distance above transducers. The average water level during the reporting period was 1.4 ft. These low pond water levels relative to those measured in previous years are the result of the pumping suspension that began in April 2017.¹ This suspension continued into 2020 for most treatment system locations except Bob Lee Wash and the floodplain trenches. The first marked water level decline shown in Figure 6 followed the April 2017 pumping suspension. To prevent desiccation of pond sediments, pumping was resumed at the trenches in mid-July 2018. The subsequent decline in pond water levels was due to the mid-June 2019 San Juan River flood, which necessitated the shutdown of all System Operation and Analysis at Remote Sites (SOARS) equipment on the floodplain and subsequent repairs. Pumping of the trenches resumed on September 8, 2019.

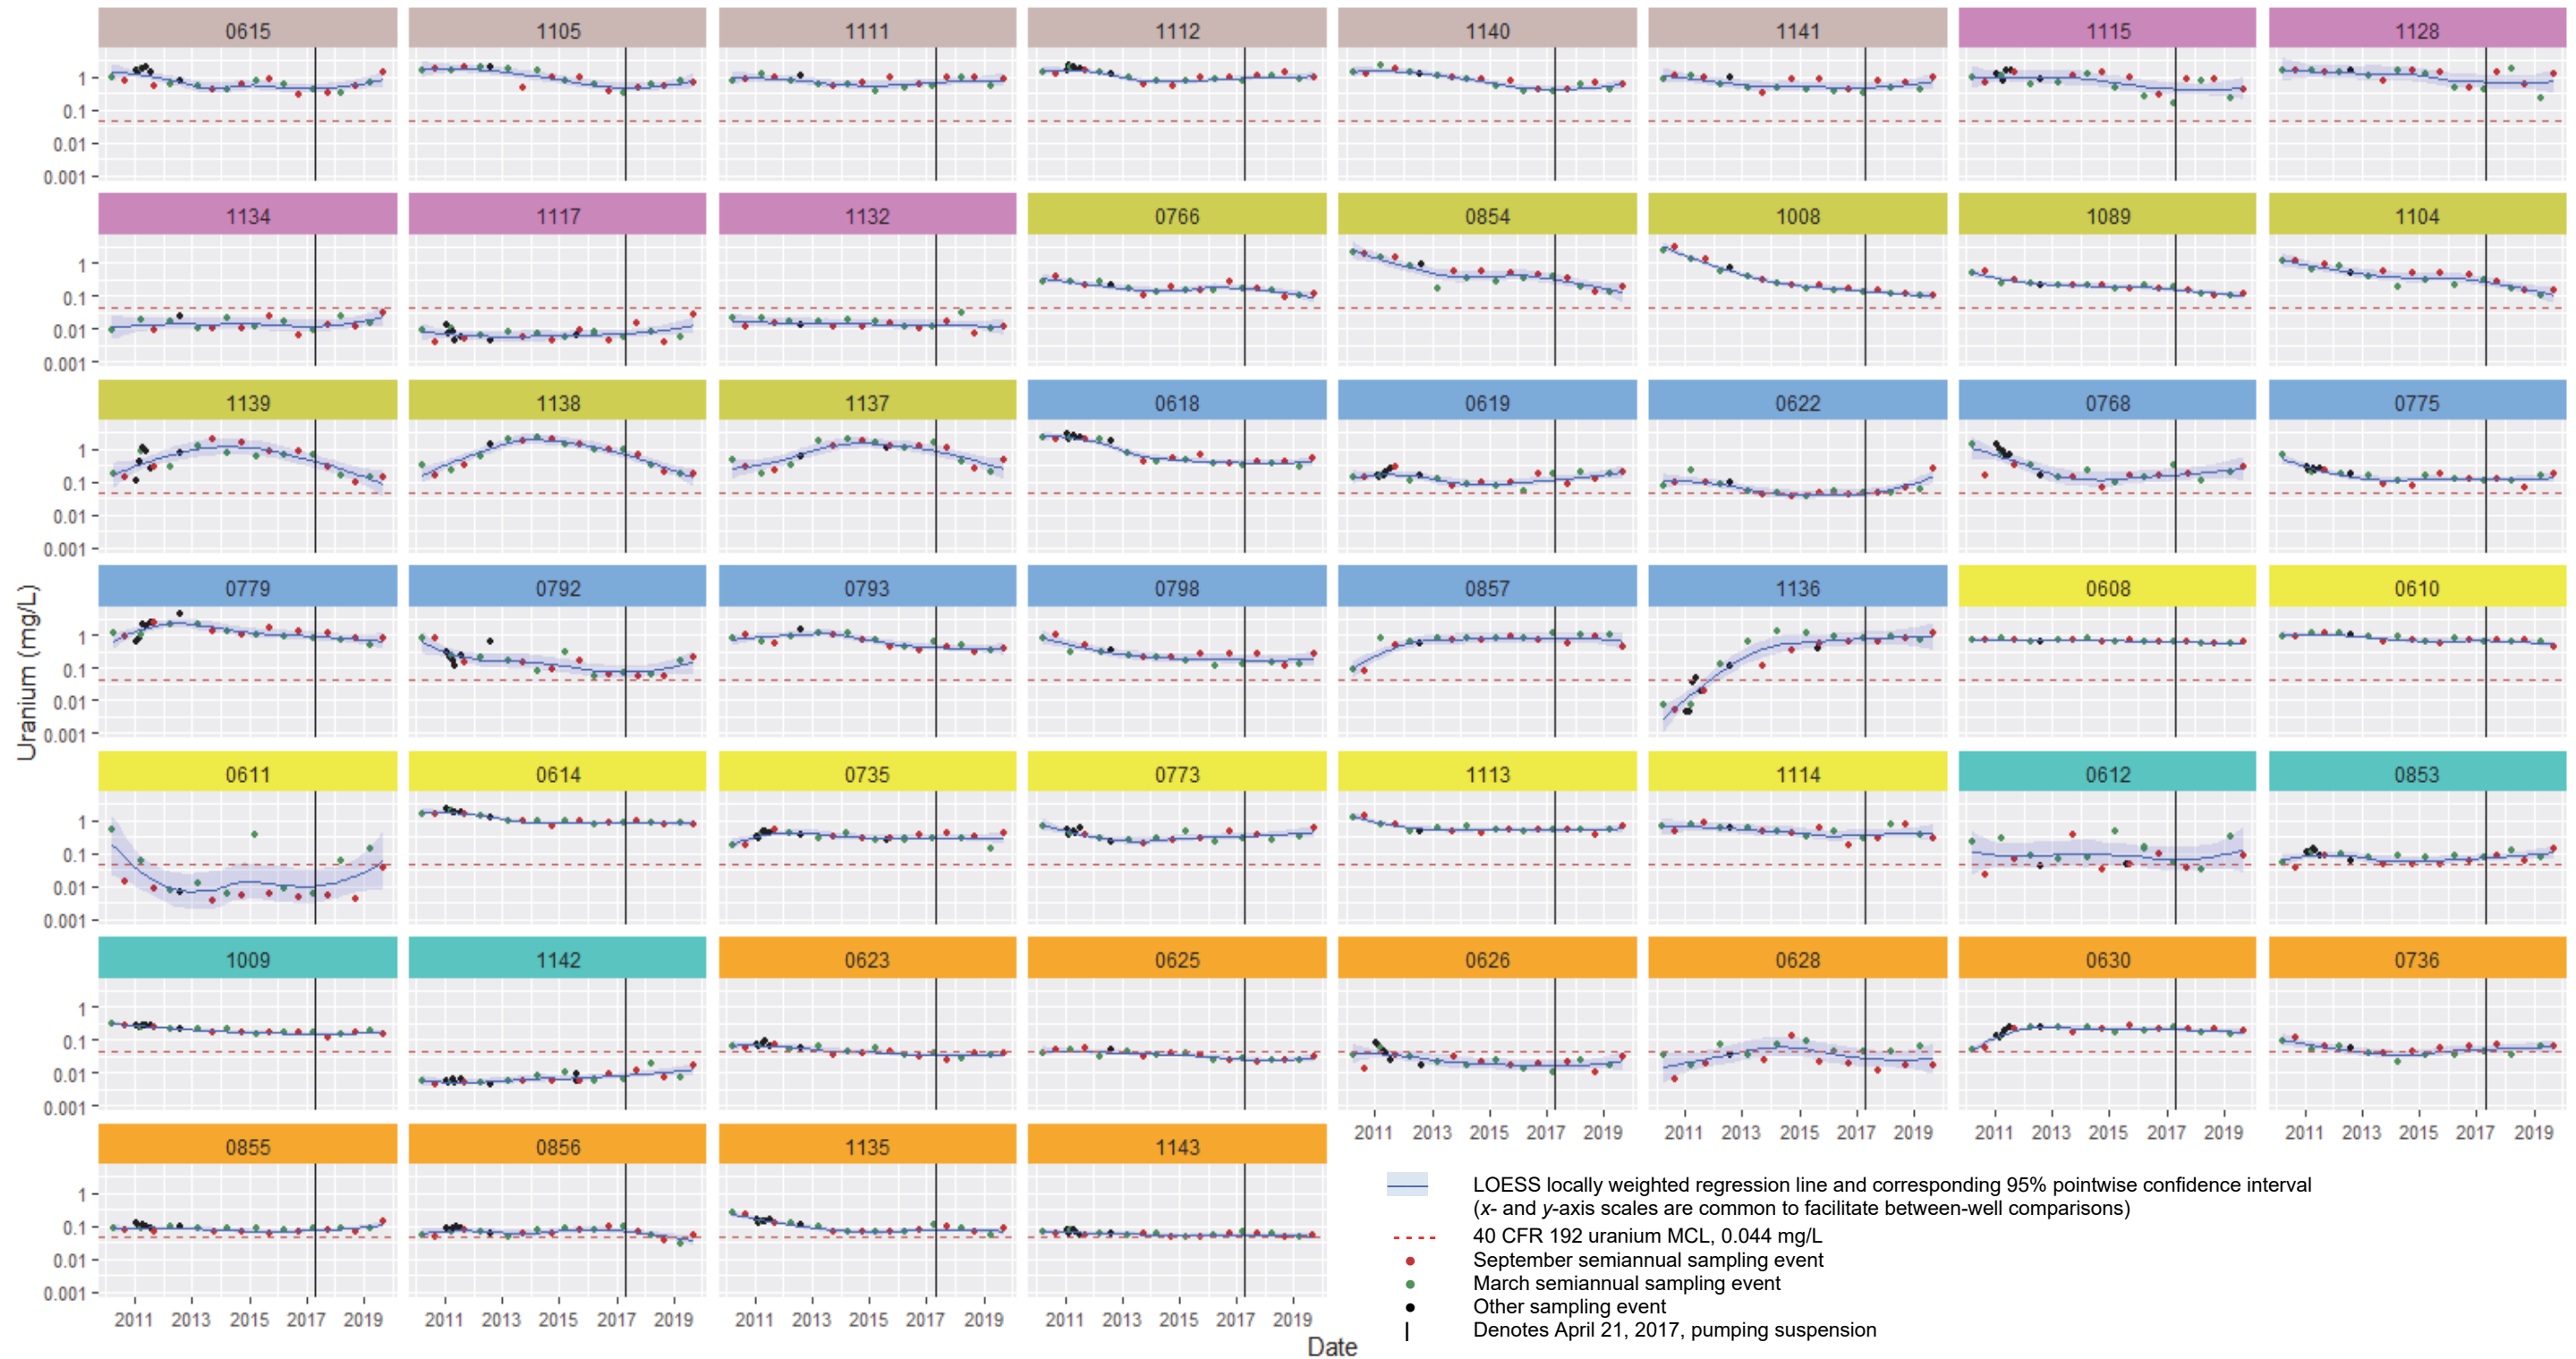
Figure 13. Uranium Time–Concentration Trends in Shiprock Site Floodplain Wells, 2010–2019: Semilog Scale

Wells ordered and color-coded by floodplain region, consistent with groupings and color-codes used in Figure 11: Trench 1 Trench 2 Well 1089 Area Central Floodplain Base of Escarpment South-Central Western Floodplain

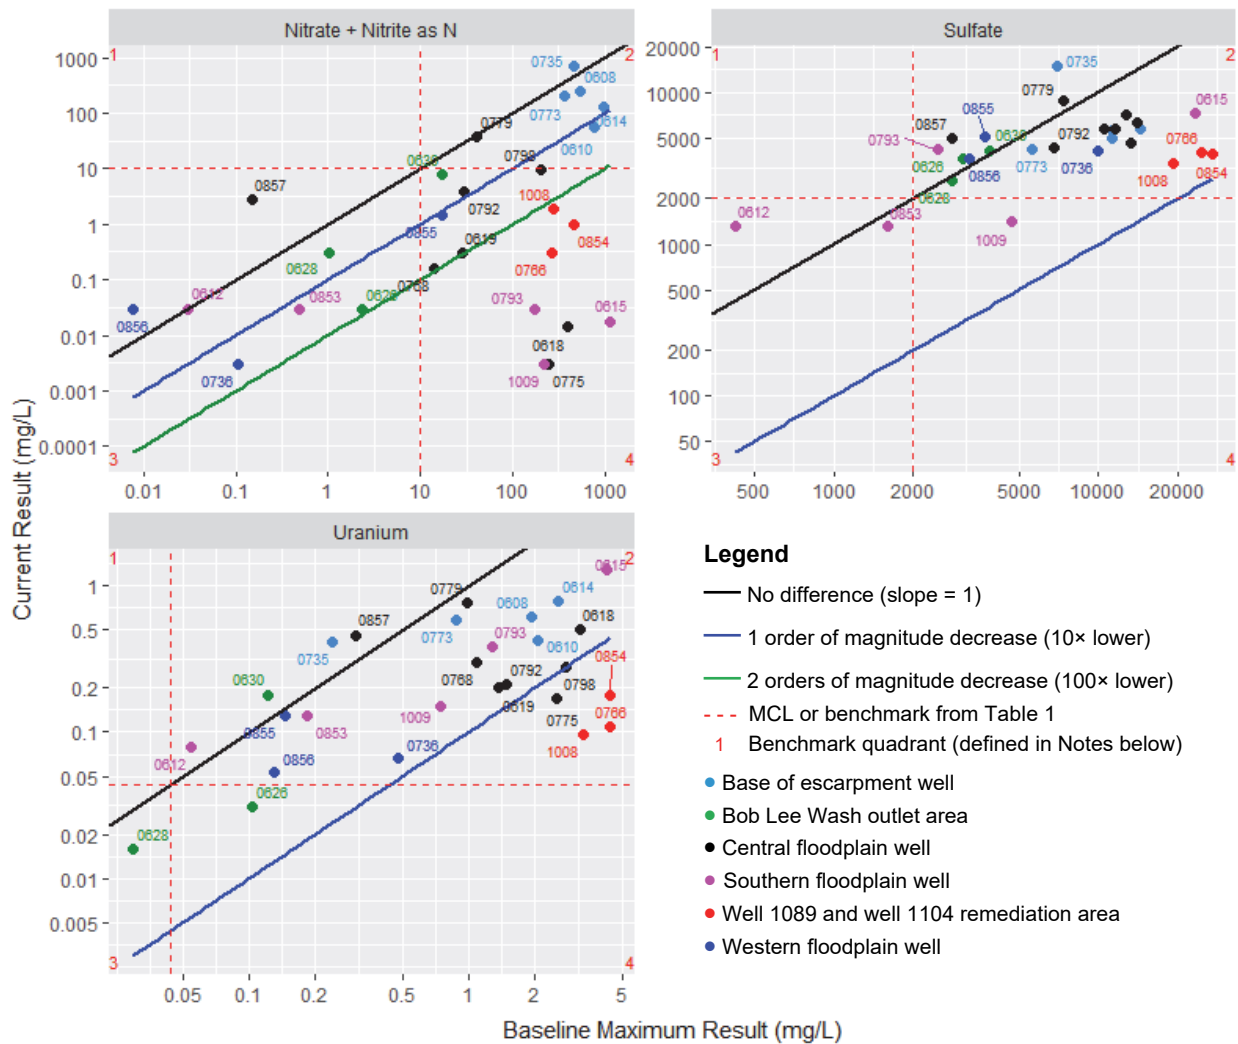
Notes: This figure only includes data for nonbackground wells sampled during both baseline (2000–2003) and current (2019–2020) periods. As such, most wells in the region of Trenches 1 and 2 are not represented, nor is western floodplain well 0734, which has been dry since 2015. Because of this, the color-coded spatial groups defined above are different from those shown in Figure 11.

There was only one sampling event this reporting period, so the current result is the September 2019 measurement. Nondetect results for nitrate are assigned the detection limit value (0.003–0.03 mg/L).

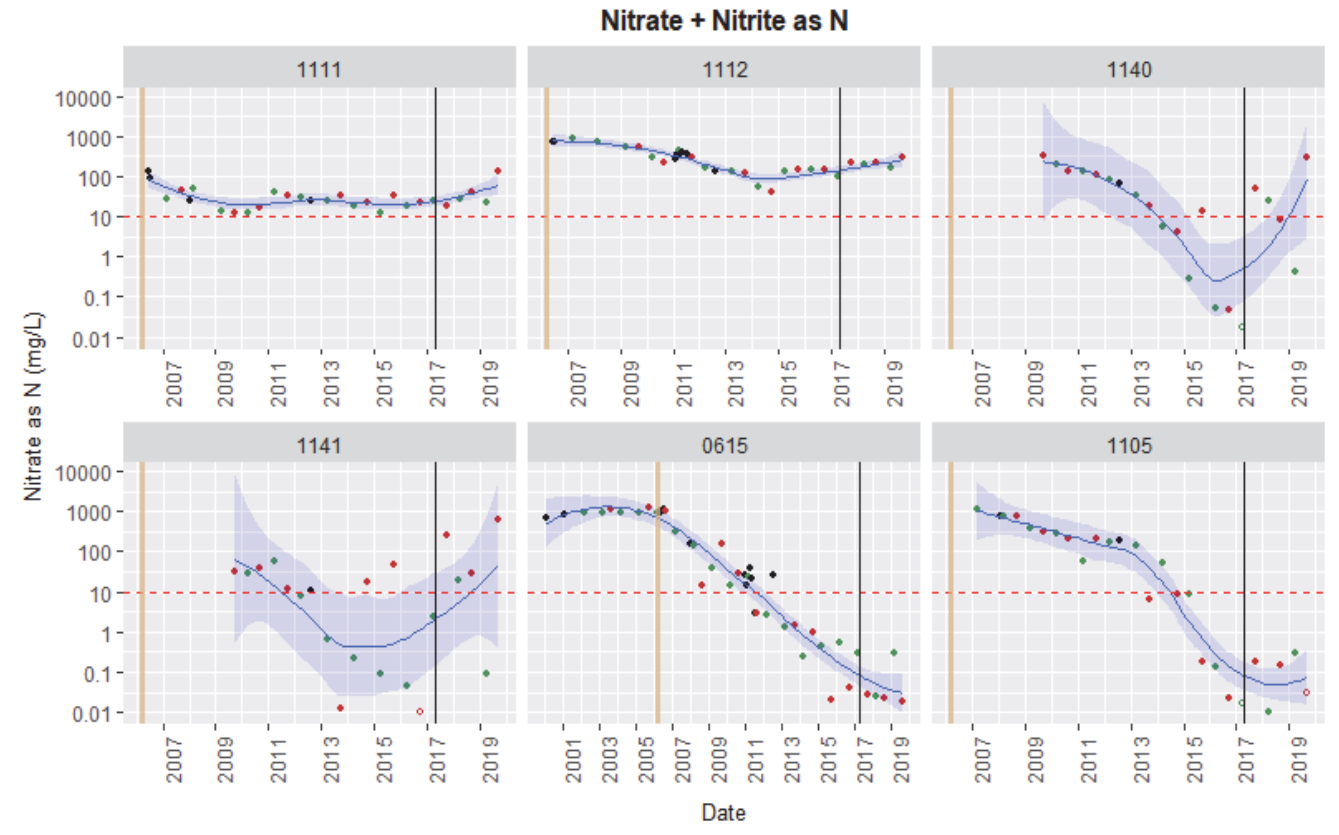
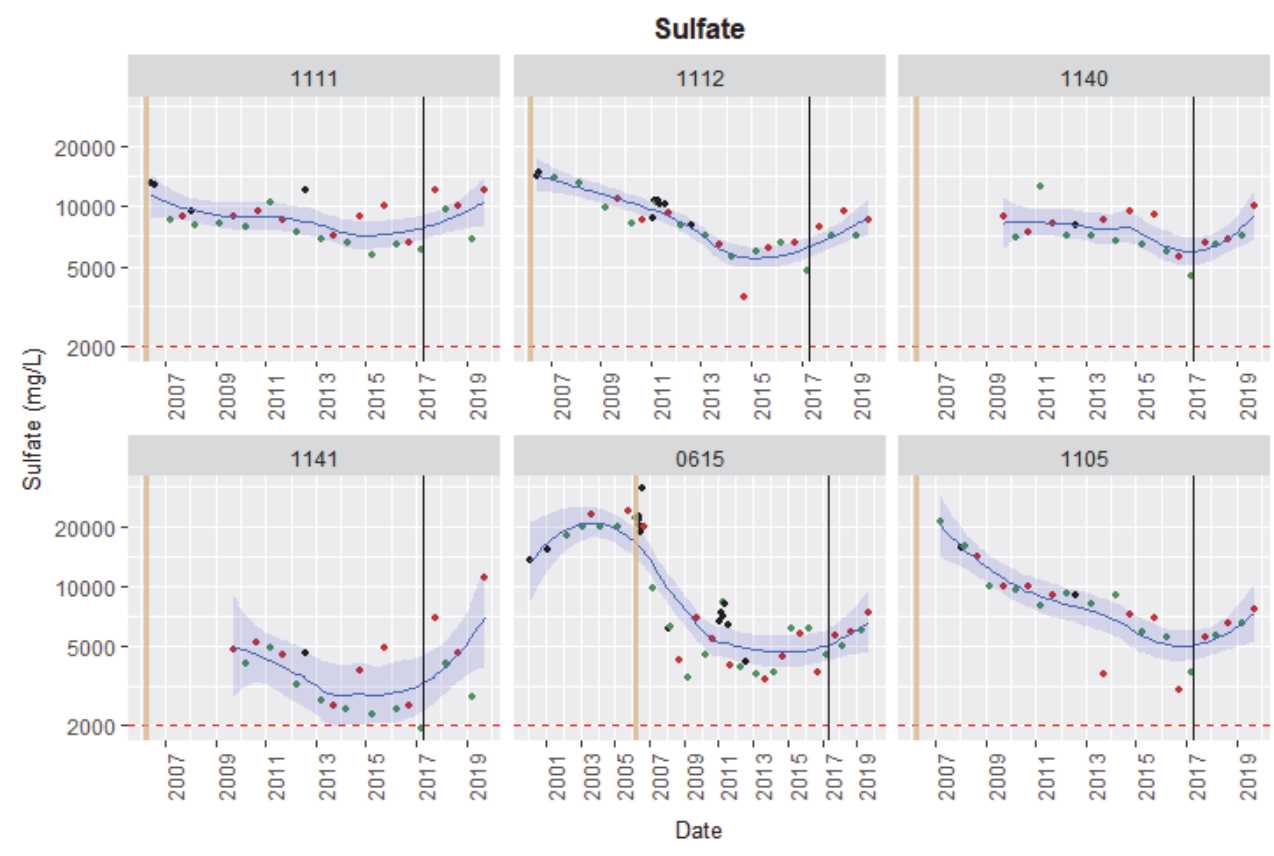
Figure A-2. Uranium, Nitrate, and Sulfate Concentration Trends in Trench 1 Area Wells: 2000–September 2019

In each plot, a nonparametric smoothing method or locally weighted regression—known as LOESS (not to be confused with the geologic term)—is used. With this approach, overall trends in the data are more apparent and not obscured by “noise.” For each constituent, wells are listed in order of increasing distance from the escarpment, shown in the inset below.

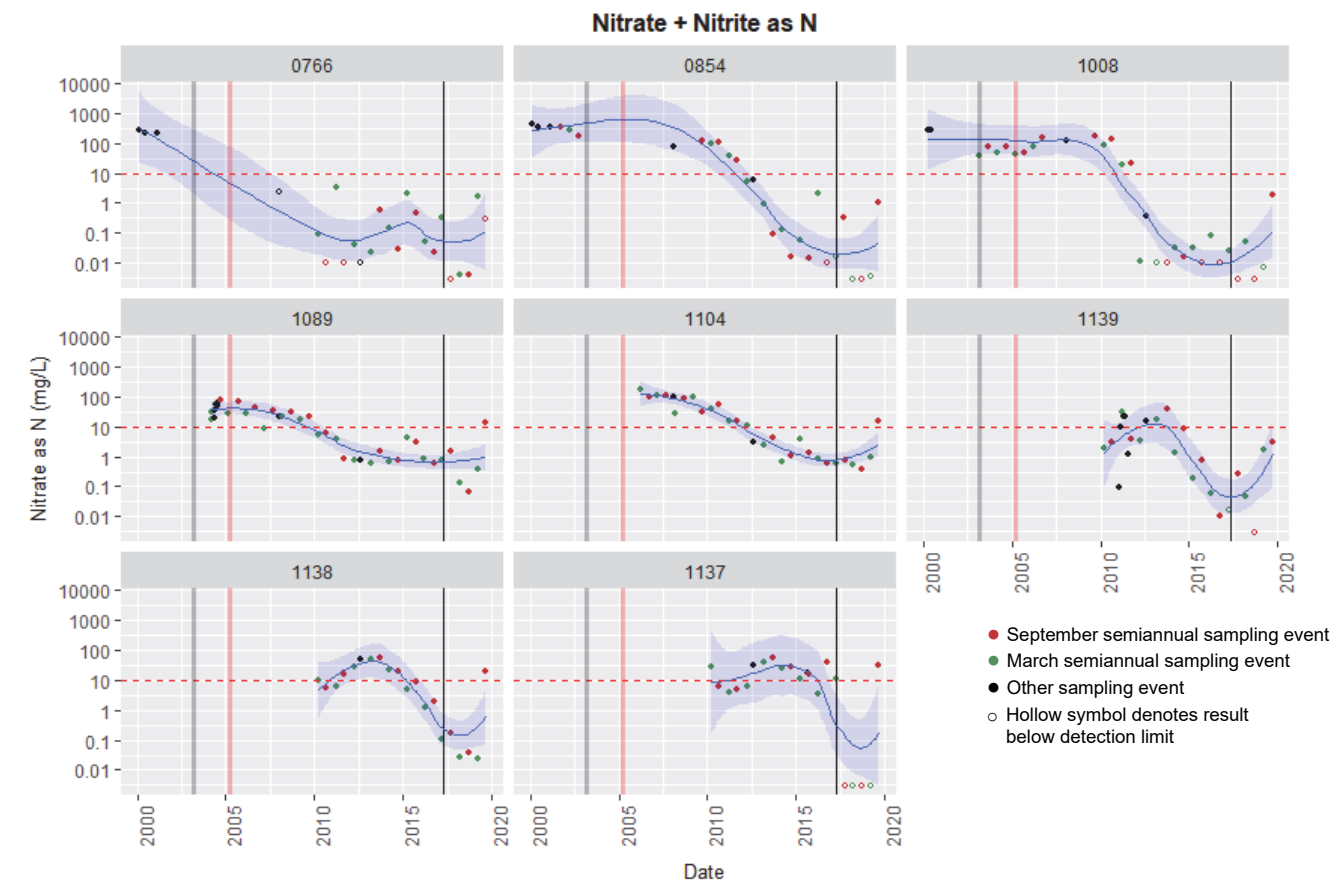
Figure A-3. Uranium, Nitrate, and Sulfate Concentration Trends in the 1089/1104 Remediation Area: 2000–September 2019

In each plot, near-river wells 1137, 1138, and 1139 are listed in order of increasing distance from the remediation area (see inset).

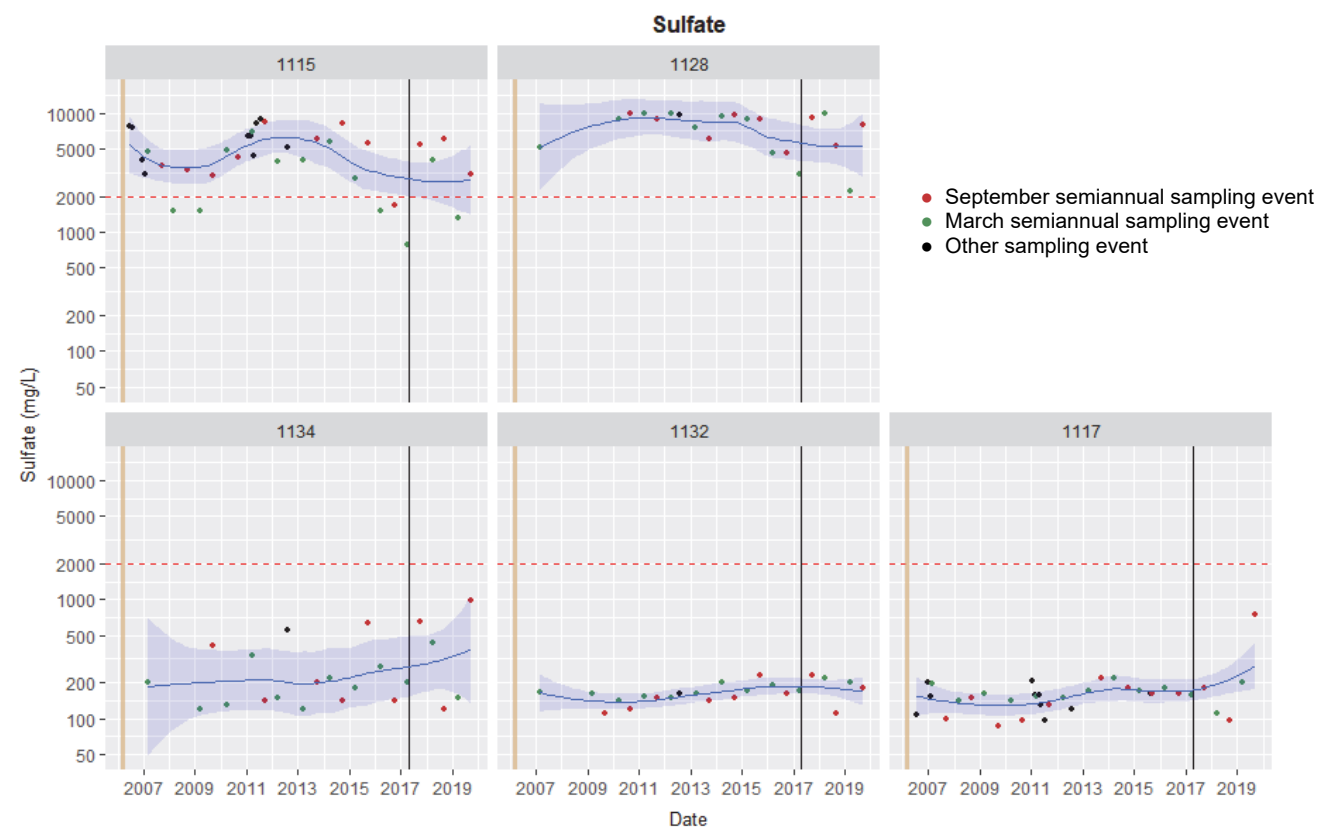
Figure A-4. Uranium, Nitrate, and Sulfate Concentration Trends in Trench 2 Area Wells: 2006–September 2019

Wells on the escarpment side of the trench, with the highest contaminant concentrations, are plotted first (in the upper portion of the figure). Wells on the river side of the trench, with markedly lower concentrations, are shown in the bottom portion of each plot (locations shown in inset below).

Vertical line | denotes time when Trench 2 was installed, in spring 2006. Trench 2 wells were installed between June 2006 and February 2007. Second vertical line | denotes when pumping on the floodplain was suspended, on April 21, 2017 (Figure 3). Pumping resumed at Trench 2 on July 19, 2018, and continued through most of the 2019–2020 reporting period.

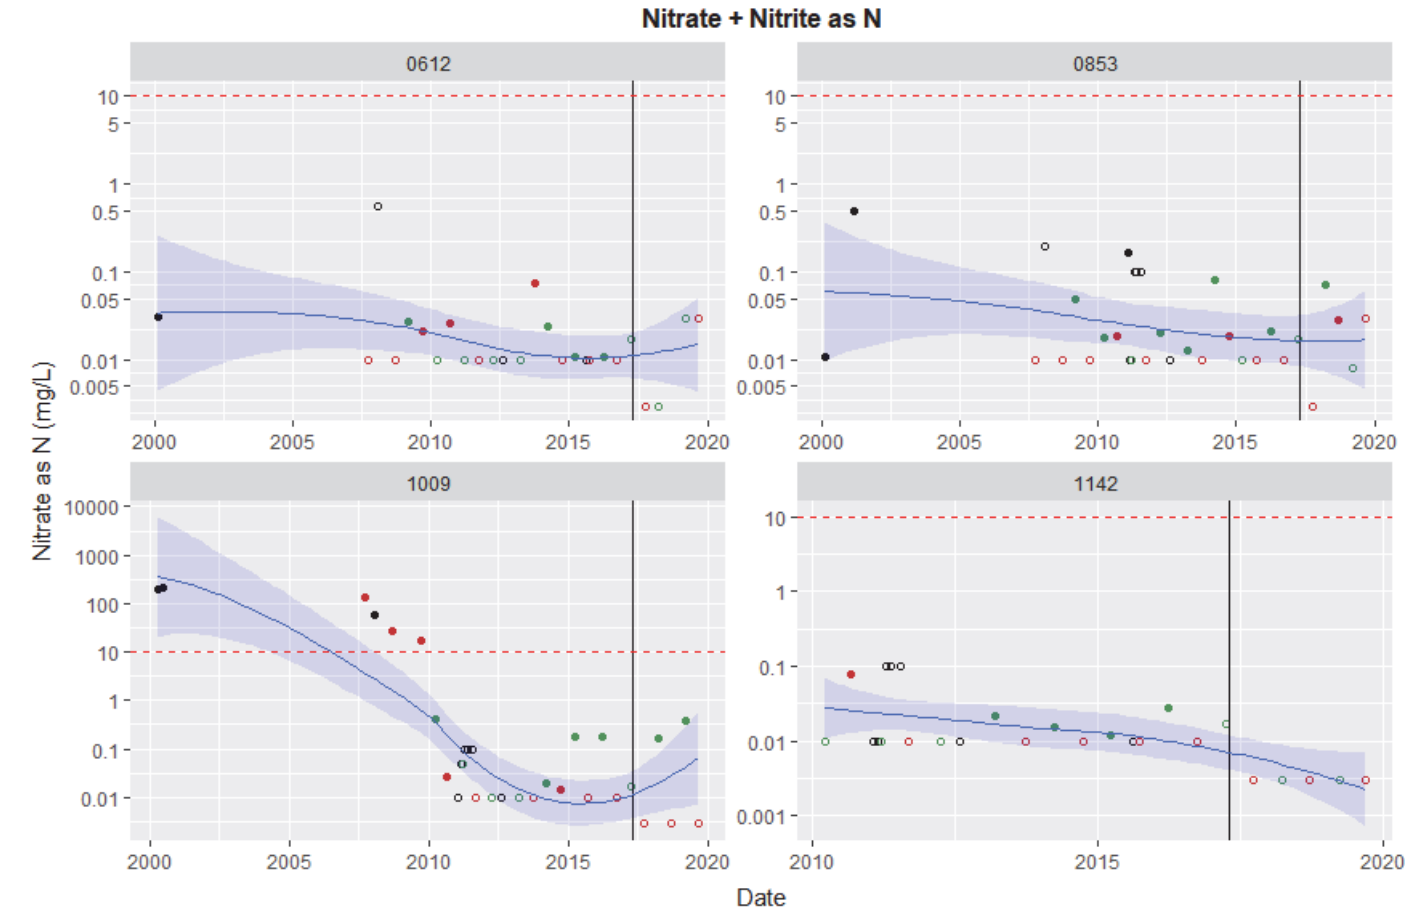
Figure A-6. Uranium, Nitrate, and Sulfate Concentration Trends in South-Central Floodplain Wells: 2007–September 2019

Unlike preceding figures, this figure includes data for only the period 2007–2019 because of the large gap in sampling between 2000–2001 and 2007 for wells 0612, 0853, and 1009. (Well 1142 was installed in January 2010.)

Vertical line | denotes when pumping on the floodplain was suspended, on April 21, 2017 (Figure 3). Pumping resumed at the trenches on July 19, 2018, and continued through most of this reporting period. Note, however, that wells 0612, 0853, and 1142 are outside the capture zone.

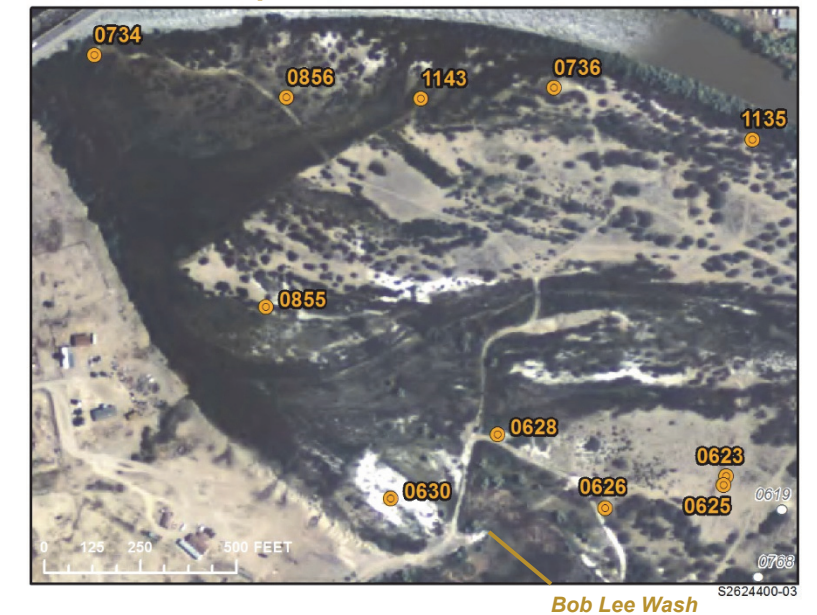
Since September 2014, well 0734 has been dry or had insufficient water to sample.

Figure A-8. Uranium, Nitrate, and Sulfate Concentration Trends in Western Floodplain Wells: 2000–September 2019
