## Environmental Report – Grants Homestake Site

Homestake Mining  
Corporation

February 2018

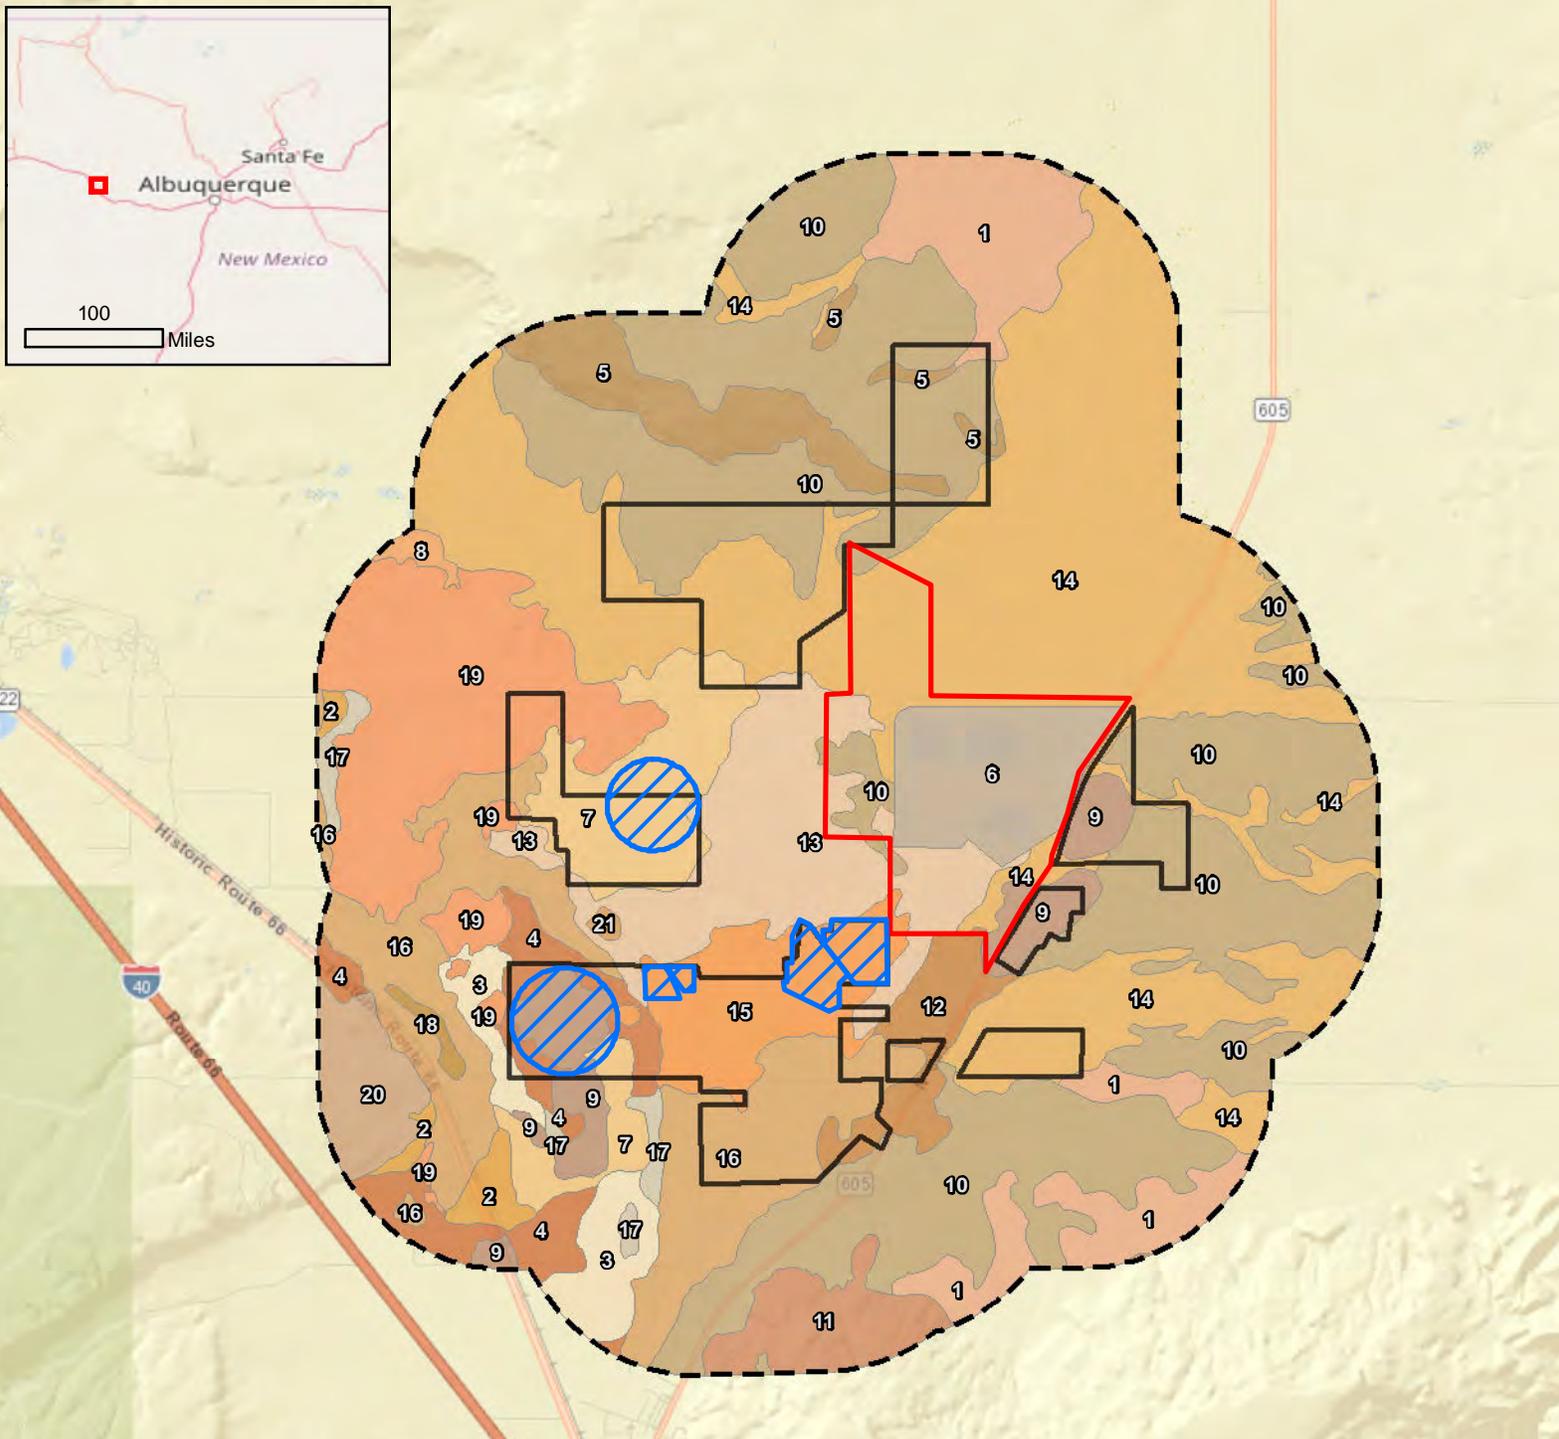
**Figure 6-1 NRCS Soil Map**  
Units  
HMC  
Cibola County, NM

1 - Aparejo-Venadito Complex	8 - Lava Flows	15 - Sparank Clay Loam
2 - Aparejo Clay	9 - Mespun Loamy Sand	16 - Venadito Clay Loam
3 - Aparejo Clay Loam	10 - Penistaja Fine Sandy Loam	17 - Venadito Sandy Clay Loam
4 - Aparejo Clay Loam, Sandy Substratum	11 - Poley-Rock Outcrop Complex	18 - Venadito Variant Clay Loam
5 - Bond-Penistaja-Rock Outcrop Complex	12 - San Mateo Clay Loam	19 - Viuda-Penistaja-Rock Outcrop Complex
6 - Dumps-Pits Complex	13 - San Mateo Sandy Clay Loam	20 - Winona-Rock Outcrop Complex
7 - Glenberg-San Mateo Complex	14 - Sparank-San Mateo Complex	21 - Zia Sandy Loam
