# **Irradiation and corrosion testing of laser powder bed fusion-manufactured materials in the AMMT program**

NRC Workshop on AMTs for Nuclear Applications, October 24-26, 2023, Rockville, MD

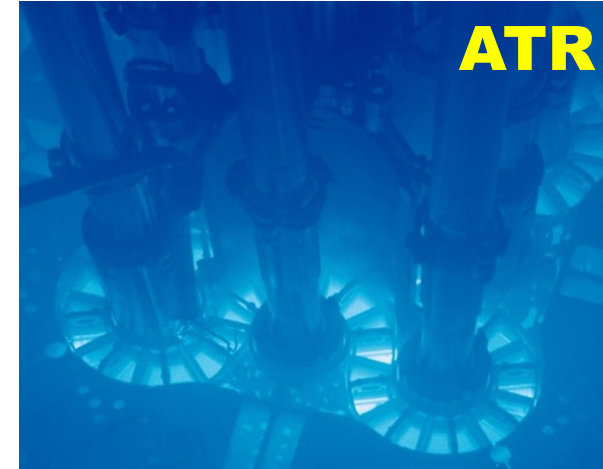
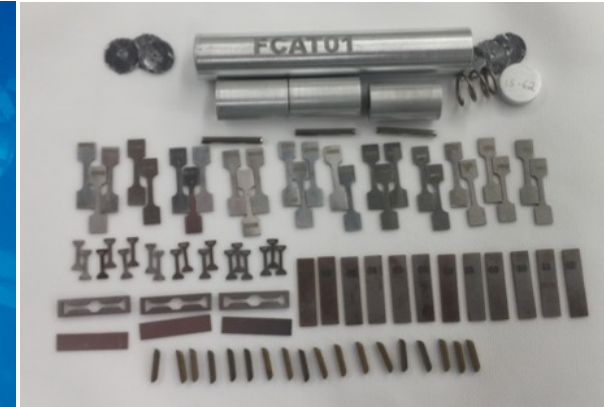
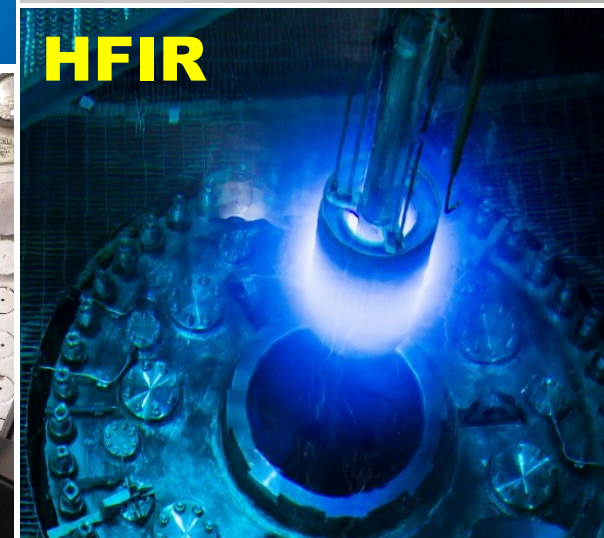
# Neutron irradiation campaigns are integrated to provide rapid insight into AM processing impacts on 316H

- **Neutron irradiations are designed to:**
  - Provide rapid screening of AM processing effects (microstructure variability) on radiation response behavior (microstructure and mechanical properties)
  - Provide targeted neutron irradiation information for promoting the regulatory acceptance of the combined use of ion and neutron irradiation data
- **Integrated campaign catering to the strengths of both High Flux Isotope Reactor (ORNL) and Advanced Test Reactor (INL) and post-irradiation examination facilities**
  - Link irradiation data of the selected materials to AM builds with high-pedigree digital signatures and well-characterized local microstructures
  - Leveraging standard capsule designs to make neutron irradiations faster and cheaper

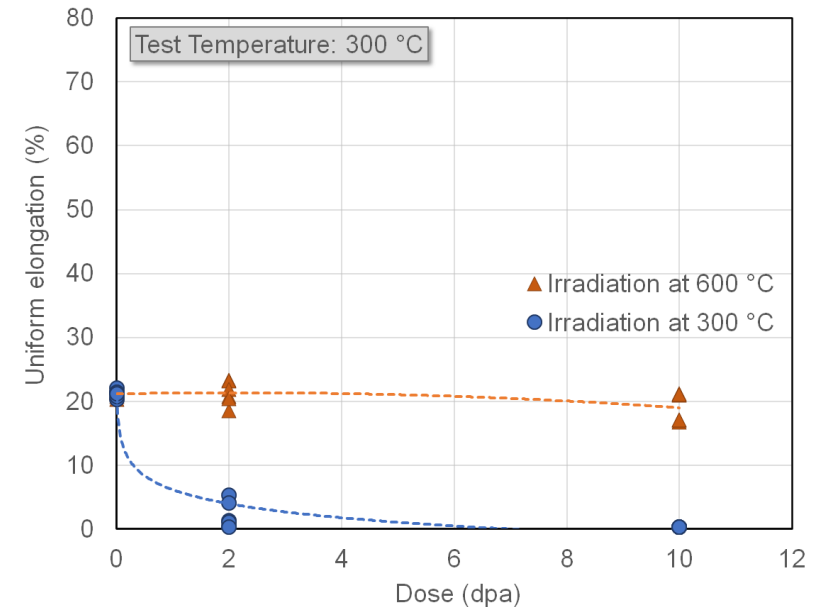
- **Variations in UTS and uniform elongation are similar after 600 °C and 300 °C irradiation**
  - Different defect mobilities: vacancies and interstitials at 600 °C, interstitials only at 300 °C
  - No consistent dependency on sampling location
  - As-built material exhibited softening, stress-relieved appeared to provide the best combination of properties
- **Complete loss of uniform elongation at 300 °C**

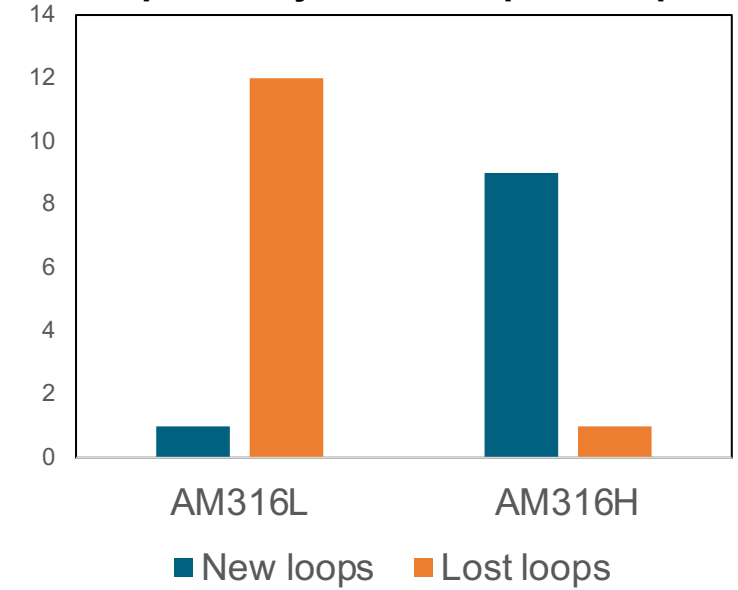
AM 316H, 600°C

Loop stability from 0.6 dpa to 1 dpa
