Subject: Resubmittal of Annual Radiological Environmental Operating Report (AREOR) –  
2024

Waterford Steam Electric Station, Unit 3  
Docket No. 50-382  
Renewed Facility Operating License No. NPF-38

Annual Radiological Environmental Operating Report – 2024

**2024 Annual Radiological Environmental Operating Report**  
**Waterford 3**  
**Document Number: 50-382**

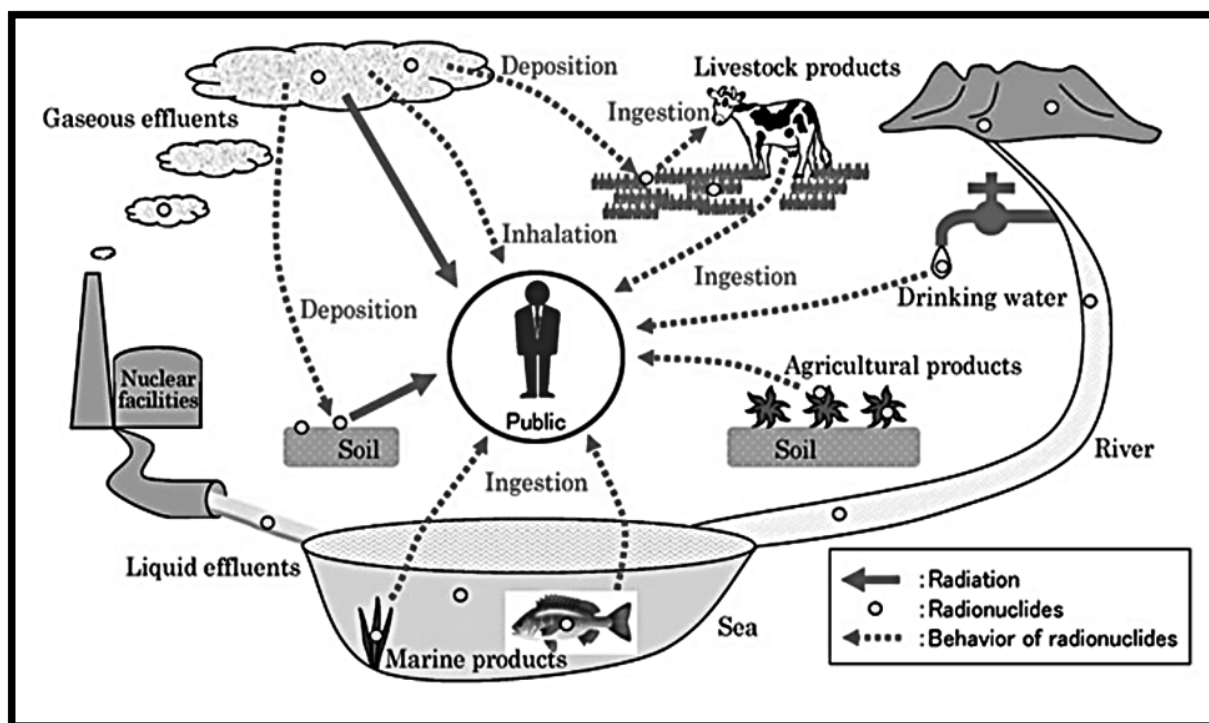
Figure 1, Potential exposure pathways to Members of the Public due to Plant Operations [7]

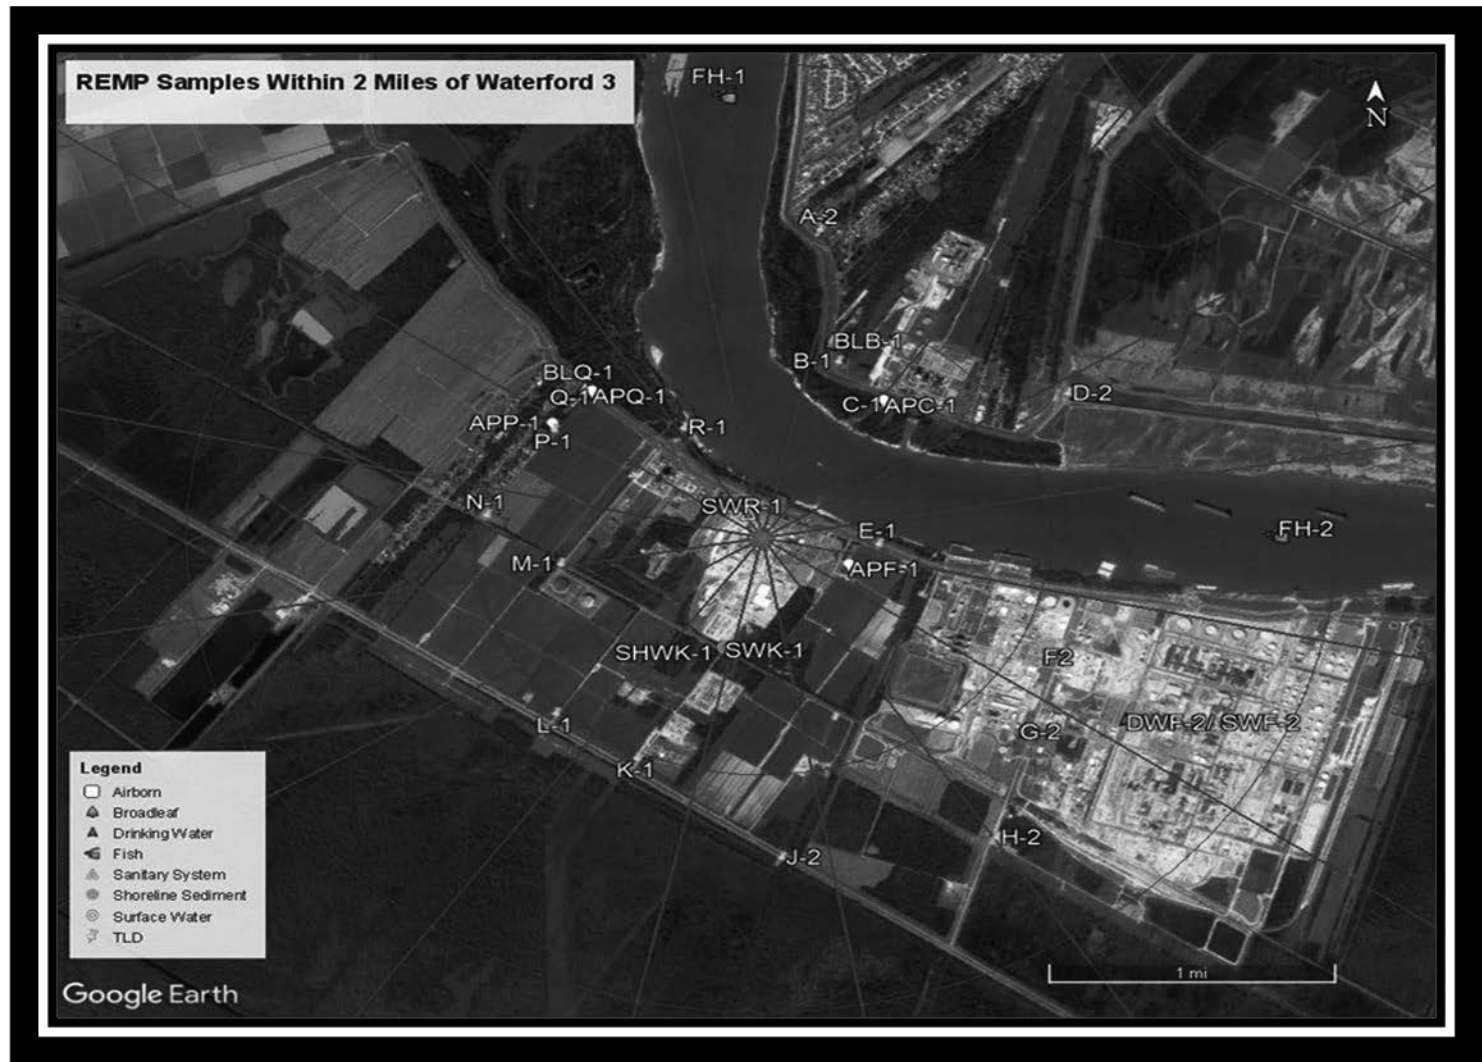
Figure 2, REMP Sample Locations (Within 2 Miles of Waterford 3)

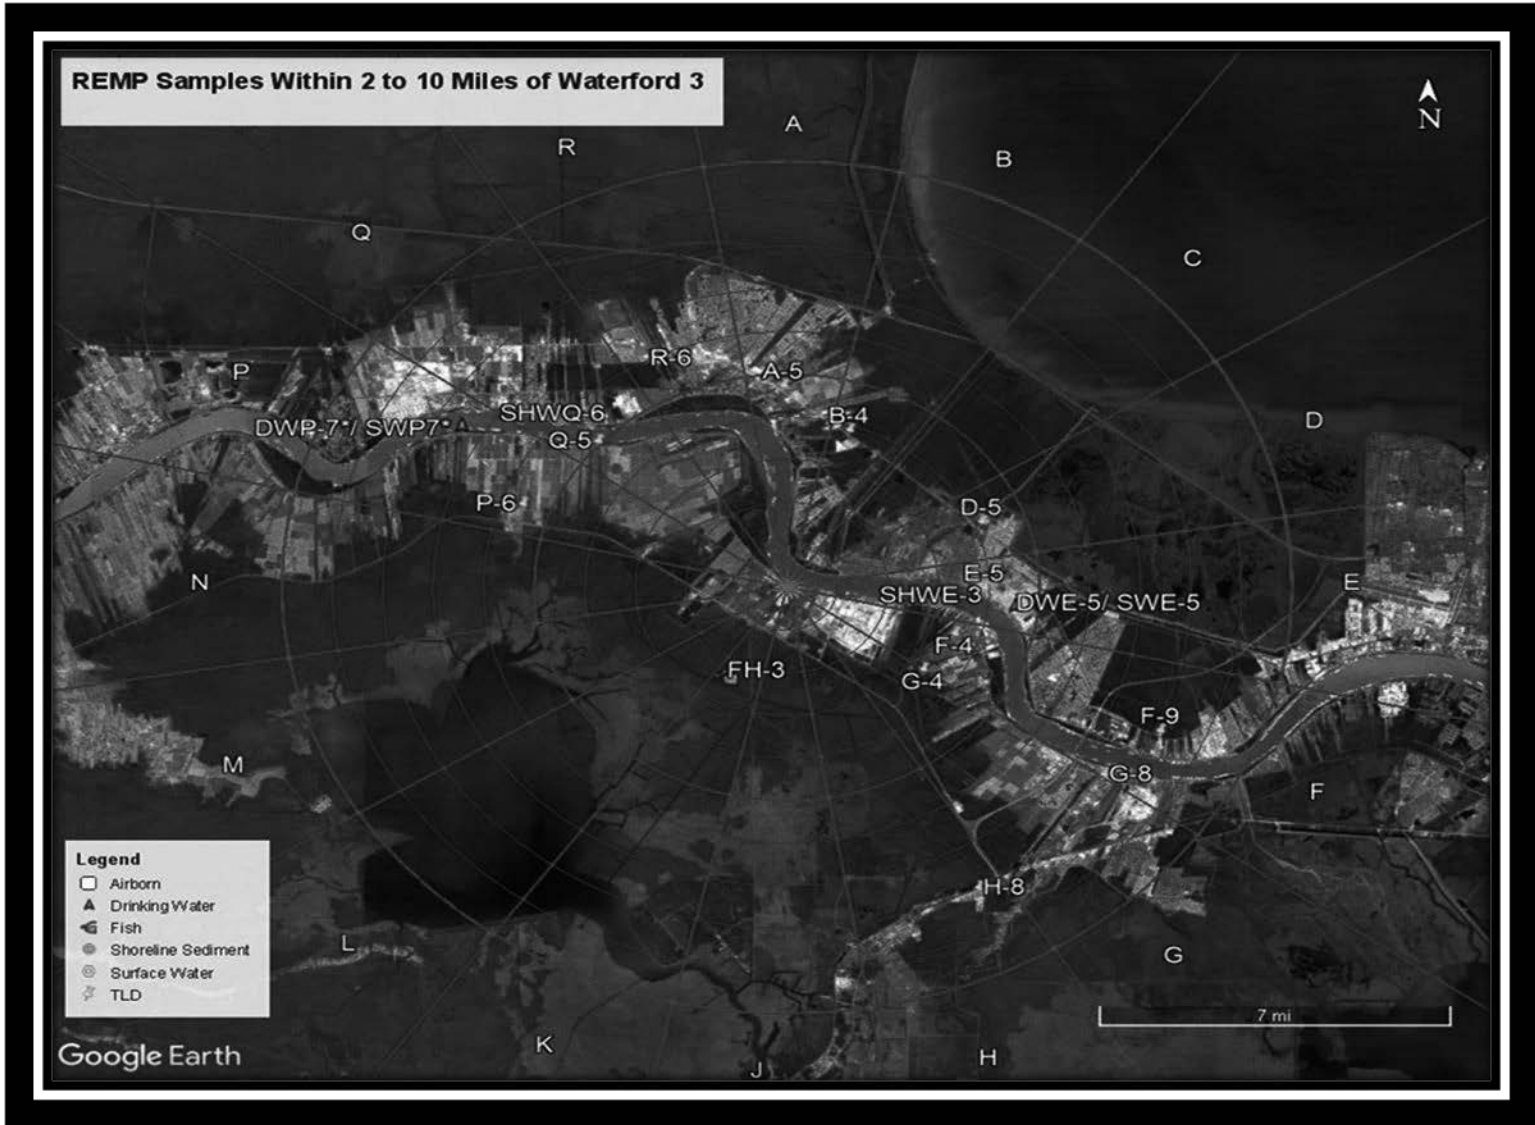
Figure 3, REMP Sample Locations (Within 2 to 10 Miles of Waterford 3)

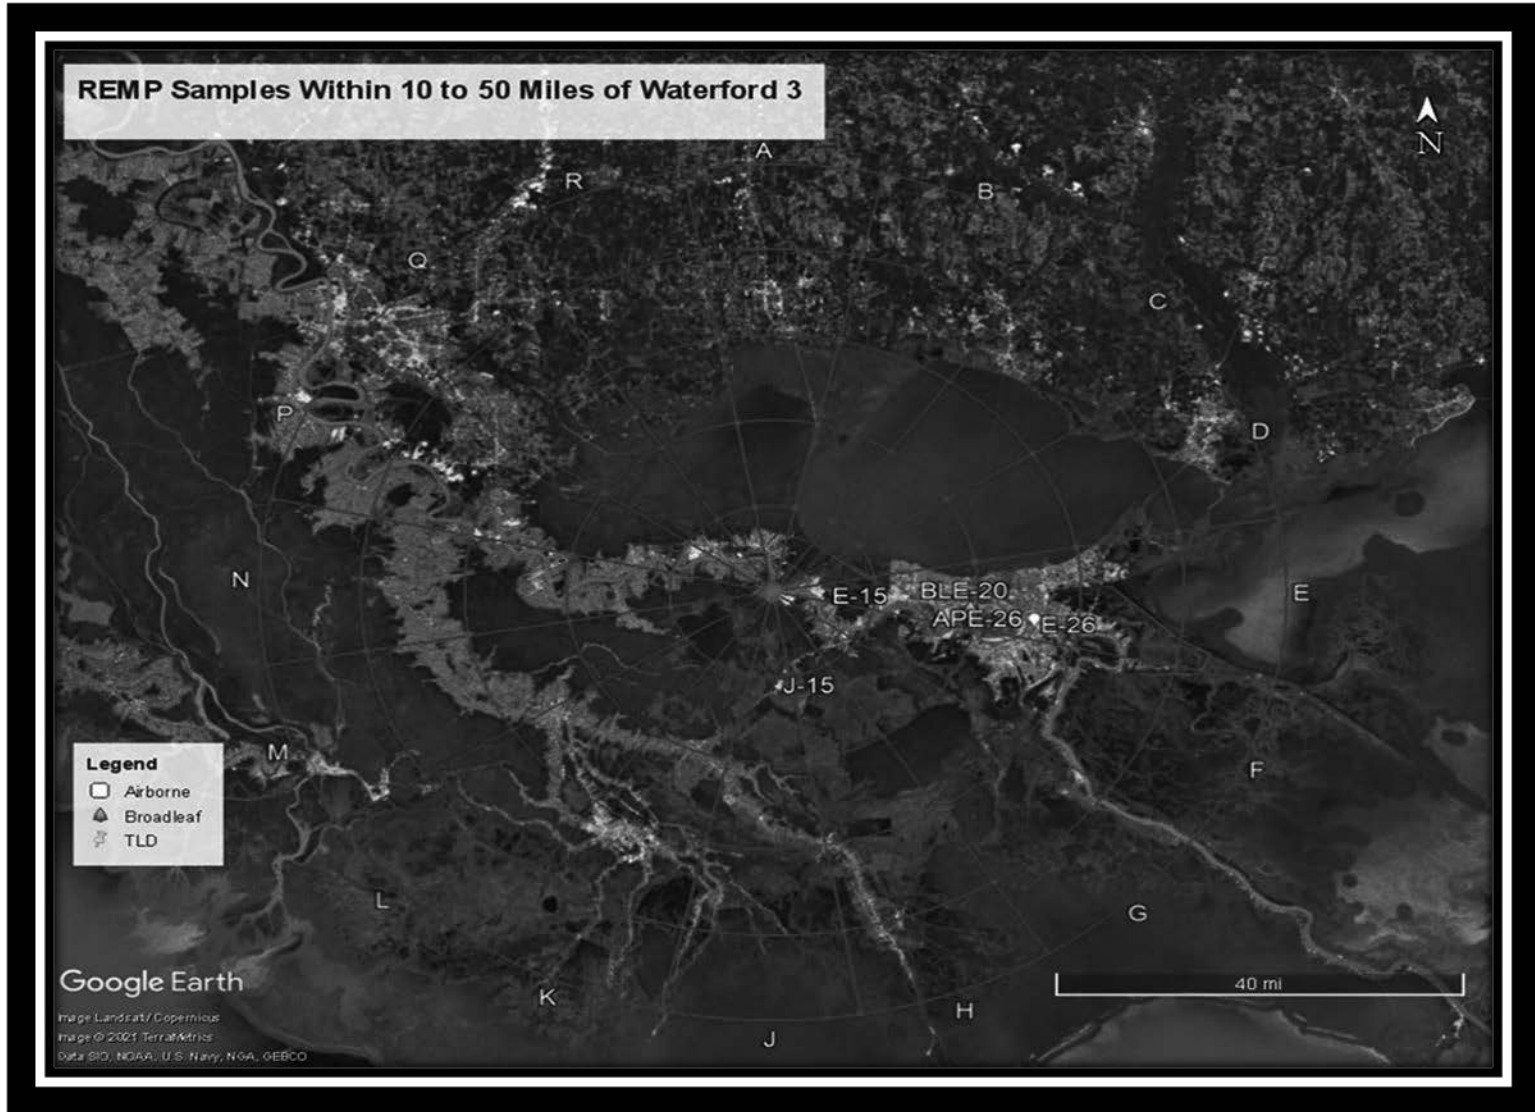
Figure 4, REMP Sample Locations (Within 10 to 50 Miles of Waterford 3)

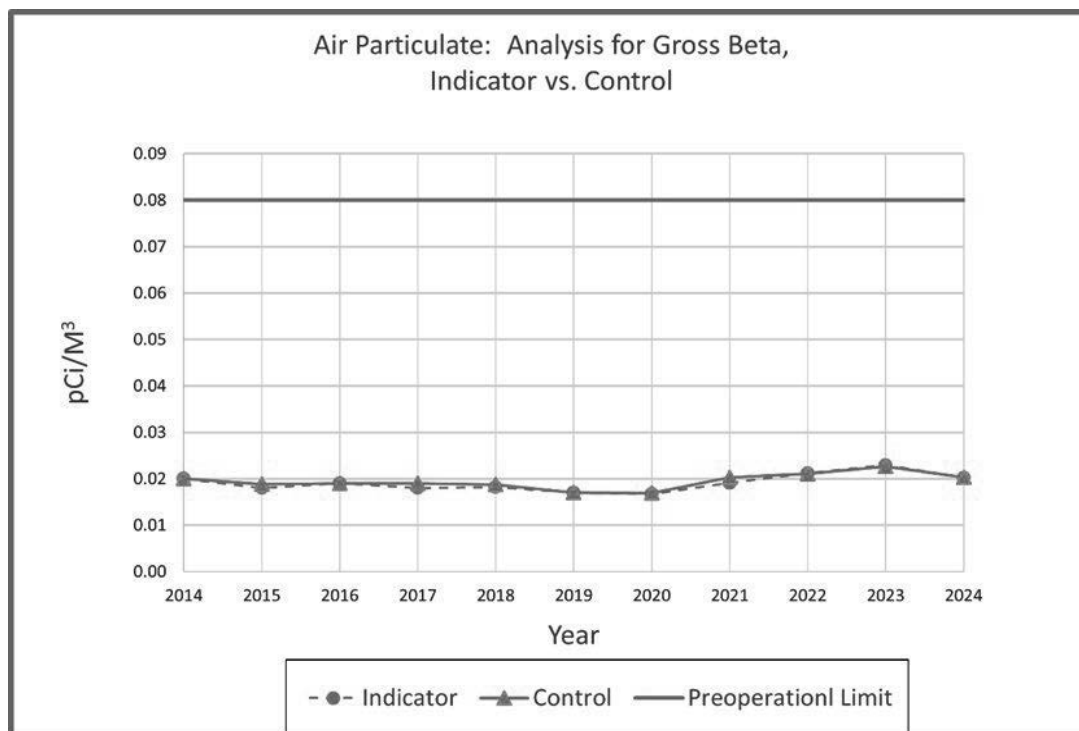
Figure 5, Air Particulate: Analysis for Gross Beta, Average for All Indicator vs. Control Location

Waterford 3 did not detect any gamma emitters in the quarterly air particulate composites or bi-weekly iodine-131 in the radioiodine cartridges during the reporting period as has been the case in previous years.

The operation of WF3 had no definable impact on this airborne pathway during 2024.

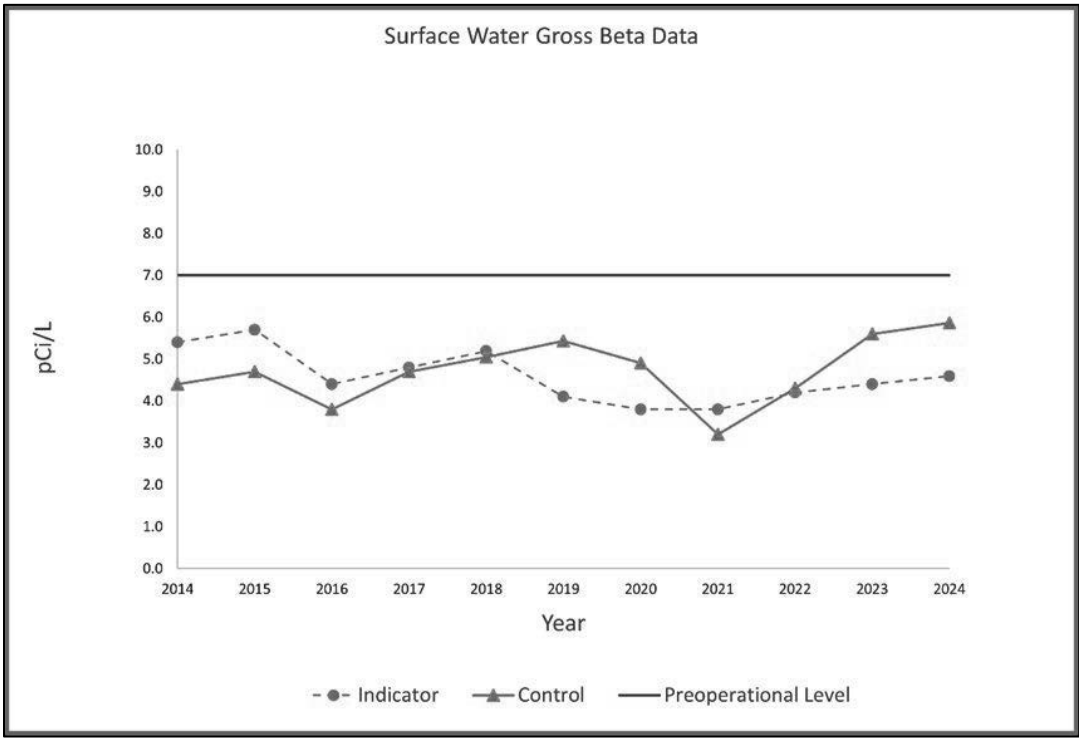
Figure 6, Surface Water Gross Beta Sample Results

Gross beta was detected in both indicator and control locations. Indicator gross beta results were comparable to results obtained from 2014-2023 of the operational REMP. Also, the 2024 gross beta annual average was less than the average for preoperational levels as shown in Figure 6, Surface Water Gross Beta Sample Results.

The operation of WF3 had no definable impact on this waterborne pathway during 2024.
