**Re: Approval of Corrective Action Report for Evaporative Pond Pipeline Discharge, DP-200, Homestake Mining Company, Grants Reclamation Project**

**Figure 1: Transfer Line Spill Boundary, Sample Locations, and Sample Soil Concentrations**

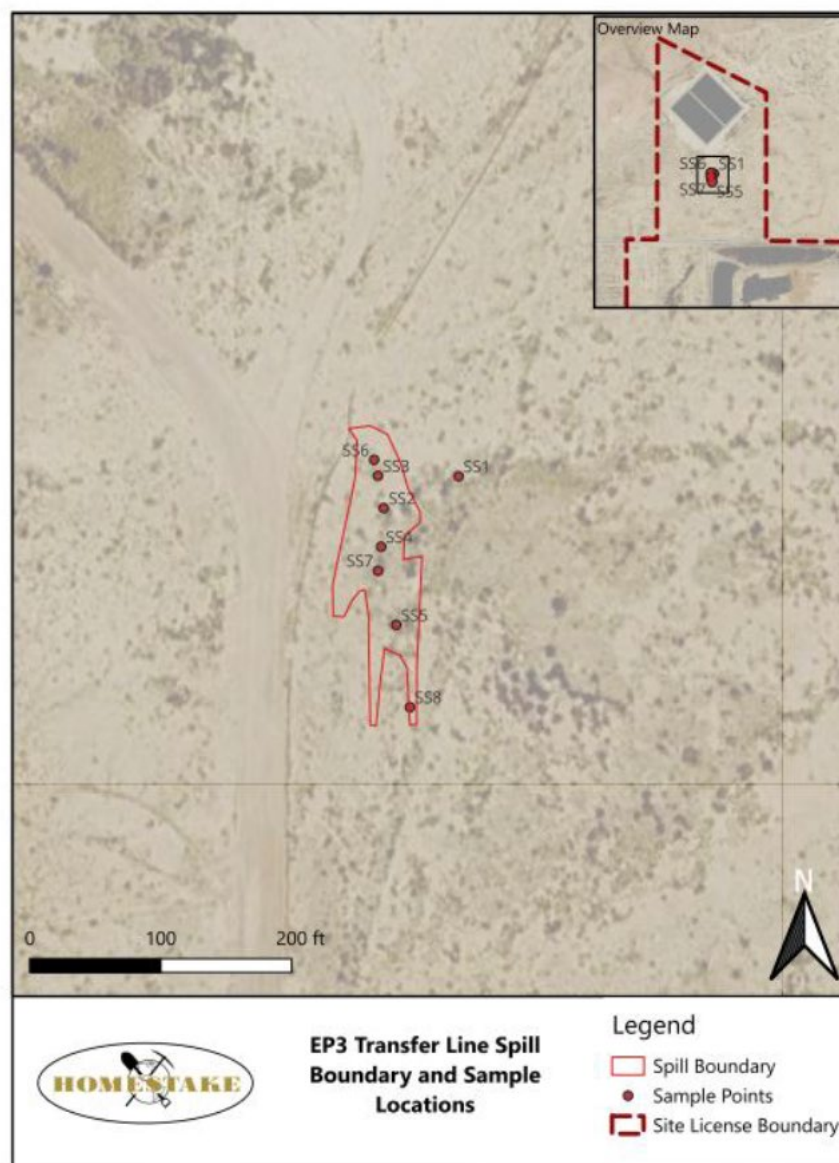
- Chloride concentrations in soil samples SS6, SS7, and SS8 were slightly elevated relative to background soil sample SS1 (see Figure 1). However, chloride concentrations in soil samples SS6, SS7, and SS8 fall within the observed range of natural concentrations in background soil samples taken from sections 28, 33, and 34 documented in the March 2010 report titled *Grants Reclamation Project Evaluation of Years 2000 Through 2009 Irrigation with Alluvial Ground Water*. Reported chloride concentrations were also far below NMED soil screening levels for chloride.

- Sulfate concentrations in soil samples SS6, SS7, and SS8 were elevated relative to background soil sample SS1 (see Figure 1). However, NMED does not have a generic soil screening level for sulfate in its Soil Screening Guidance. The NMED groundwater standard for sulfate is 600 mg/L, and groundwater beneath the evaporative pond pipeline discharge area already contains sulfate concentrations greater than 1,000 mg/L. At this location, the depth to groundwater is approximately 60 feet below ground surface, consisting of unsaturated alluvial material. Given the depth to groundwater and the existing sulfate concentrations in groundwater, it is unlikely that the release would result in a measurable increase in groundwater sulfate concentrations. Additionally, the spill area is located hydraulically upgradient of the hydraulic barrier created by injection into the alluvial aquifer. The injection wells, in conjunction with the collection wells, provide hydraulic control to limit the potential migration of impacted groundwater from this area.

- Approximately 870 cubic yards (2-ft average depth) of additional material were scraped and transported to the Trash Pit and STP for disposal under a RWP between June 18 and June 25, 2026.

- A total of 941 cubic yards of contaminated material were scraped and removed from the spill location.
- Molybdenum and uranium concentrations in soil samples SS6, SS7, and SS8 returned concentrations consistent with the background concentrations reported for background soil sample SS1.
