Addendum OP-5b-2

Soil Profile Photographs

Order 1 Soil Survey Photolog

Lost Creek Project WDEQ-LQD Permit to Mine Application Original Dec07; Rev6 Feb10

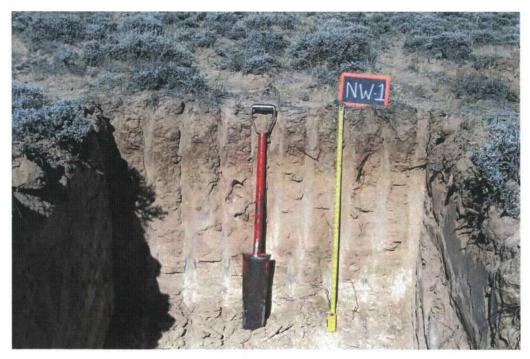
1. Photo of NWPadPr1 pit.

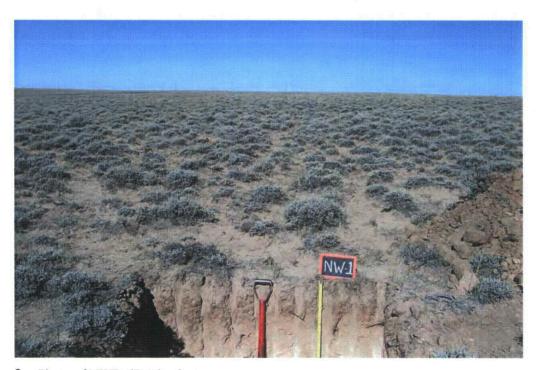
2. Photo of NWPadPr1 landscape.

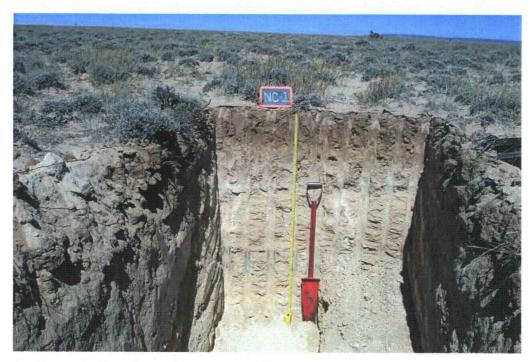
3. Photo of NCPadPr1 landscape.

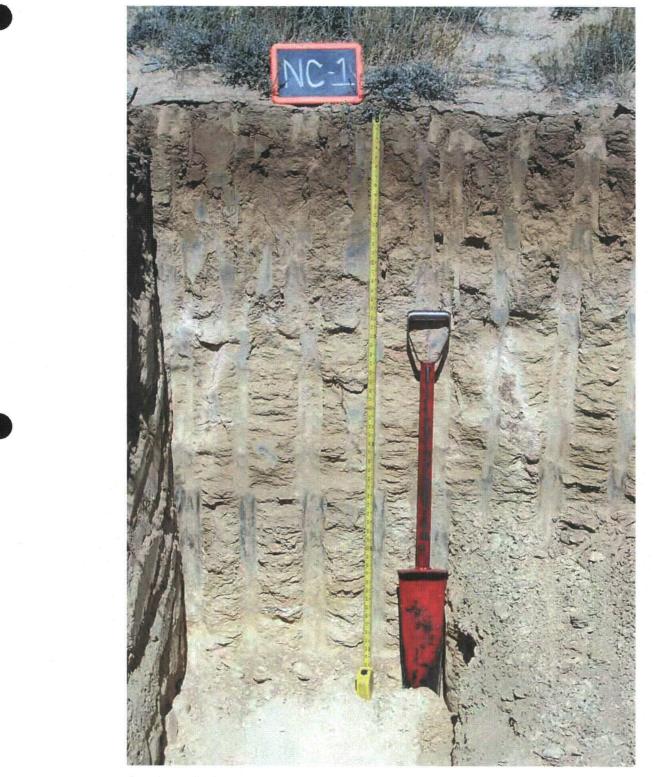
4. Photo of NCPadPr1 pit.

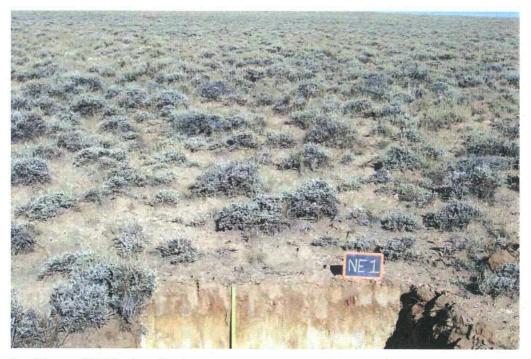
7. Photo of NEPadPr1 landscape.

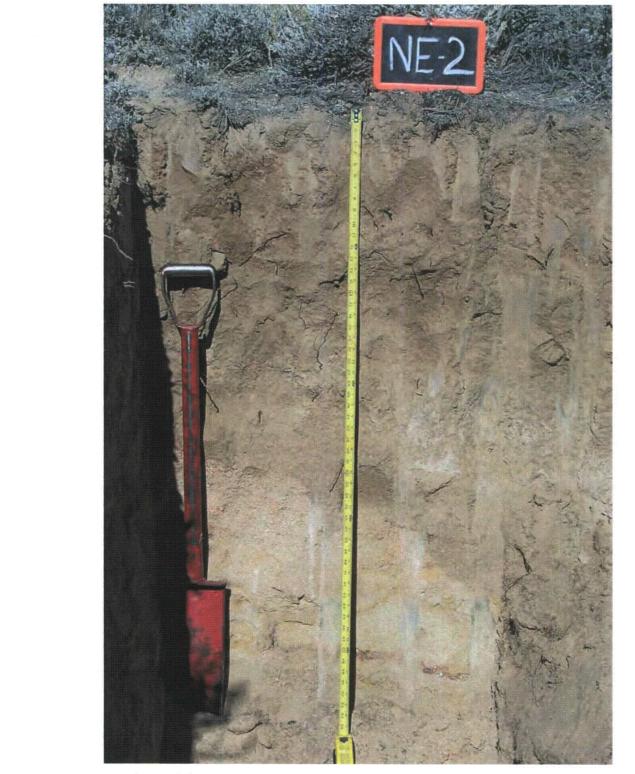
9. Photo of NEPadPr2 pit.

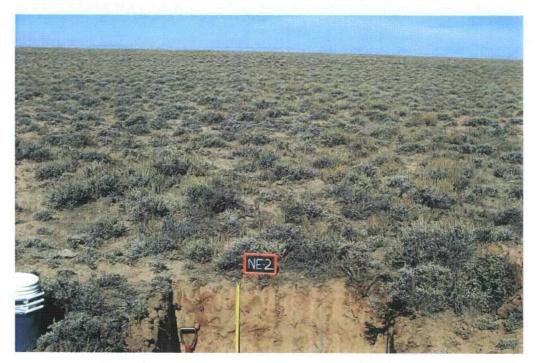
10. Photo of NEPadPr2 landscape.

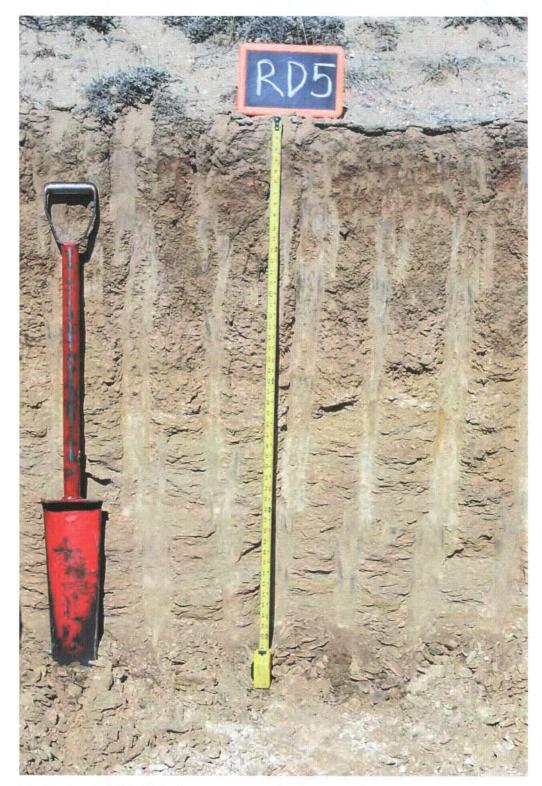
15. Photo of EWPadPr5 pit.

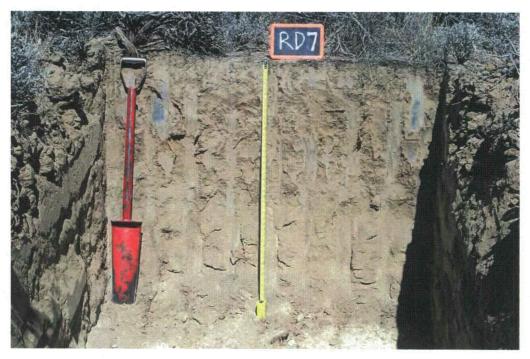
17. Photo of EWPadPr7 pit.

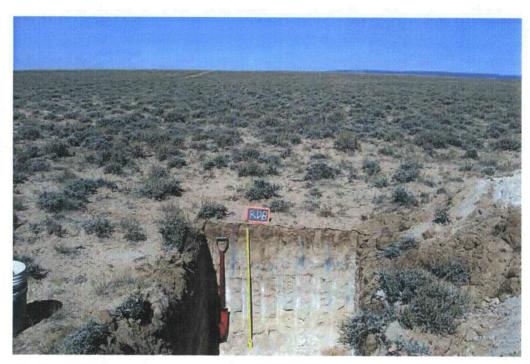
22. Photo of EWPadPr8 landscape.

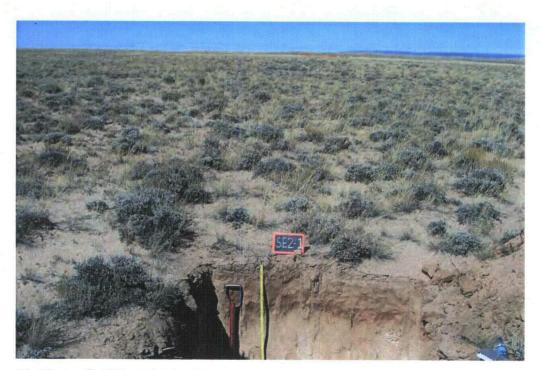
23. Photo of SEPad2Pr1 landscape.
