Recent Materials Inspections of PWR Reactor Internals

Glenn Gardner, Dominion
Chair, Reactor Internals Working Group

NRC RIC Meeting
March 2015

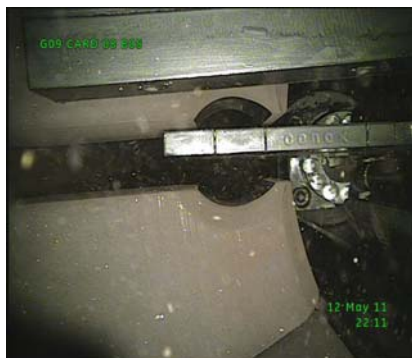
VT-3/Measurement W Control Rod Guide Cards

Acceptable

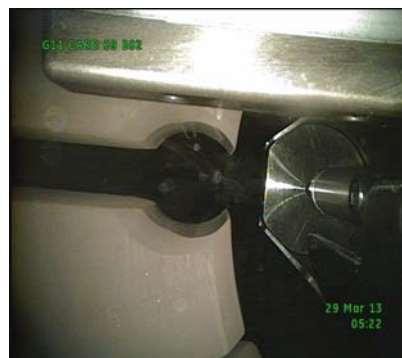
Observed Wear

- No macroscopic effects of void swelling
 - No distortions, cracking, or excessive bolting failure
- High-strength nickel alloy clevis insert bolting failures
 - However, not in safety function load path
- Guide card wear will require monitoring
 - MRP Interim guidance MRP-2014-006 issued
