**Subject: Beaver Valley Power Station, Unit No. 1 and No. 2
BV-1 Docket No. 50-334, License No. DPR-66
BV-2 Docket No. 50-412, License No. NPF-73
Reply to Request for Information Concerning BVPS Responses to
NRC Bulletins 2001-01 and 2002-01**

Beaver Valley Power Station, Unit No. 1 and No. 2
Reply to Request for Additional Information
NRC Bulletins 2001-01 and 2002-01
L-02-054
Page 2

Attachment A

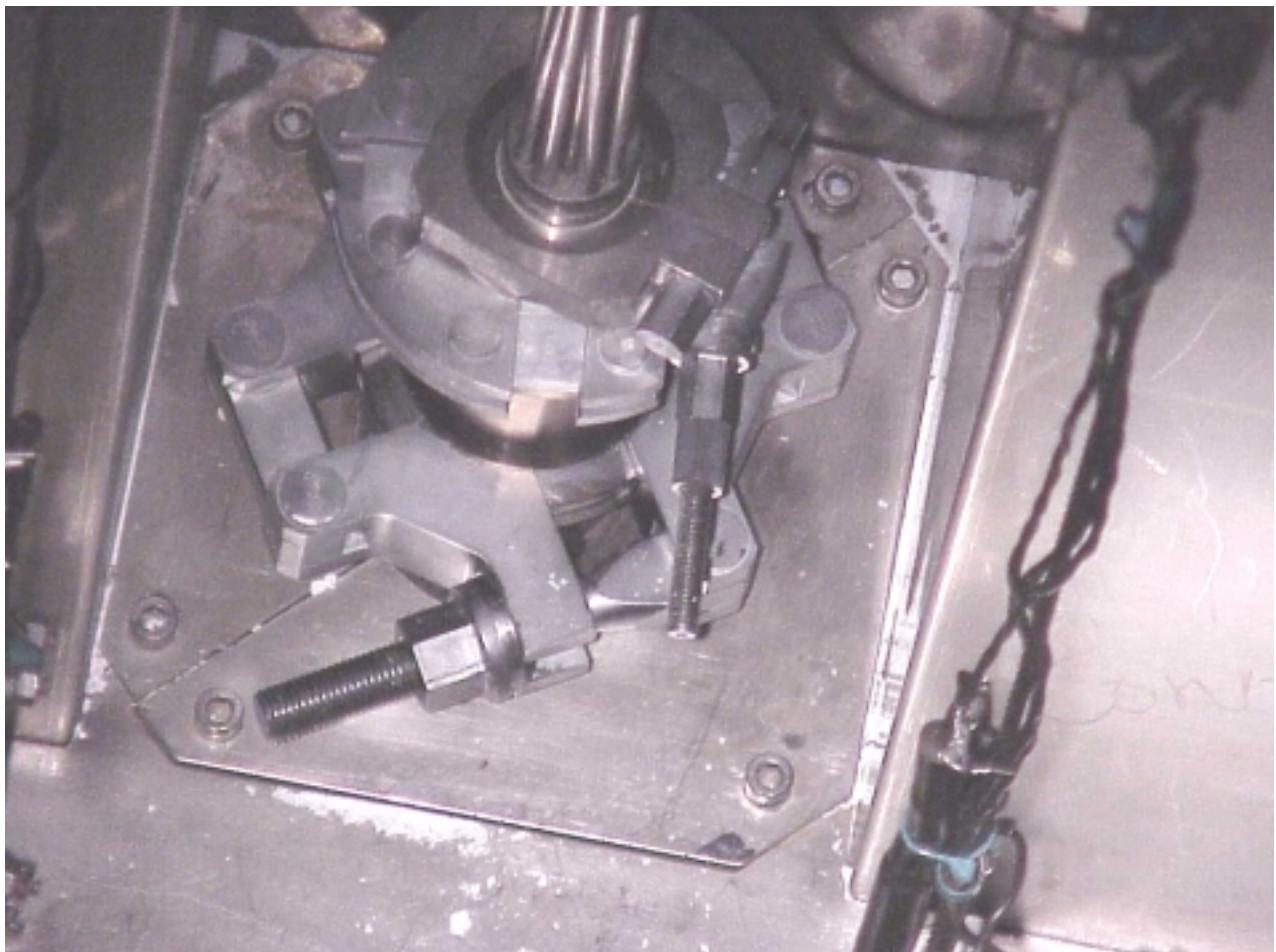
- At BVPS Unit 2, following the 2R09 refueling outage in February 2002, there was a light, dry dusting of boric acid observed on the upper surface of the #1 Conoseal when the system was initially pressurized to approximately 300 psi. Based on follow-up inspections of the area, it was determined that this was not an active leak. Additionally, during a subsequent forced outage on April 5, 2002, a containment entry was made and NDE personnel photographed the conoseal. The photos of the #1 Conoseal confirmed that there is no active leakage. (See Figure 3 which provides a copy of the subject photo.)

BVPS Unit 2
Conoseal #1

Photo taken during subsequent forced outage on April 5, 2002
(showing no evidence of active leakage)
