Examination of Diablo Canyon Unit 1 Steam Generator Tube No. R20C54

51-5046570-01 Final Report, August 2004

Prepared for Pacific Gas & Electric Company

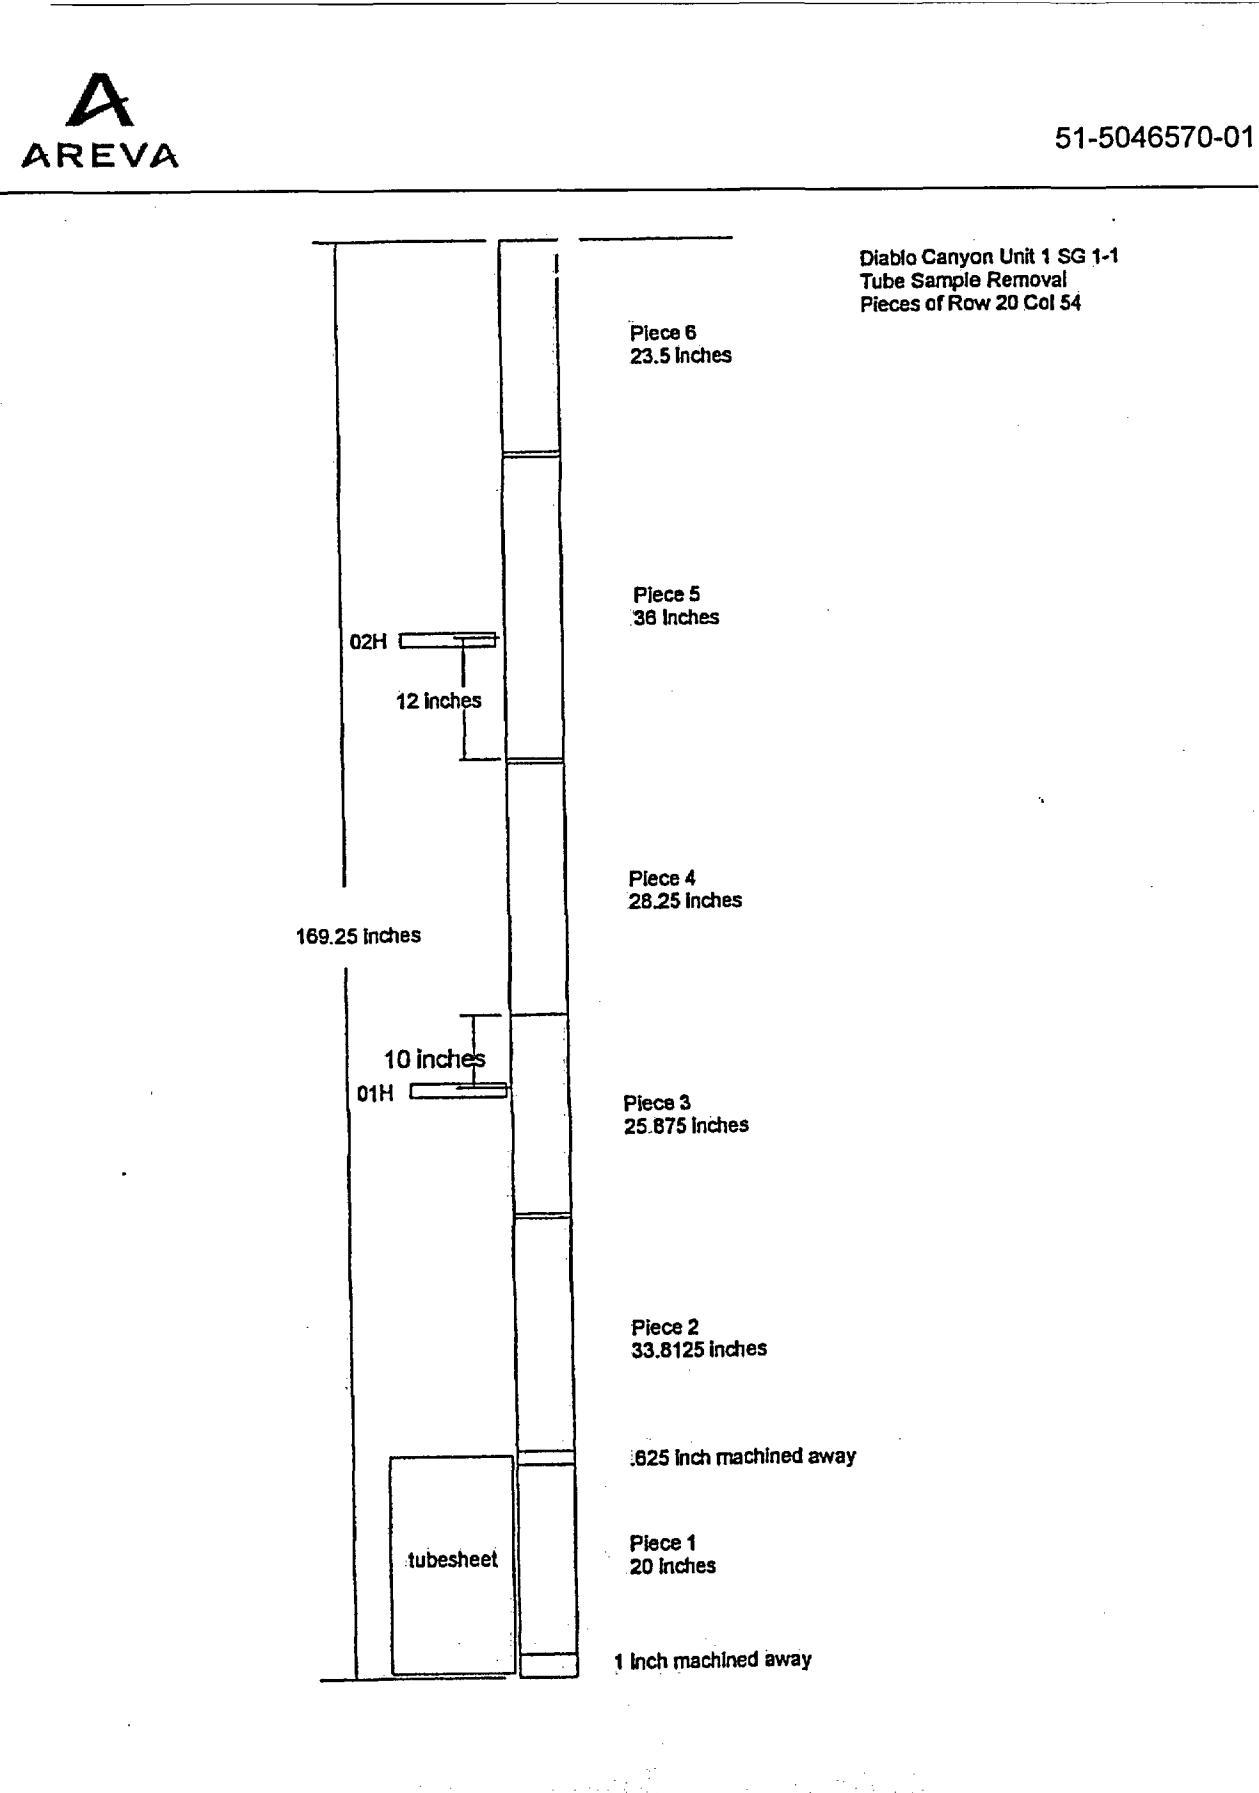
Figure 1. Pulled tube diagram - SG 11 tube no. R20C54

Sections of tube number R20C54 from Diablo Canyon SG 11 were received at the Framatome ANP (FANP) SERF-4 facility on Wednesday, May 5, 2004. The tube sections removed and their relative elevation in the steam generator are illustrated in Figure 1. Section (piece) numbers 3, 4, and 5, containing the 1H and 2H TSP locations and the free span tubing between these locations were unpacked, inspected, and prepared for testing. Results of the receipt inspection are documented in Reference 1 and are summarized in Table 1.

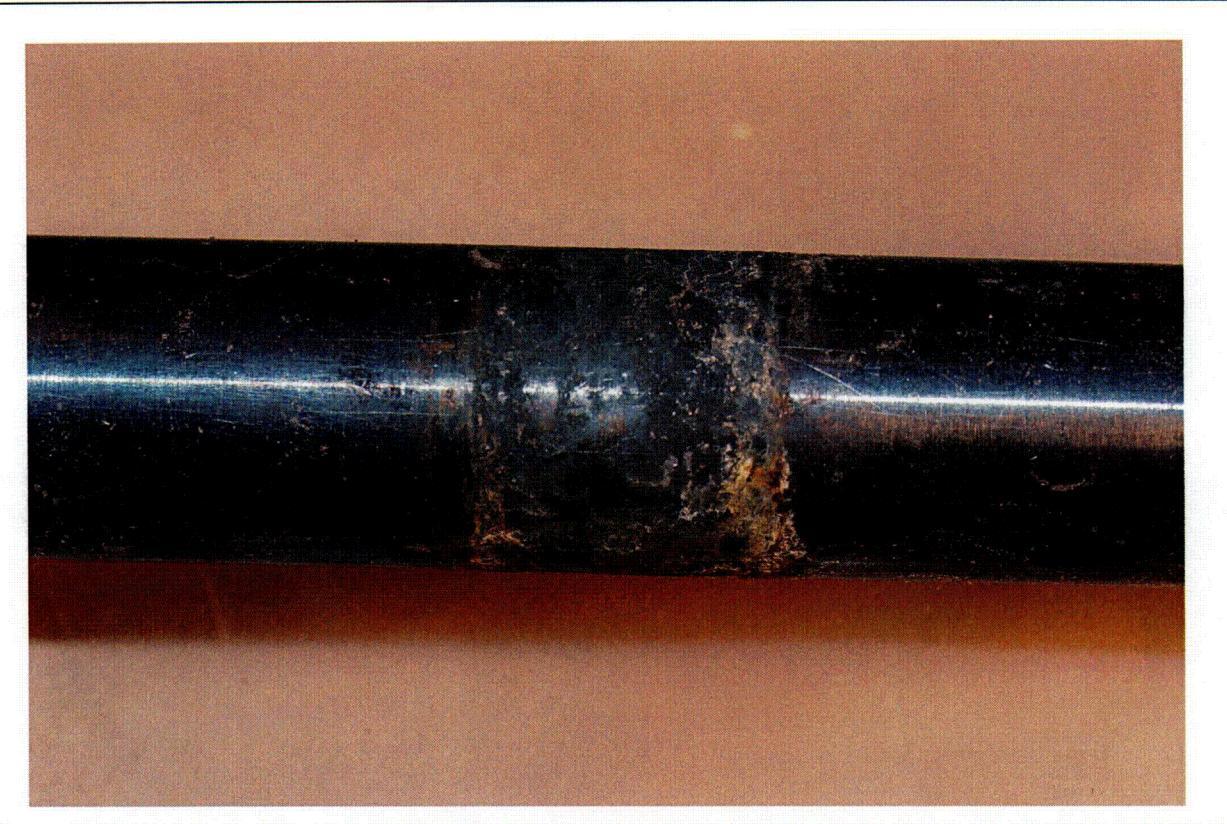
Figure 2 illustrates the typical as-received appearance of tube number R20C54 at the 1H TSP intersection. As can be seen in the photograph, the location at which the support plate contacted the tube is clearly visible from the remaining accumulation of deposits.

In general, the OD of the tube was gun-metal grey in color, with axial patches and spots of copper colored oxide (Figure 2) present on all of the sections.

Figure 2. Receipt photograph of 1H TSP intersection (section 3) at 0 degrees. Bottom (in SG) is to the left.

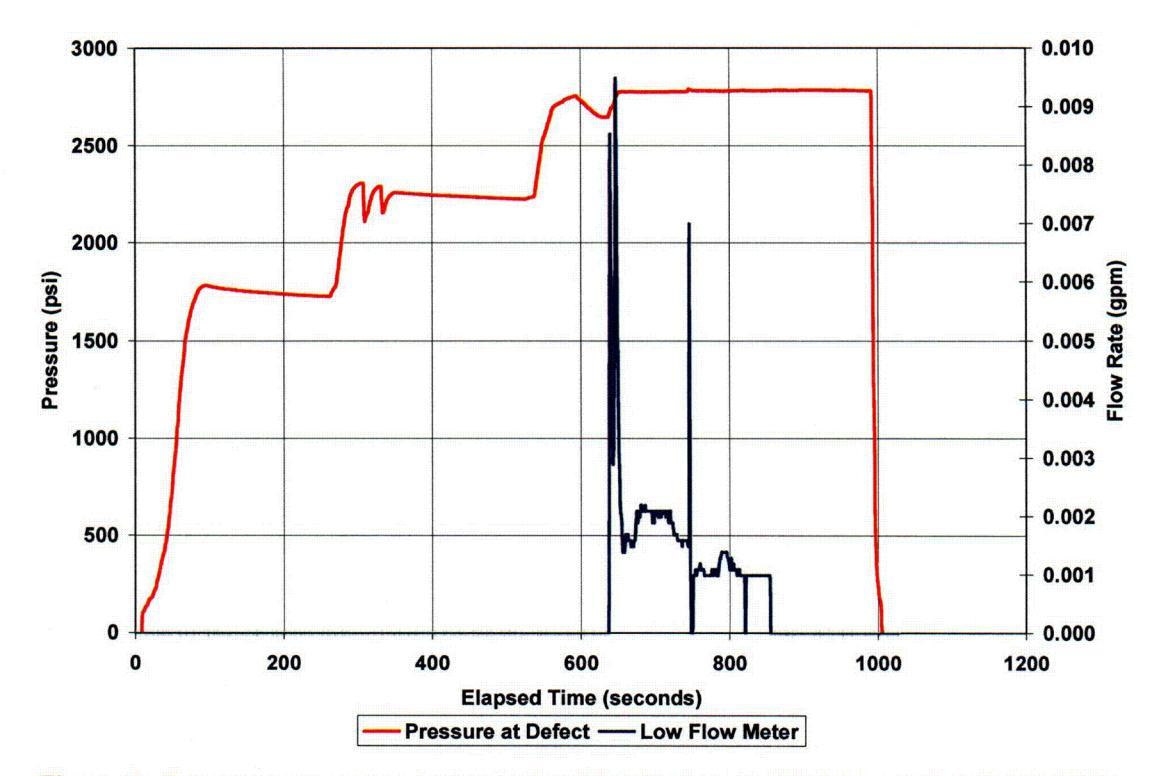
The test pressure and leak rate versus time (time in seconds) results for tube section R20C54-3 are shown in Figure 3. Tube section R20C54-5 (2H TSP) did not leak at any of the pressure differentials tested. Tube section R20C54-3 (1H TSP) developed a small leak at the highest pressure tested. The maximum leak rate recorded during the 5 minute hold period was ~0.002 gpm. After ~2 minutes, the leakage decreased first to ~0.001 gpm and then to less than detectable (<0.001 gpm). Although deionized water was used in the tests to minimize the potential for particles in the water, it's possible that particulates in the pulled tube test specimen may have deposited within the crack.

Figure 3. Room temperature leak rate for SG 11 tube no. R20C54, section 3 (1H TSP)

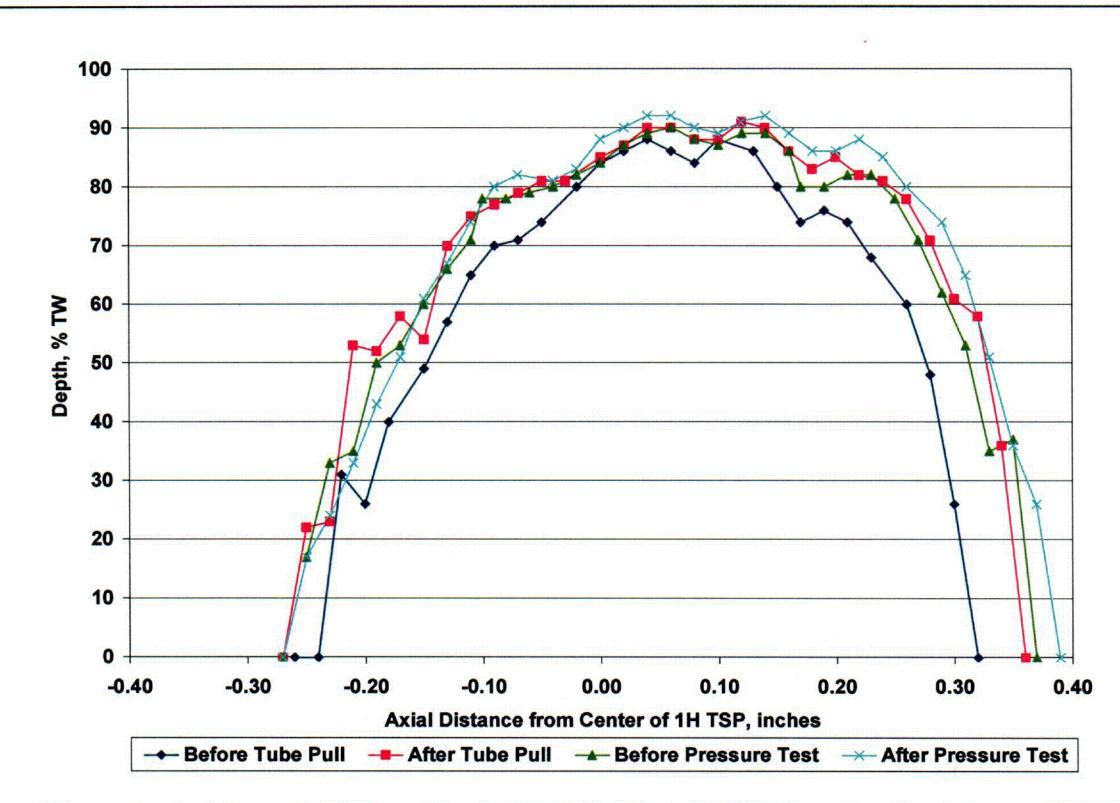
Figure 4. Axial crack NDE profile at 19° (SAI #1) at 1H TSP location for tube no. R20C54

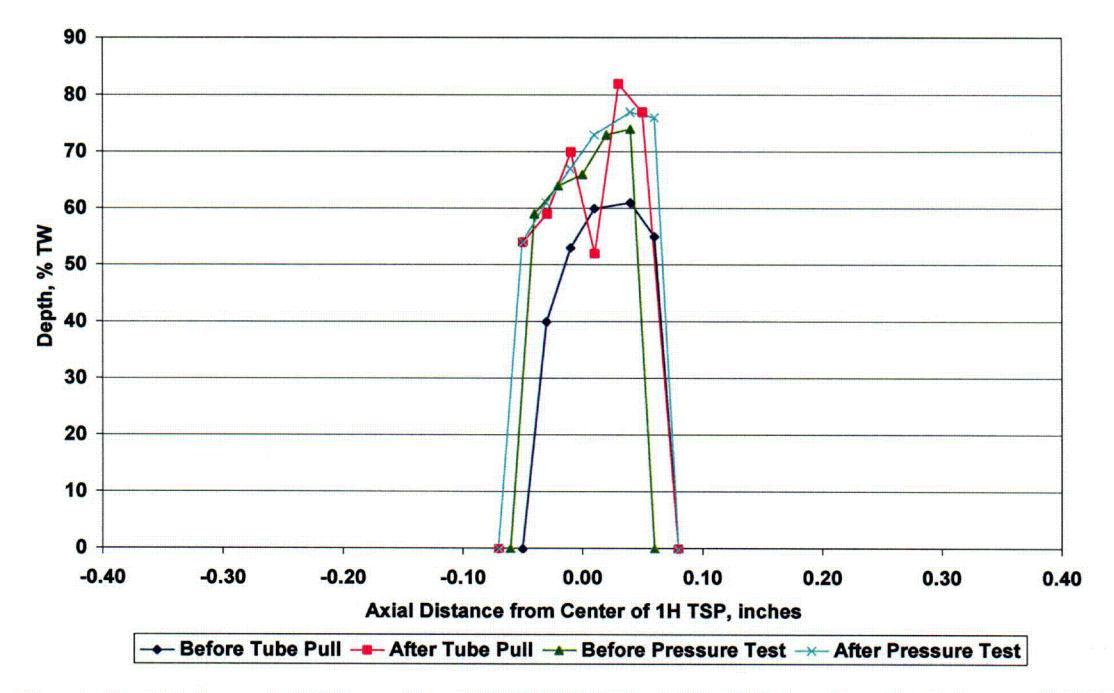
Figure 5. Axial crack NDE profile at 330° (SAI #2) at 1H TSP location for tube no. R20C54

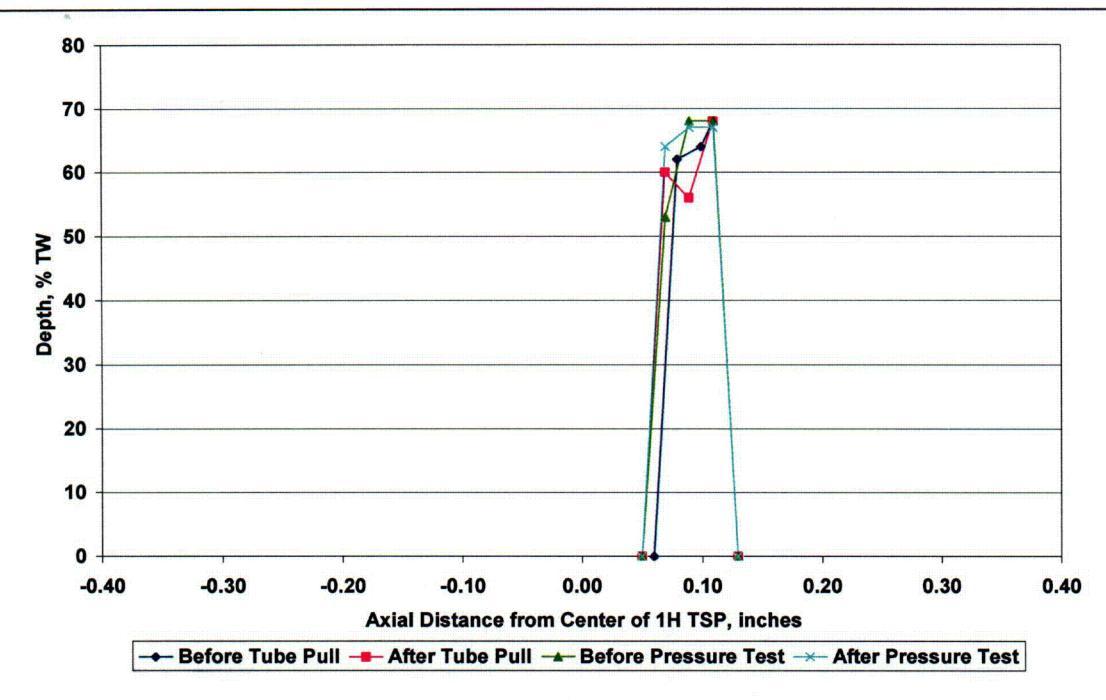
Figure 6. Axial crack NDE profile at 292° (SAI #3) at 1H TSP location for tube no. R20C54

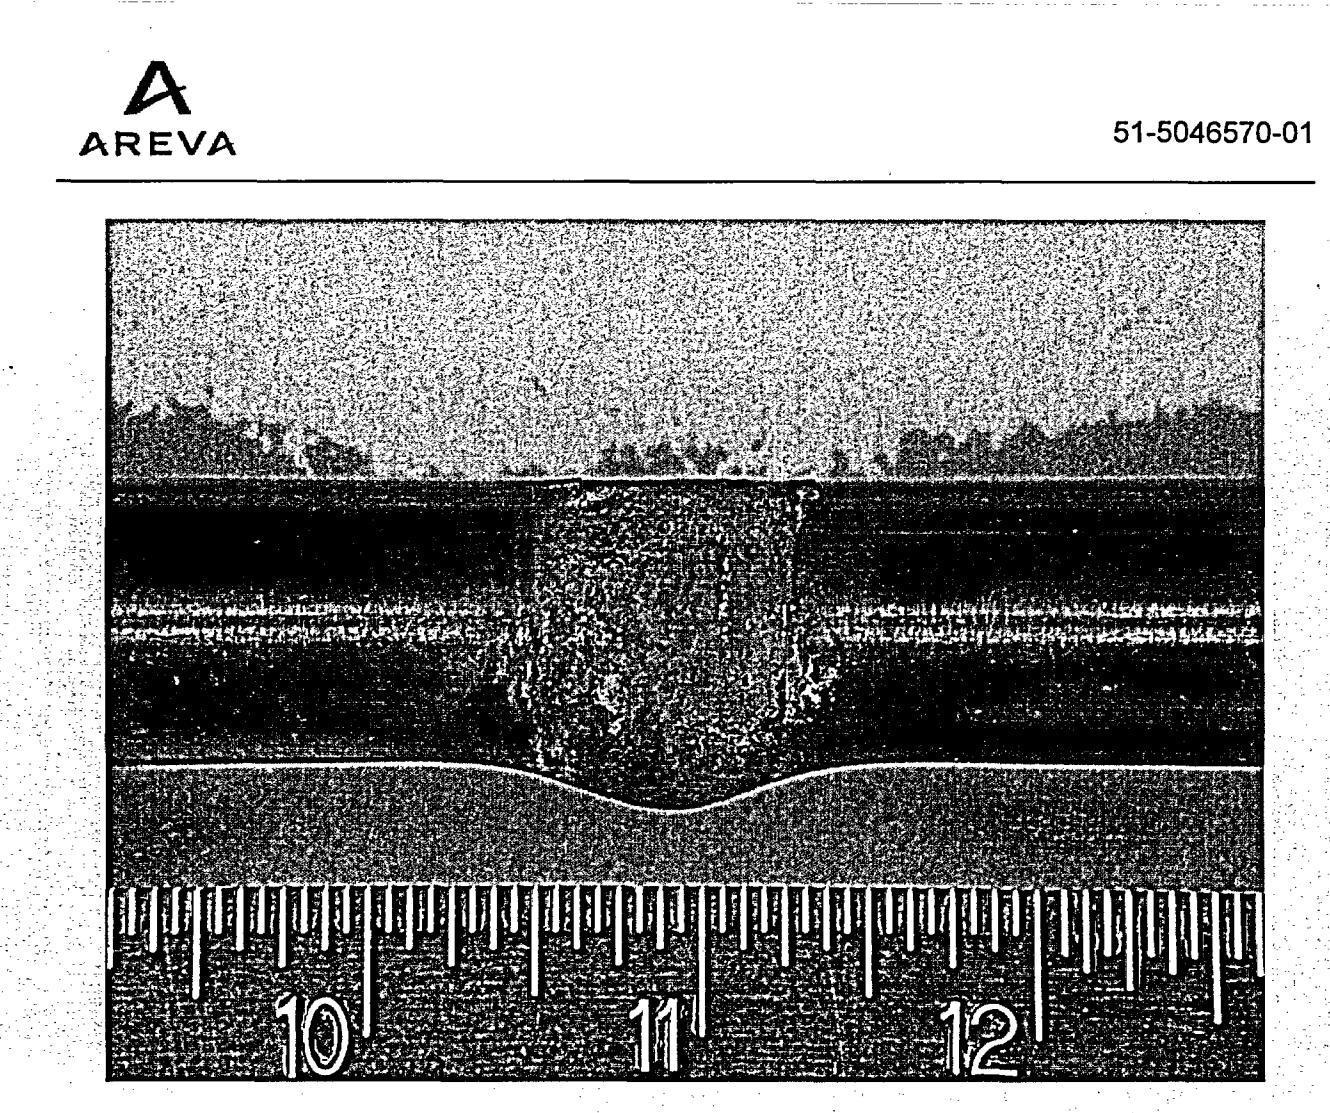
Figure 38: 1H TSP region at 270° after burst testing. 1.7X

Macro photographs of this tube section in 45° intervals are provided in Figures 32 - 39, and a similar photograph centered over the fish mouth opening at 19° is provided in Figure 40. Higher magnification photographs of the counter clockwise (CCW) and clockwise (CW) burst rupture surfaces, showing the oxidized intergranular corrosion areas, are provided in Figures 41 and 42. The burst region was located at approximately 19°, with the bottommost extent of the oxidized defect region near the bottom of the TSP. SEM fractography (Section 2.9) later revealed a total axial extent of ~0.7 inches and a length of ~0.12 inches where the defect was 100% through wall.

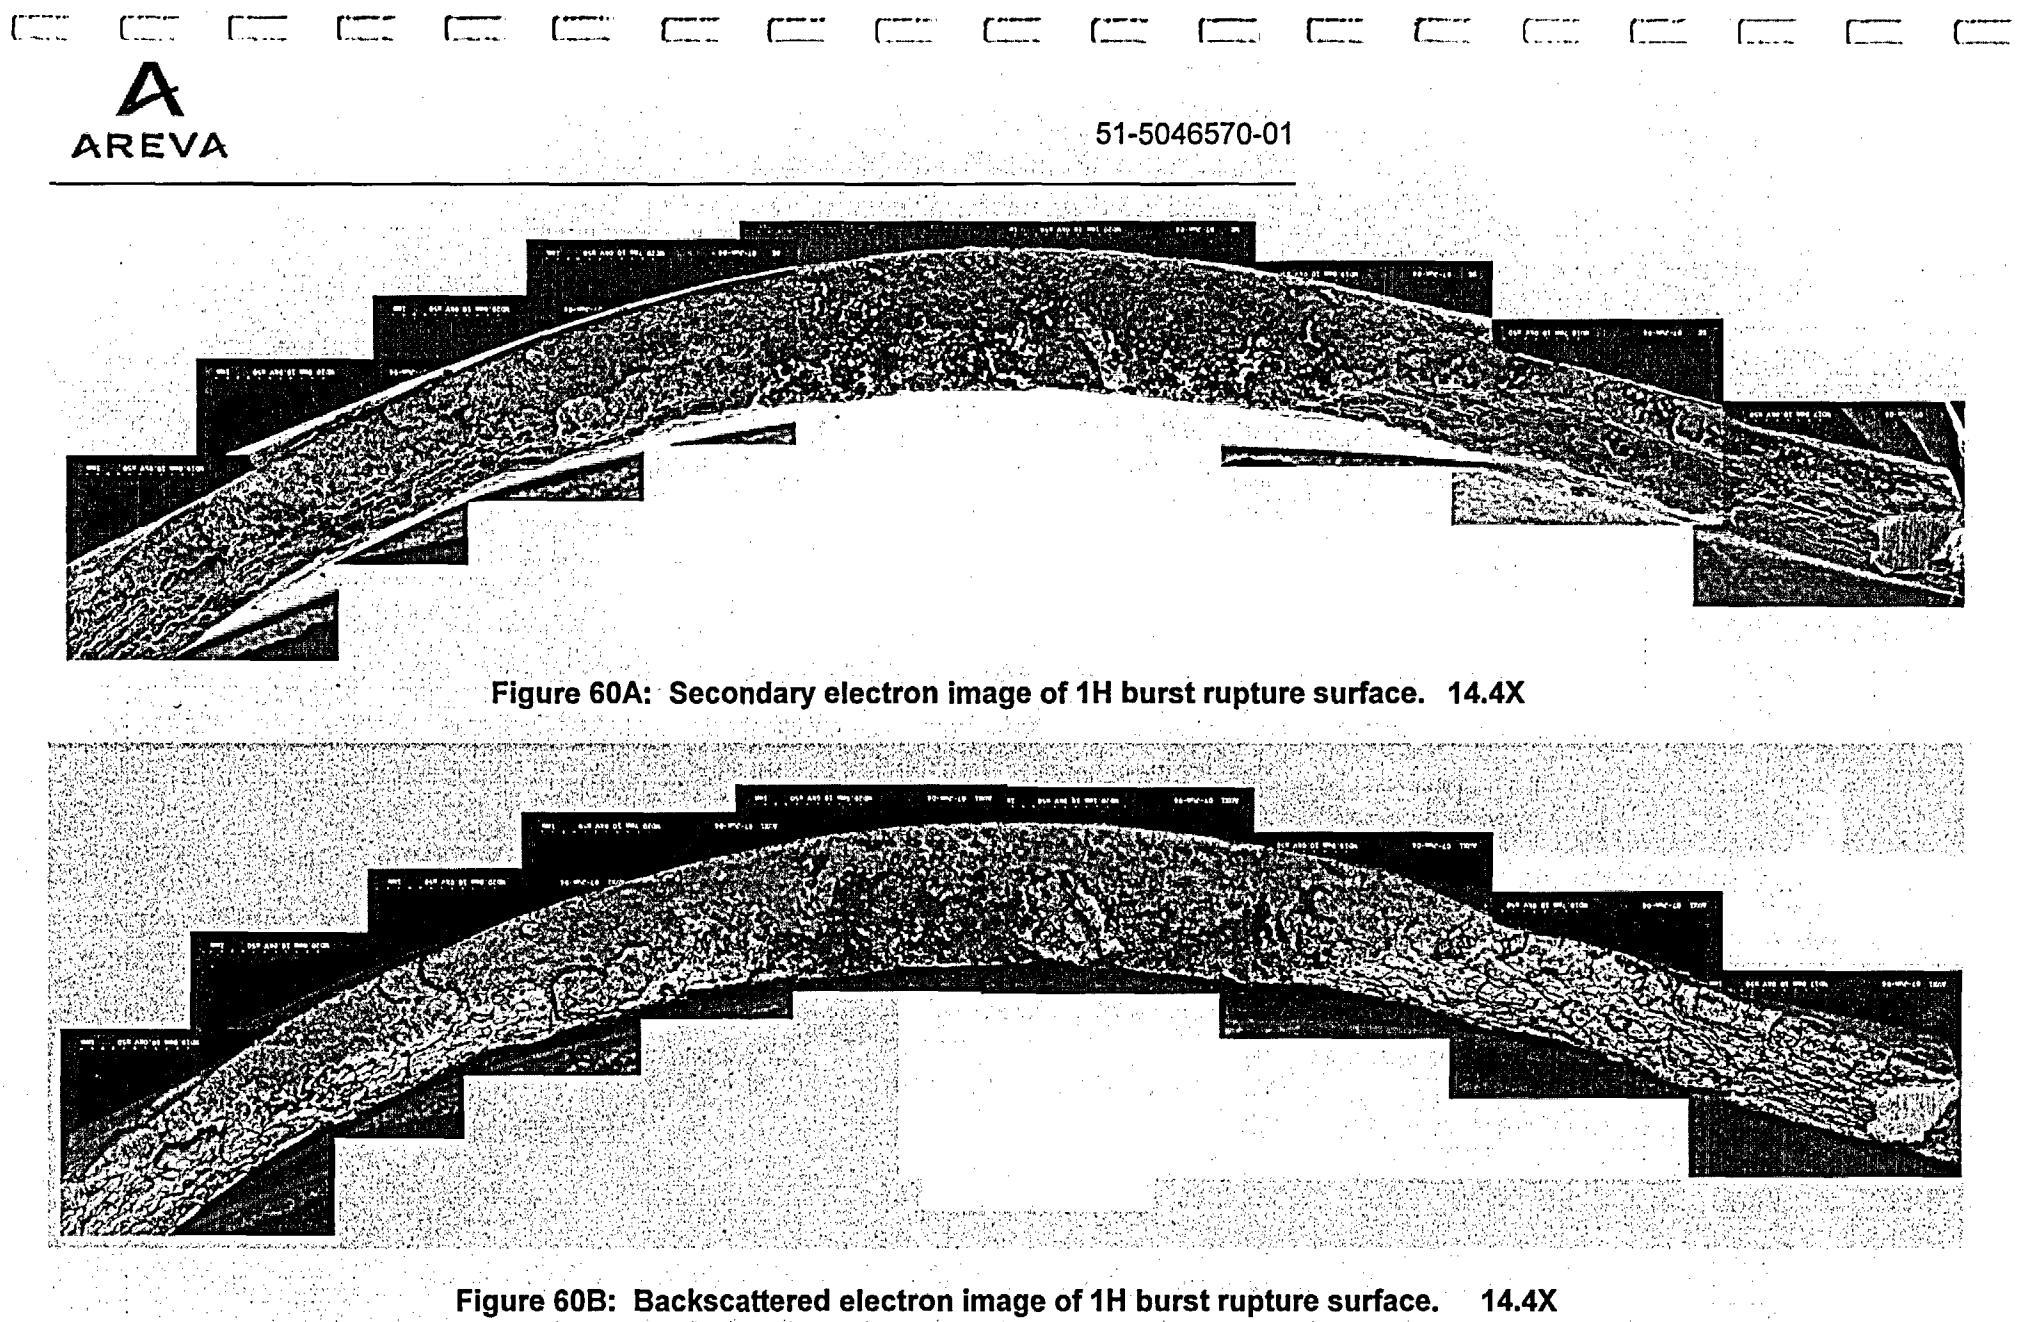
Low magnification photo mosaics of the counterclockwise (CCW) fracture surface from R20C54-3B2 are provided in Figure 60 (rotated 180° to keep axial bottom to the left in this report). The secondary electron (SE) image provides the best topographical information, whereas the backscattered electron (BSE) image provides information on material density (less dense materials, such as oxides and plastic bladder material, show up darker).

Figure 60: SEM mosaics of 1H burst rupture surface (bottom to left)

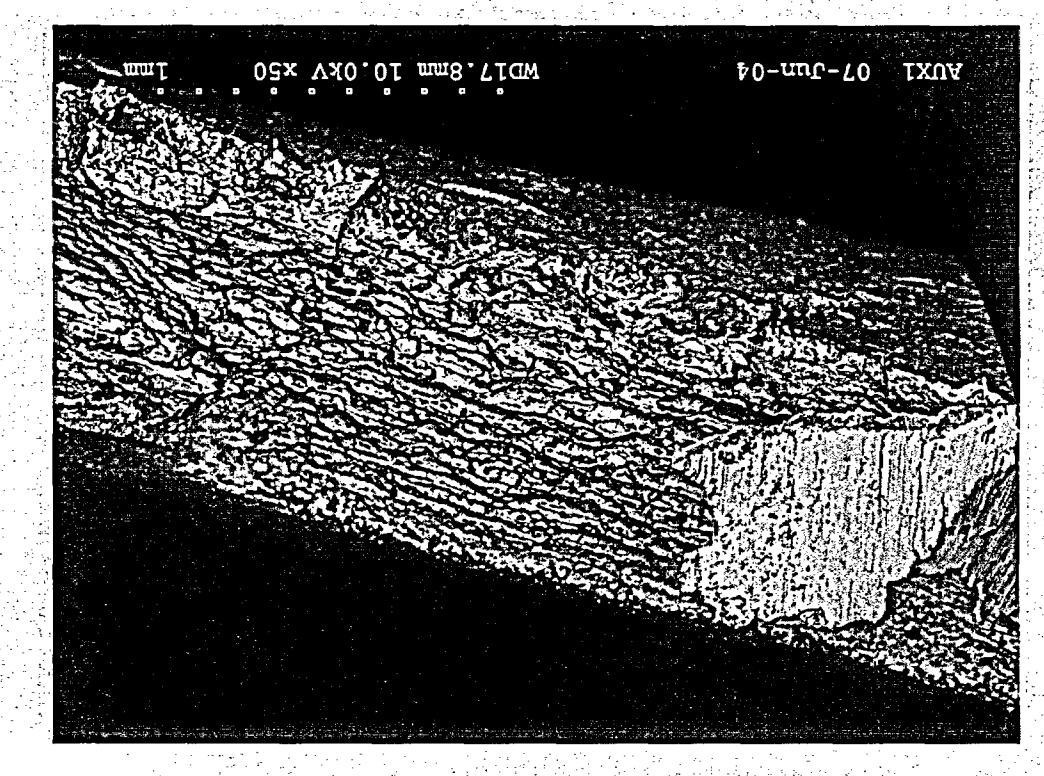
Figure 66: SE image of top edge of IGSCC on burst rupture surface of 1H TSP. 50X

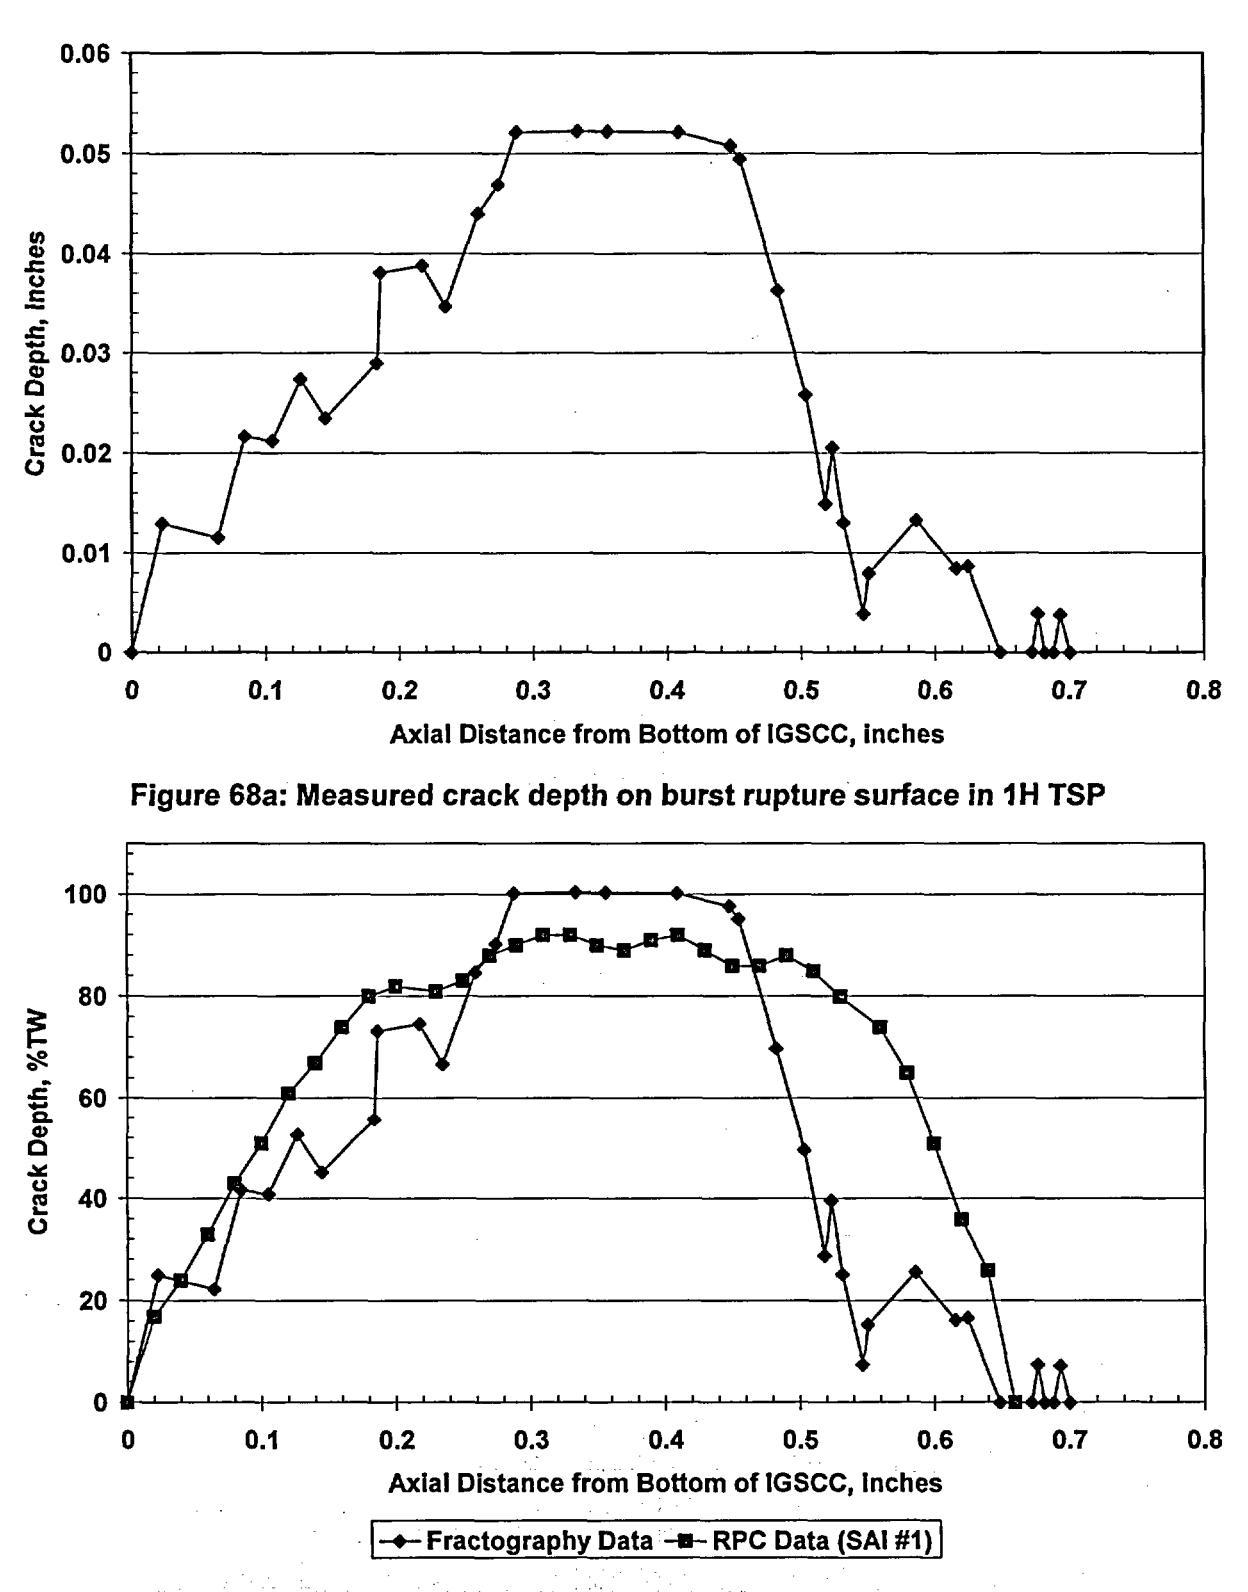
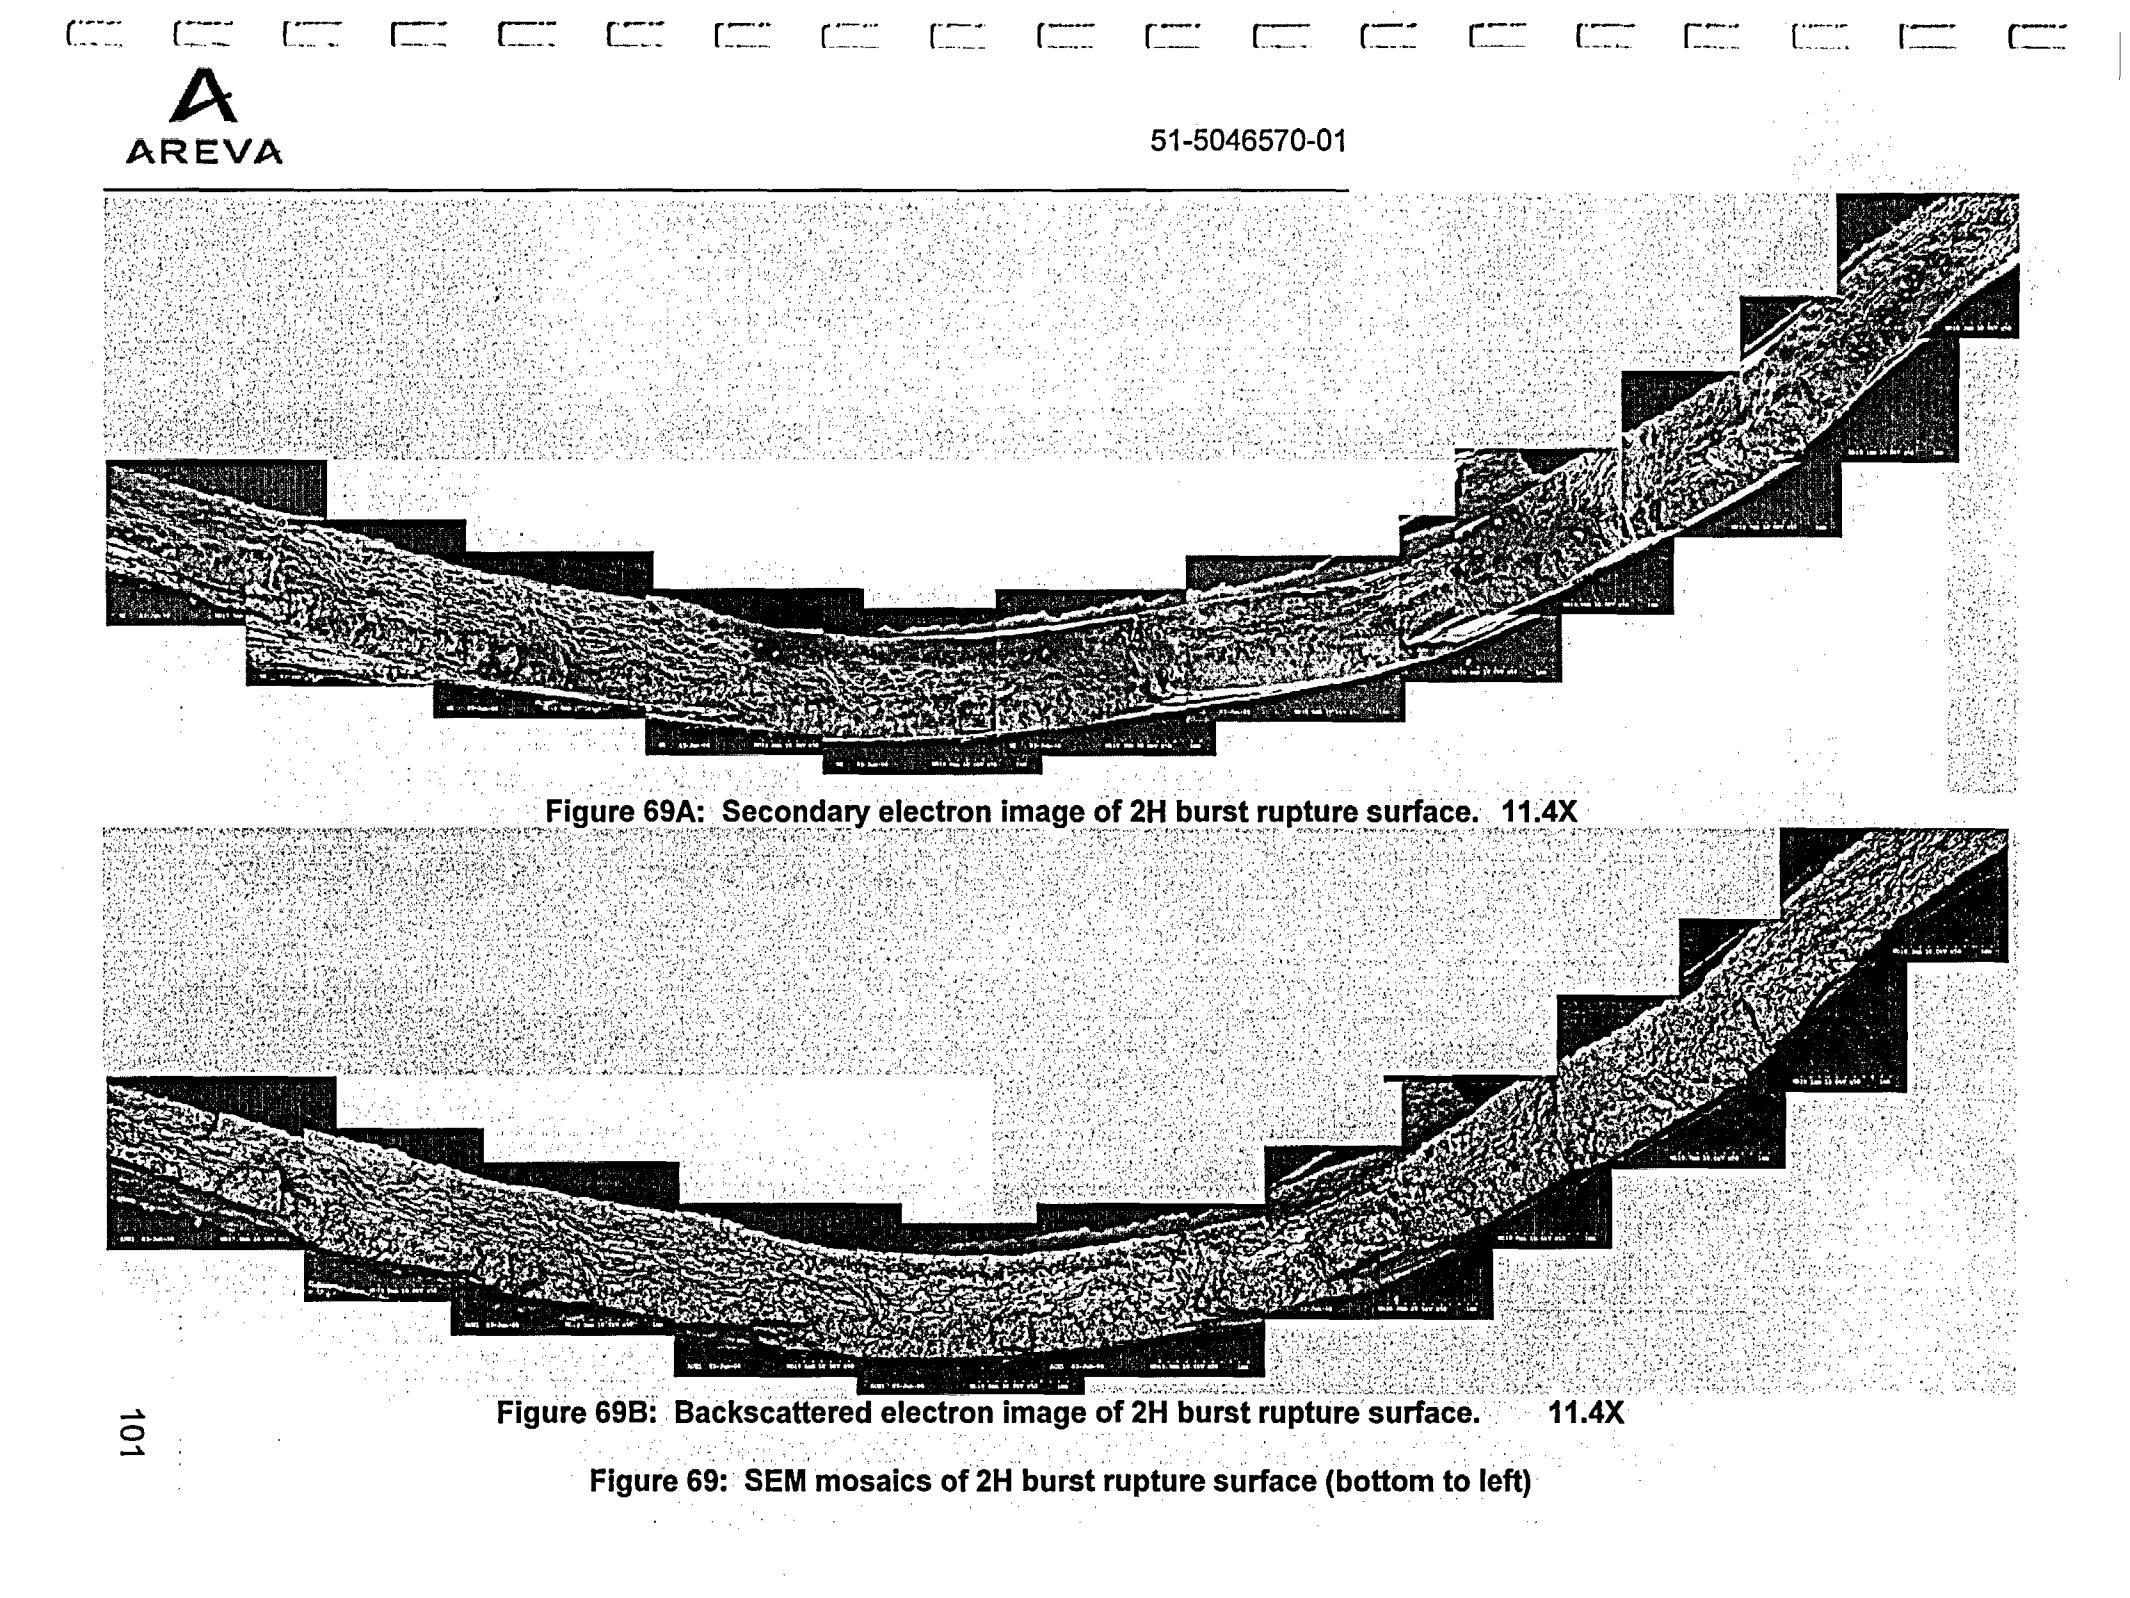
leak test, were identified. Comparison of the measured crack depth profile vs. the post-leak rate test RPC data is shown in Figure 68b. The measured crack depths were normalized using a nominal wall thickness of 0.052 inches.

Figure 68b: Comparison of measured crack depth vs. post leak rate RPC data Figure 68: Measured depth of IGSCC (SAI #1) in 1H TSP

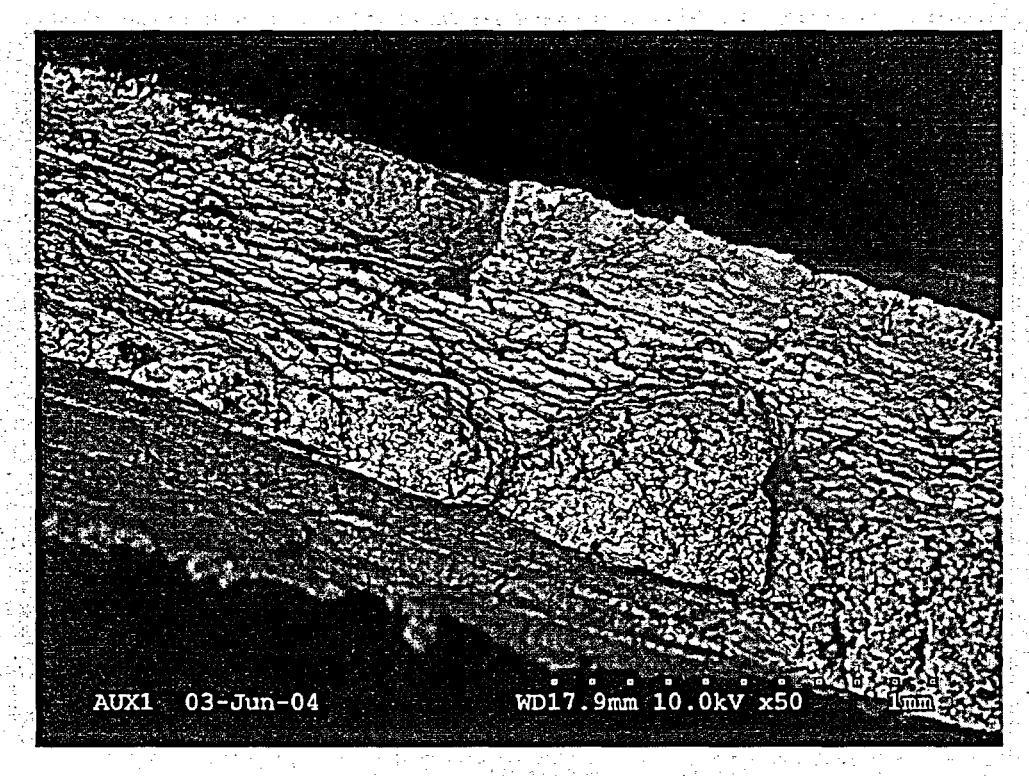
Figure 70: SE image of bottom edge of IGSCC on burst rupture surface of 2H TSP. 50X

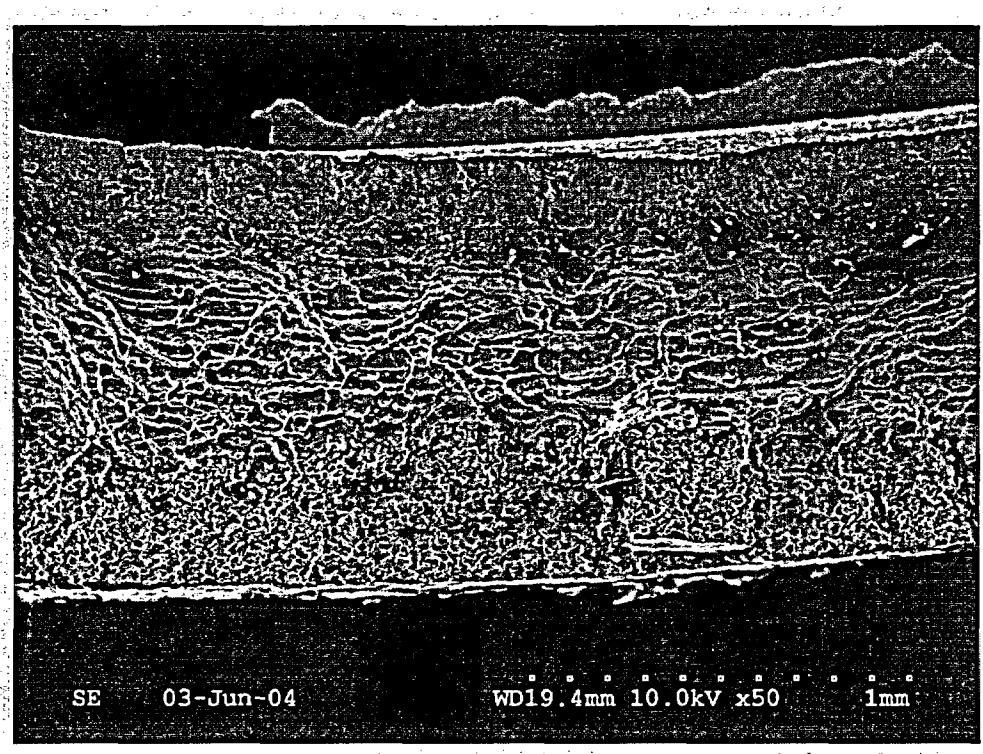
Figure 72: SE image of central region of burst rupture surface of 2H TSP. 50X

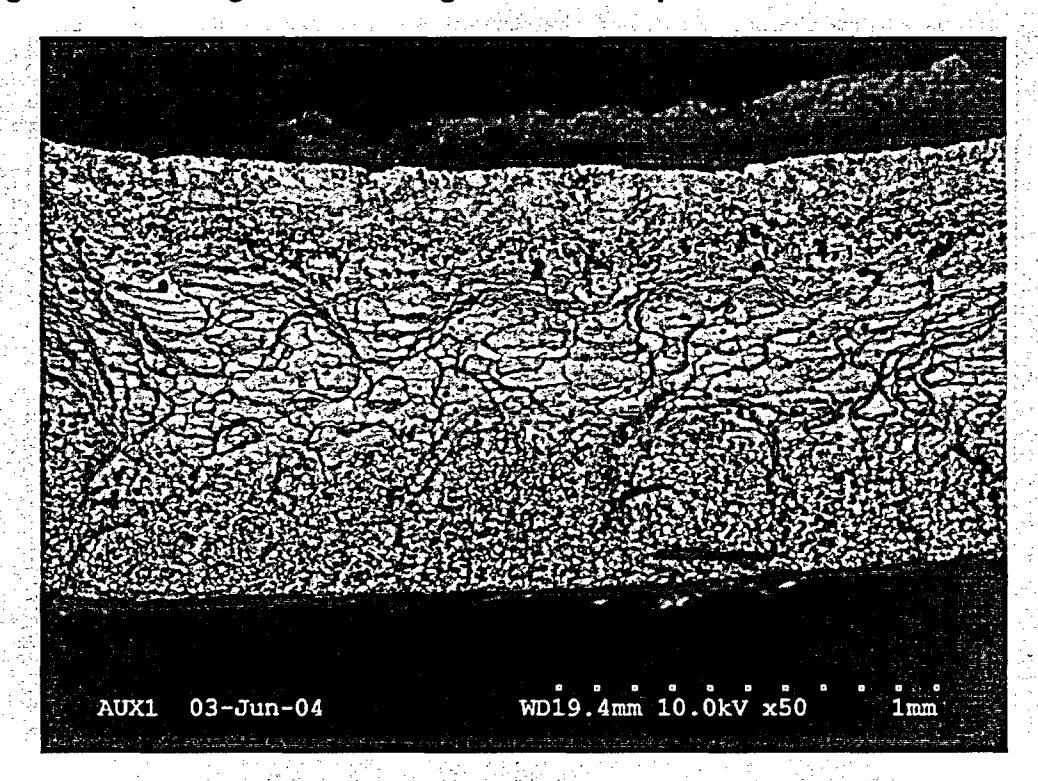
Figure 73: BSE image of central region of burst rupture surface of 2H TSP. 50X

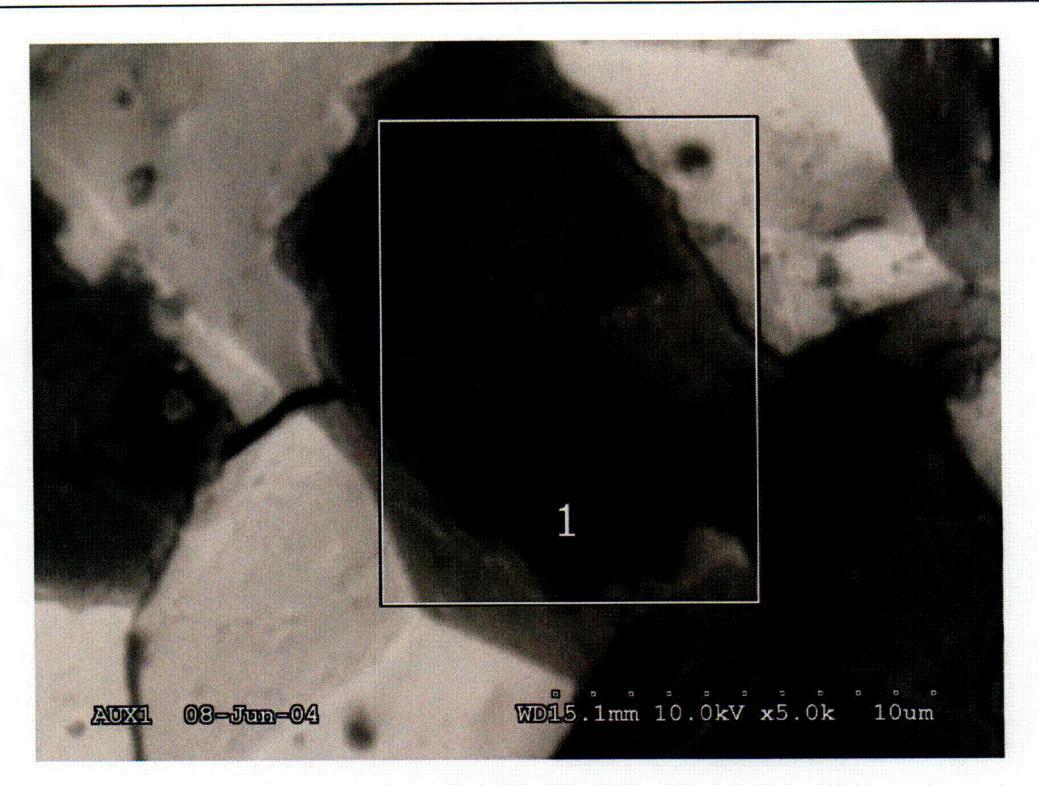
Areas on the burst rupture surface of R20C54-5B3 (2H TSP) were examined using energy dispersive spectroscopy (EDS) to look for the presence of detrimental elements that may have contributed to the intergranular corrosion. This sample was selected since it had not been subjected to high-temperature oxidation in the furnace (the 1H TSP region was oxidized in this manner). Sulfur, silica, and potassium were detected on the fracture surface as shown in the EDS spectrum in Figure 79. The presence of sulfur was confirmed and trace levels of magnesium and lead were also indicated by wavelength dispersive spectroscopy (WDS) analysis.

Figure 79A: BSE image of an area on 2H burst rupture surface. 5000X

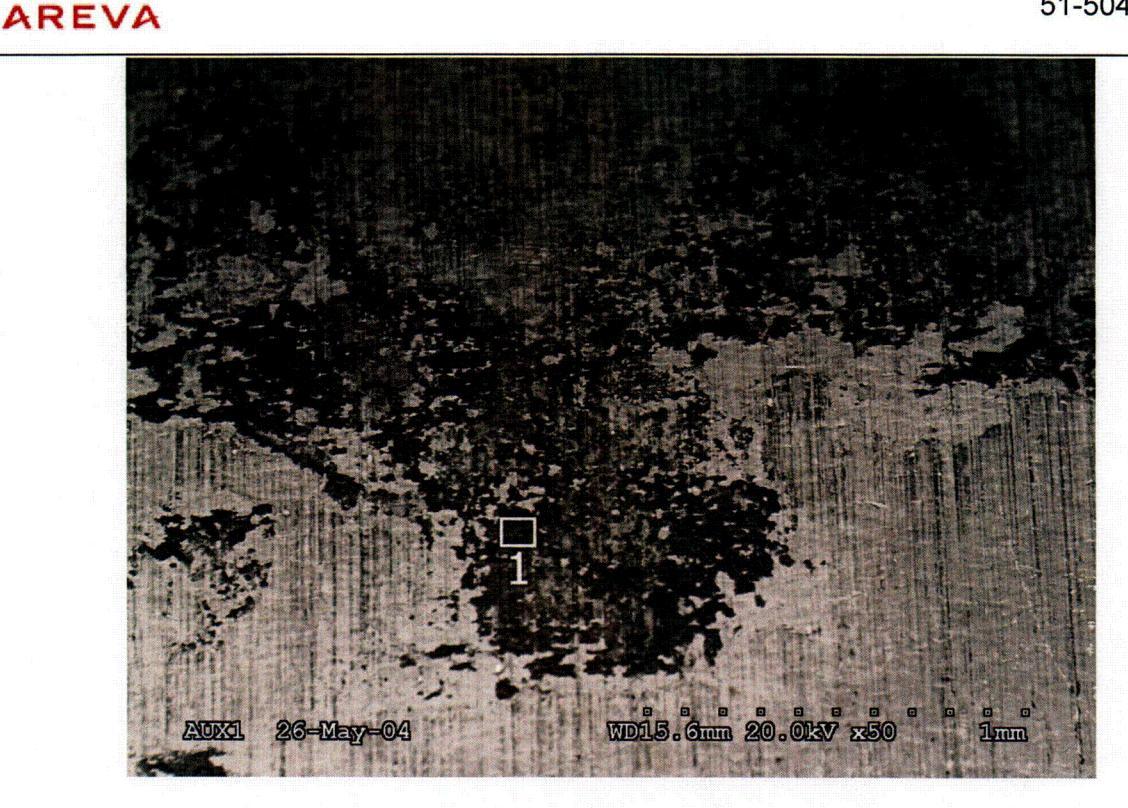
Copper colored deposits were visible on some areas of the tubing OD in the free span areas. A typical example is shown in Figure 80. EDS analysis was performed to identify this material, and as shown in Figure 81, it was composed of aluminum, zinc, and oxygen. Neither copper metal nor copper oxides were detected.

Figure 81A: BSE image of typical copper colored deposit area. 50X
