Examination of Diablo Canyon Unit 1 Steam Generator Tube No. R20C54

51-5046570-01 Final Report, August 2004

Prepared for Pacific Gas & Electric Company

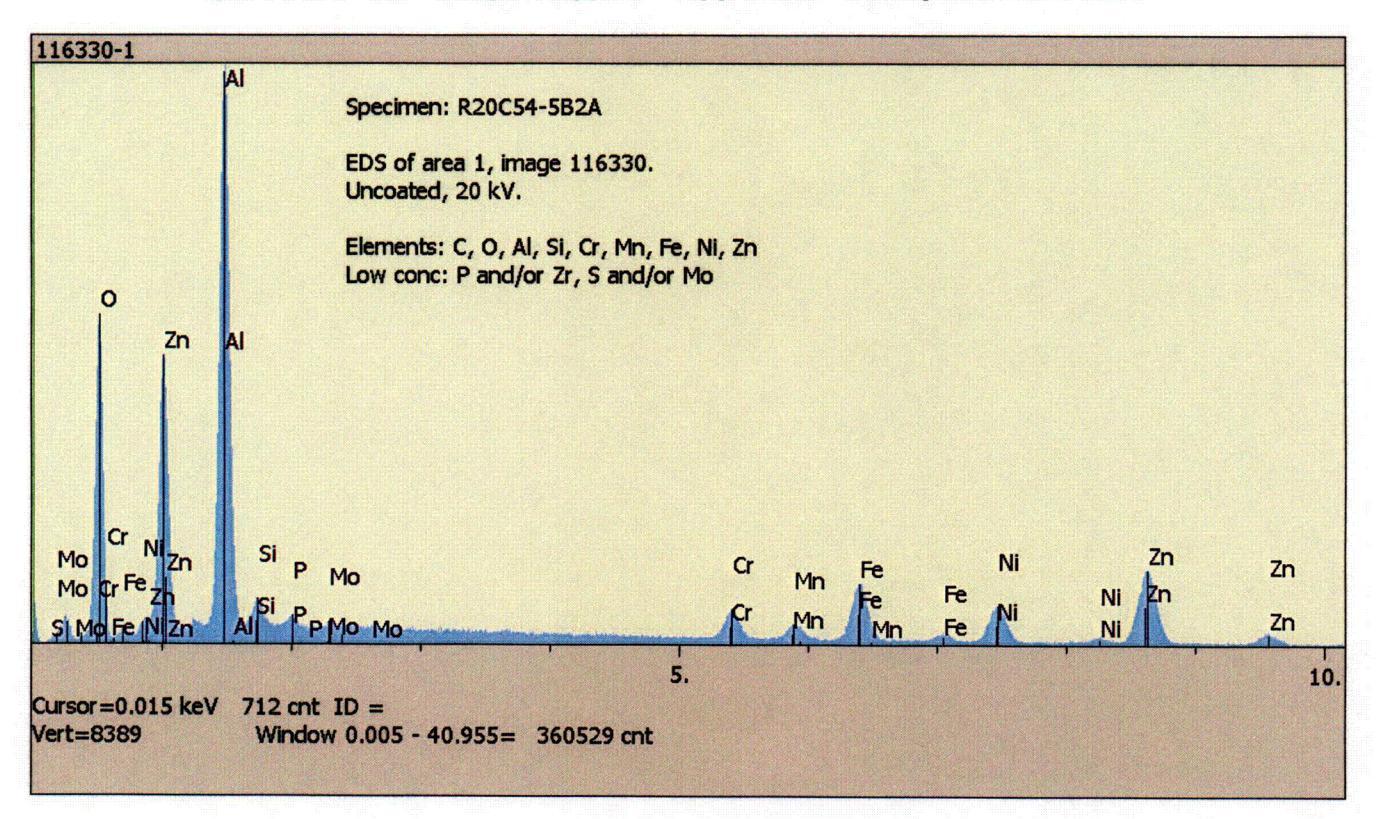
Copper colored deposits were visible on some areas of the tubing OD in the free span areas. A typical example is shown in Figure 80. EDS analysis was performed to identify this material, and as shown in Figure 81, it was composed of aluminum, zinc, and oxygen. Neither copper metal nor copper oxides were detected.

Figure 81B: EDS analysis of area 1 in Figure 74A showing AI, Zn, O. Figure 81: SEM/EDS analysis of copper colored deposits on tube OD.

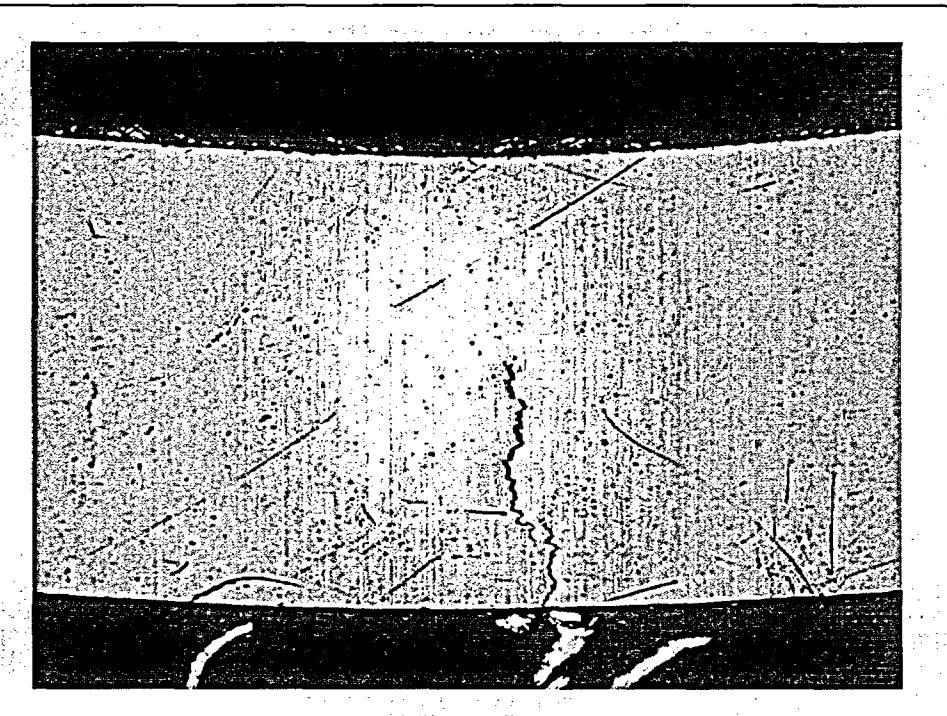
Figure 82 is a polished cross-section showing a 53% through wall secondary crack at 298° that corresponds to the approximate location of eddy current indication SAI #3 (at 292°). The intergranular nature of the cracking is apparent in the etched photomicrograph of the same area in Figure 83. A number of other axial intergranular penetrations were noted around the circumference of the tube at this location, and these are tabulated in Table 18.

Figure 82: 53% TW indication near 298° in centerline of 1H TSP, corresponding to approximate location of secondary eddy current indication. 46X

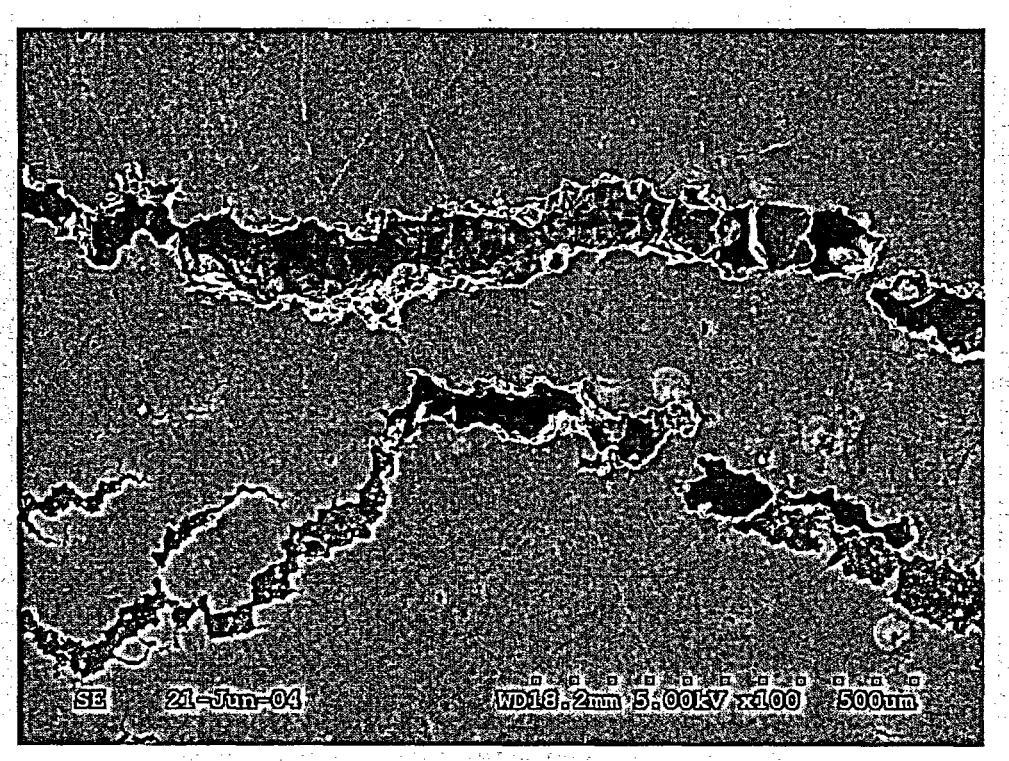
Figure 89: Area "C" in Figure 80. 99X

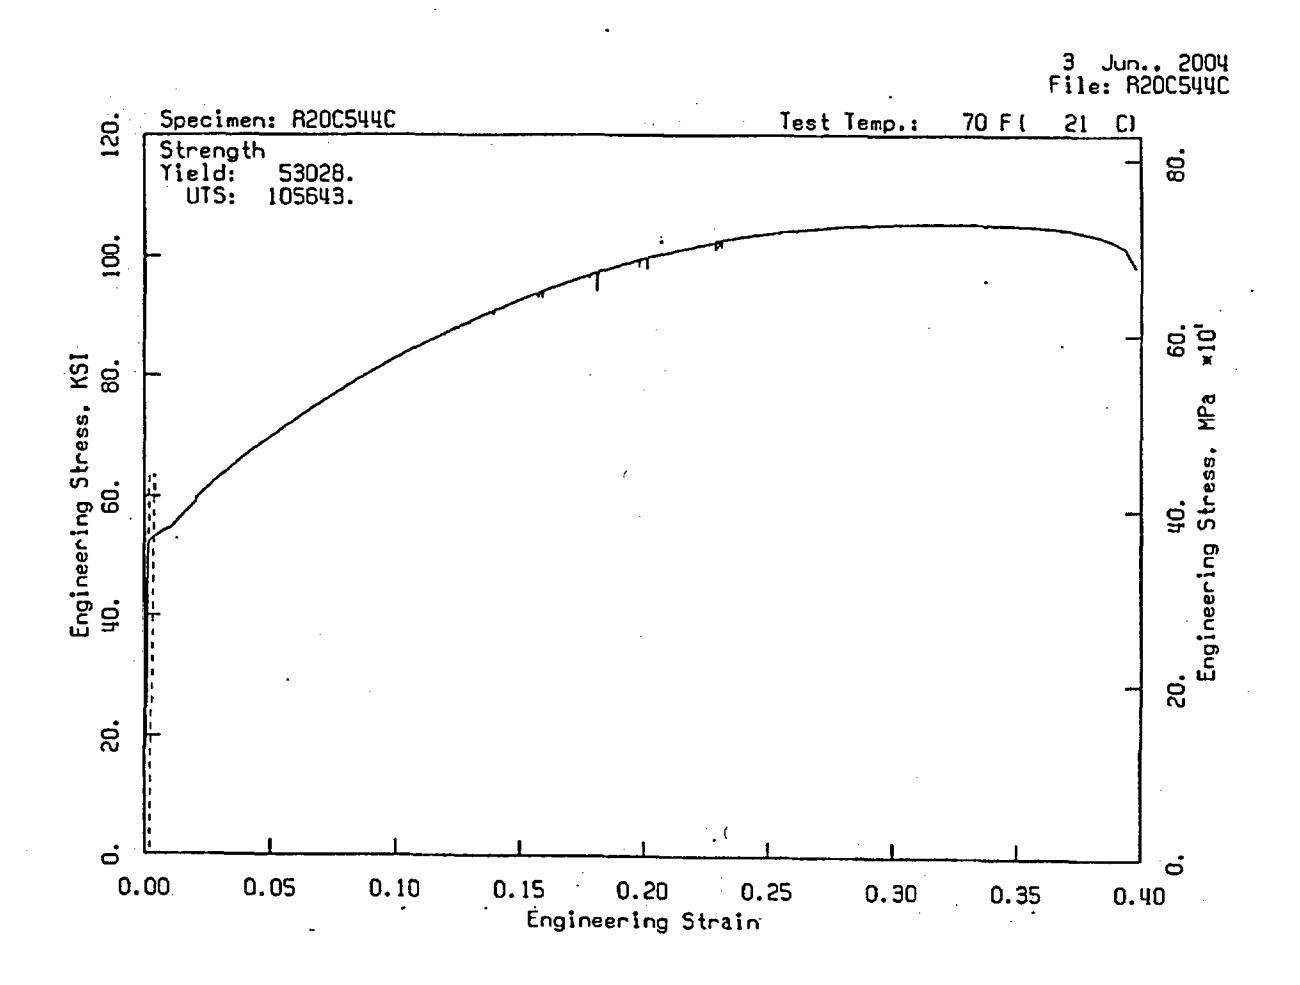
One sample from a free span region was tensile tested at 70°F, and the results are provided in Table 15. The engineering stress/strain curve is provided in Figure 138. The nominal tubing OD was 0.873 inches and the nominal wall thickness was 0.0524 inches.

Figure 138: Engineering stress/strain curve for tensile specimen R20C54-4C
