**Annual Site Inspection and Monitoring Report  
for Uranium Mill Tailings Radiation Control Act  
Title I Disposal Sites**

**Annual Report for the Period  
January 1, 1998, Through December 31, 1998**

**February 1999**

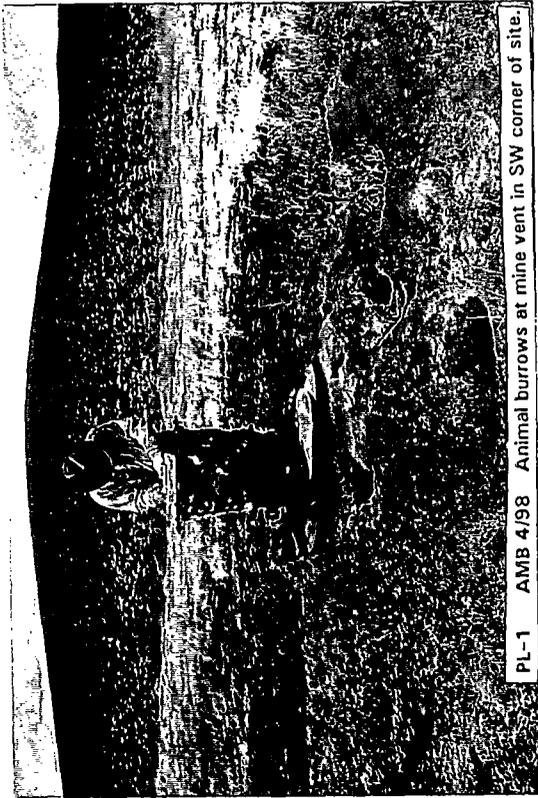
PL-1 AMB 4/98 Animal burrows at mine vent in SW corner of site.

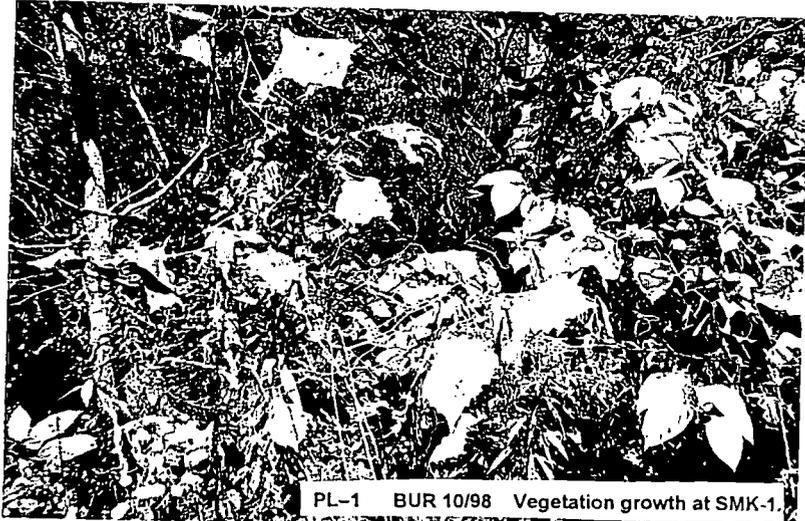
Site Entrance Gate. The site entrance gate is in excellent condition. Just inside the gate is site marker, SMK-1, also in excellent condition. The site marker is overgrown by dense woody vegetation (BUR PL-1). The area around the marker will be cleared periodically.

PL-1 BUR 10/98 Vegetation growth at SMK-1.

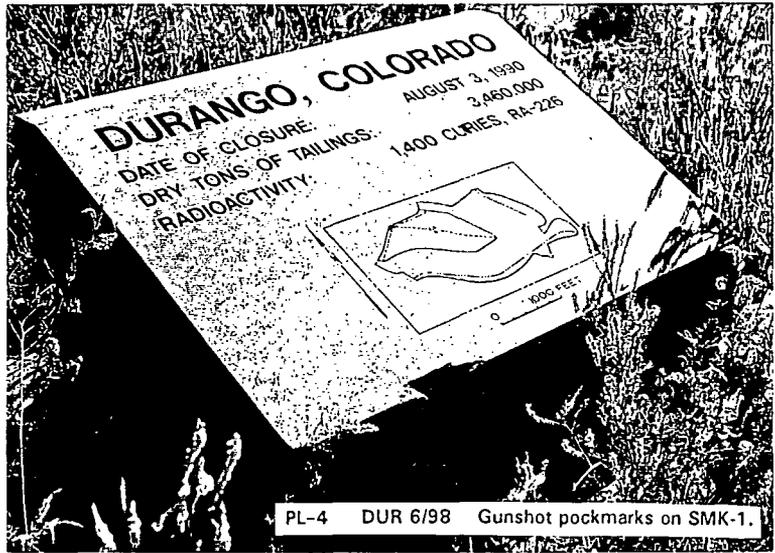
PL-4 DUR 6/98 Gunshot pockmarks on SMK-1.

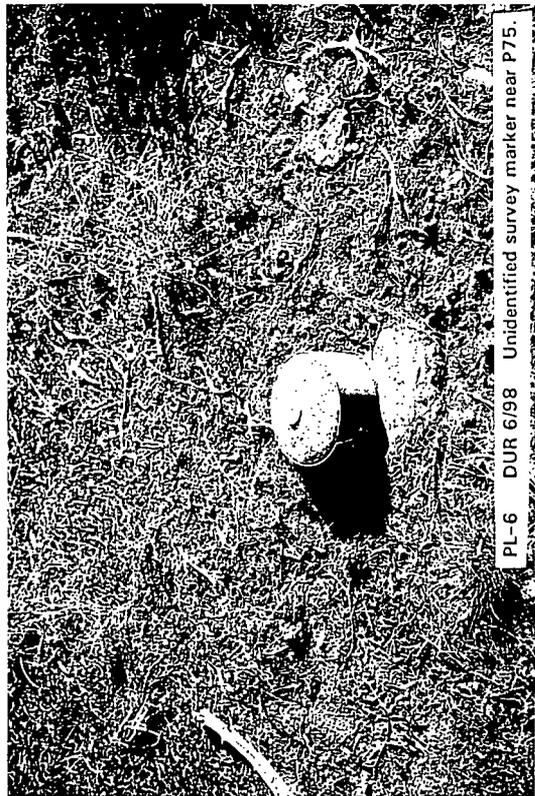
PL-6 DUR 6/98 Unidentified survey marker near P75.

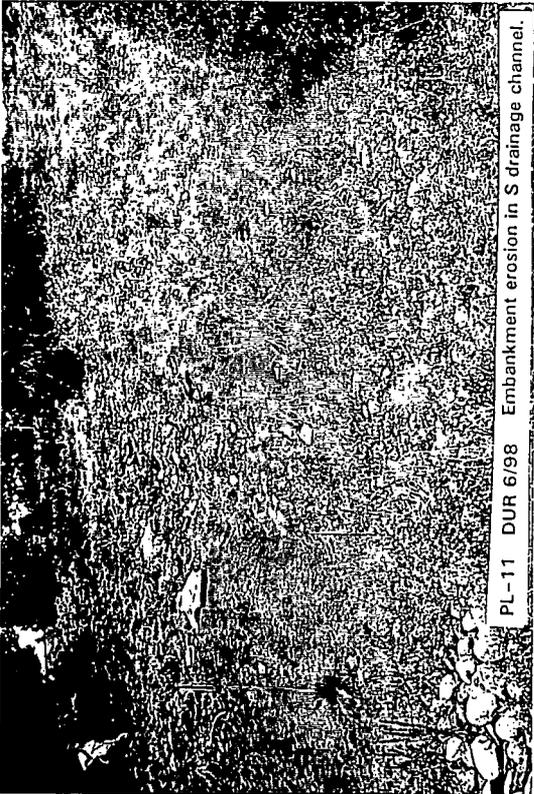
PL-11 DUR 6/98 Embankment erosion in S drainage channel.

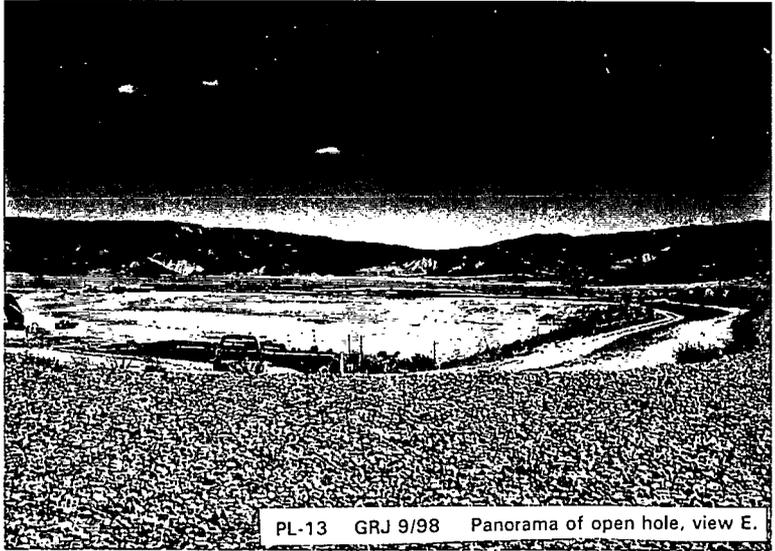
PL-13 GRJ 9/98 Panorama of open hole, view E.

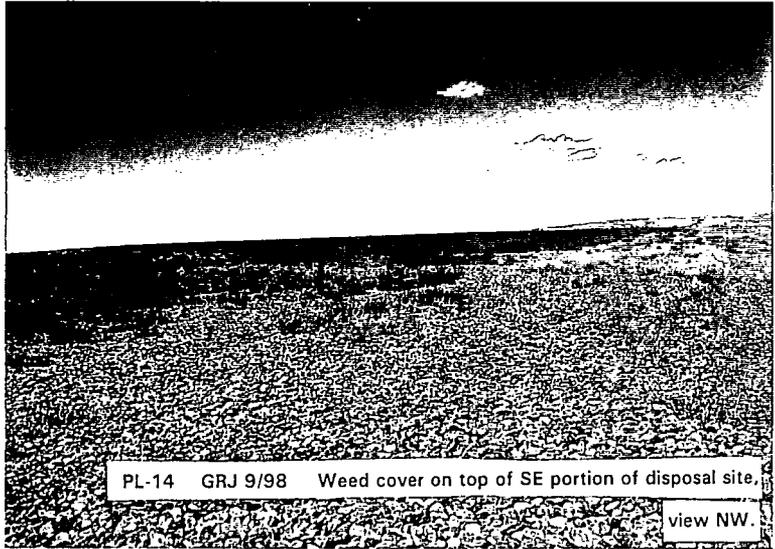
PL-14 GRJ 9/98 Weed cover on top of SE portion of disposal site, view NW.

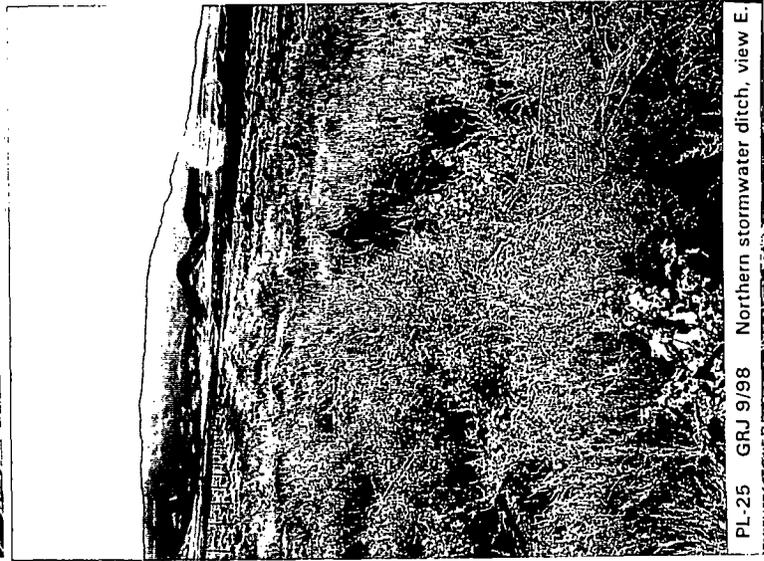
PL-25 GRJ 9/98 Northern stormwater ditch, view E.

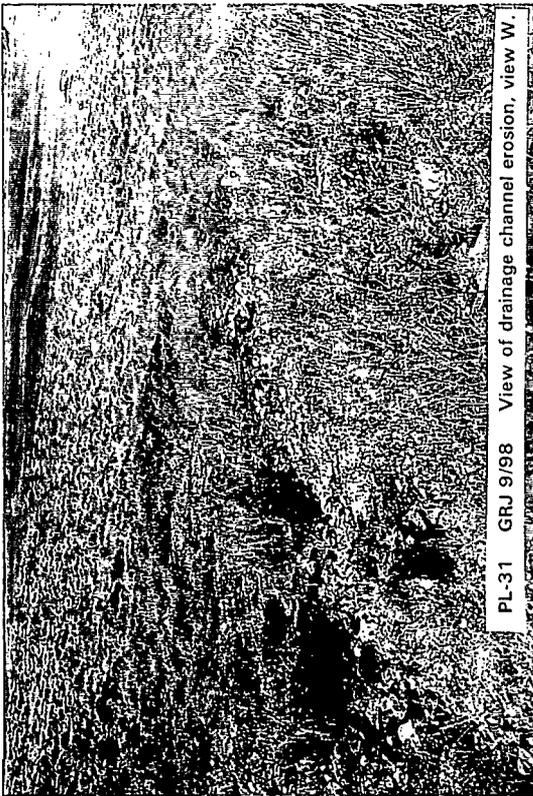
PL-31 GRJ 9/98 View of drainage channel erosion, view W.

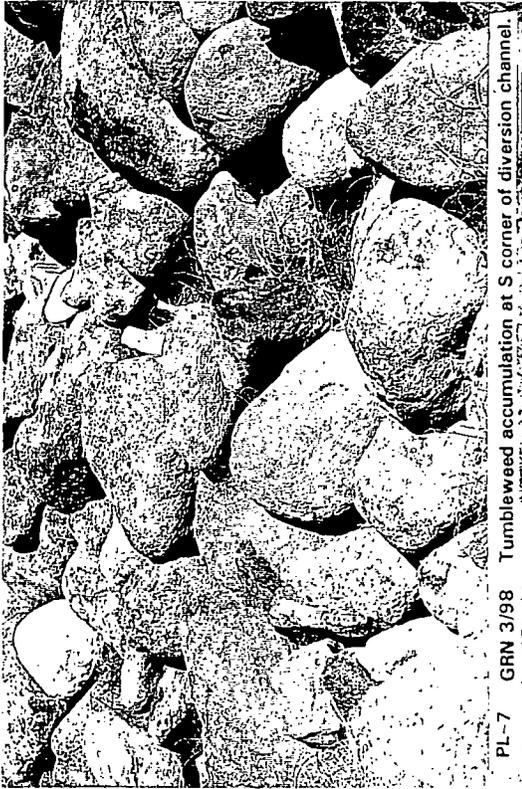
The accumulation of tumbleweeds in the diversion channel on the south and southwest sides of the disposal cell is minor and unchanged from previous years (GRN PL-7). Tumbleweed accumulation along the security fence is also minor and insignificant.

PL-7 GRN 3/98 Tumbleweed accumulation at S corner of diversion channel.

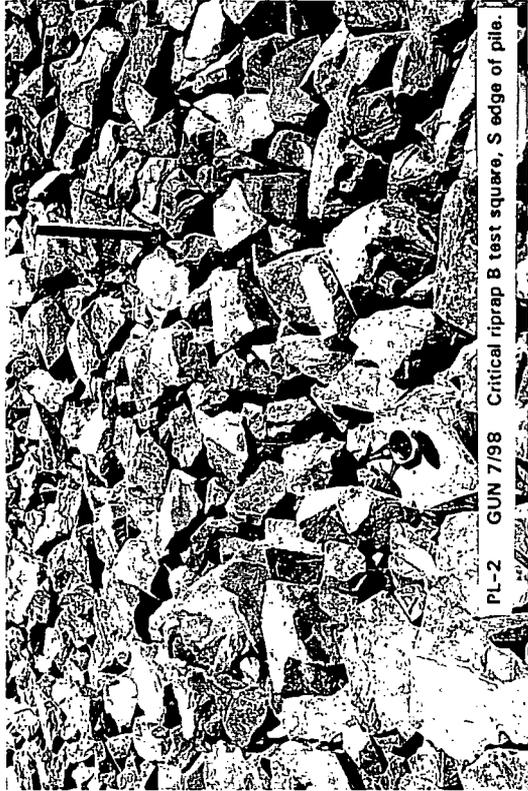
The riprap in six test squares was carefully inspected and photographed according to the procedure in the LTSP. Each test square, roughly 1 square meter, is in a "critical flow path" location in a diversion channel (Figure GUN-1). Corners of each square are marked with orange paint. Each square was photographed with the photographer facing north (approximately). The compass in each photograph indicates true north. Rock-by-rock comparison in this year's photographs (GUN PL-1 through GUN PL-6) with photographs taken in 1997 shows no deterioration of any rock.

PL-2 GUN 7/98 Critical riprap B test square, S edge of pile.

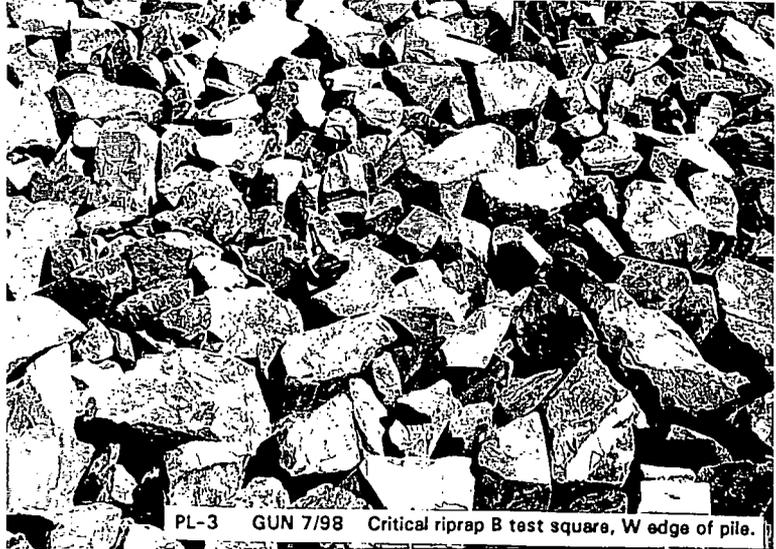
PL-3 GUN 7/98 Critical riprap B test square, W edge of pile.

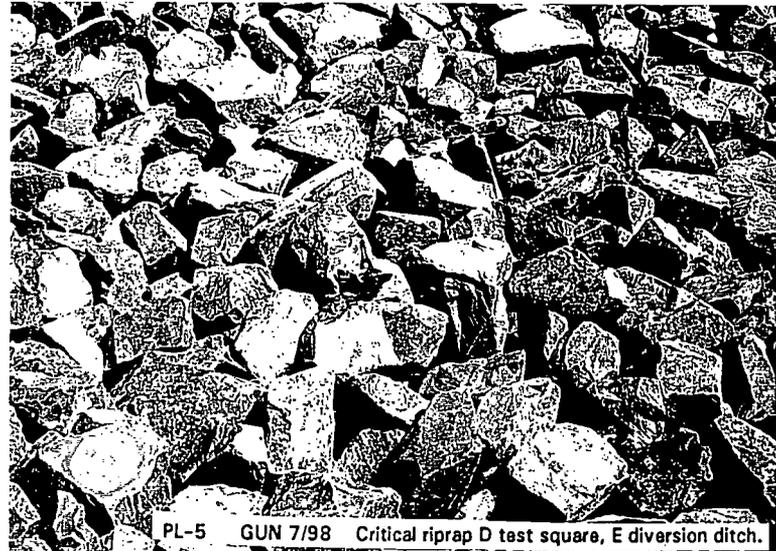
PL-5 GUN 7/98 Critical riprap D test square, E diversion ditch.

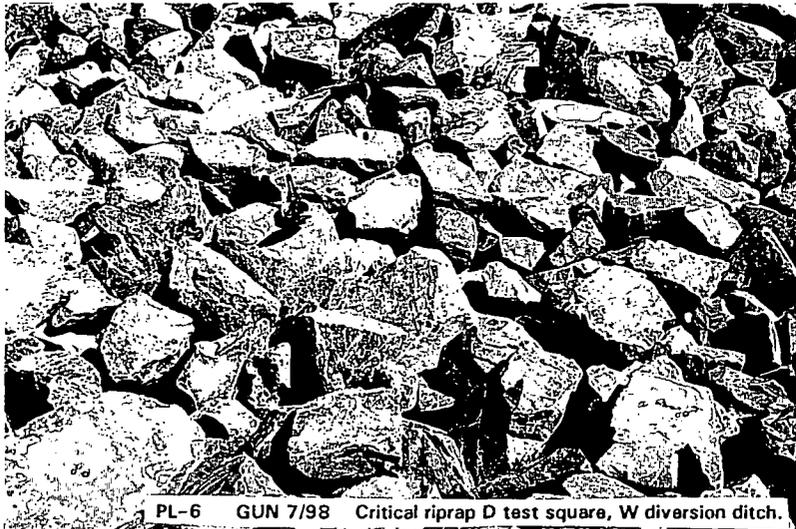
PL-6 GUN 7/98 Critical riprap D test square, W diversion ditch.

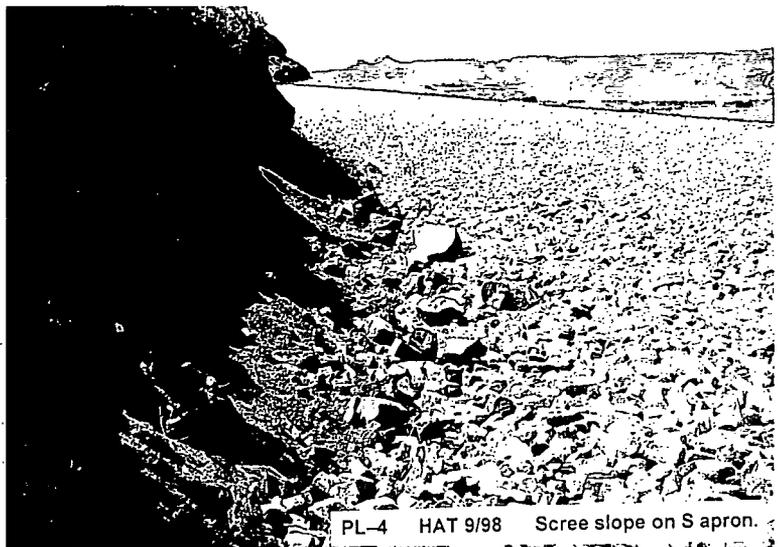
Sloughing of rock and soil from the cliffs above the south apron of the disposal cell continues, but the scree slope along the base of the cliffs is not significantly larger than before. The scree slope is approximately 18-to-24-in. high against the base of the vertical face of native rock. Some larger pieces of sandstone (up to 12-in. in diameter) have rolled down the cliff face and out onto the riprap apron, as noted during previous inspections (HAT PL-4). Mass wasting from the cliffs above the south apron is a slow process that is expected to continue. It is not a result of large-scale erosion in the cliffs above. Nor is this small accumulation of scree at the base of the cliffs a threat to the long-term performance of the disposal cell.

PL-4 HAT 9/98 Scree slope on S apron.

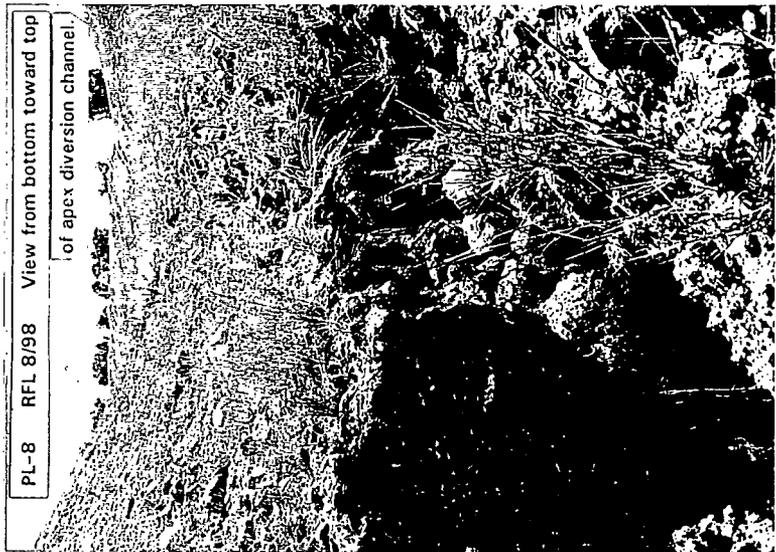
An unlined interceptor trench at the uphill end or apex of the disposal cell protects the disposal cell from erosion and stormwater run on (Figure RFL-1). The trench diverts water into the natural drainage (gulch) on the west. Erosion is occurring in the bottom of the interceptor trench, but this aspect was anticipated in the design (RFL PL-6, RFL PL-7, and RFL PL-8). The interceptor trench is expected eventually to erode to bedrock.

PL-8 RFL 8/98 View from bottom toward top of apex diversion channel.

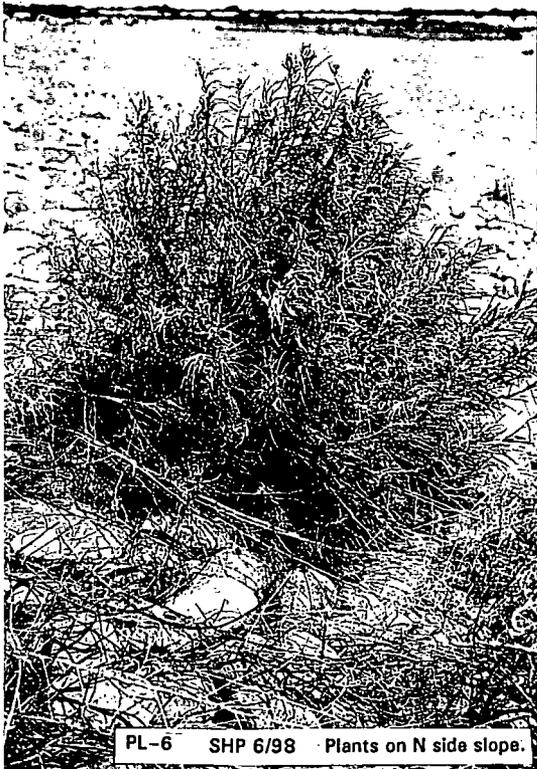
PL-6 SHP 6/98 Plants on N side slope.

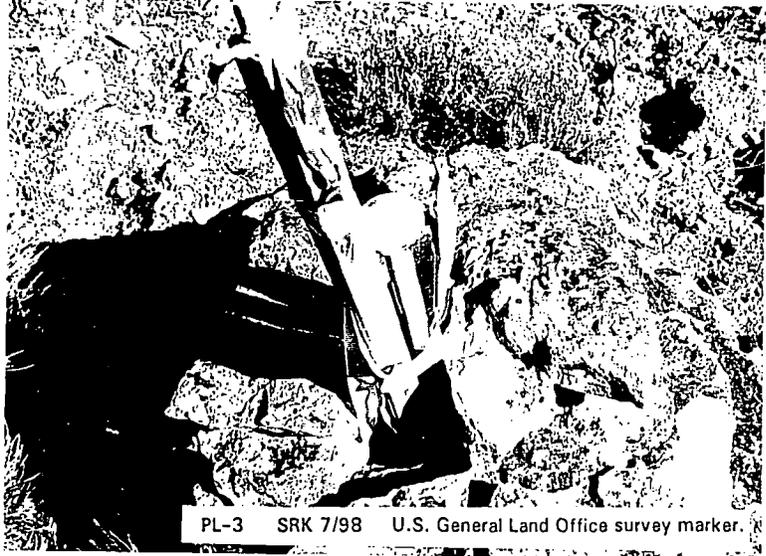
PL-3 SRK 7/98 U.S. General Land Office survey marker.
