**Long-Term Surveillance and Monitoring Program**

**1998 Annual Site Inspection  
and Monitoring Report for  
Uranium Mill Tailings Radiation  
Control Act Title II Disposal Sites**

**Edgemont, South Dakota, Disposal Site**

**1998 Annual Report**

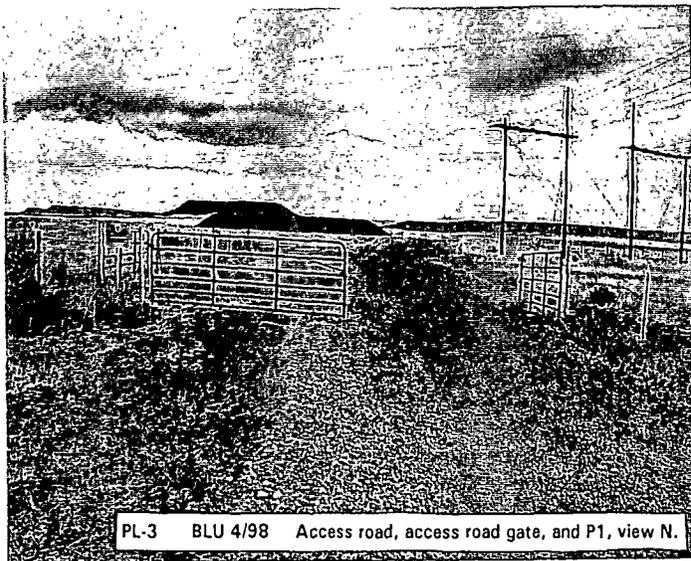
PL-3 BLU 4/98 Access road, access road gate, and P1, view N.

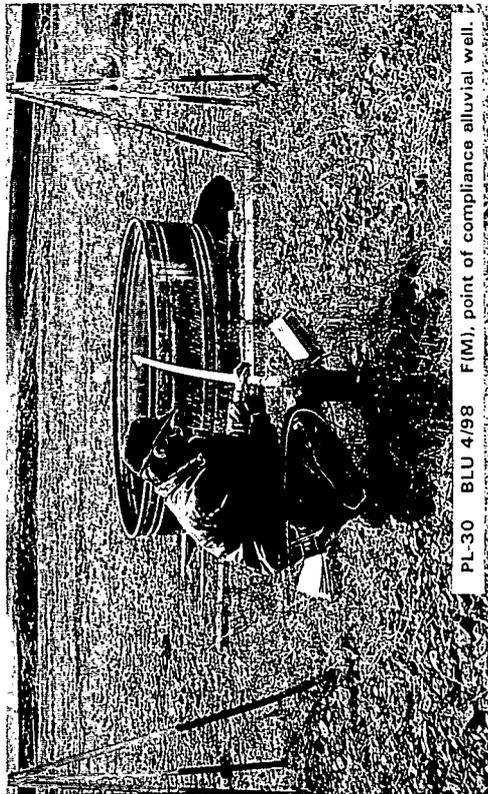
PL-30 BLU 4/98 F(M), point of compliance alluvial well.

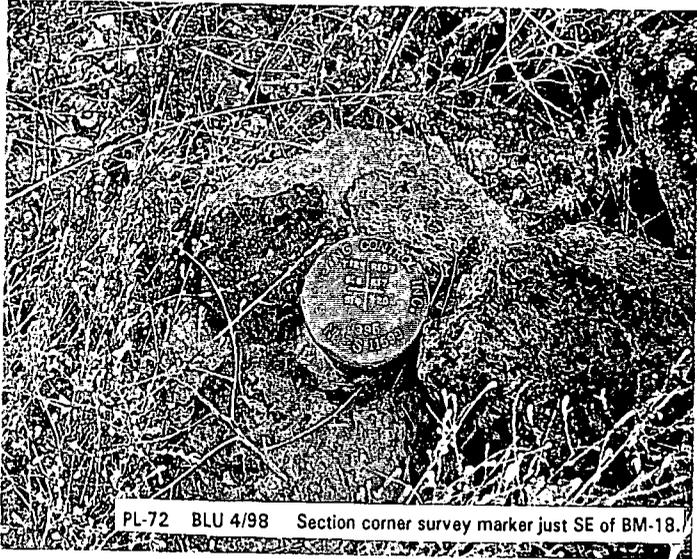
PL-72 BLU 4/98 Section corner survey marker just SE of BM-18.

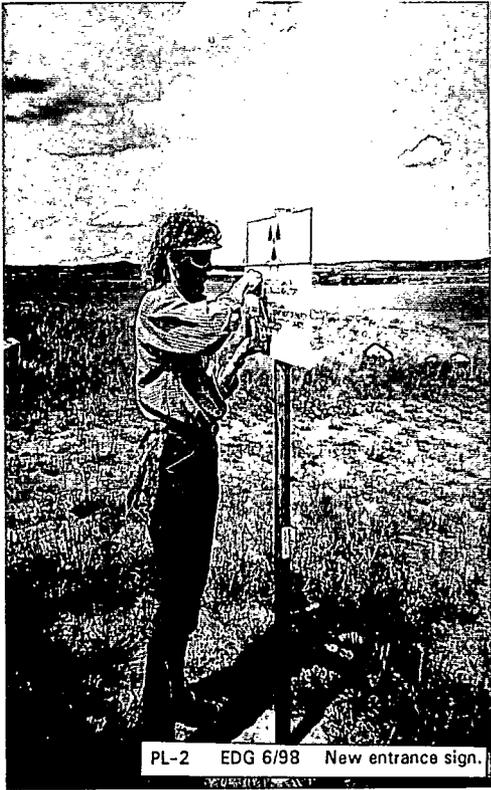
Access to the Edgemont disposal site is immediately off an all-weather county road and is unimpaired. The entrance gate is a simple barbed-wire gate secured by a padlocked chain. The gate is in good condition. The site marker, recently installed, is just inside the gate to the left (EDG PL-1). During the inspection, inspectors placed an entrance sign on a newly installed sign post just inside the gate to the right (EDG PL-2).

PL-2 EDG 6/98 New entrance sign.

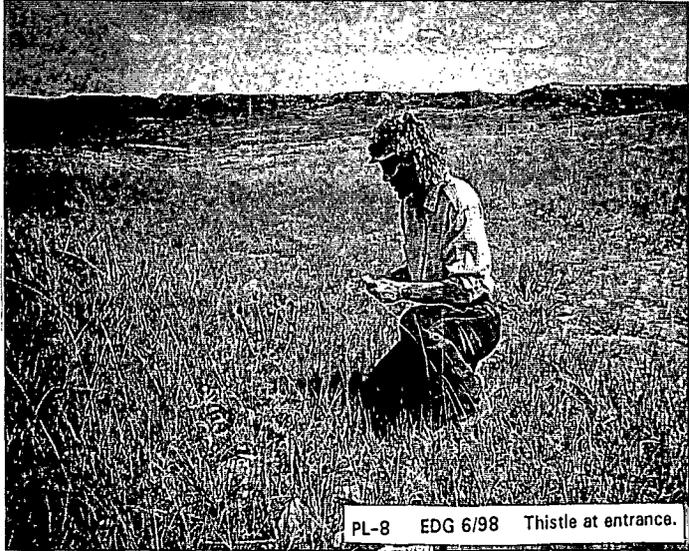
PL-8 EDG 6/98 Thistle at entrance.
