Appendix C1

SEM/EDS Data for Unused and Test #2, Day-30 Aluminum Coupons

Appendix C2

SEM/EDS Data for Unused and Test #2, Day-30 Copper Coupons

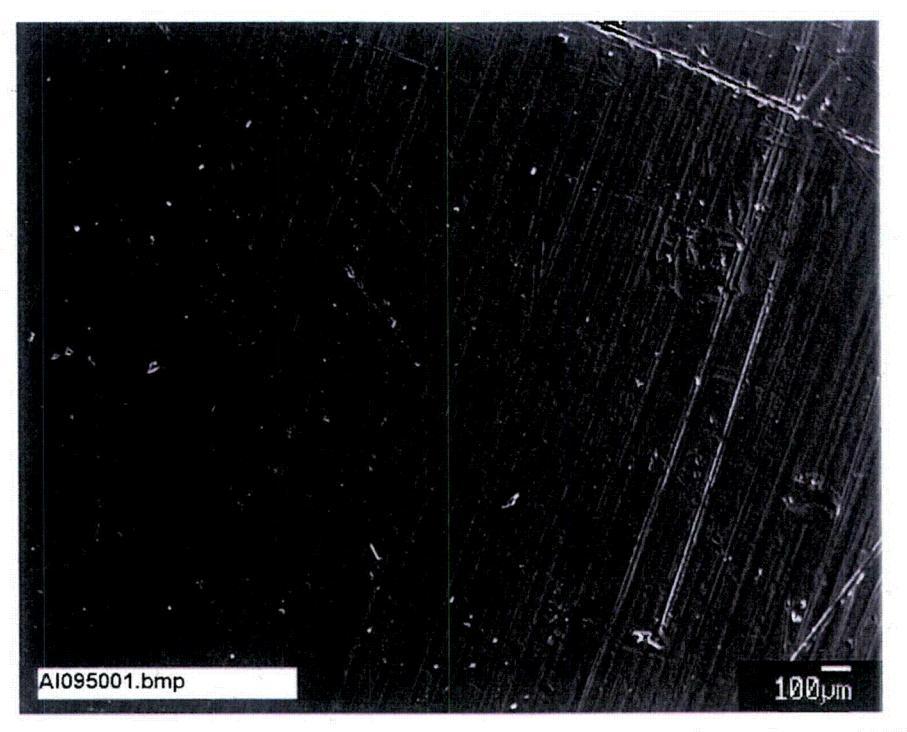
Figure C1-1. SEM image at 40× magnification for an unused aluminum coupon. (Al095001)

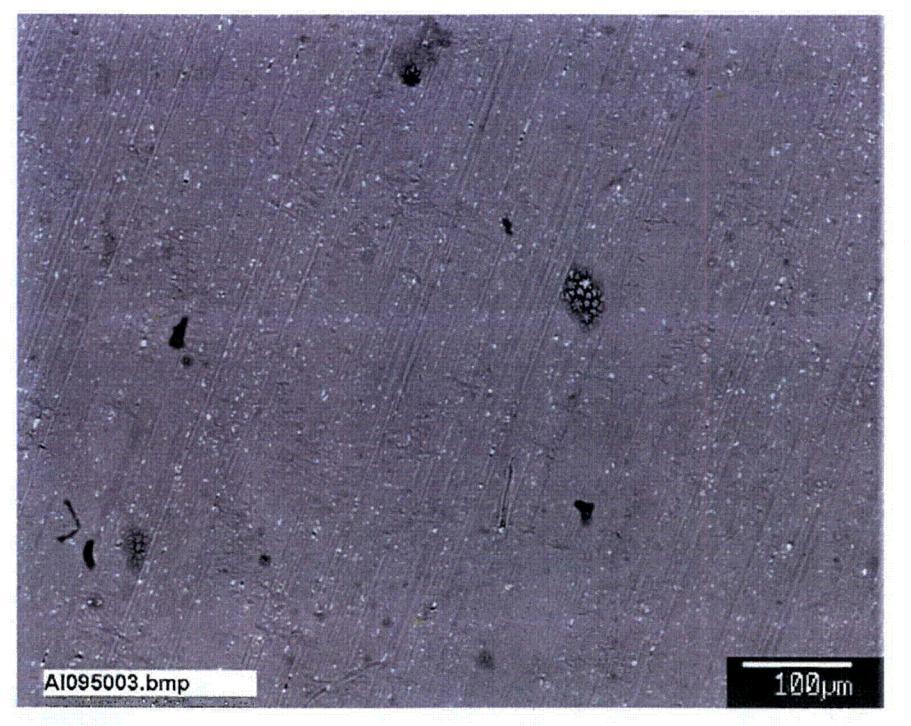
Figure C1-3. Backscattered SEM image at 150× magnification for an unused aluminum coupon. (Al095003)

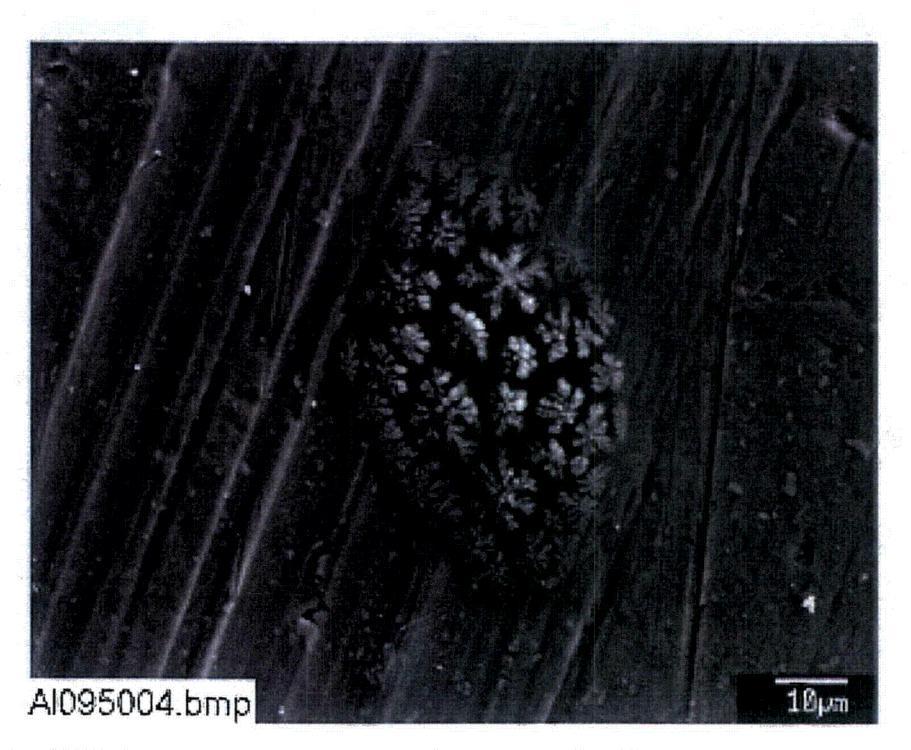
Figure C1-4. SEM image close-up (1000×) of contaminant "flower" on an unused aluminum coupon, as shown in Figure C1-3. (Al095004)

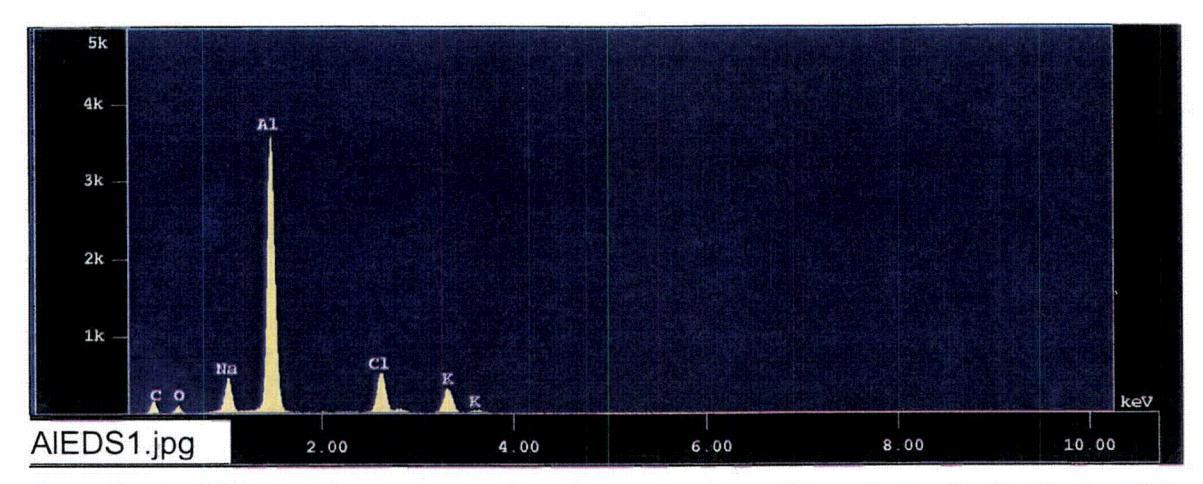
Figure C1-5. EDS counting spectrum for the contaminant "flower" shown in Figure C1-4. (AIEDS1)

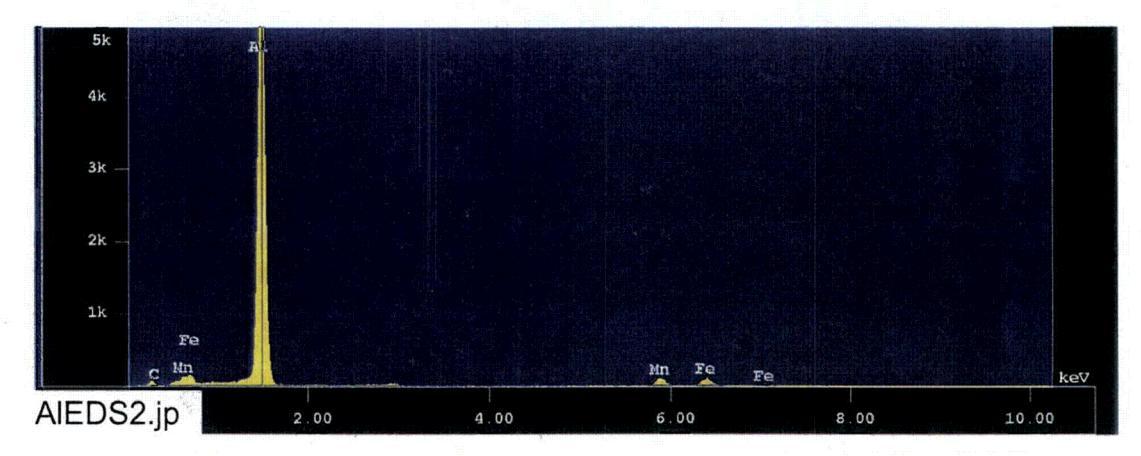
Figure C1-8. EDS counting spectrum for the white spots shown in Figure C1-7. (AlEDS2)

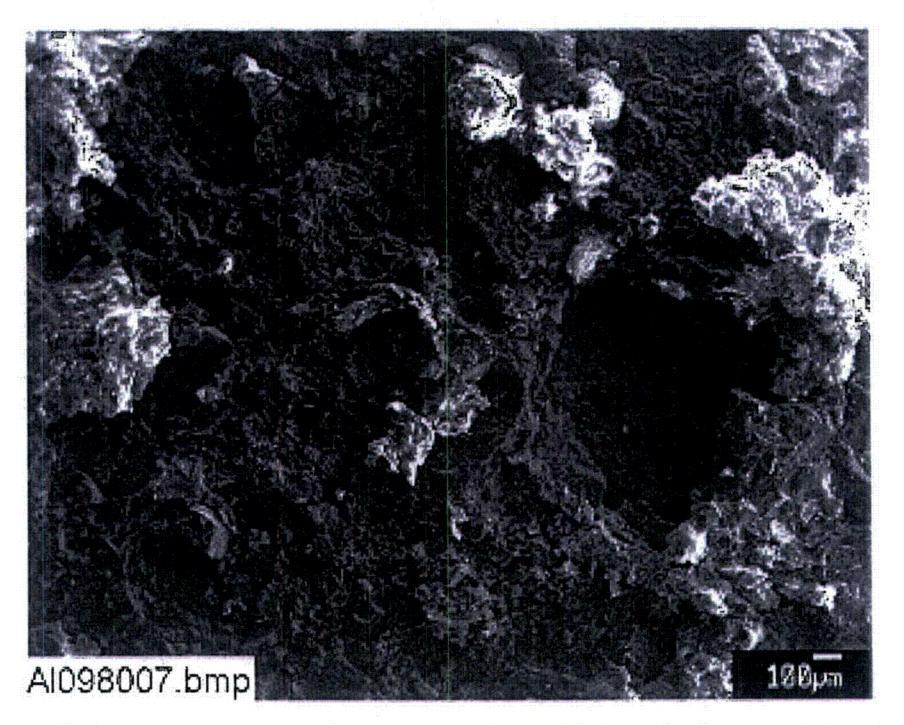
Figure C1-10. SEM image at 40× magnification for a Test #2, Day-30 submerged aluminum coupon. (Al098007)

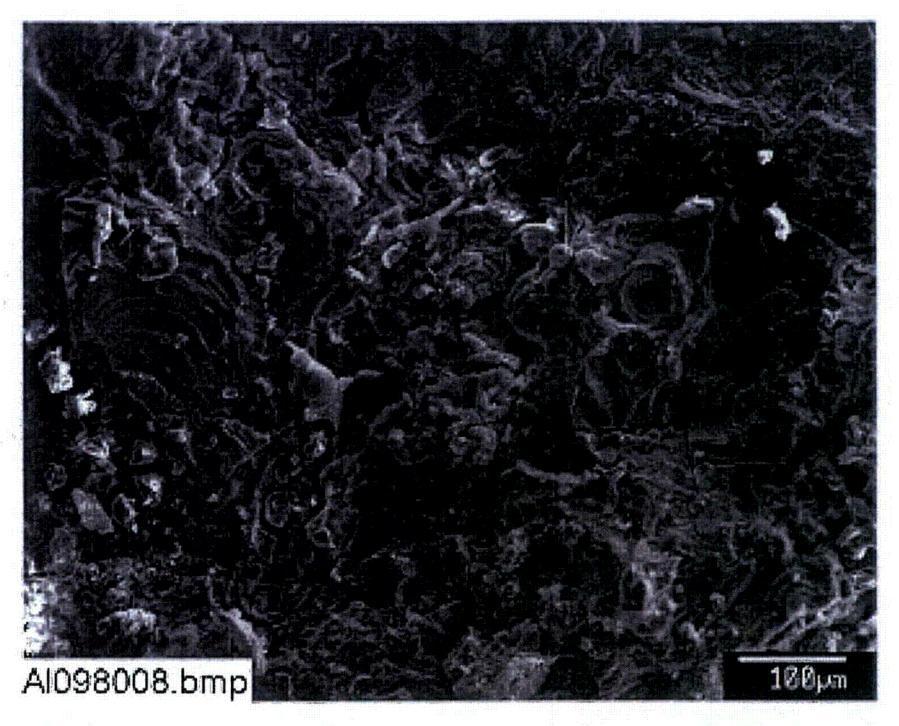
Figure C1-11. SEM image at 150× magnification for a Test #2, Day-30 submerged aluminum coupon. (Al098008)

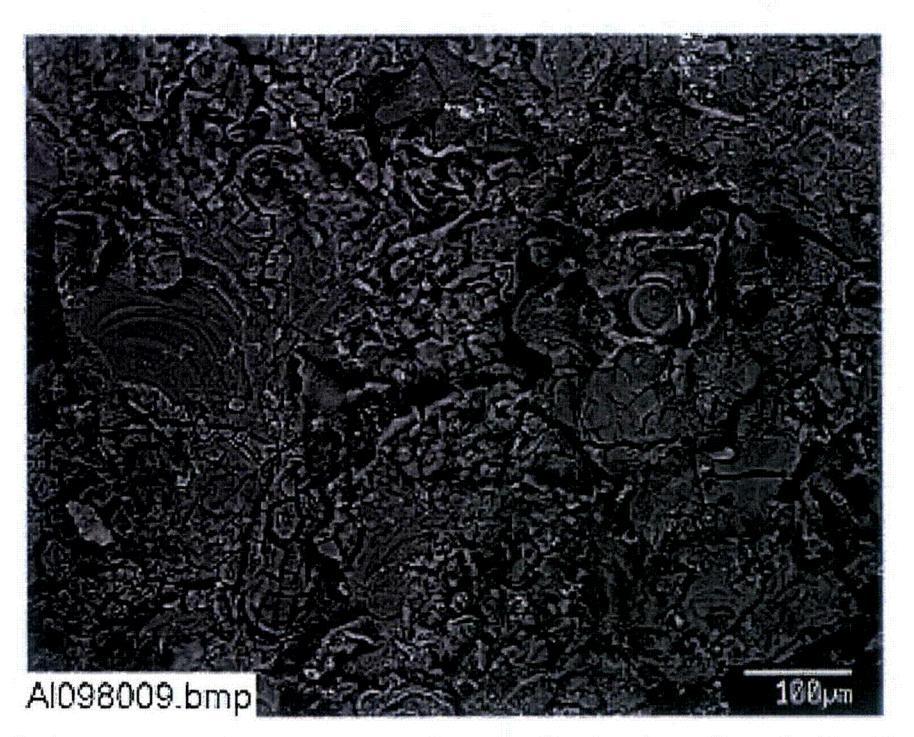
Figure C1-12. Backscattered SEM image at 150× magnification for a Test #2, Day-30 submerged aluminum coupon. (Al098009)

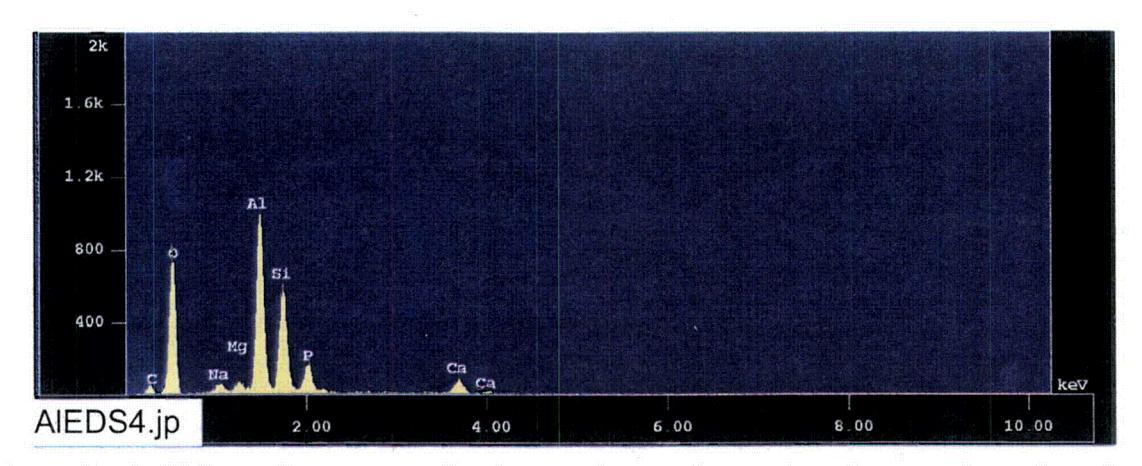
Figure C1-13. EDS counting spectrum for the smooth corrosion product shown on the surface of an aluminum coupon in Figure C1-11. (AIEDS4)

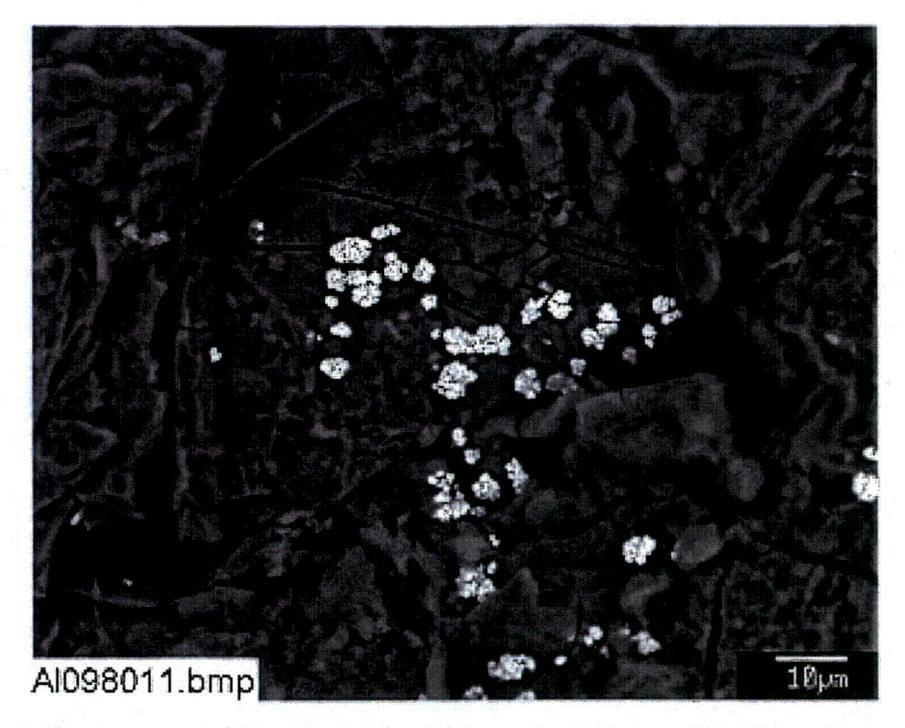
Figure C1-15. Backscattered SEM image of at higher magnification (1000×) for the same area of a submerged aluminum coupon shown in Figure C1-14. (Al098011)

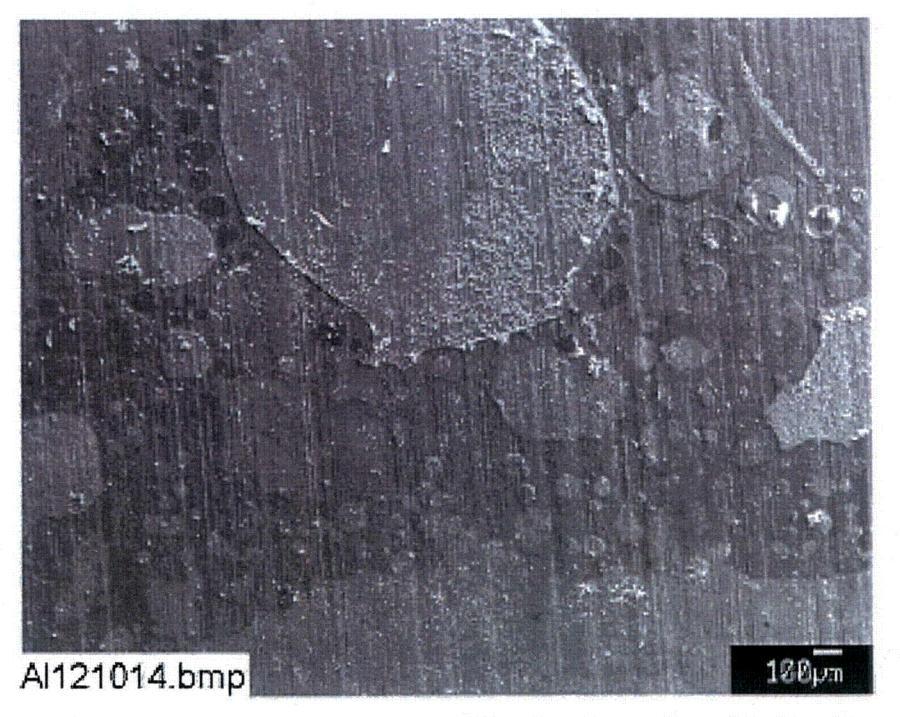
Figure C1-20. SEM image overview at 40× magnification for a Test #2, Day-30 unsubmerged aluminum coupon. (Al121014)

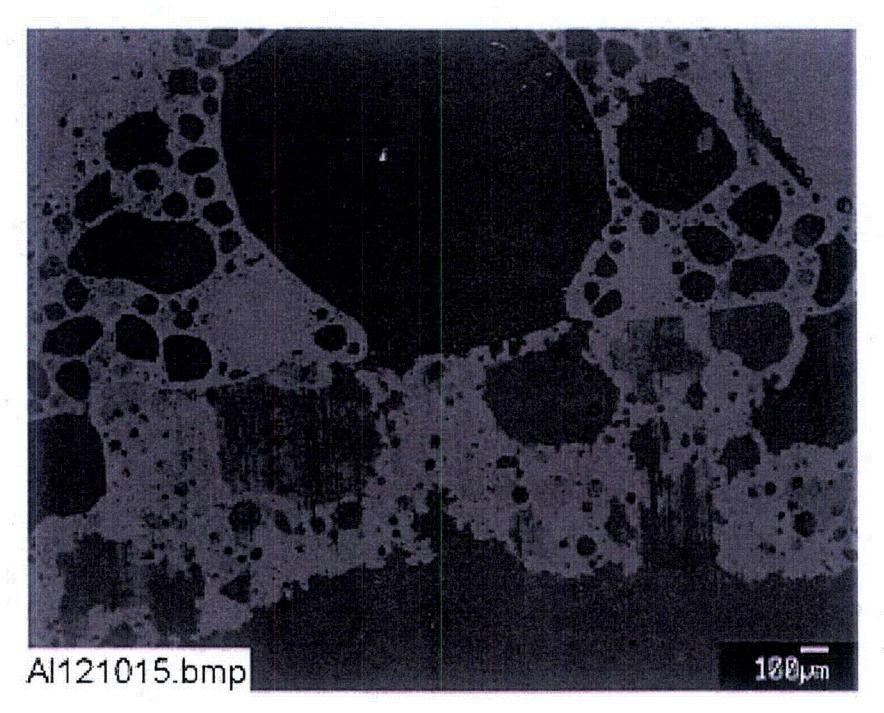
Figure C1-21. Backscattered SEM image overview at 40× magnification for a Test #2, Day-30 unsubmerged aluminum coupon. (Al121015)

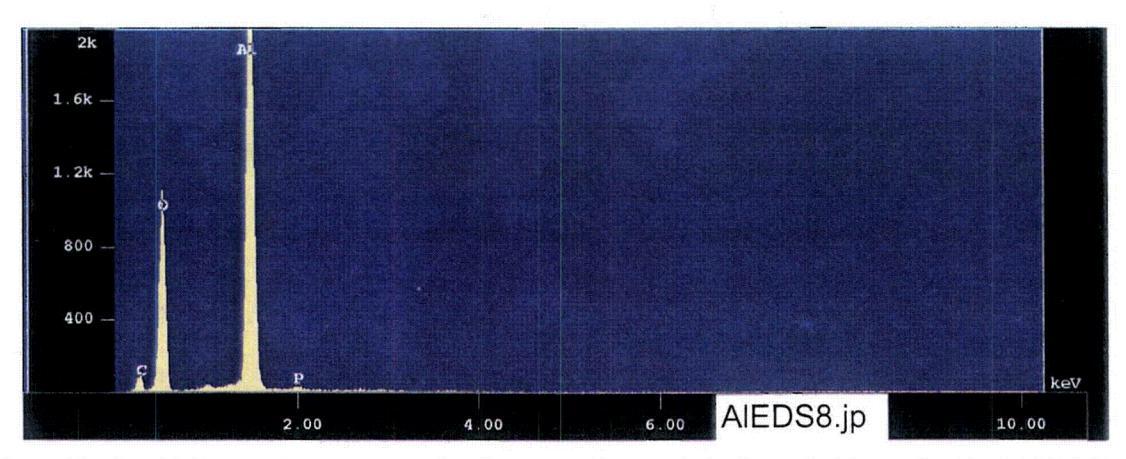
Figure C1-26. EDS counting spectrum for the wormlike crystals shown in Figure C1-22. (AIEDS8)

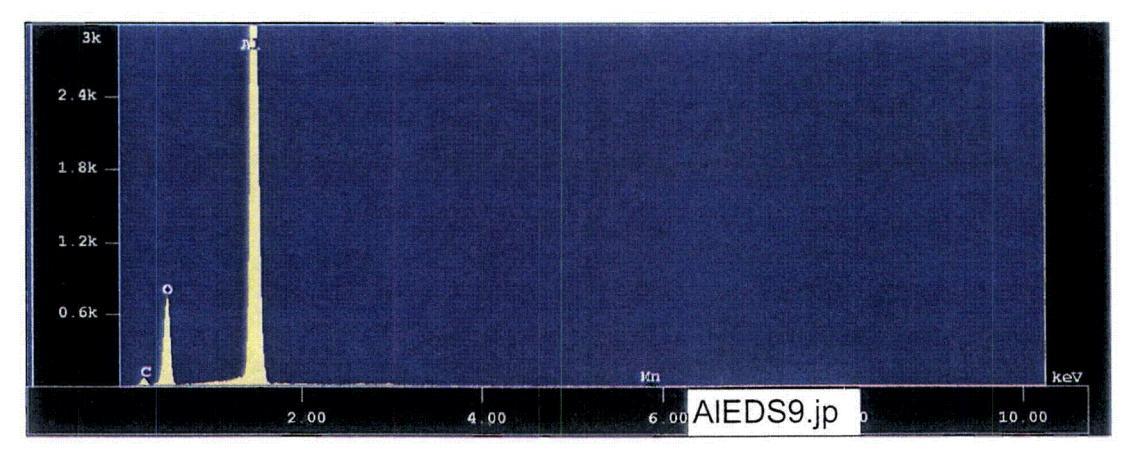
Figure C1-27. EDS counting spectrum for the coupon surface away from wormlike crystals shown in Figure C1-22. (AIEDS9)

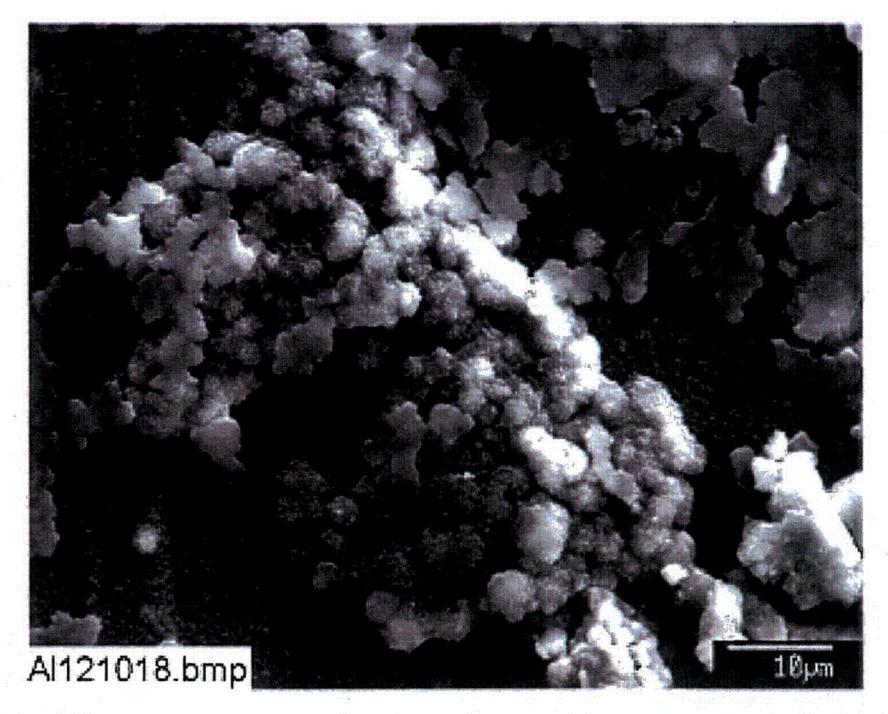
Figure C1-28. SEM image close-up (1000×) of wormlike crystals shown in Figure C1-22 for a Test #2, Day-30 unsubmerged aluminum coupon. (Al121018)

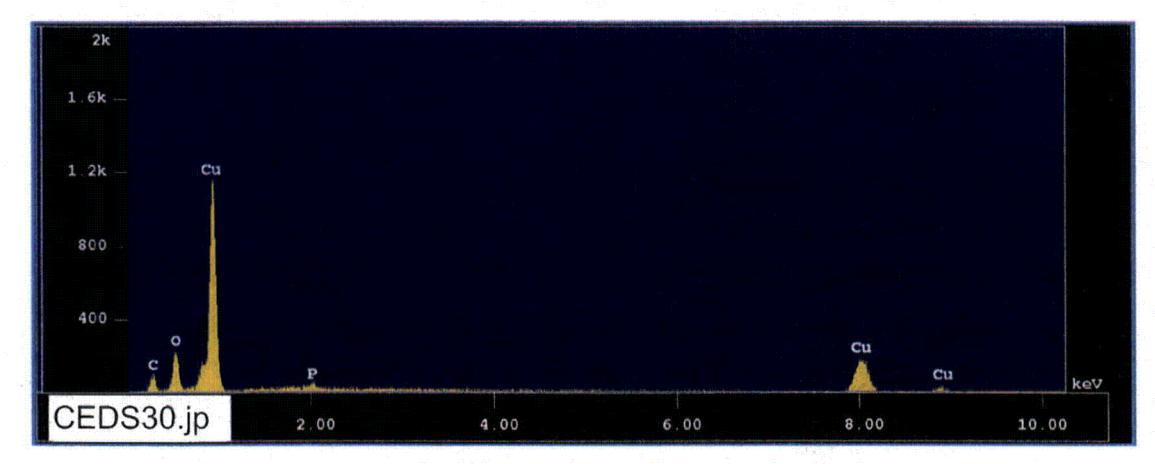
Figure C2-8. EDS counting spectrum for one of the dark spots shown in Figure C2-7. (CEDS30)

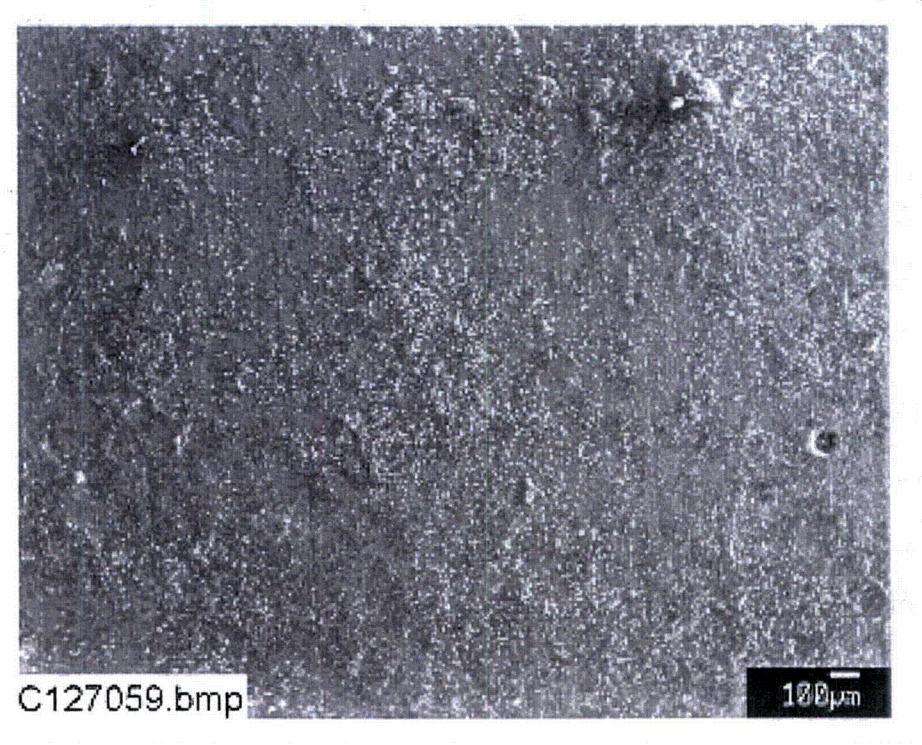
Figure C2-9. SEM image for a Test #2, Day-30 submerged copper coupon. (C127059)

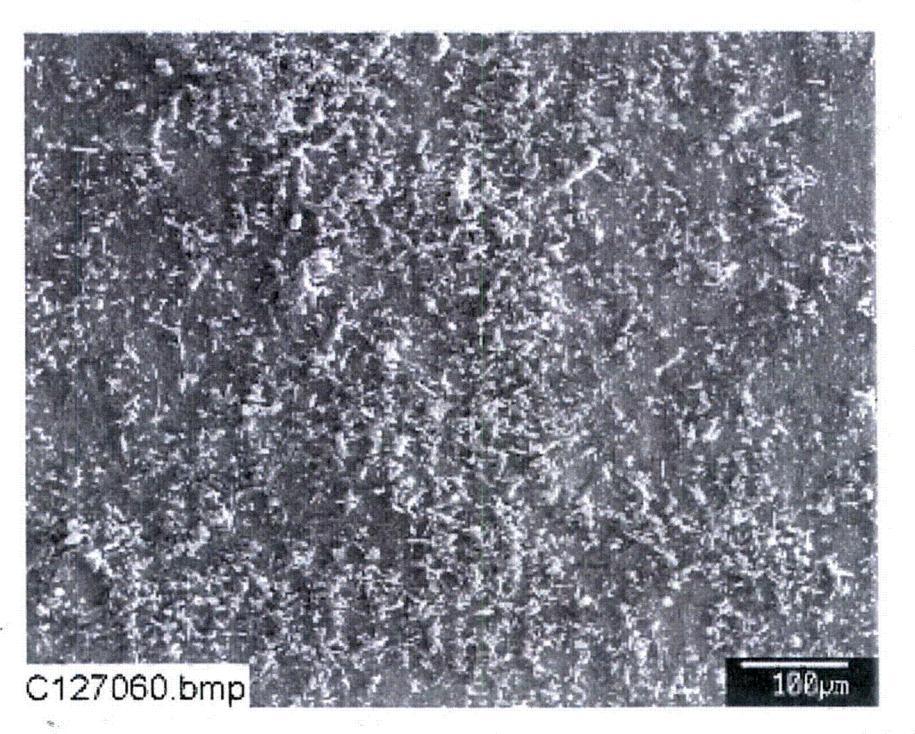
Figure C2-10. SEM image for a Test #2, Day-30 submerged copper coupon. (C127060)

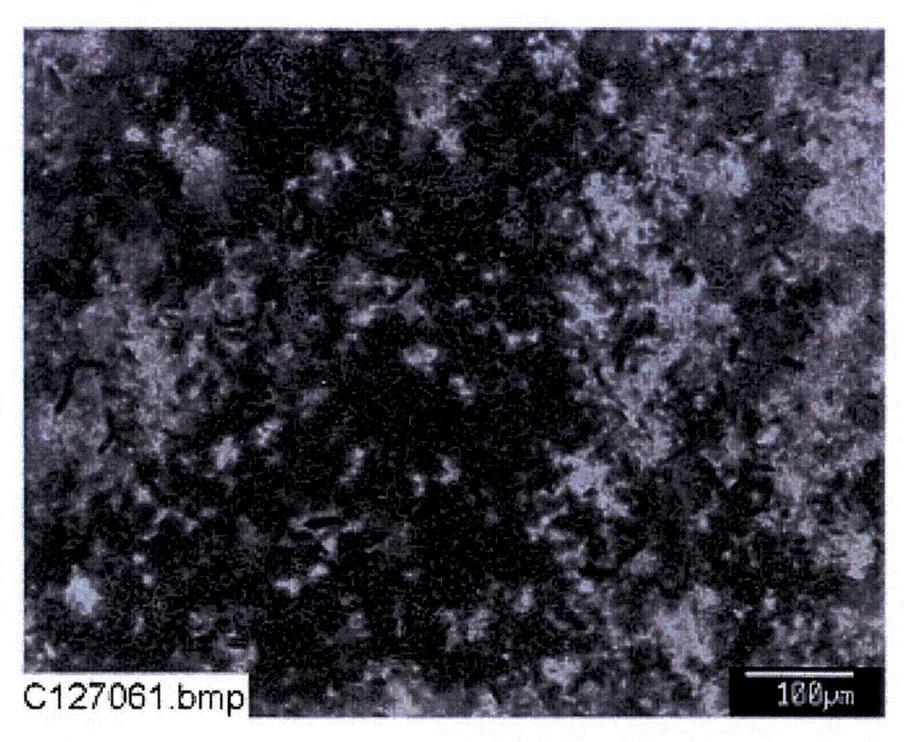
Figure C2-11. Backscattered SEM image for a Test #2, Day-30 submerged copper coupon. (C127061)

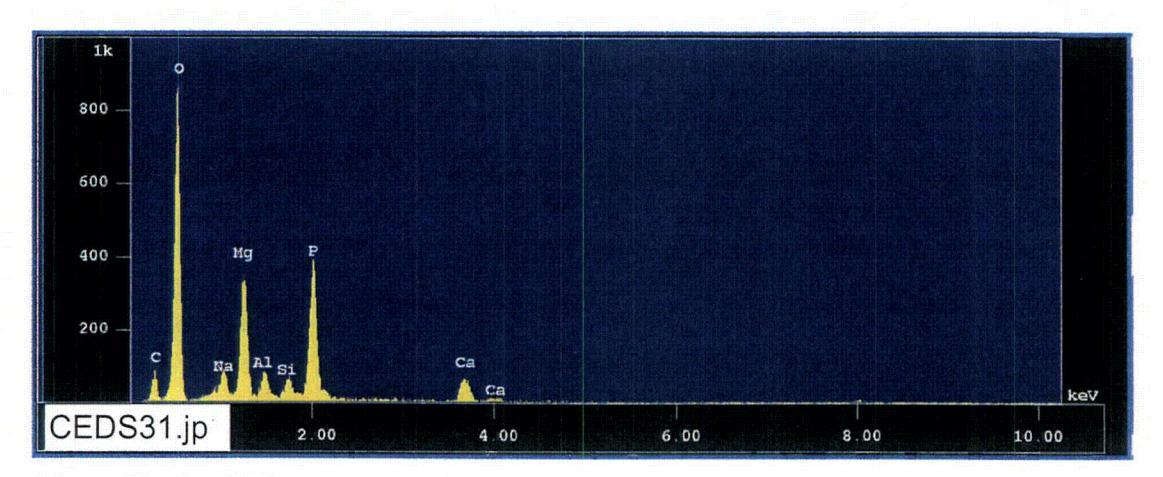
Figure C2-13. EDS counting spectrum for the dark patches shown in Figure C2-11. (CEDS31)

The results from the chemical composition analysis for CEDS31 are given in Table C2-1.

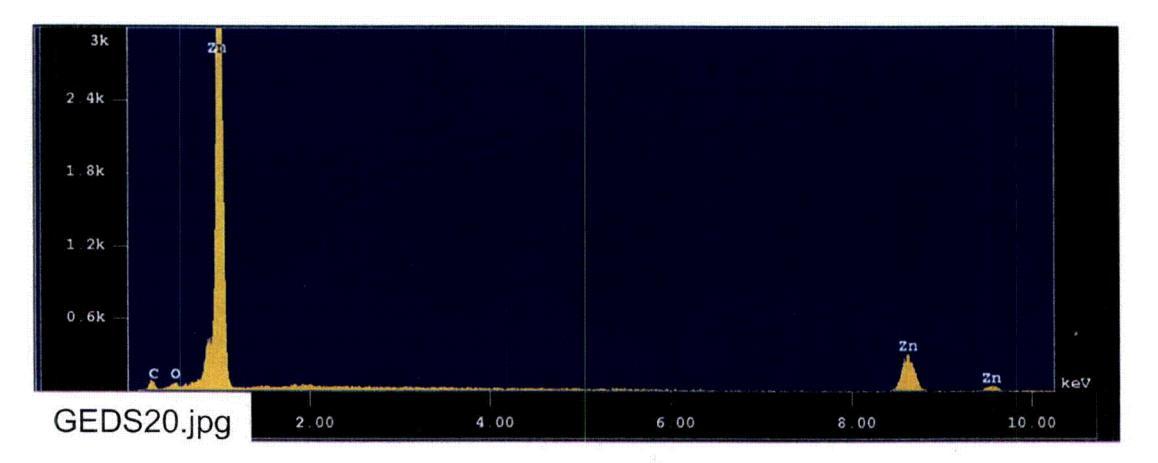
Figure C3-5. EDS counting spectrum for a smooth zinc surface. (GEDS20)

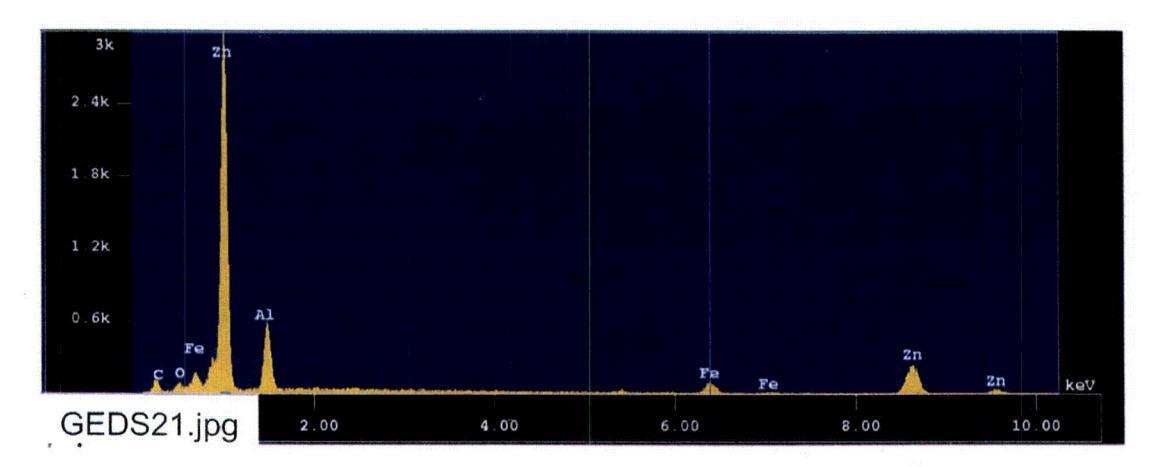
Figure C3-6. EDS counting spectrum for the small dark circular spots shown in Figure C3-4. (GEDS21)

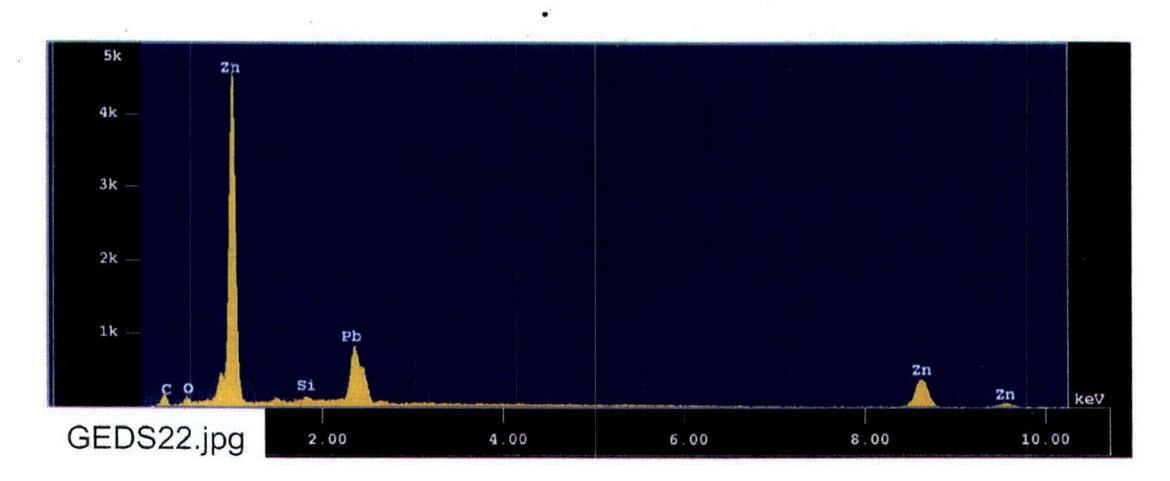
Figure C3-7. EDS counting spectrum for the bright spots shown in Figure C3-4. (GEDS22)

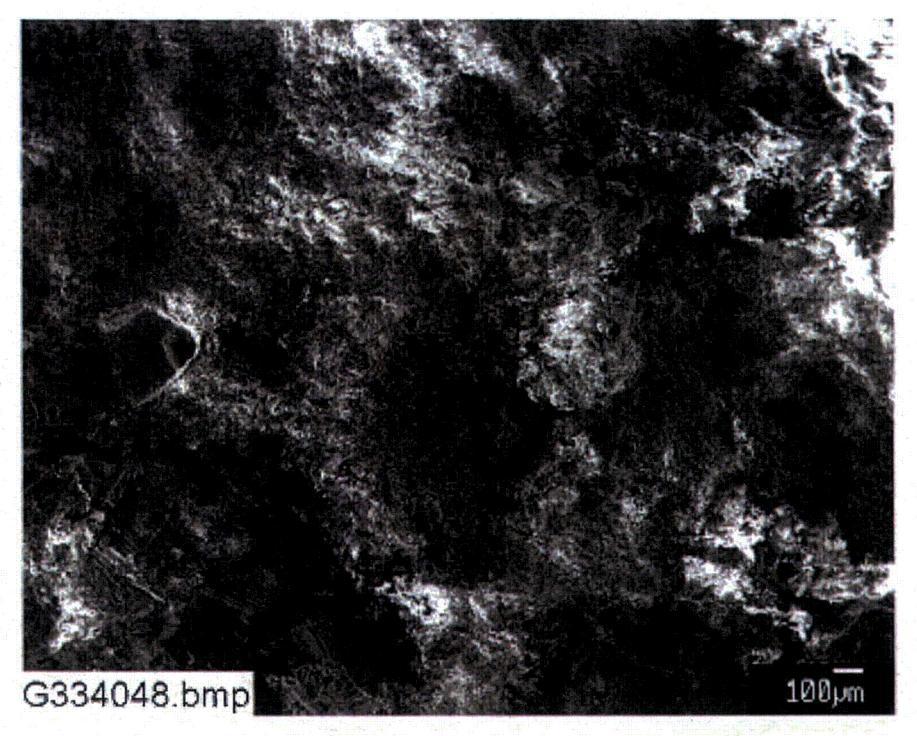
Figure C3-8. SEM image for a Test #2, Day-30 submerged galvanized steel coupon. (G334048)

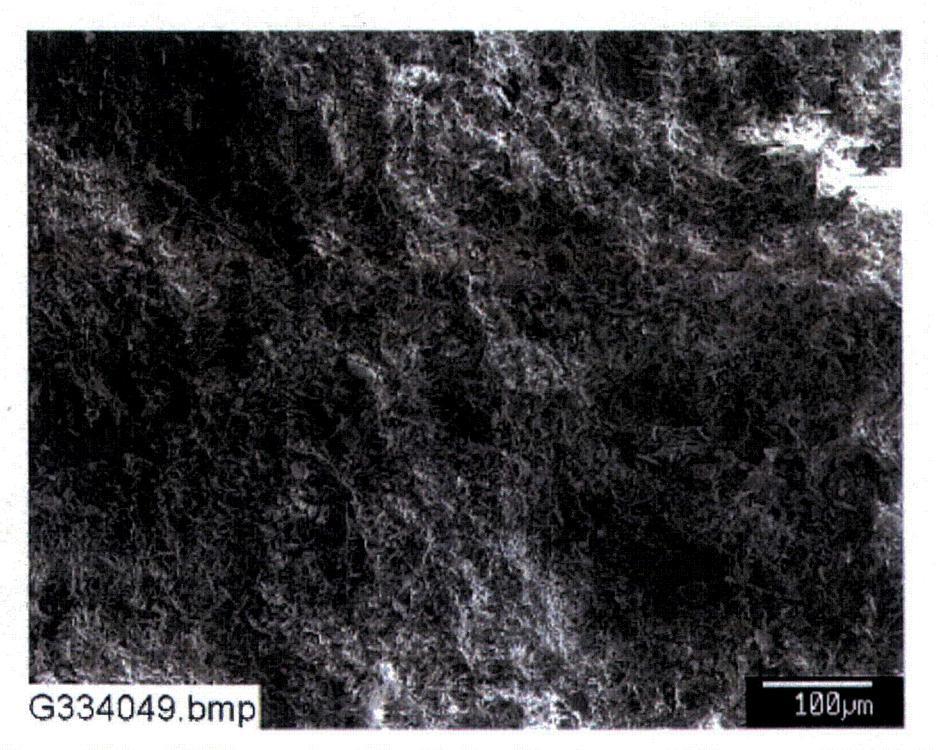
Figure C3-9. SEM image for a Test #2, Day-30 submerged GS coupon. (G334049)

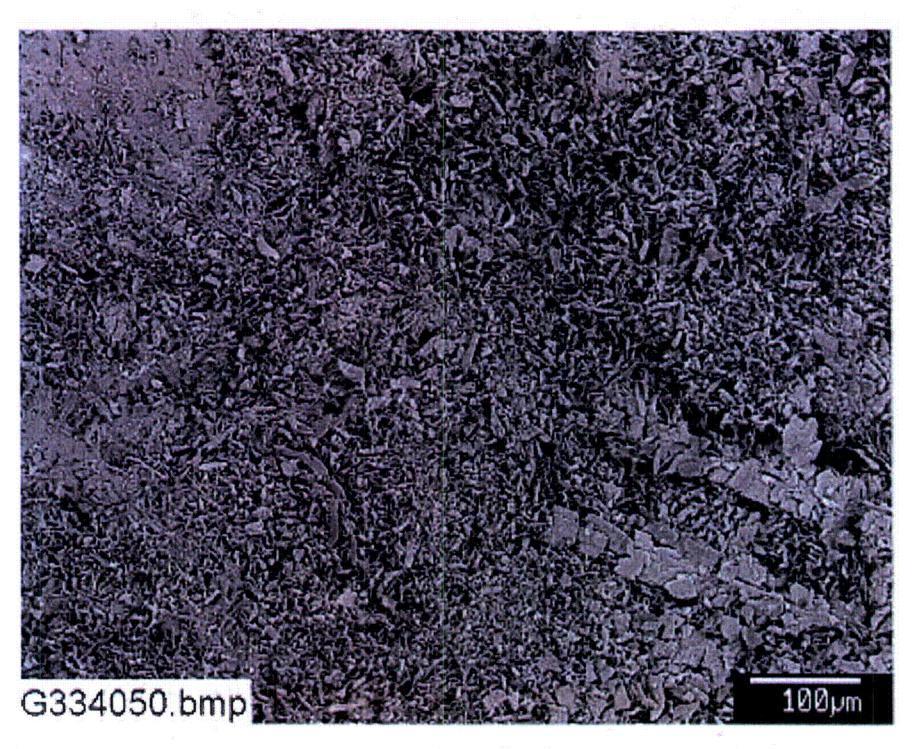
Figure C3-10. Backscattered SEM image for a Test #2, Day-30 submerged GS coupon. (G334050)

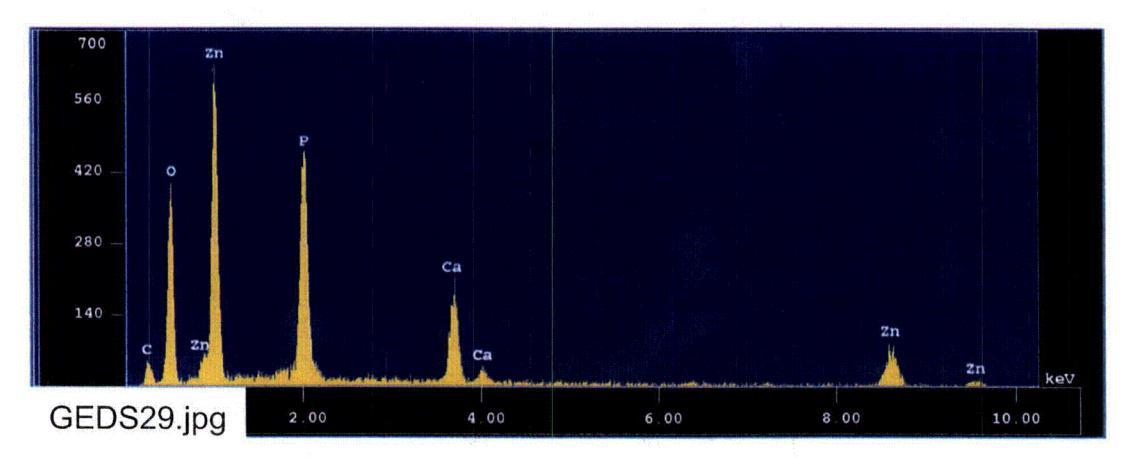
Figure C3-11. EDS counting spectrum on fiberlike crystals shown in Figure C3-10. (GEDS29)

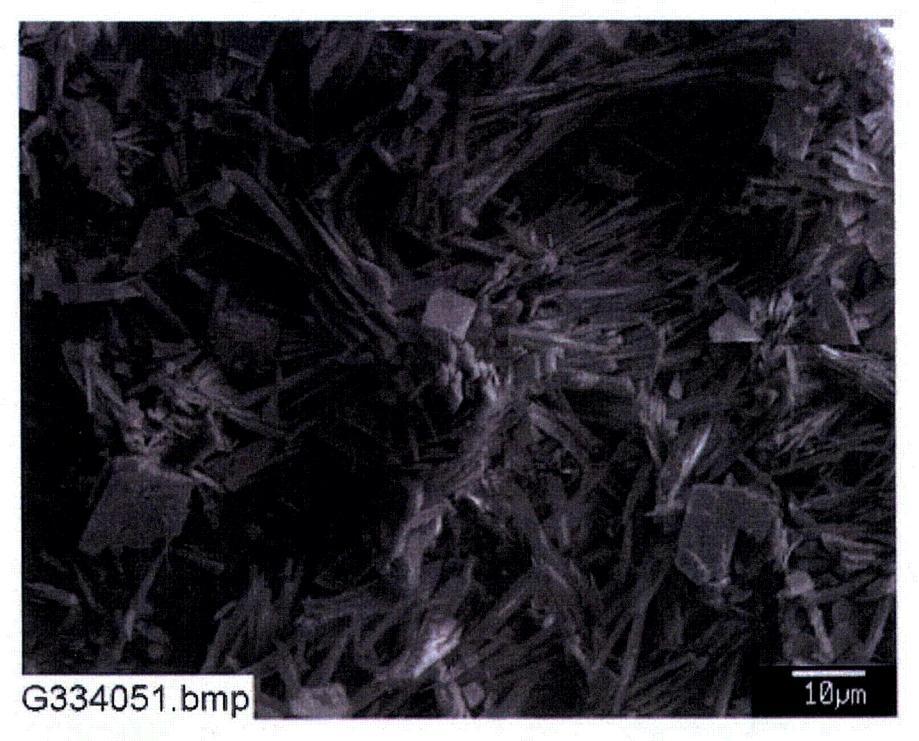
Figure C3-12. SEM image for a Test #2, Day-30 submerged GS coupon. (G334051)

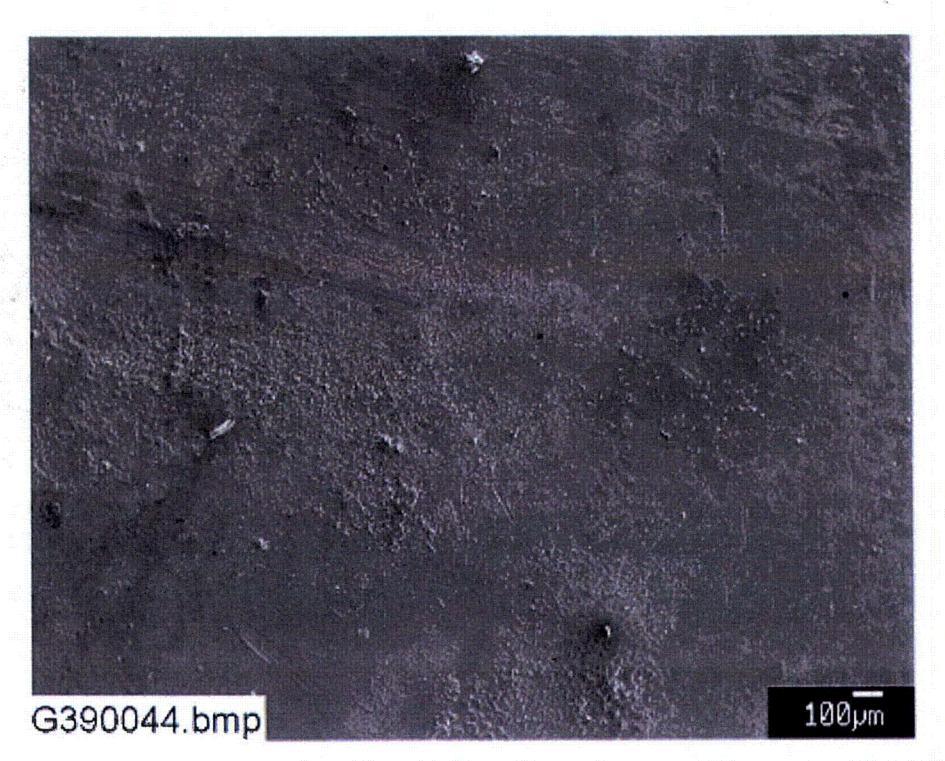
Figure C3-13. SEM image for a Test #2, Day-30 unsubmerged GS coupon. (G390044)

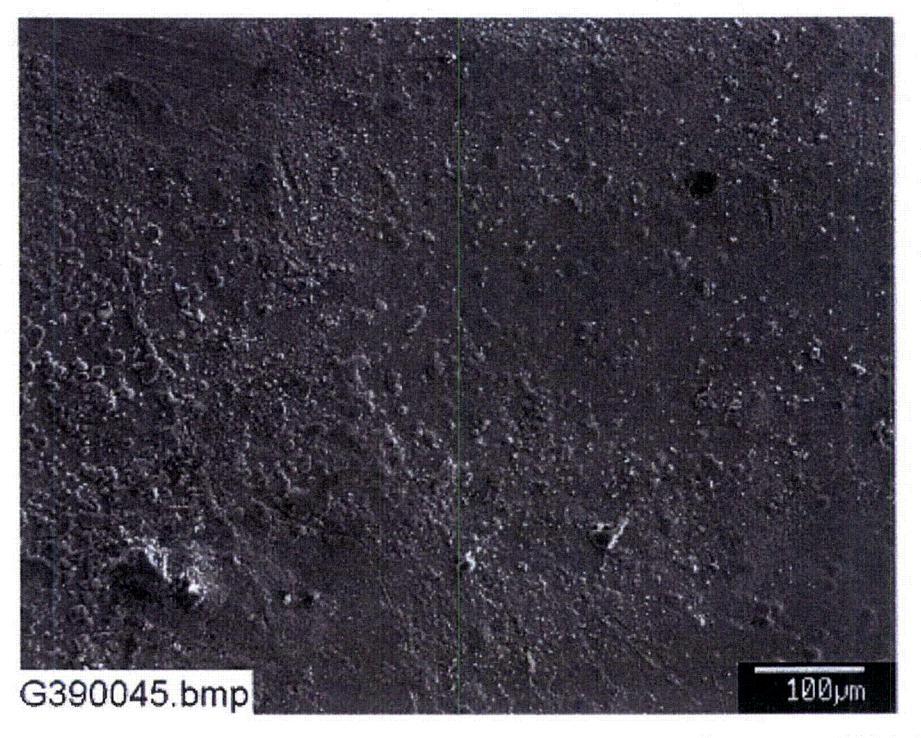
Figure C3-14. SEM image for a Test #2, Day-30 unsubmerged GS coupon. (G390045)

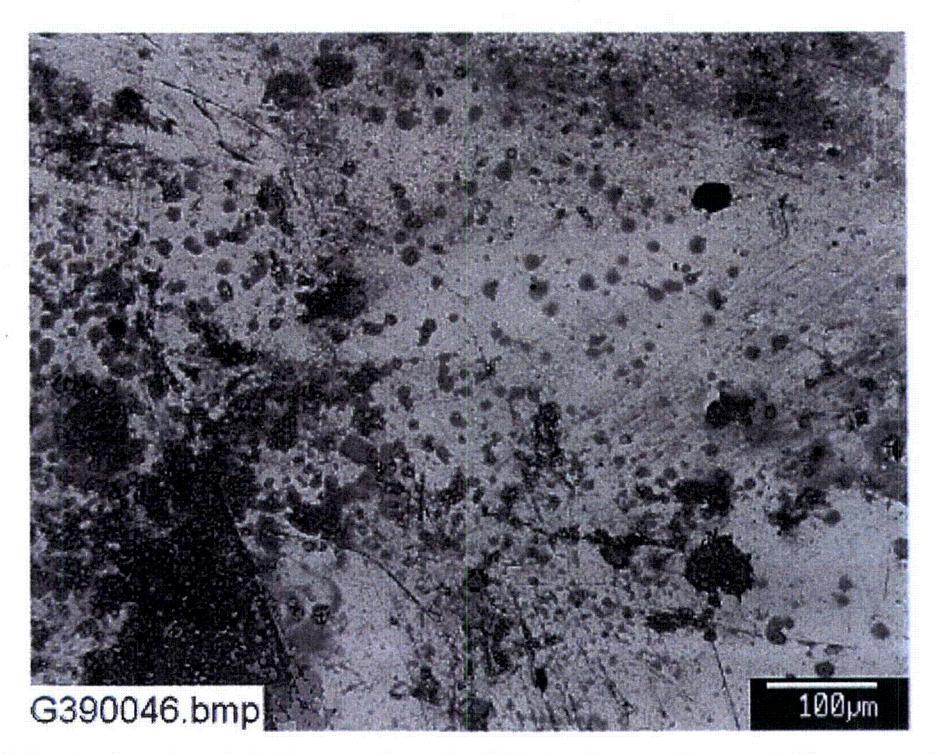
Figure C3-15. Backscattered SEM image for a Test #2, Day-30 unsubmerged GS coupon. (G390046)

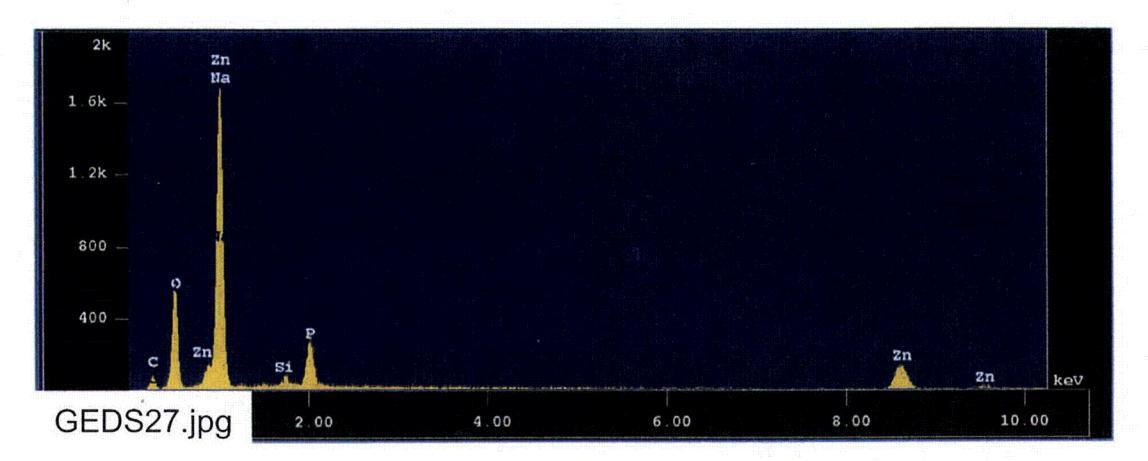
Figure C3-16. EDS counting spectrum on the dark spots shown in Figure C3-15. (GEDS27)

The results from the chemical composition analysis for GEDS27 are given in Table C3-1.

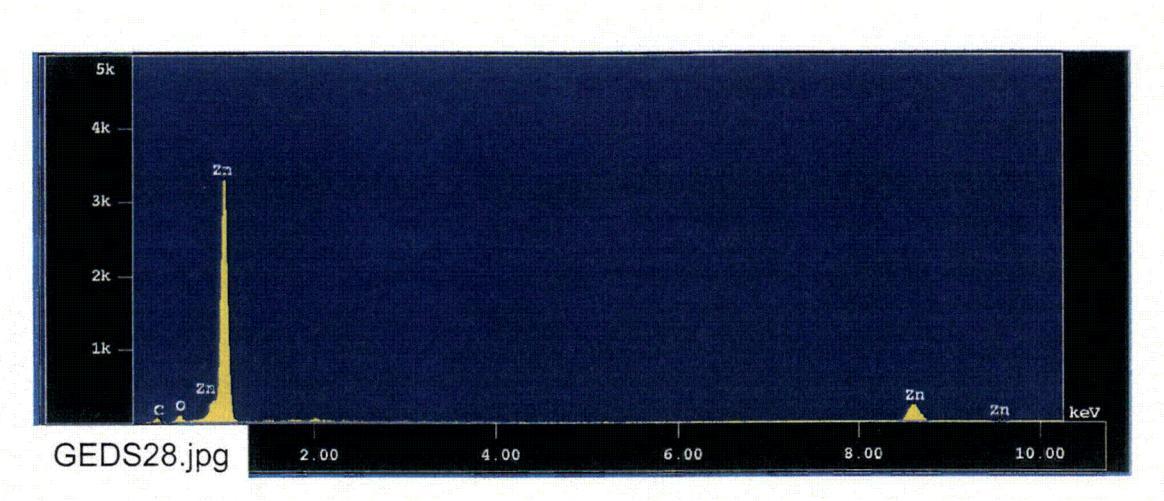
Figure C3-17. EDS counting spectrum on the light surface shown in Figure C3-15. (GEDS28)

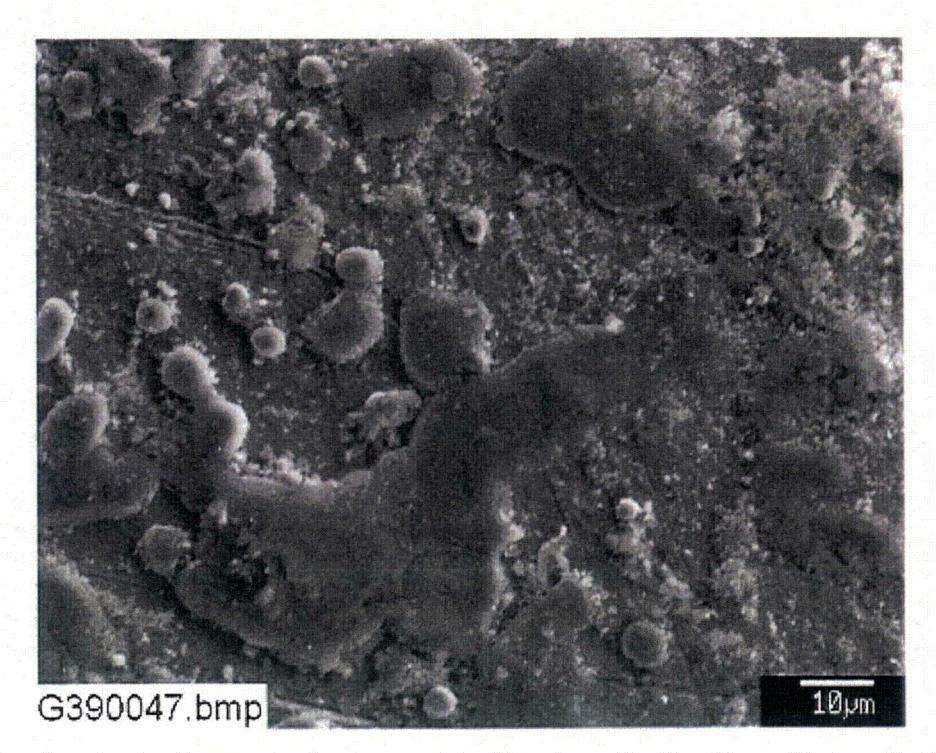
Figure C3-18. SEM image at 1000× magnification for a Test #2, Day-30 unsubmerged GS coupon. (G390047)

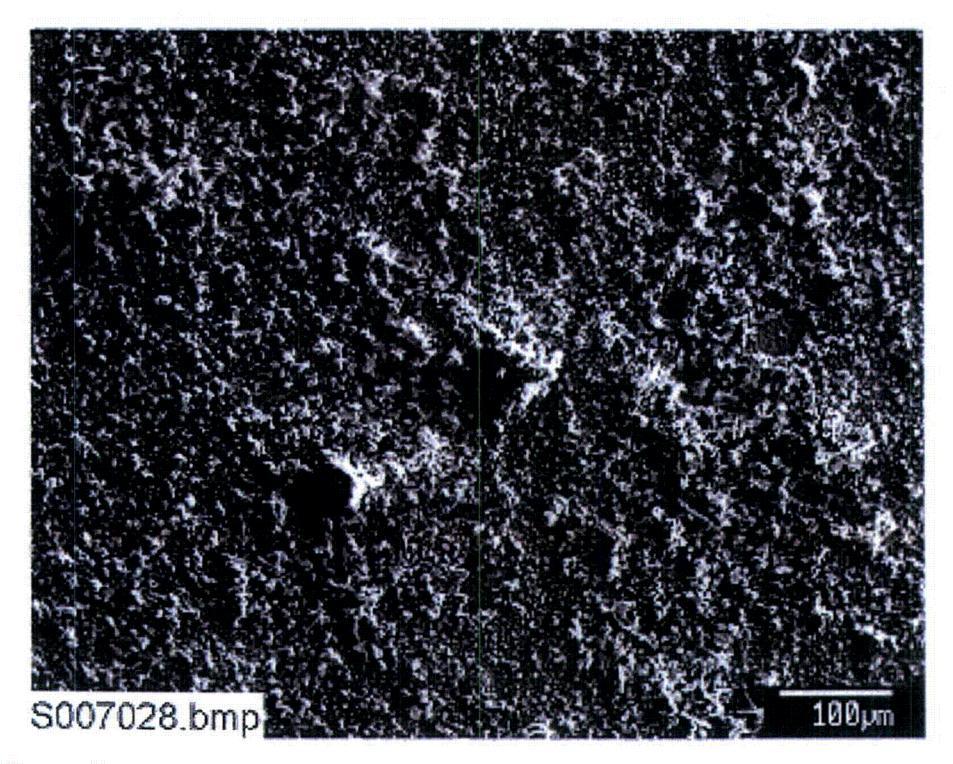
Figure C4-6. SEM image for a Test #2, Day-30 submerged steel coupon. (S007028)
