Appendix C1

SEM/EDS Data for Unused and Test #2, Day-30 Aluminum Coupons

Appendix C2

SEM/EDS Data for Unused and Test #2, Day-30 Copper Coupons

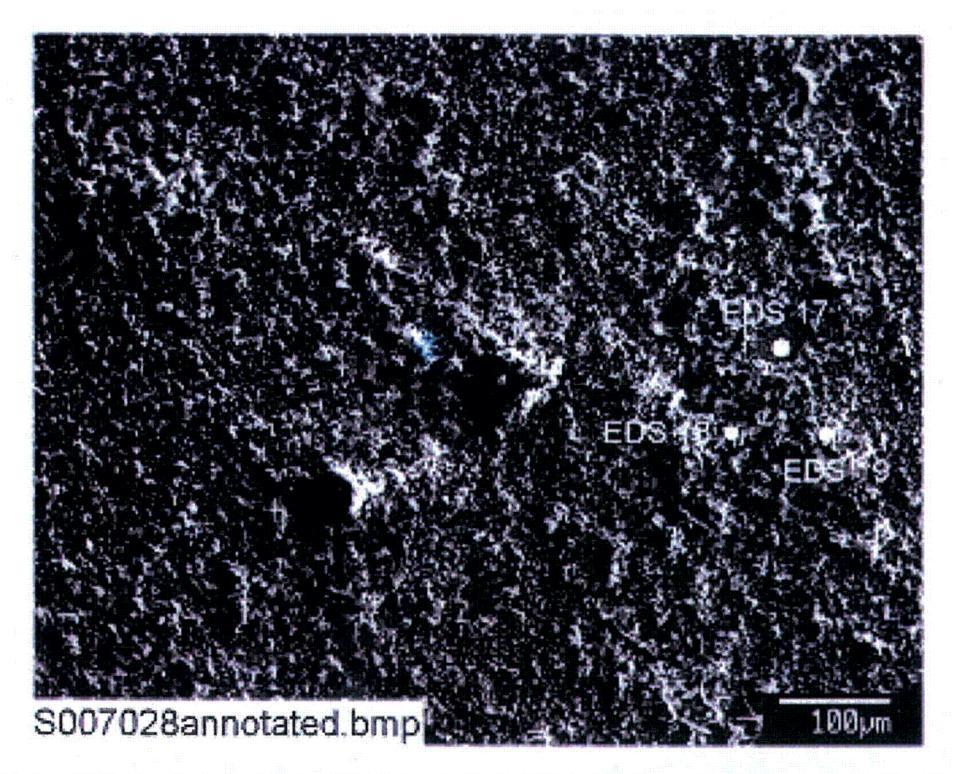
Figure C4-7. SEM image for the corrosion surface of a Test #2, Day-30 submerged steel coupon. (S007028annotated)

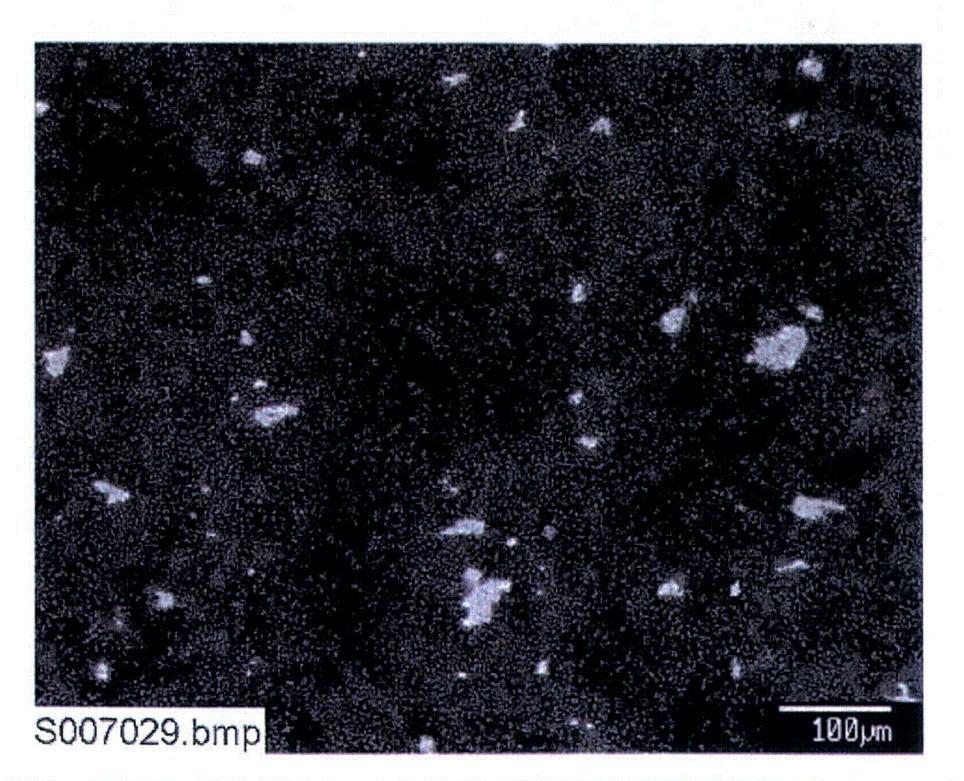
Figure C4-8. Backscattered SEM image for a Test #2, Day-30 submerged steel coupon. (S007029)

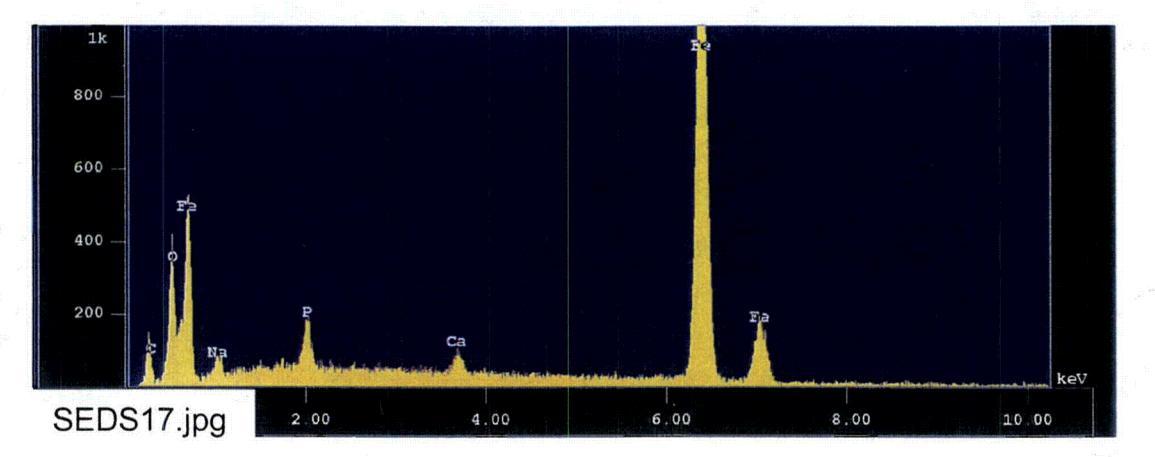
Figure C4-9. EDS counting spectrum for the light spot shown in Figure C4-8. (SEDS17)

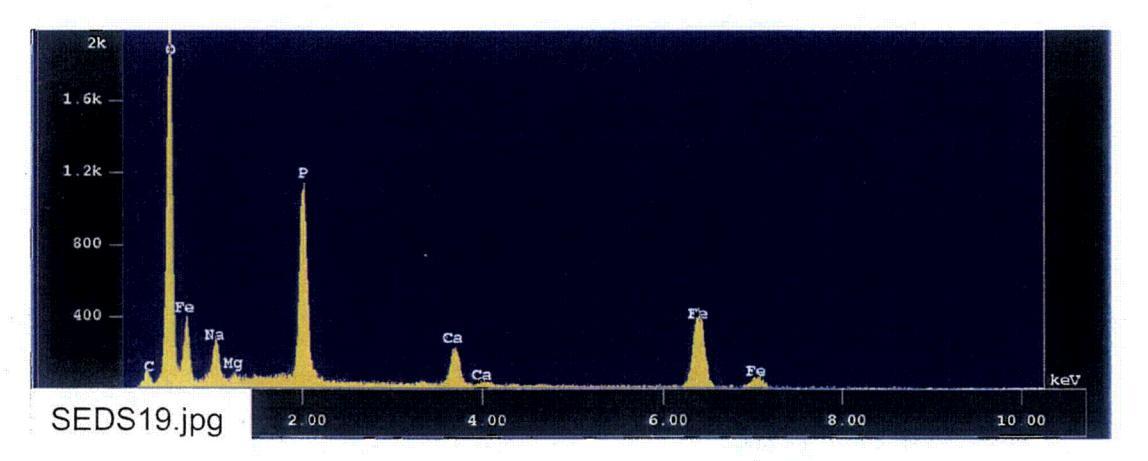
Figure C4-12. EDS counting spectrum for the clumps surrounding crystals shown in Figure C4-10. (SEDS19)

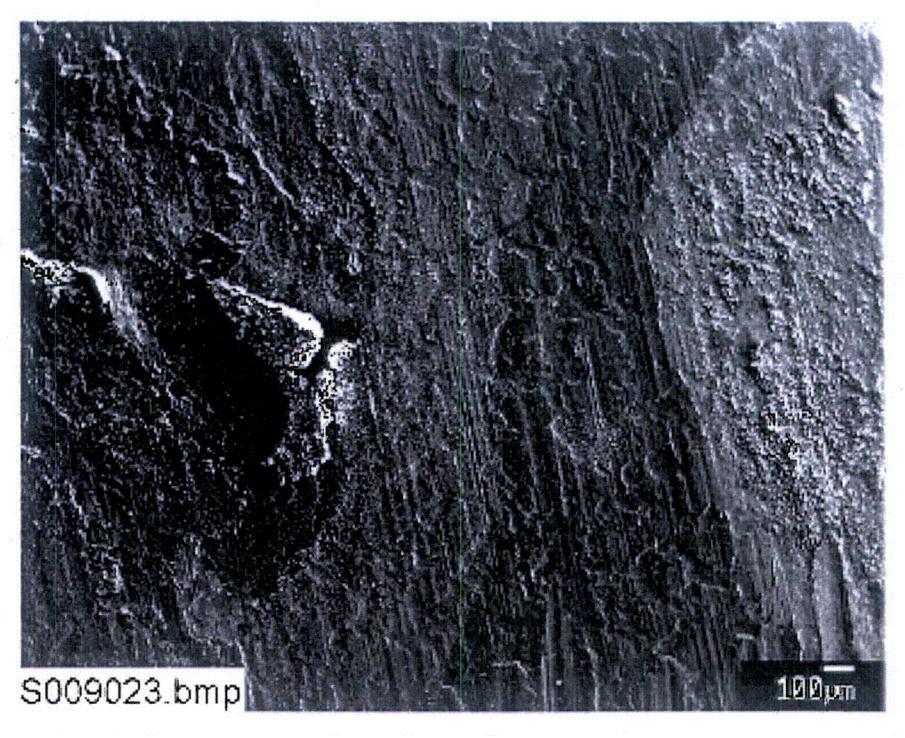
Figure C4-13. SEM image for a Test #2, Day-30 unsubmerged steel coupon. (S009023)

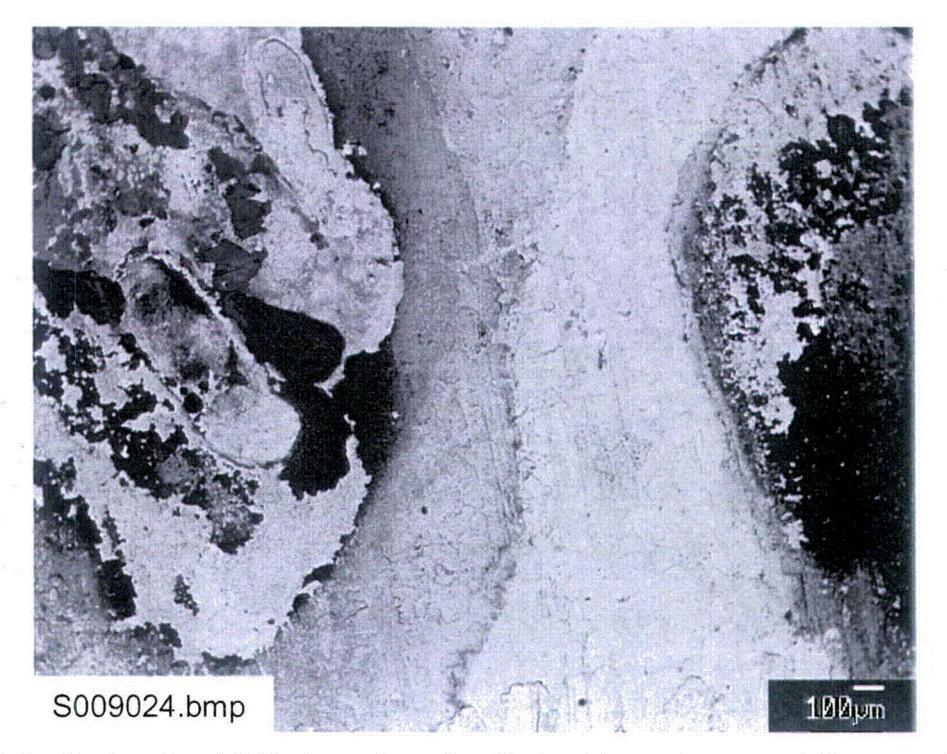
Figure C4-14. Backscattered SEM image for a Test #2, Day-30 unsubmerged steel coupon. (S009024)

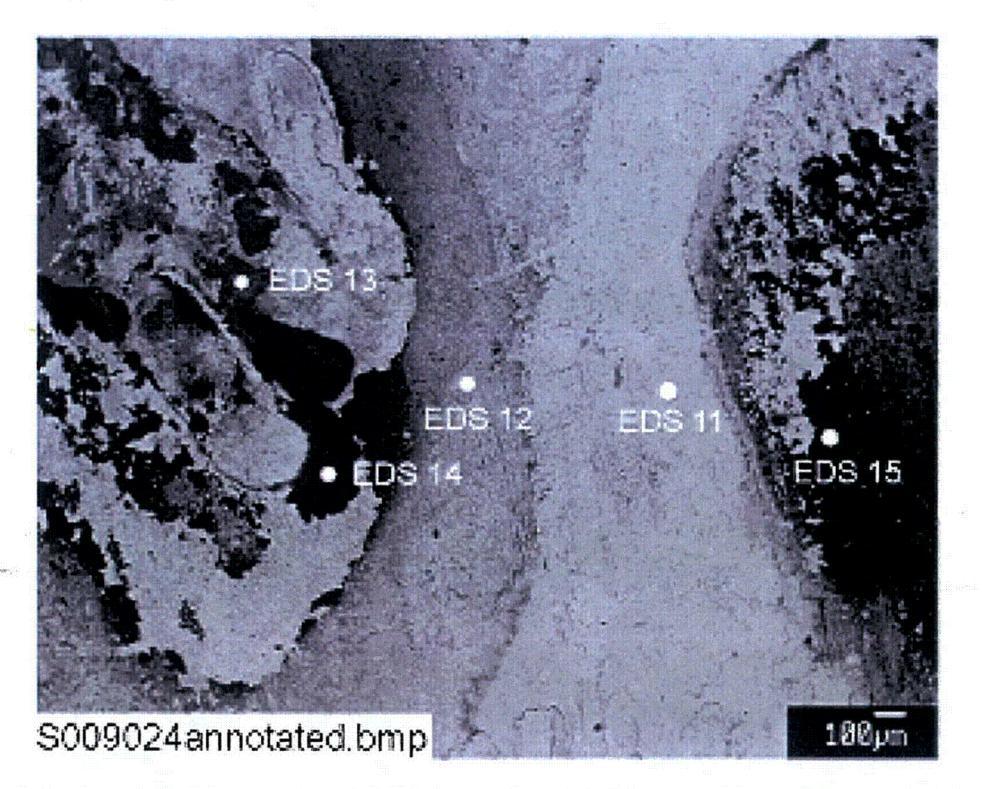
Figure C4-15. Annotated backscattered SEM image for a Test #2, Day-30 unsubmerged steel coupon. (S009024annotated)

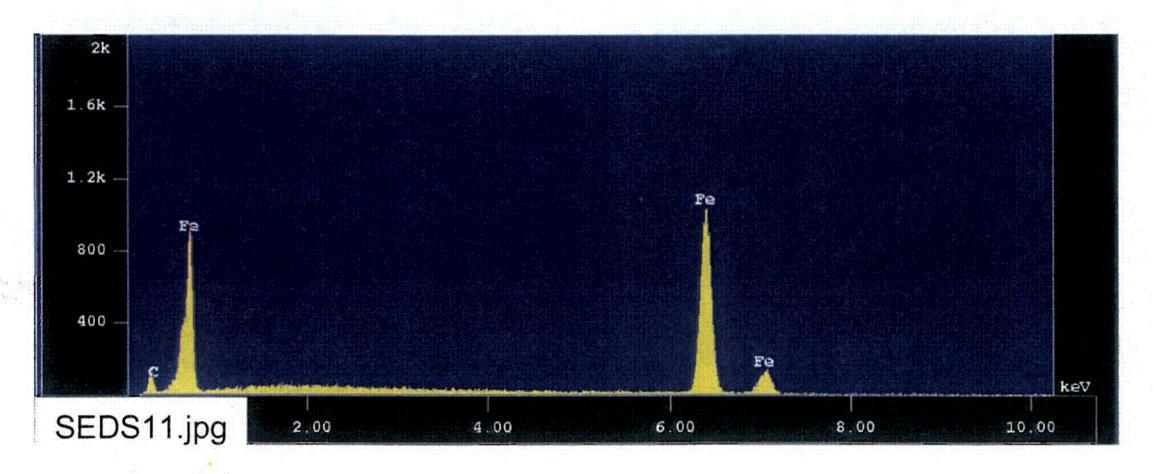
Figure C4-16. EDS counting spectrum for the light streak (EDS-11) shown in Figure C4-15. (SEDS11)

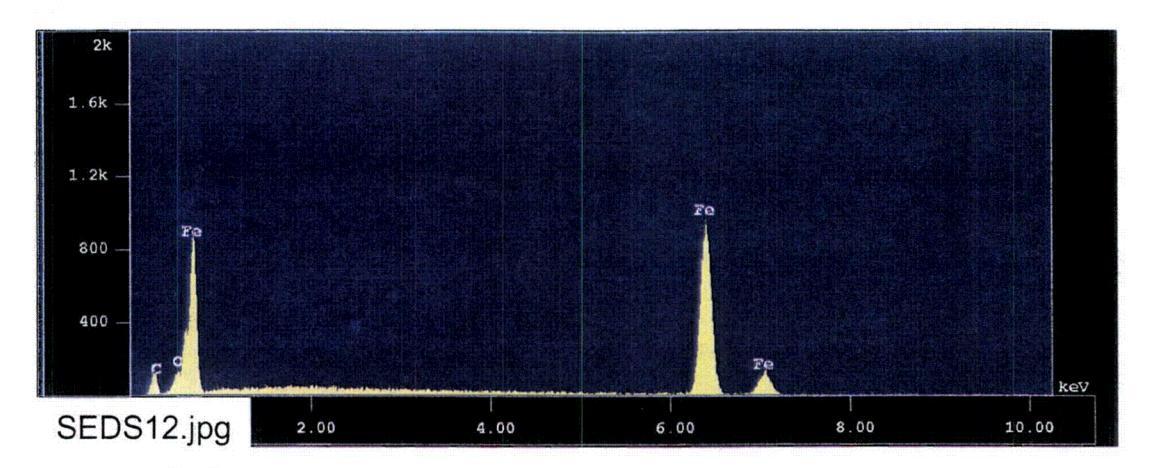
Figure C4-17. EDS counting spectrum for the light grey streak (EDS-12) shown in Figure C4-15. (SEDS12)

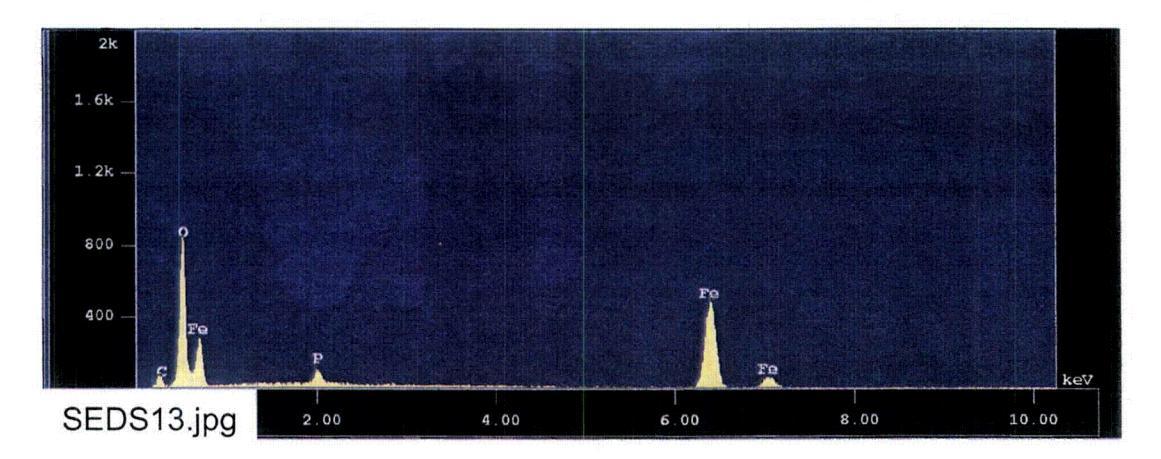
Figure C4-18. EDS counting spectrum for the medium grey spot (EDS-13) shown in Figure C4-15. (SEDS13)

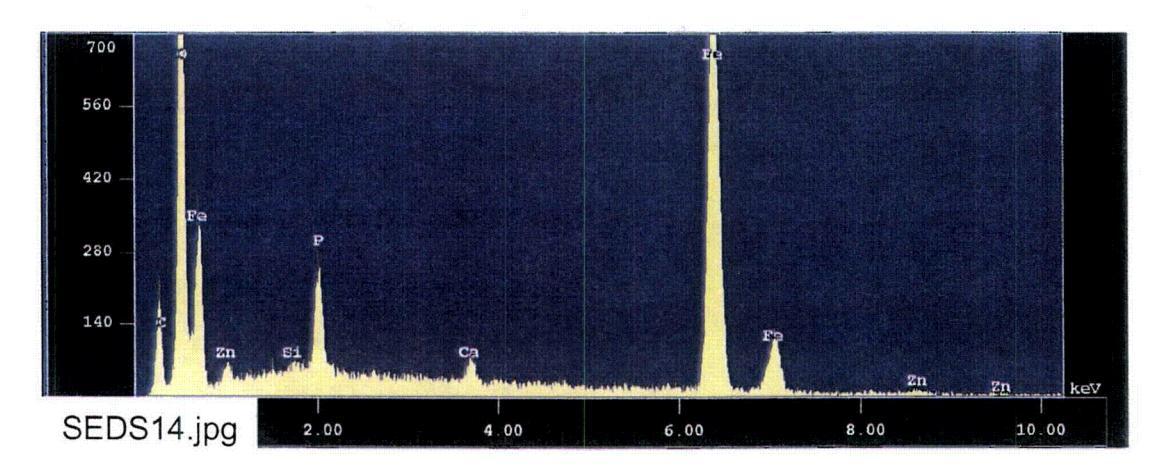
Figure C4-19. EDS counting spectrum for the dark grey spot (EDS-14) shown in Figure C4-15. (SEDS14)

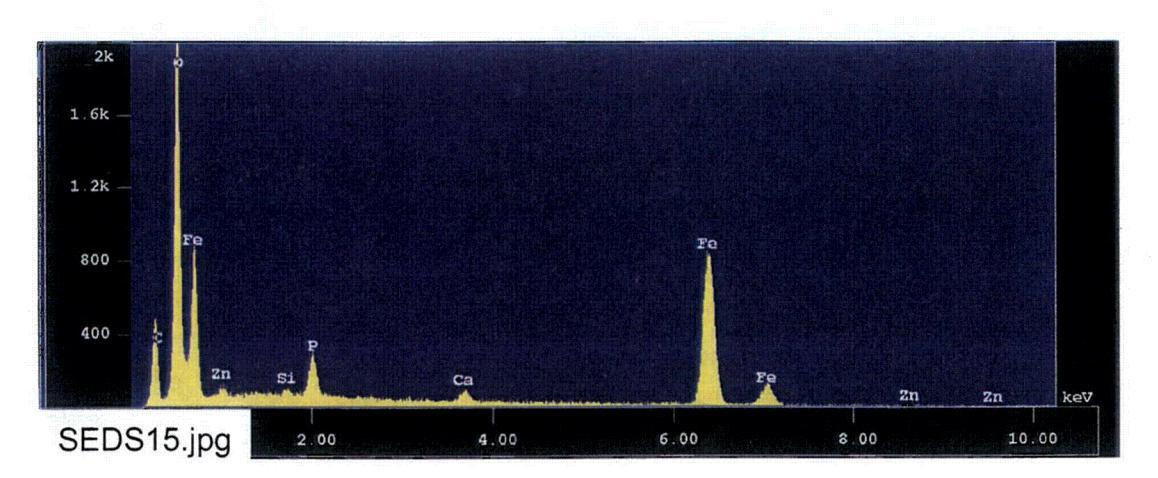
Figure C4-20. EDS counting spectrum for the dark spot (EDS-15) shown in Figure C4-15. (SEDS15)

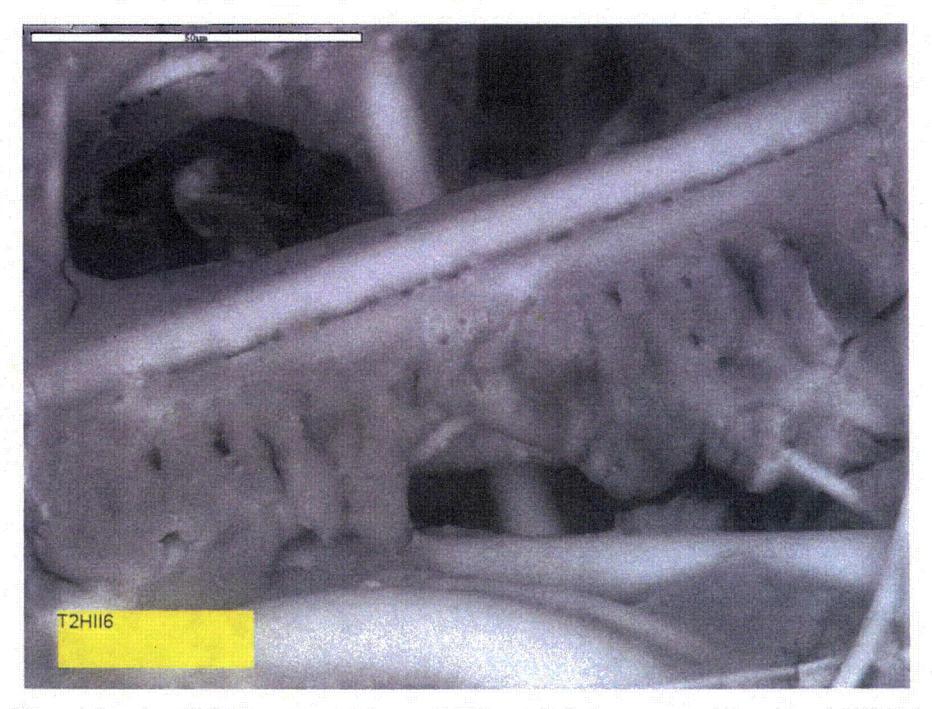
Figure D1-6. SEM image of Figure D1-5 at 1000 times magnification. (T2HII6)

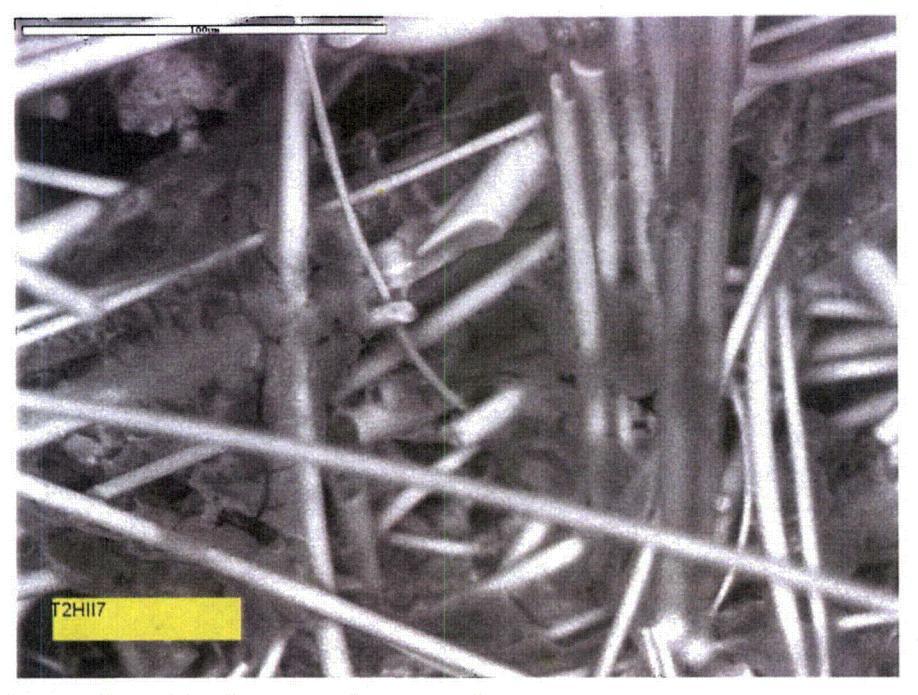
Figure D1-7. SEM image of high-flow interior for another sample area. (T2HII7)

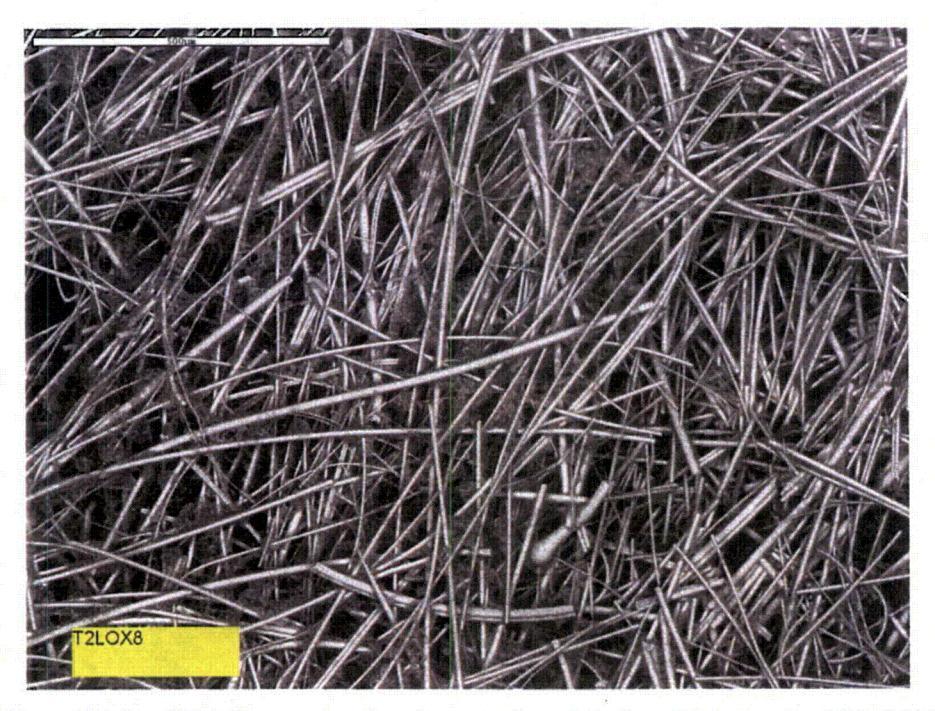
Figure D1-8. SEM image overview for exterior of the low-flow sample. (T2LOX8)

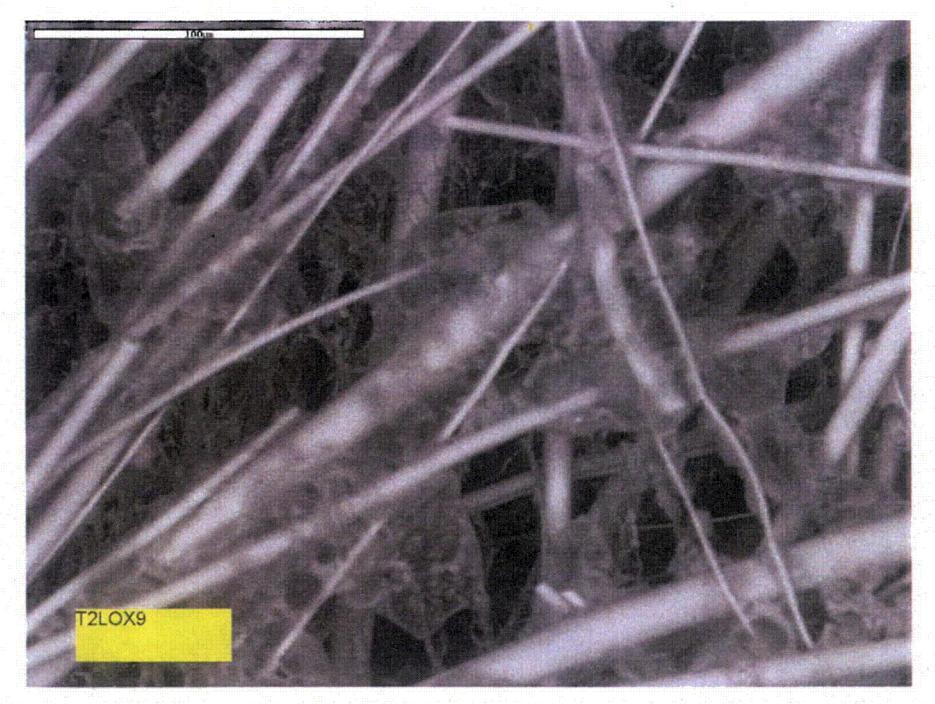
Figure D1-9. SEM image of the upper left portion of Figure D1-8, low-flow exterior. (T2LOX9)

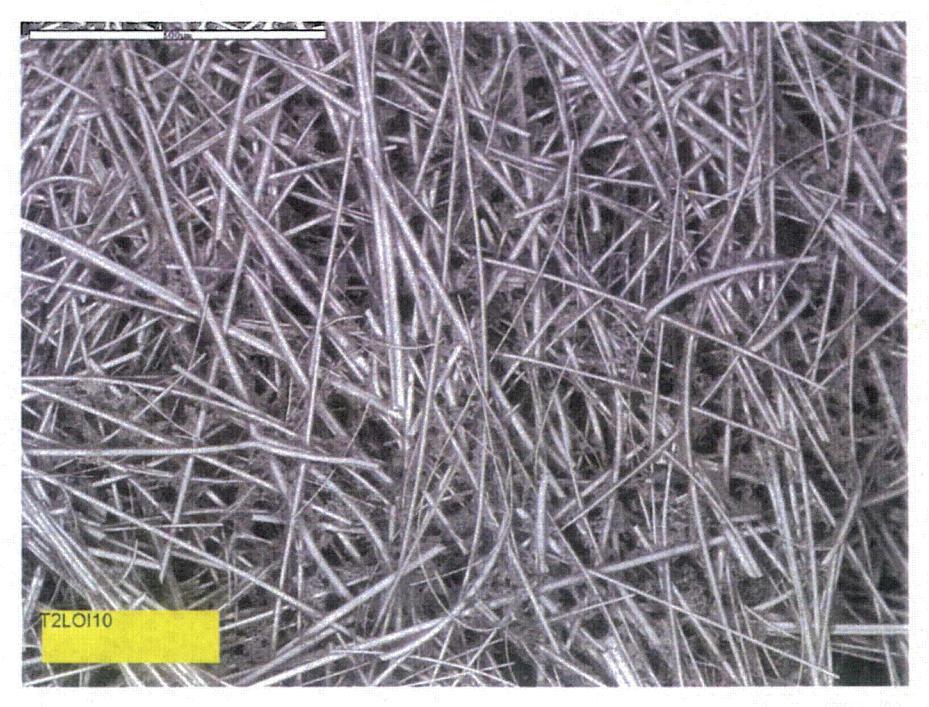
Figure D1-10. SEM image overview for interior of the low-flow sample. (T2LOI10)

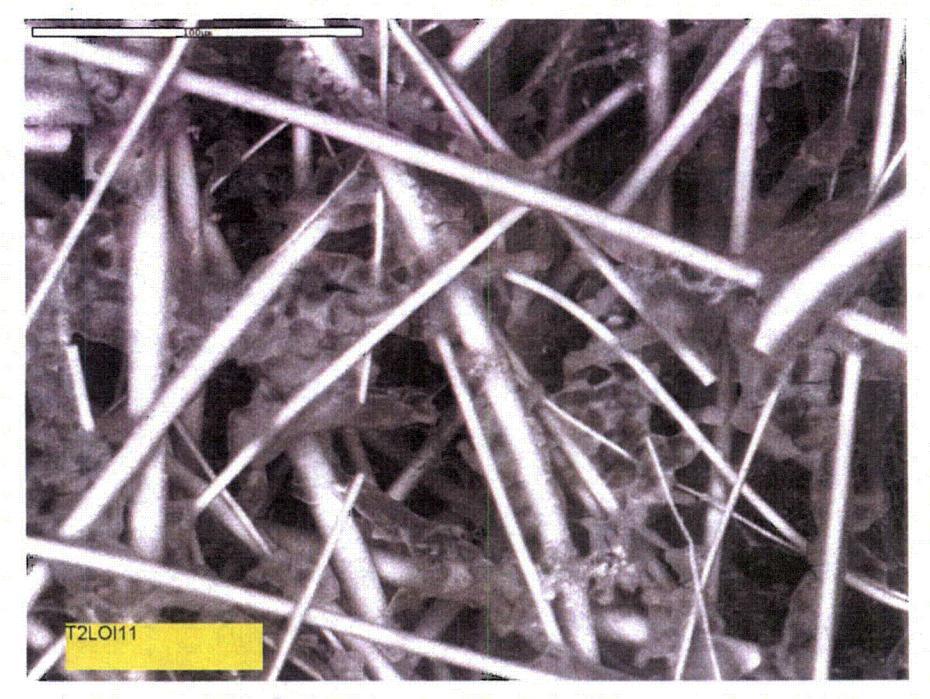
Figure D1-11. SEM image on the center of Figure D1-10, low-flow interior. (T2LO111)

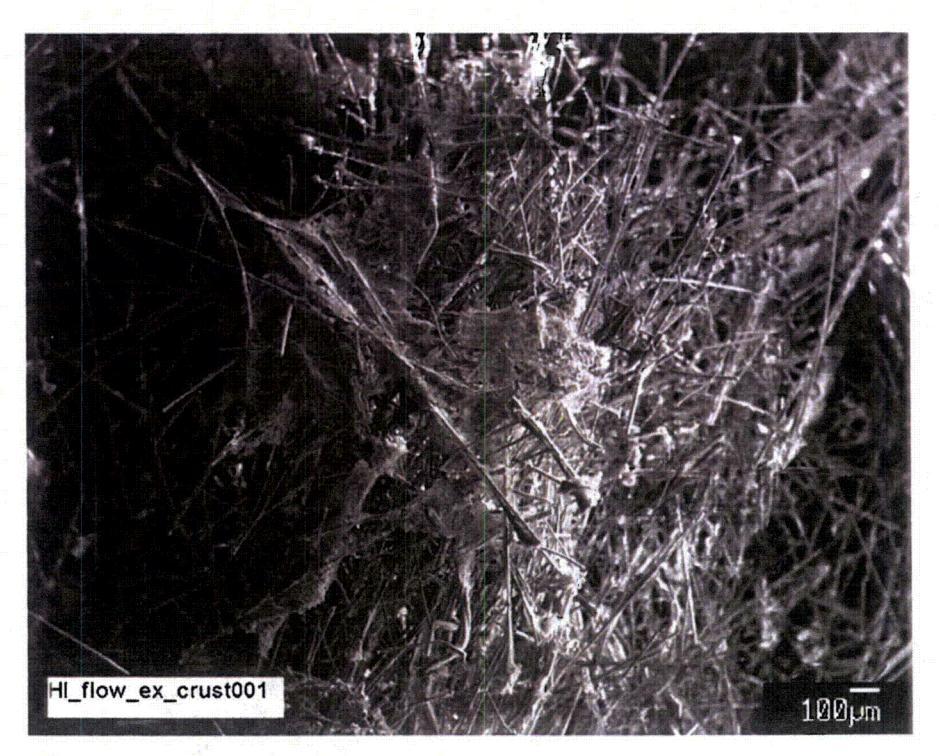
Figure D1-12. SEM image overview of exterior crust. (HI_flow_ex_crust001)

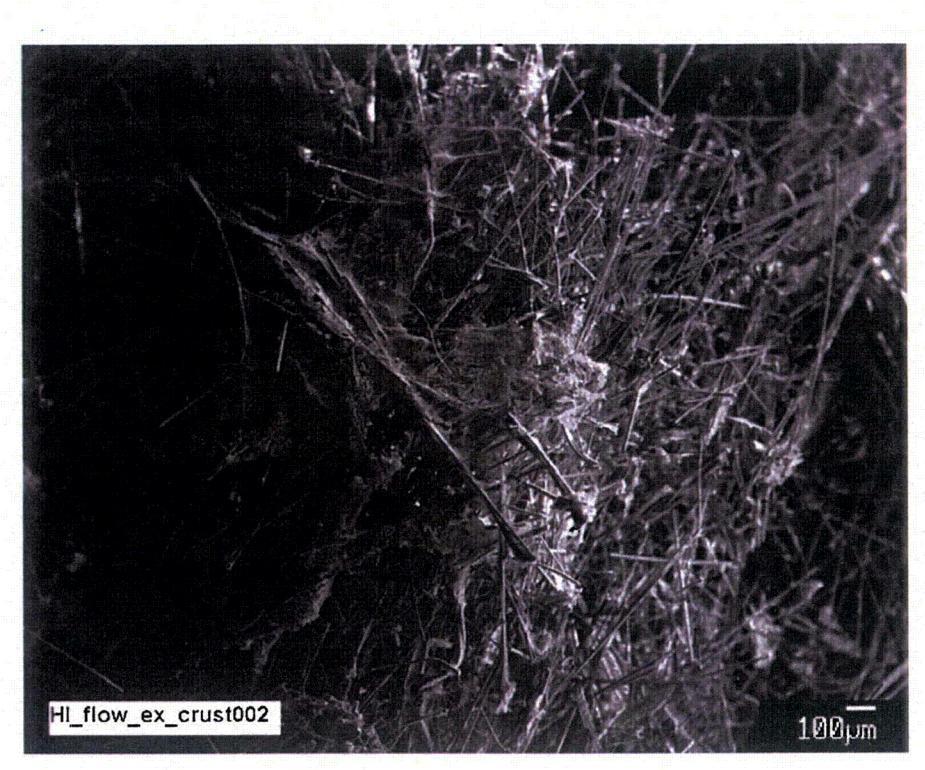
Figure D1-13. SEM image overview of the same area of Figure D1-12. (HI_flow_ex_crust002)

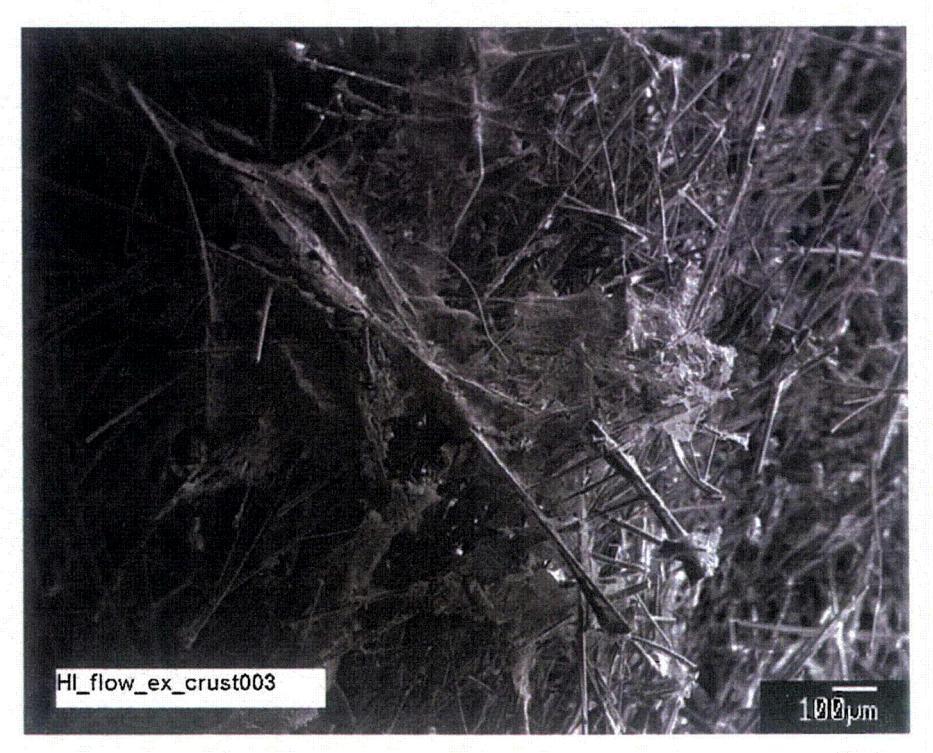
Figure D1-14. SEM image close-up view of crust. (HI_flow_ex_crust003)

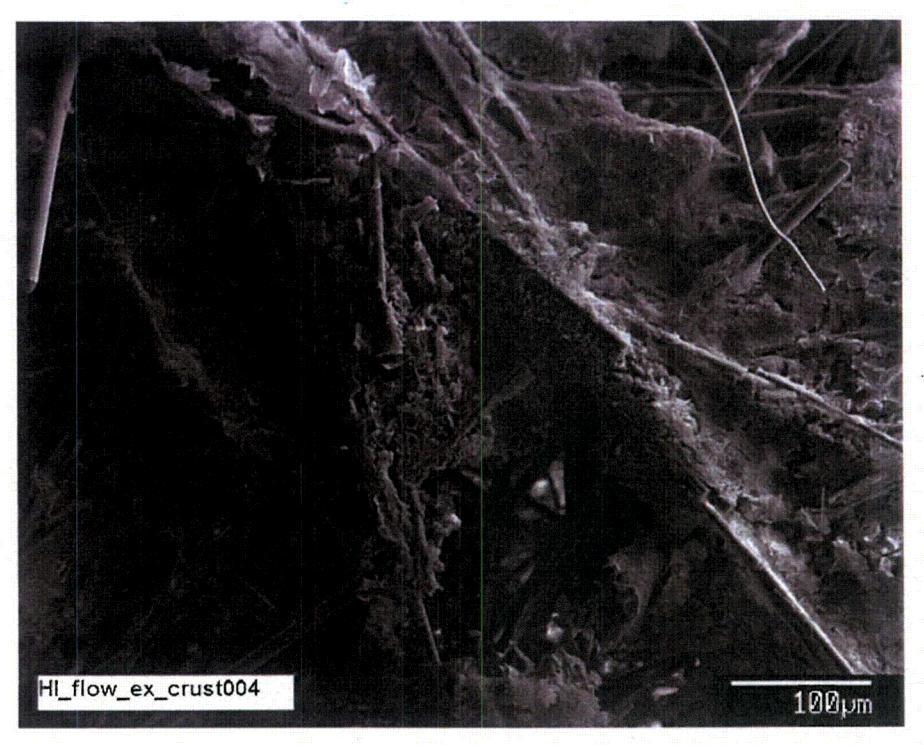
Figure D1-15. SEM image of crust at 150 times magnification. (HI_flow_ex_crust004)

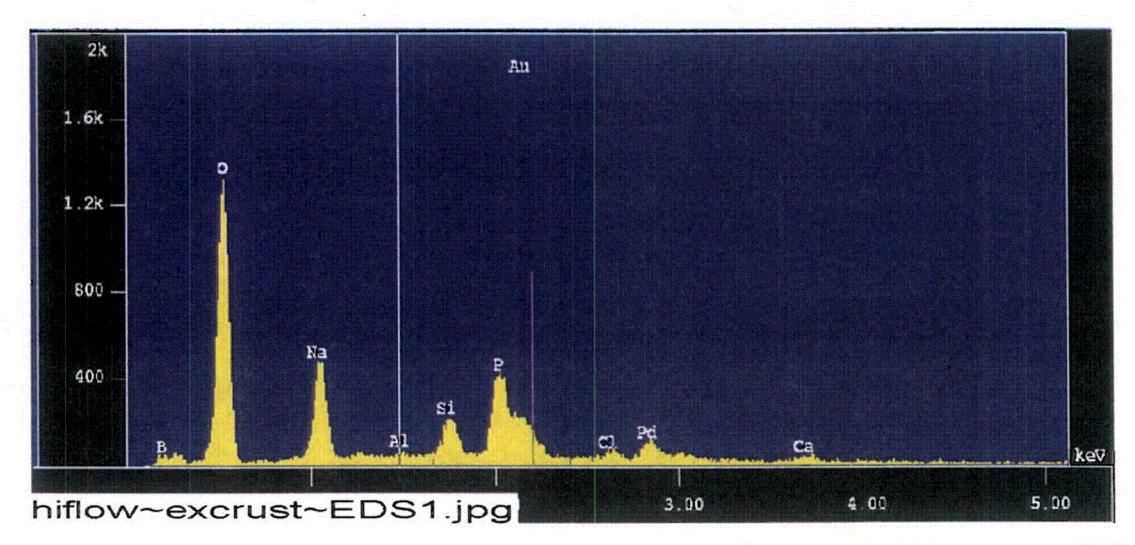
Figure D1-16. Counting spectrum image of the deposit area in Figure D1-15. (hiflow~excrust~EDS1)

The results from the chemical composition analysis for hiflow~excrust~EDS1 are given Table D1-1.

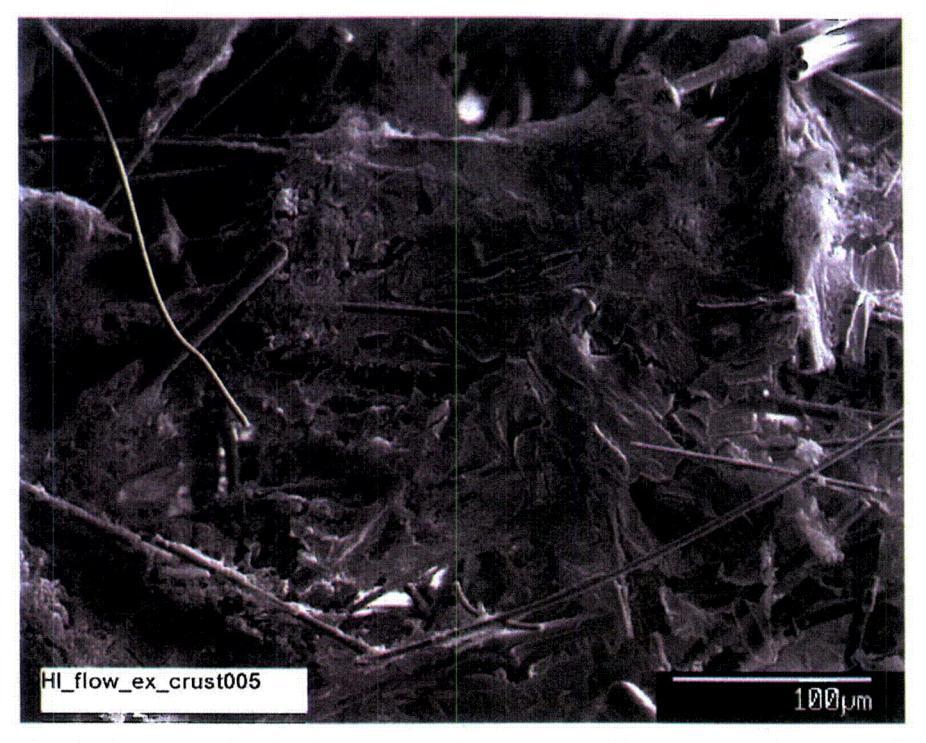
Figure D1-17. SEM image of a new exterior crust area at 270 times magnification. (HI_flow_ex_ crust005)

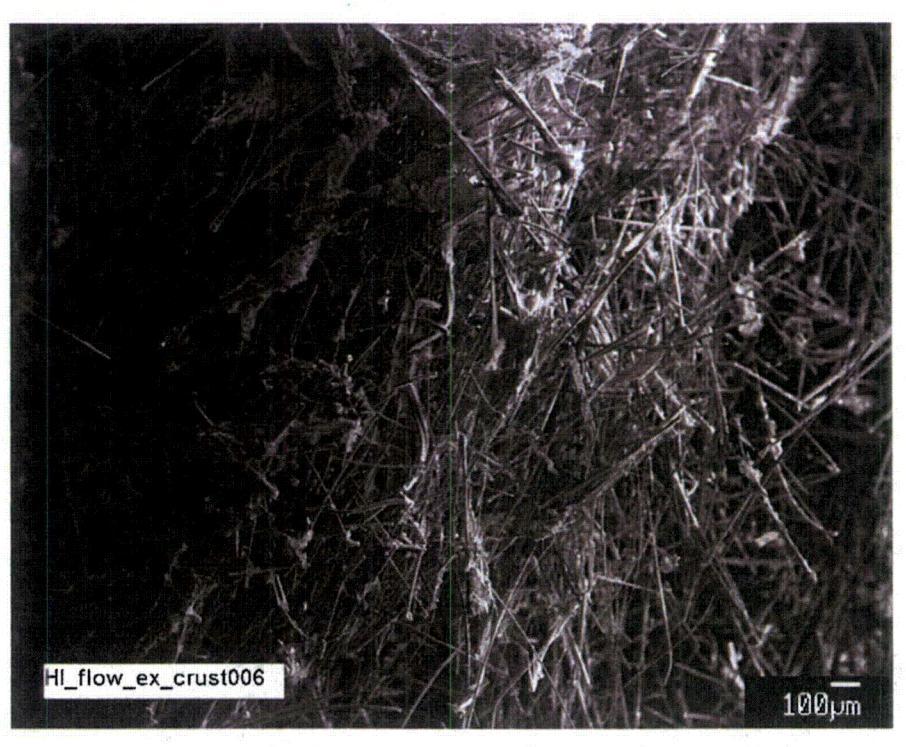
Figure D1-19. SEM image overview of another area for the exterior crust. (HI_flow_ex_crust006)

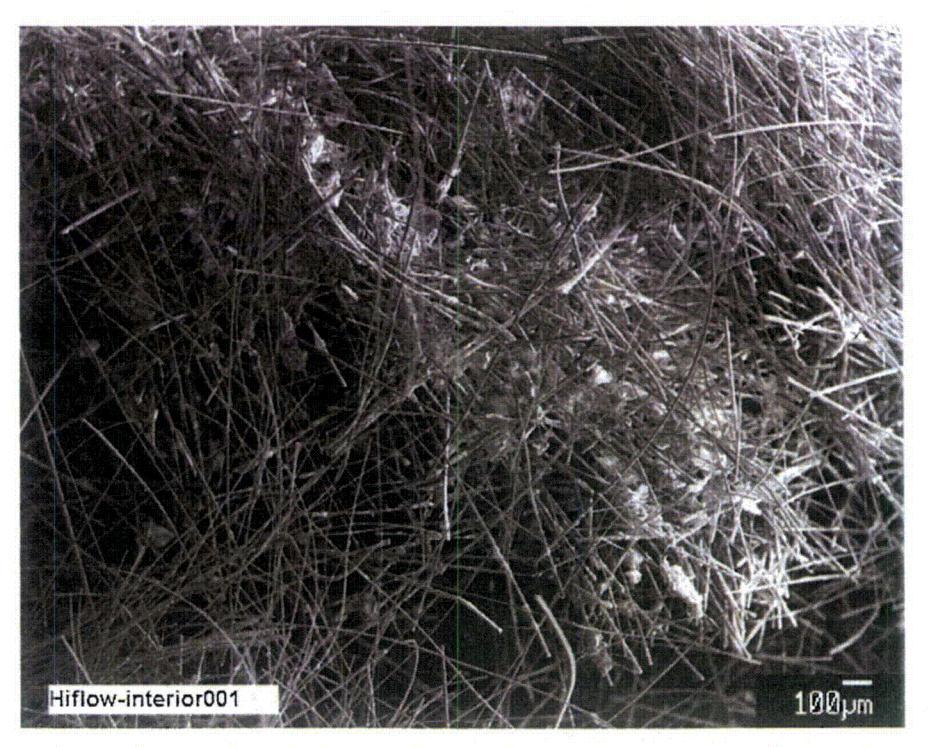
Figure D1-20. Test #2, Day-16 SEM image overview. (Hiflow-interior001)

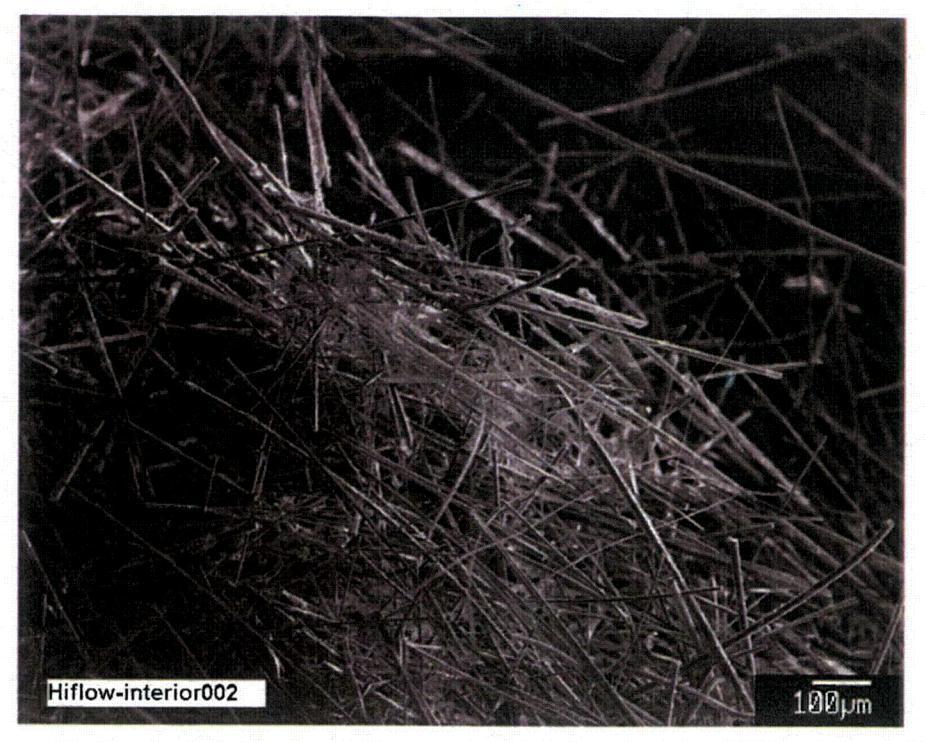
Figure D1-21. Test #2, Day-16 SEM image for high-flow interior. (Hiflow-interior002)

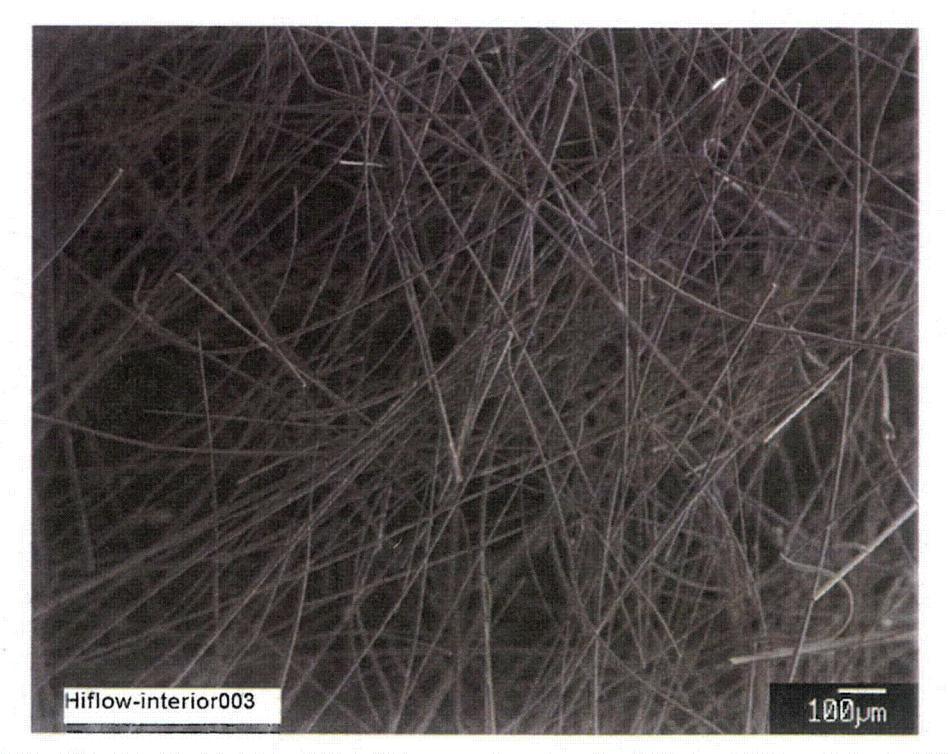
Figure D1-22. Test #2, Day-16 SEM image showing clean fibers. (Hiflow-interior003)

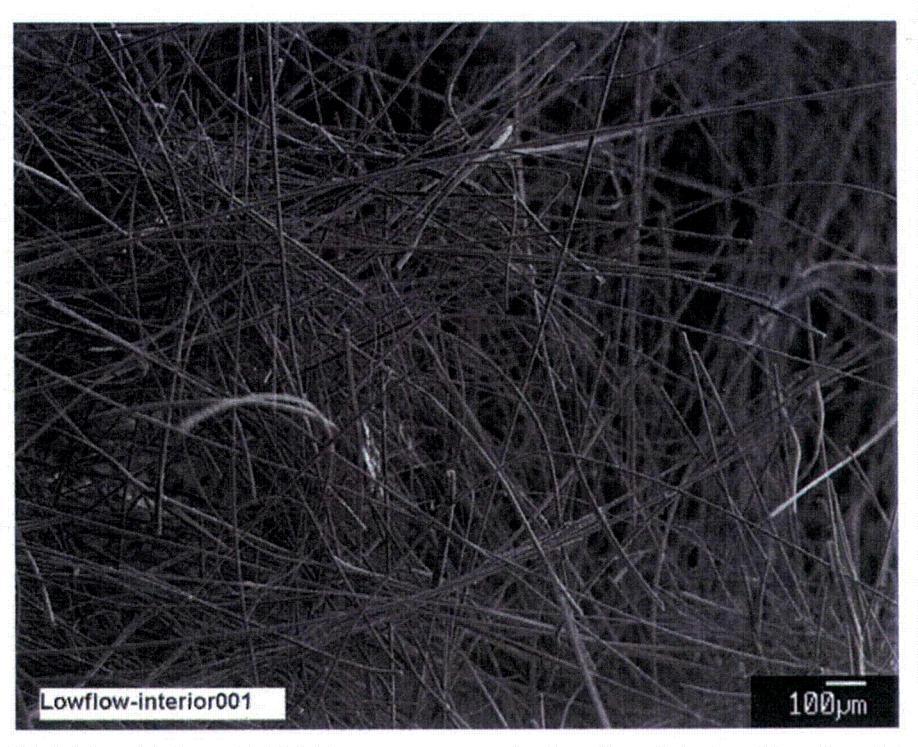
Figure D1-25. Test #2, Day-16 SEM image overview for low-flow interior. (Lowflow-interior001)

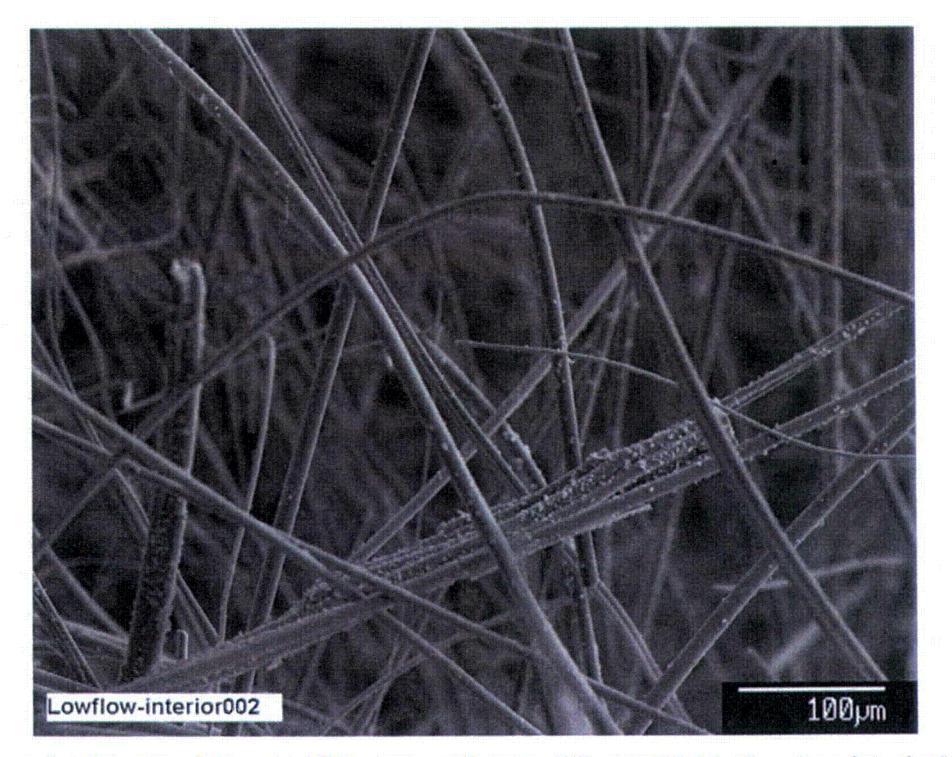
Figure D1-26. Test-2 Day-16 SEM close-up image of Figure D1-25. (Lowflow-interior002)

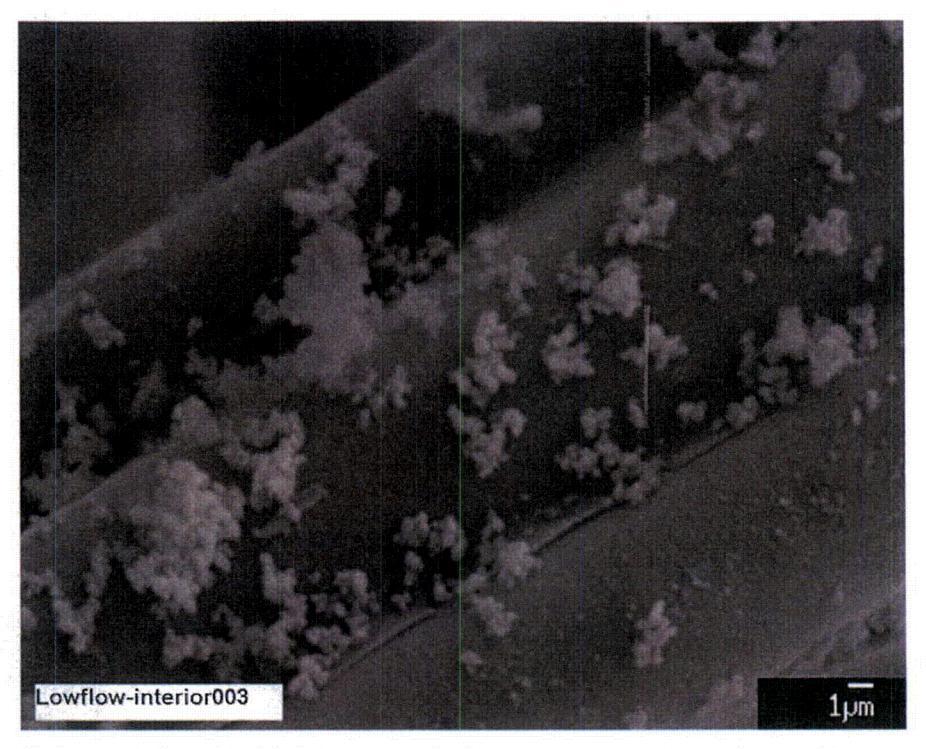
Figure D1-27. Test #2, Day-16 SEM image at 3500 times magnification of deposits shown in Figure D1-26. (Lowflow-interior003)

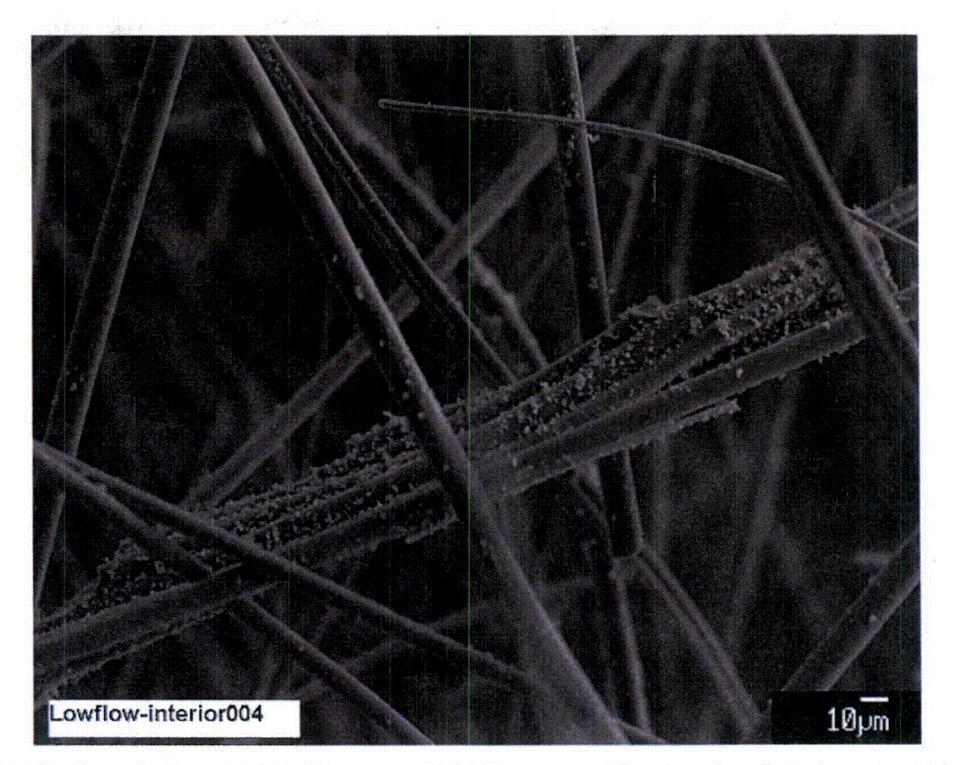
Figure D1-28. Test #2, Day-16 SEM image at 370 times magnification showing close-up of deposits in Figure D1-26. (Lowflow-interior004)

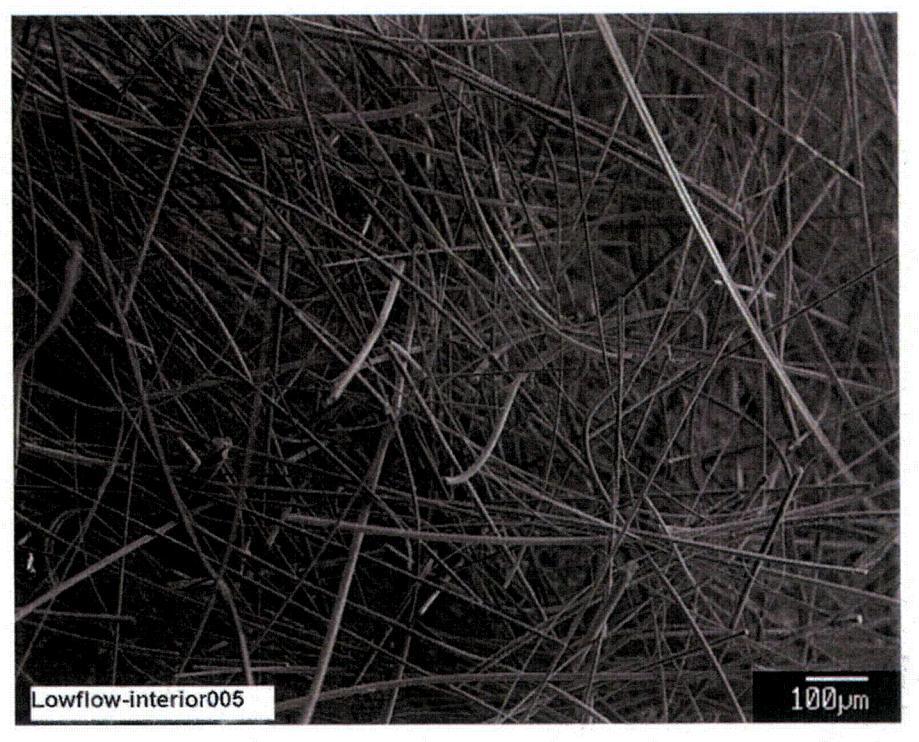
Figure D1-29. Test #2, Day-16 SEM image overview of a new sample area. (Lowflow-interior005)
