Appendix C1

SEM/EDS Data for Unused and Test #2, Day-30 Aluminum Coupons

Appendix C2

SEM/EDS Data for Unused and Test #2, Day-30 Copper Coupons

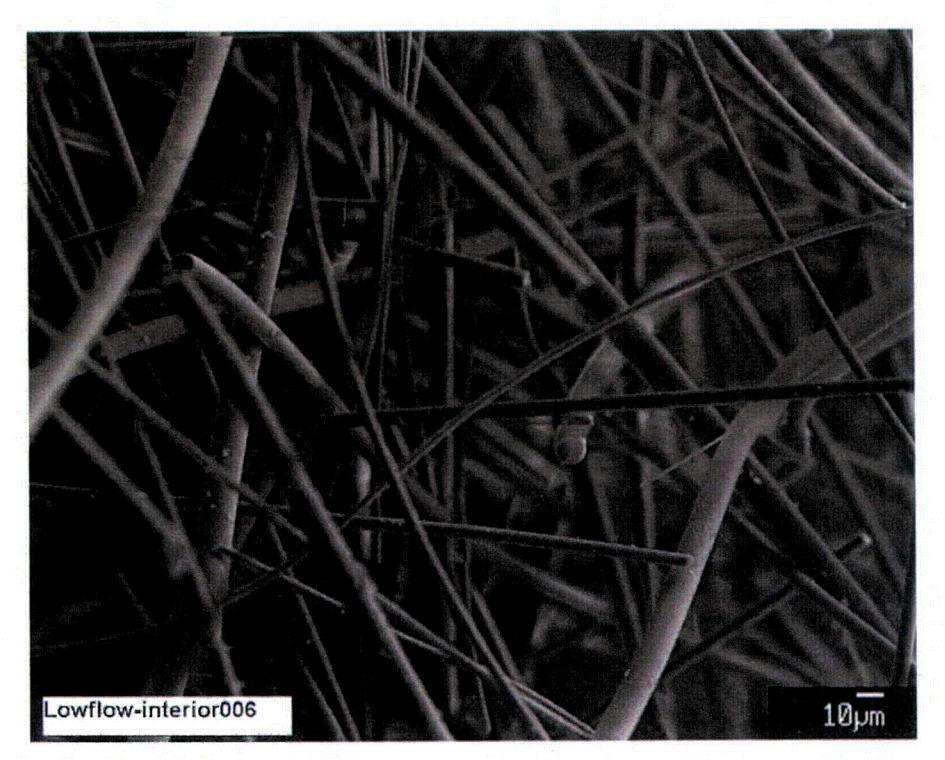
Figure D1-30. Test #2, Day-16 SEM image zooming in on Figure D1-29. (Lowflow-interior006)

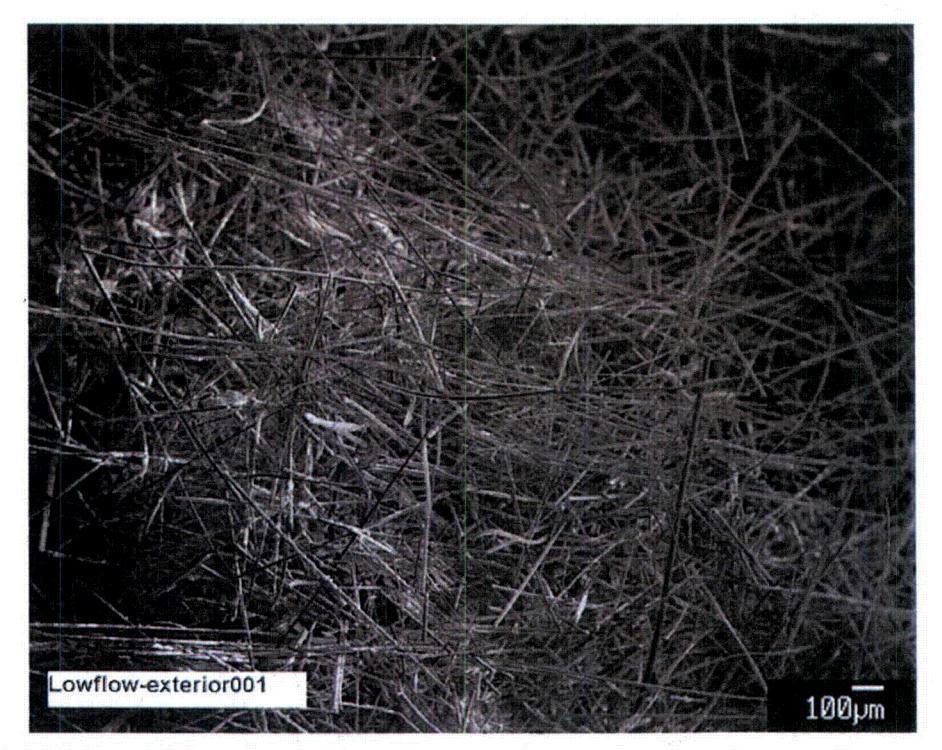
Figure D1-32. Test #2, Day-16 SEM image overview for low-flow exterior. (Lowflow-exterior001)

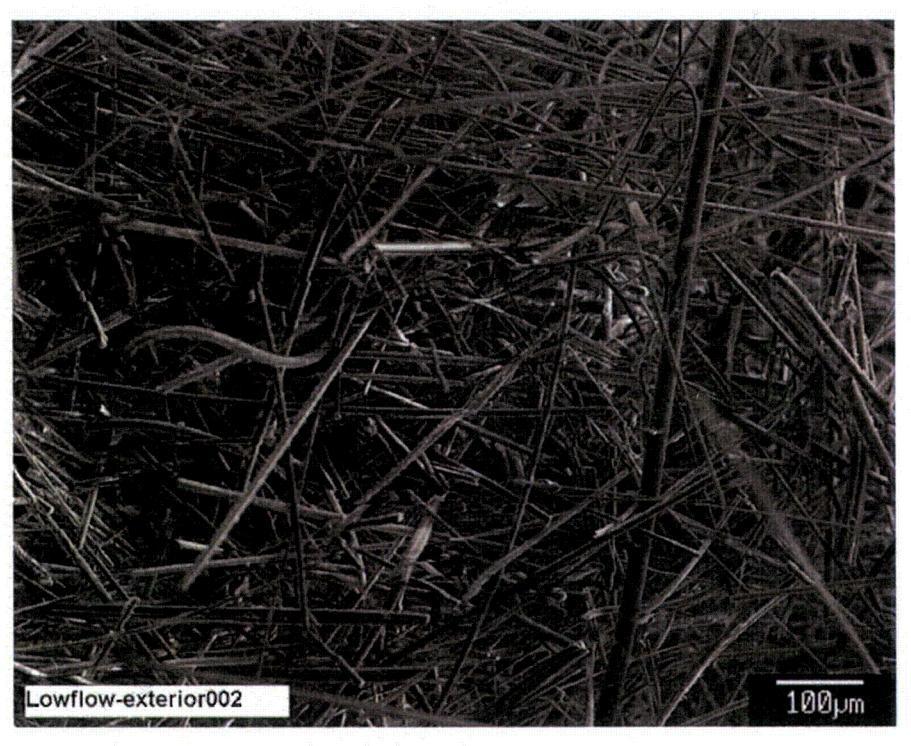
Figure D1-33. Test #2, Day-16 SEM image close-up (charging) of Figure D1-32. (Lowflow-exterior002)

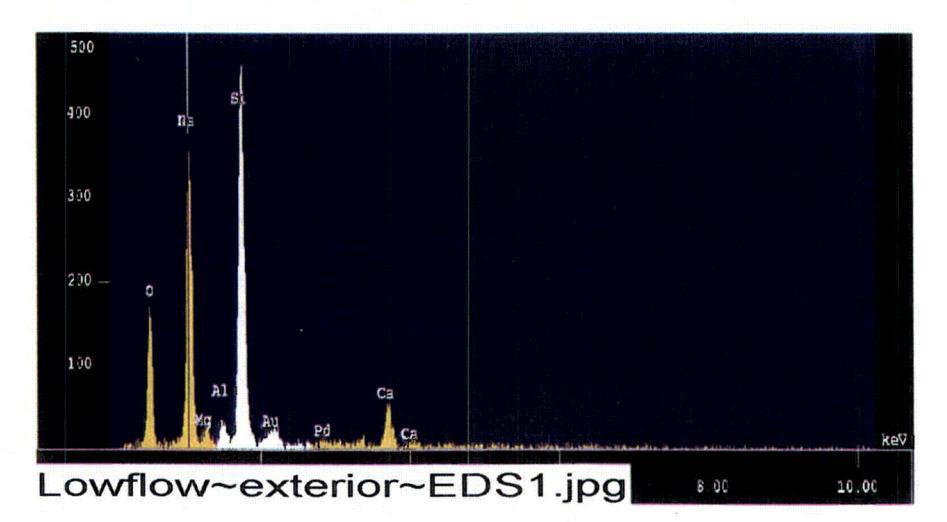
Figure D1-35. Test #2, Day-16 counting spectrum image for a particle on the fiberglass shown in Figure D1-34. (Lowflow~exterior~EDS1)

The results from the chemical composition analysis for Lowflow~exterior~EDS1 are given in Table D1-3.
