# Crystal River Unit #3 *Containment Delamination Update*

November 20<sup>th</sup> 2009

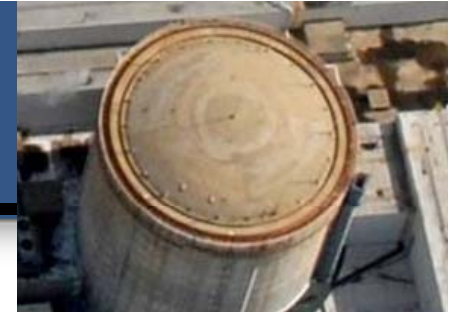
# 1976 Dome Delamination Cause<sup>(1)</sup>

- Compression - tension interaction failure occurred
- Contributing Effects
  - ◆ Radial tension due to pre-stressing
  - ◆ Thermal effects
  - ◆ Tendon alignment
  - ◆ Stress concentrations
  - ◆ Shrinkage
- Combined with biaxial compressive stresses and lower than normal<sup>(2)</sup> direct tensile strength of concrete

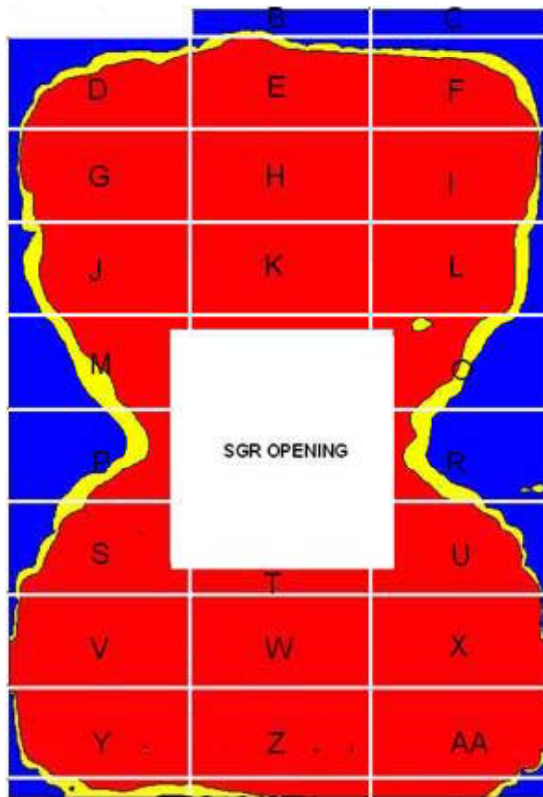
NDE Measurements  
(figure not to scale)

# Preliminary Comparison of FEA Results to Extent of Condition Measurements
