9.0 Lakeview, Oregon, Disposal Site

The Lakeview, Oregon, Uranium Mill Tailings Radiation Control Act (UMTRCA) Title I Disposal Site, inspected on July 14 and 15, 2009, was in good condition. No cause for a follow-up or contingency inspection was identified.

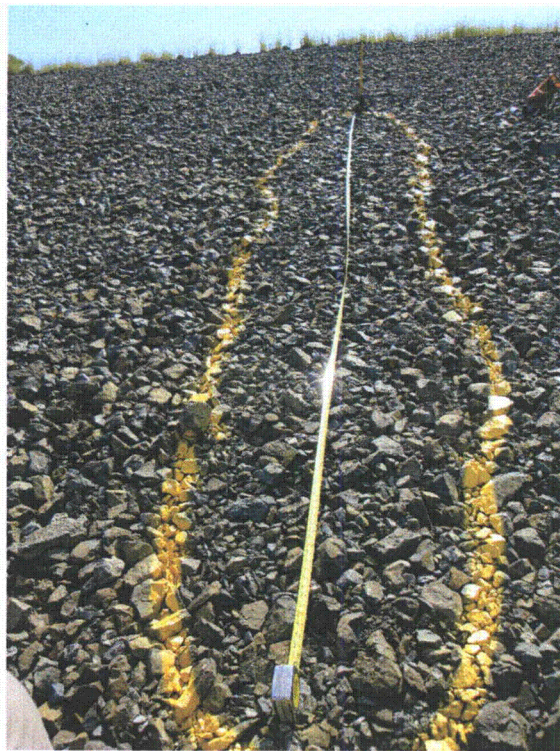
Degradation of the rock riprap observed at the site since the mid-1990s has been monitored annually as part of the inspection to determine the mean diameter (D_{50}) of the riprap on the western side slope. The D_{50} value measured during the 2009 monitoring is 2.47 inches, which falls below the original D_{50} design size range of 2.7 to 3.9 inches for the side slope riprap. The 2009 D_{50} value is 0.14 inch greater than the value of 2.33 inches measured in 2008. The U.S. Department of Energy (DOE) initiated annual rock durability monitoring during the 2009 annual inspection to quantify the various rock types and general durability classes of the west side slope rock. The results of the durability monitoring showed that most of the rocks (63.4 percent) monitored on the west side slope were classified as having a general durability class of "highly durable" or "durable." DOE is evaluating the rock types, durability, rock sizes, and D_{50} calculation methods, and is working to resolve the riprap degradation issue to ensure the long-term protection of the cell from erosion during a severe precipitation event.

LKV 7/2009. PL-5. "Streak" area with smaller-sized rocks on west side slope.

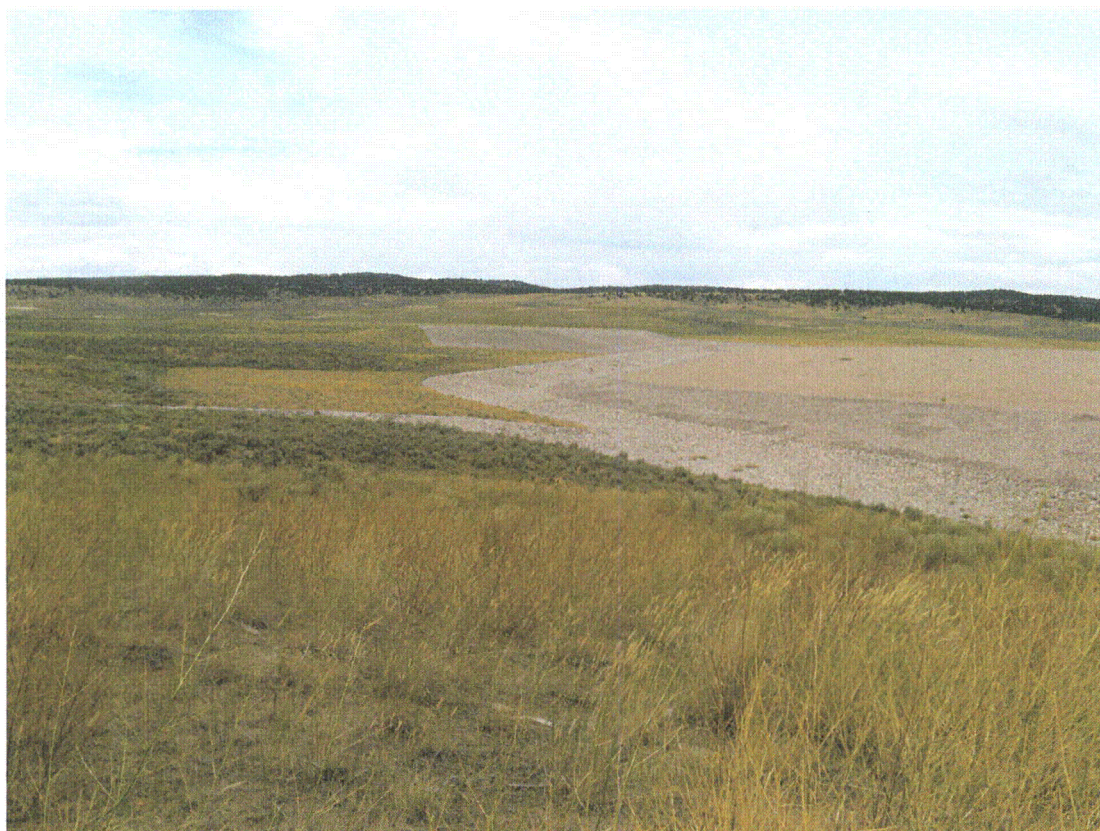
MAY 8/2009. PL-2. Western portion of the disposal cell and confluence of Diversion Channels No. 1 and 2.

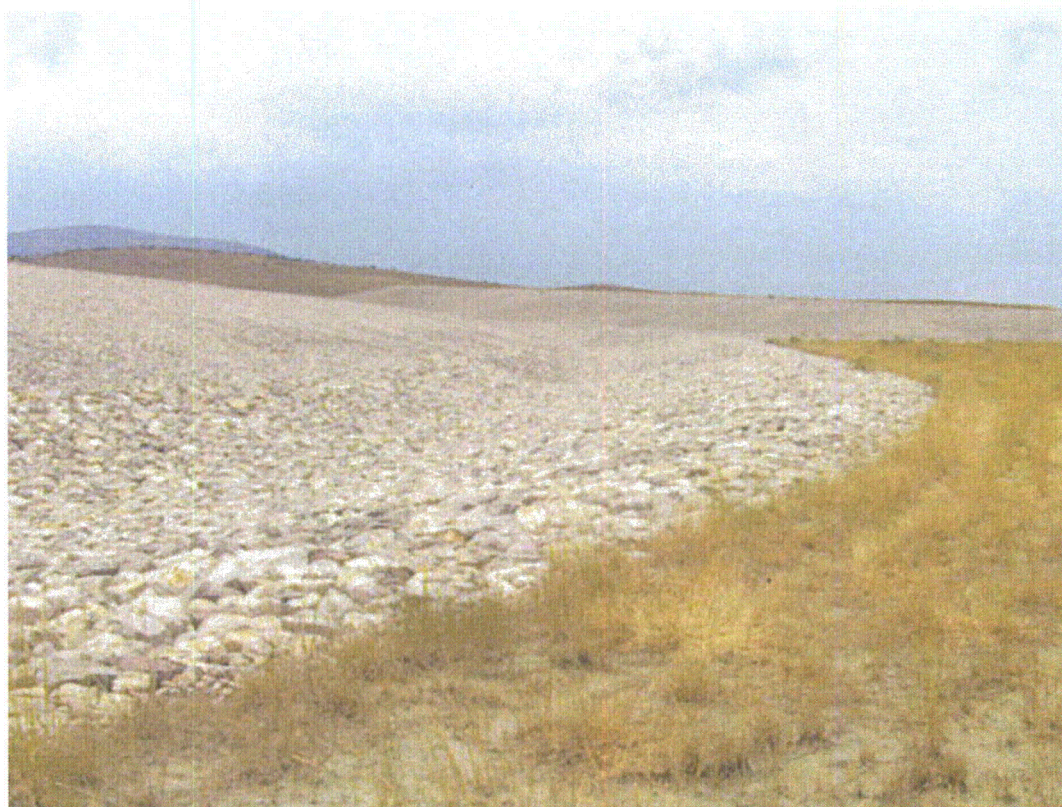
MAY 8/2009. PL-5. Diversion Channel No. 1 north of the disposal cell.

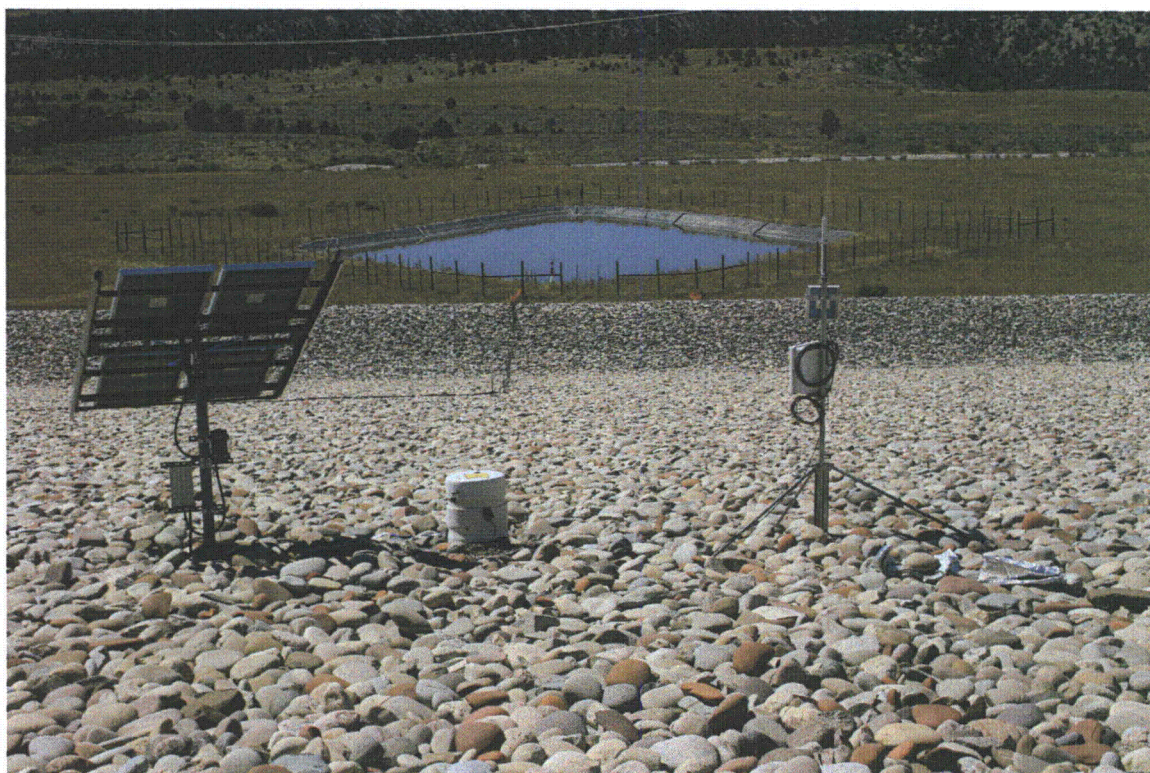
RFL 8/2009. PL-2. View of the evaporation pond and solar panel at MW-02 to the south.

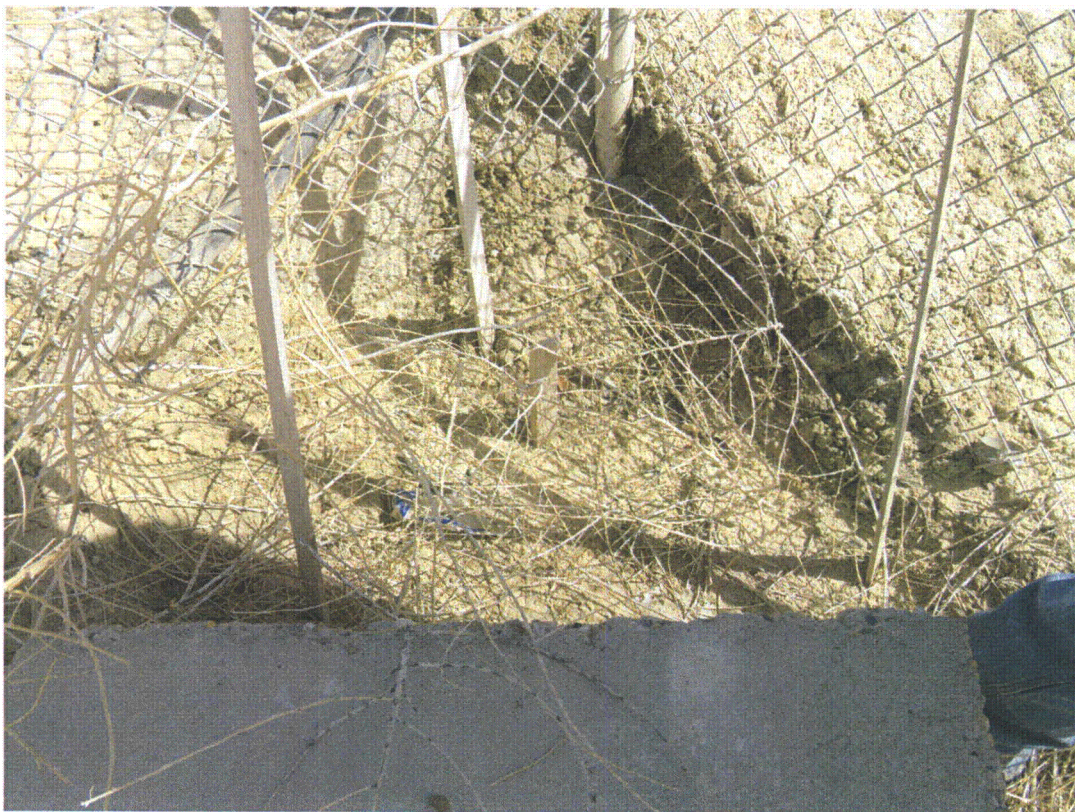
SLC 4/2009. PL-3. Covered boundary monument BM-3 in the southeast of the site.

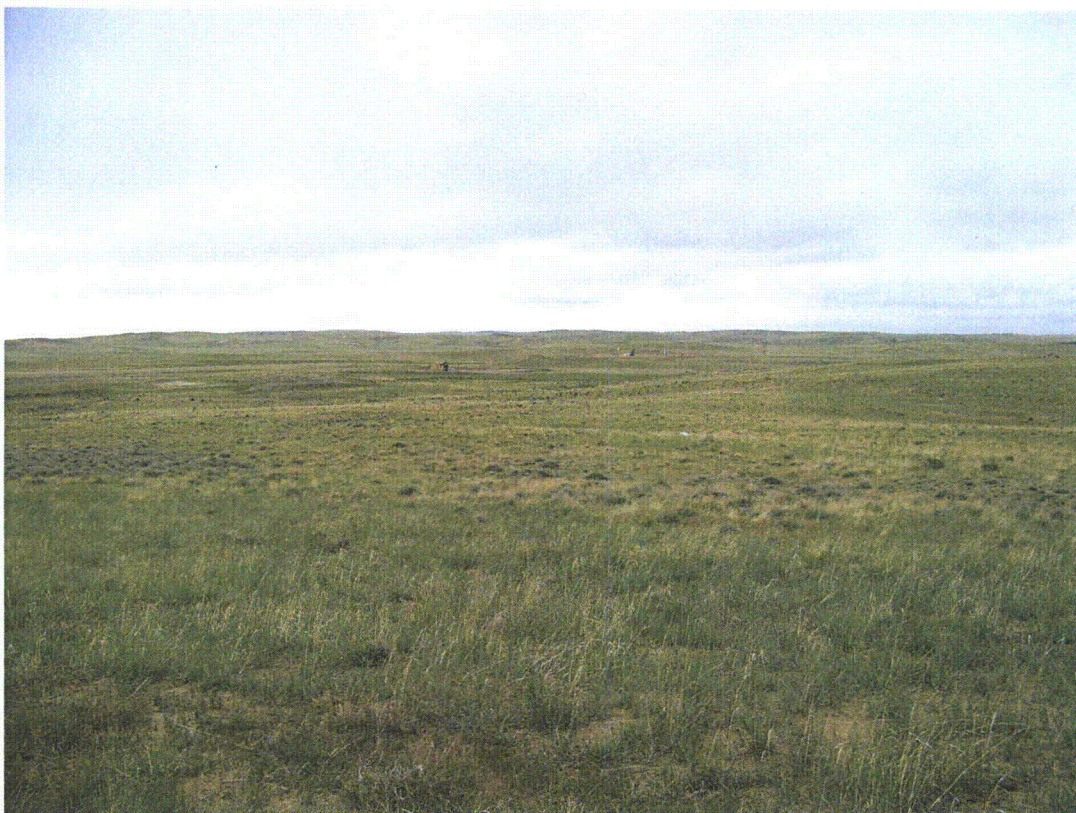
SPK 6/2009. PL-2. Northeast view across the site.

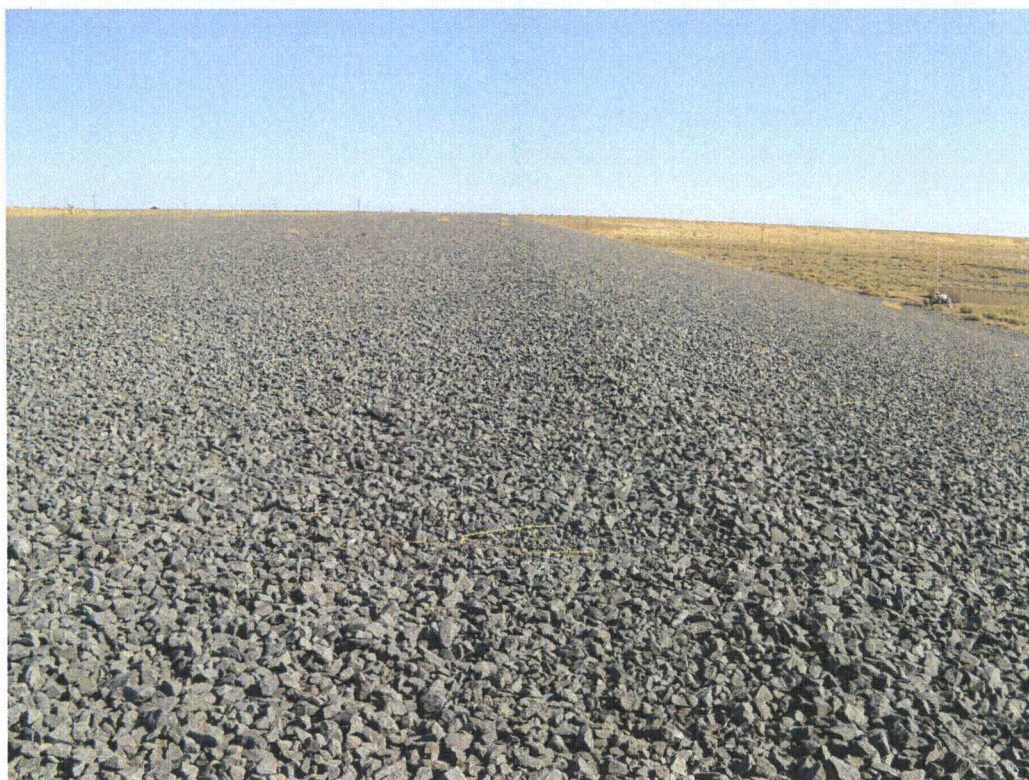
TUB 4/2009. PL-2. View to the north showing the east edge of the disposal cell cover.
