2.12 Appendices

2.12.1 Certification Tests on CTU-1

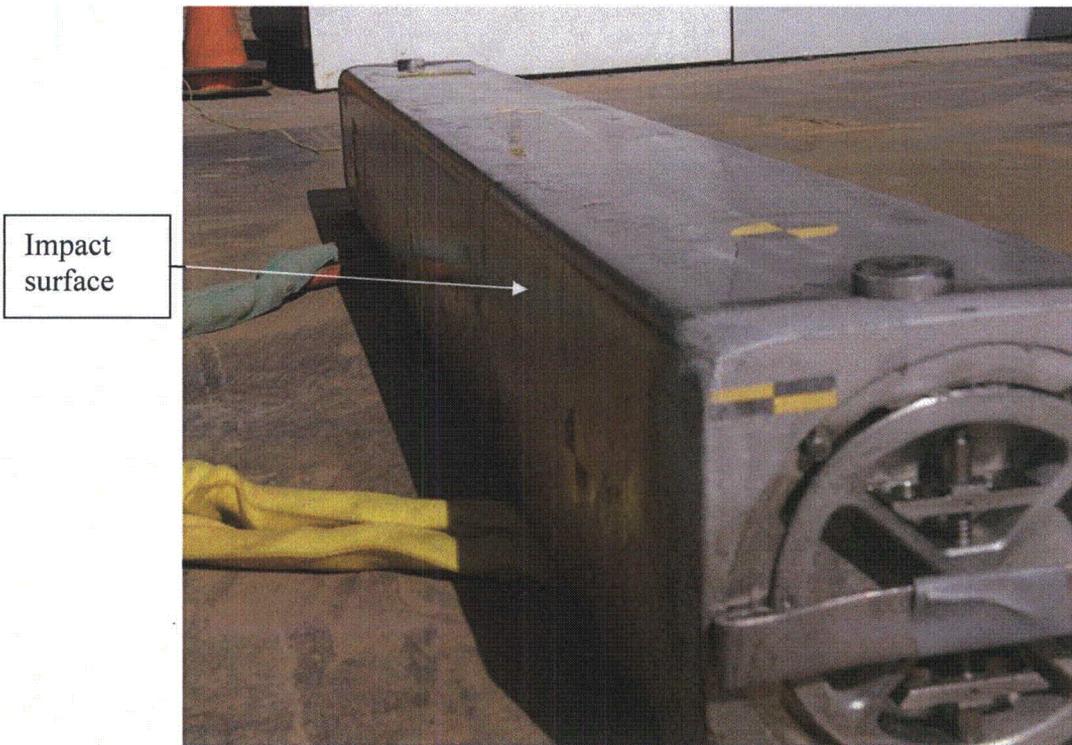
Figure 2.12.1-23 - CTU Following CD3-1 Impact

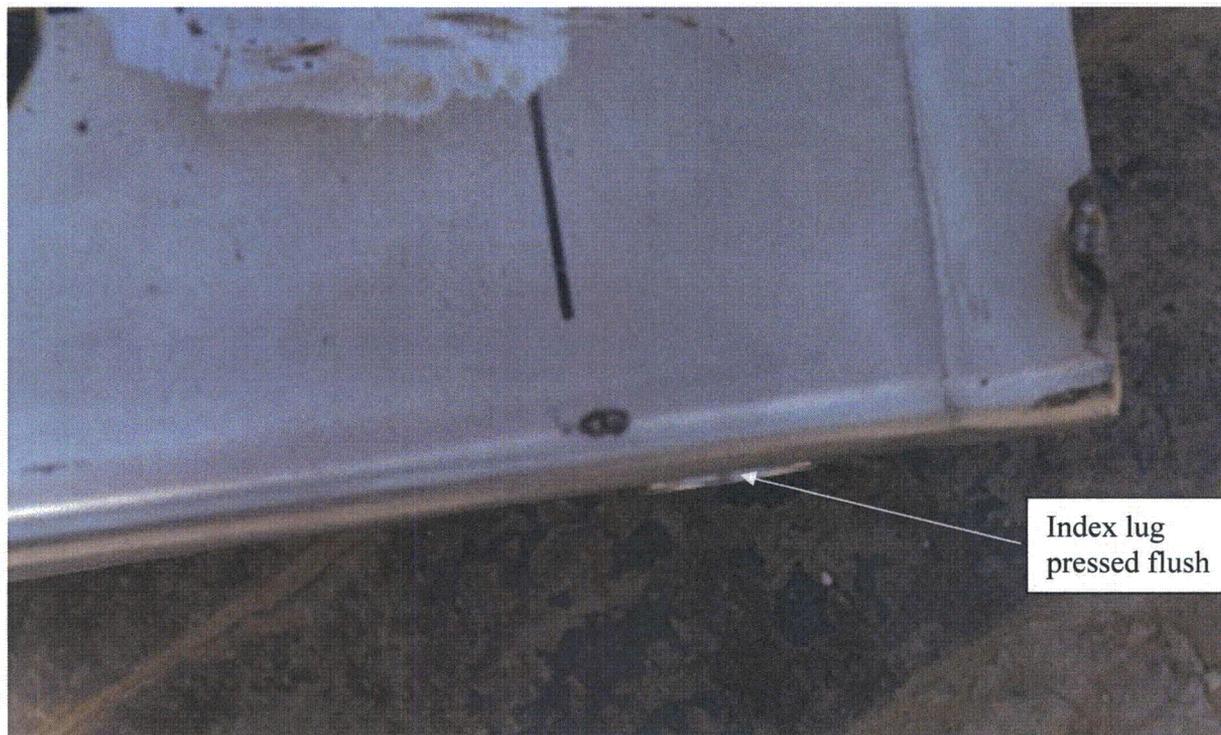
Figure 2.12.1-38 - Side View of CTU Following CD2.C-1 Drop

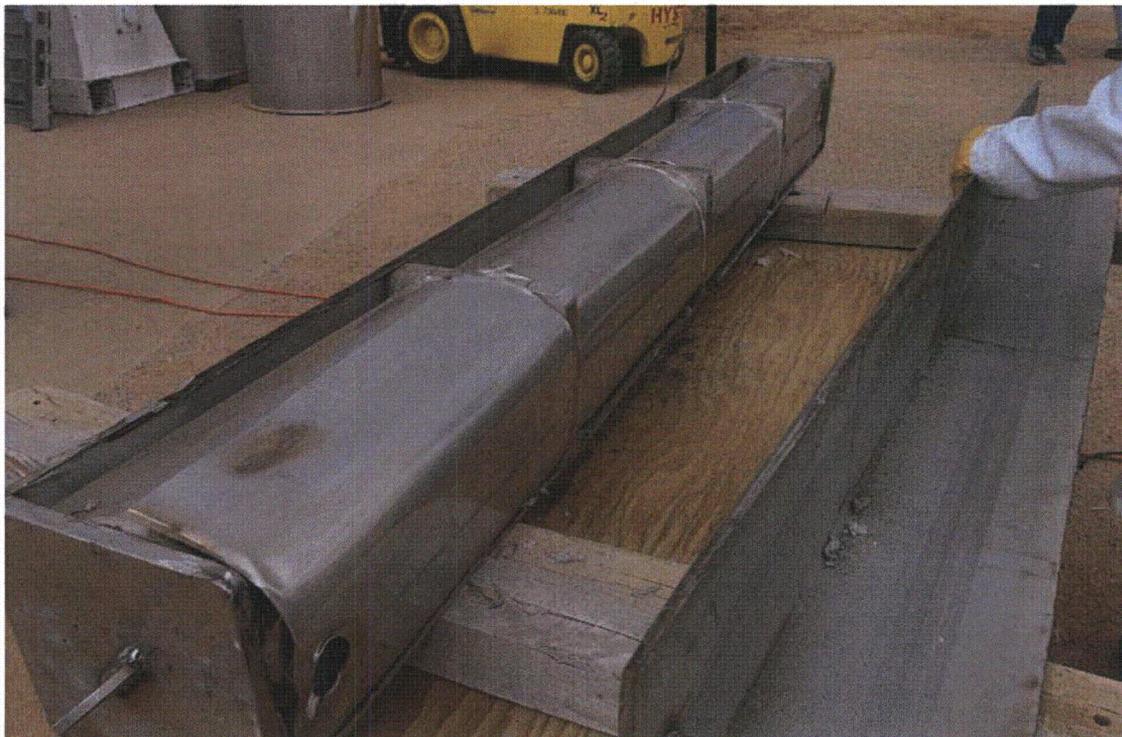
Figure 2.12.1-48 - Exposure of Thermal Shield

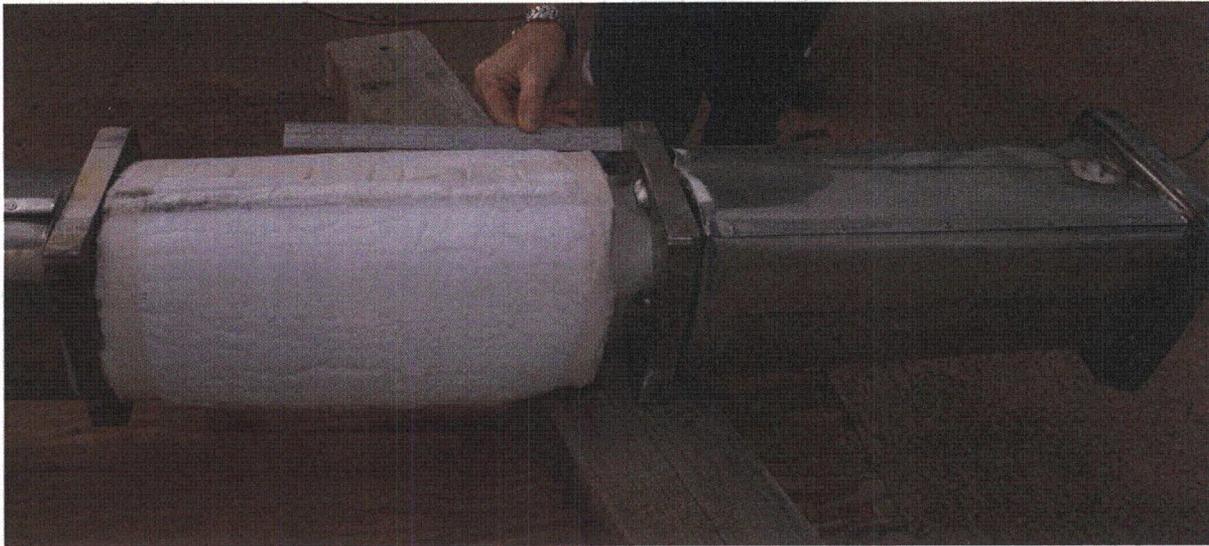
Figure 2.12.1-50 - Middle Insulation After Removal of Thermal Shield

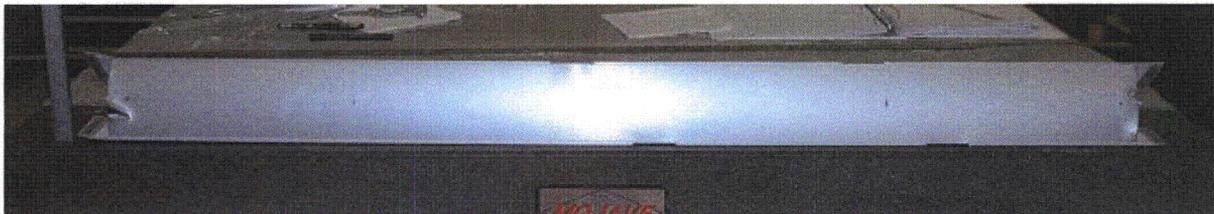
Figure 2.12.1-57 - ATR Fuel Element Inspection

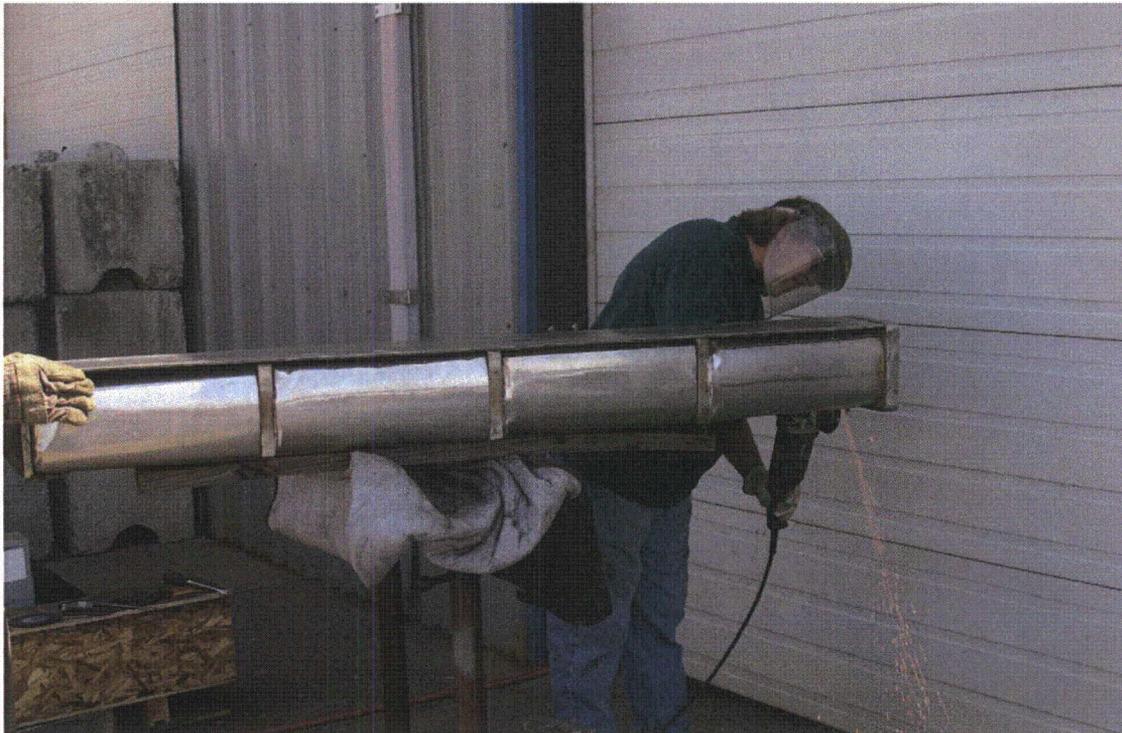
Figure 2.12.2-18 - Thermal Shield Condition, View 1

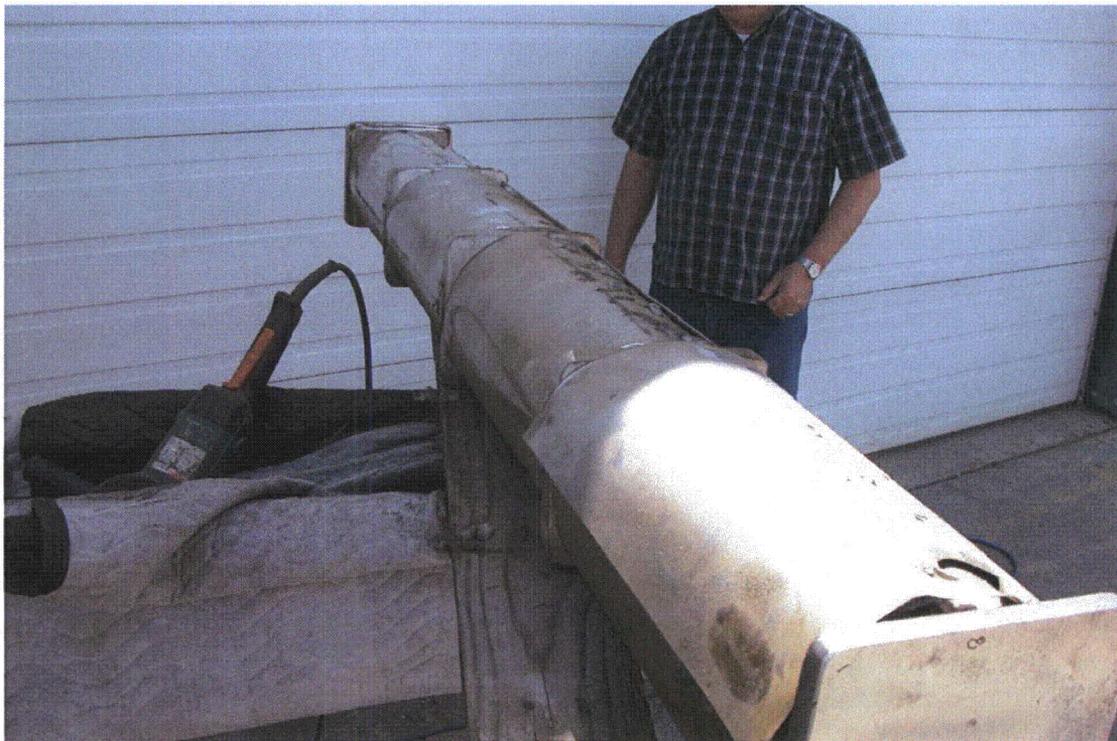
Figure 2.12.2-20 - Thermal Shield Condition, View 3

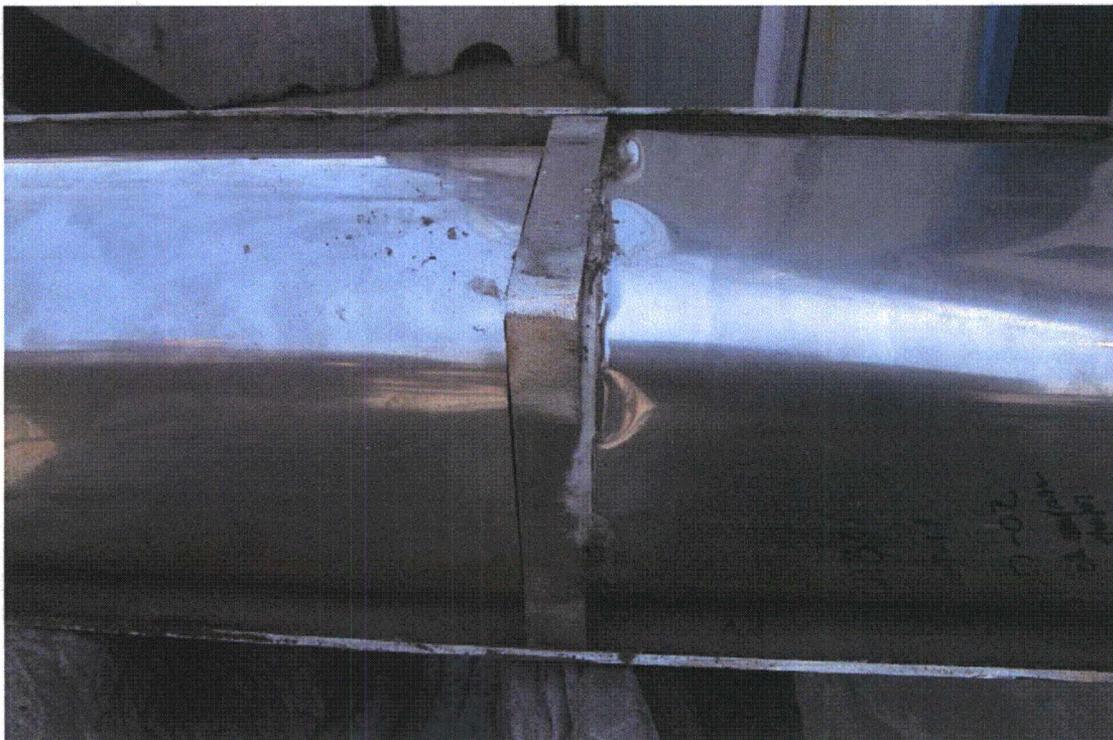
Figure 2.12.2-21 - Thermal Shields at Interface to Stiffening Rib

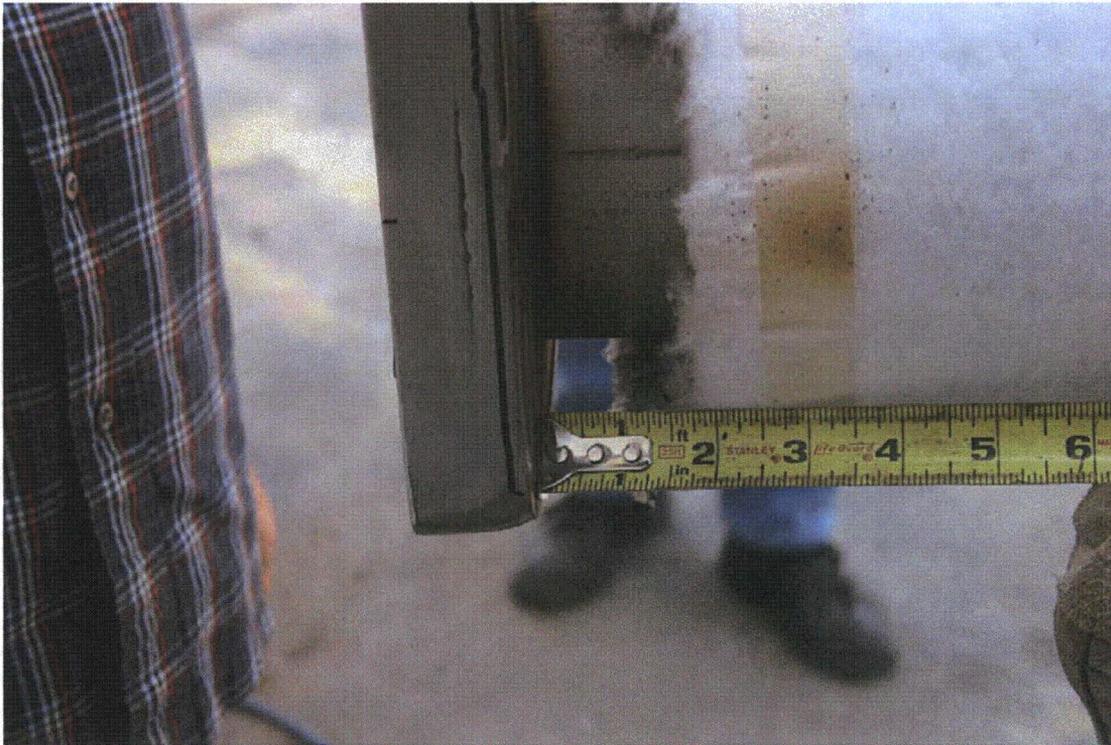
Figure 2.12.2-23 - Insulation Gap at Package Closure End

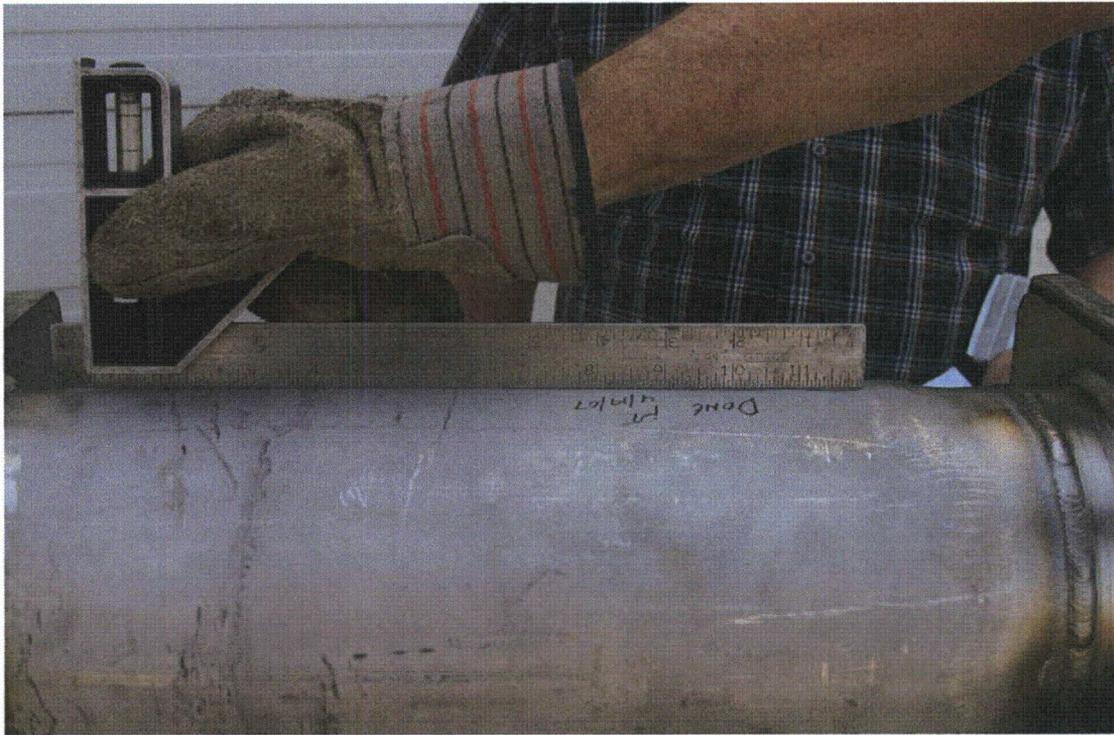
Figure 2.12.2-29 - Tube to Bottom End Plate – View 2
