2.12 Appendices

2.12.1 Certification Tests on CTU-1

This report describes the methods and results of a series of tests performed on the Advanced Test Reactor (ATR) Fresh Fuel Shipping Container (FFSC) transportation package shown in Figure 2.12.1-1. The objective of testing was to conduct drop tests in accordance with the requirements of 10 CFR 71, §71.71 Normal Conditions of Transport (NCT), and §71.73 Hypothetical Accident Conditions (HAC). The verification of the loose fuel plate basket structural integrity and the performance of the package insulation are supported by the tests described in Section 2.12.1, *Certification Tests on CTU-2*.

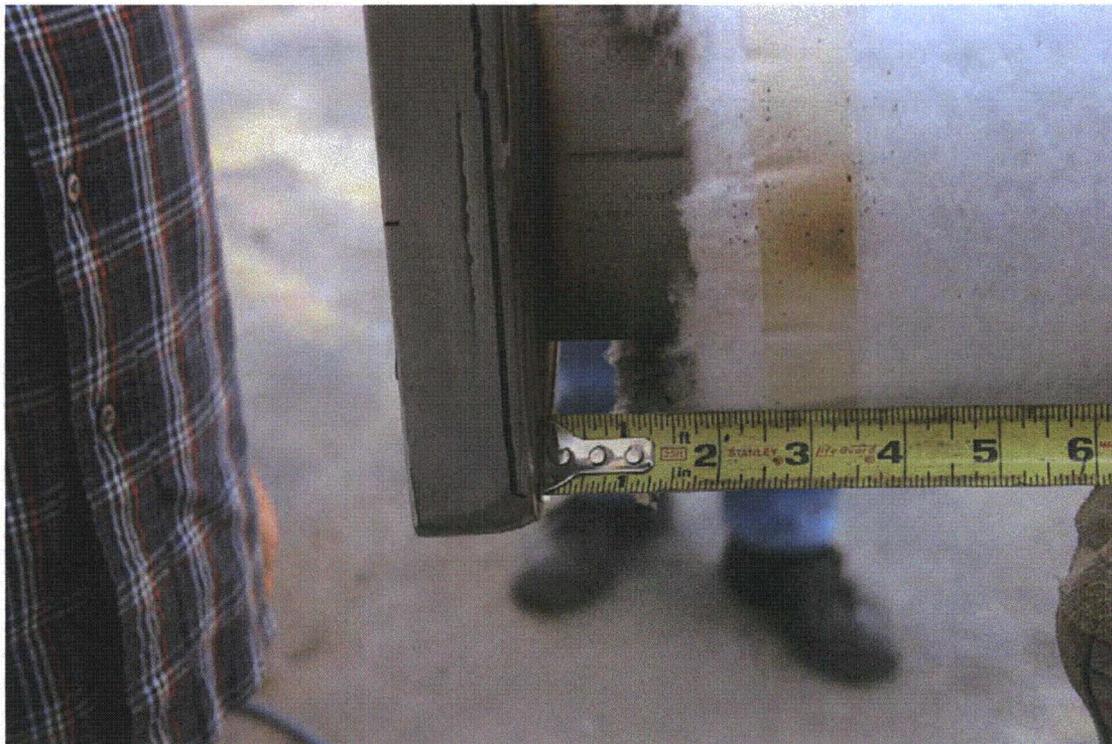
Figure 2.12.2-22 - Exposed Insulation - Overview
