TEST REPORT

REPORT NO. 45918-01
OUR JOB NO. 45918
YOUR P. O. NO. 84YLFP22
CONTRACT N/A
PAGE 1 of 52 PAGE REPORT
DATE February 21, 1997

VIBRATION TESTING OF AN ES-2 SHIPPING CONTAINER

Lockheed Martin Energy Systems, Inc.
Oak Ridge, TN

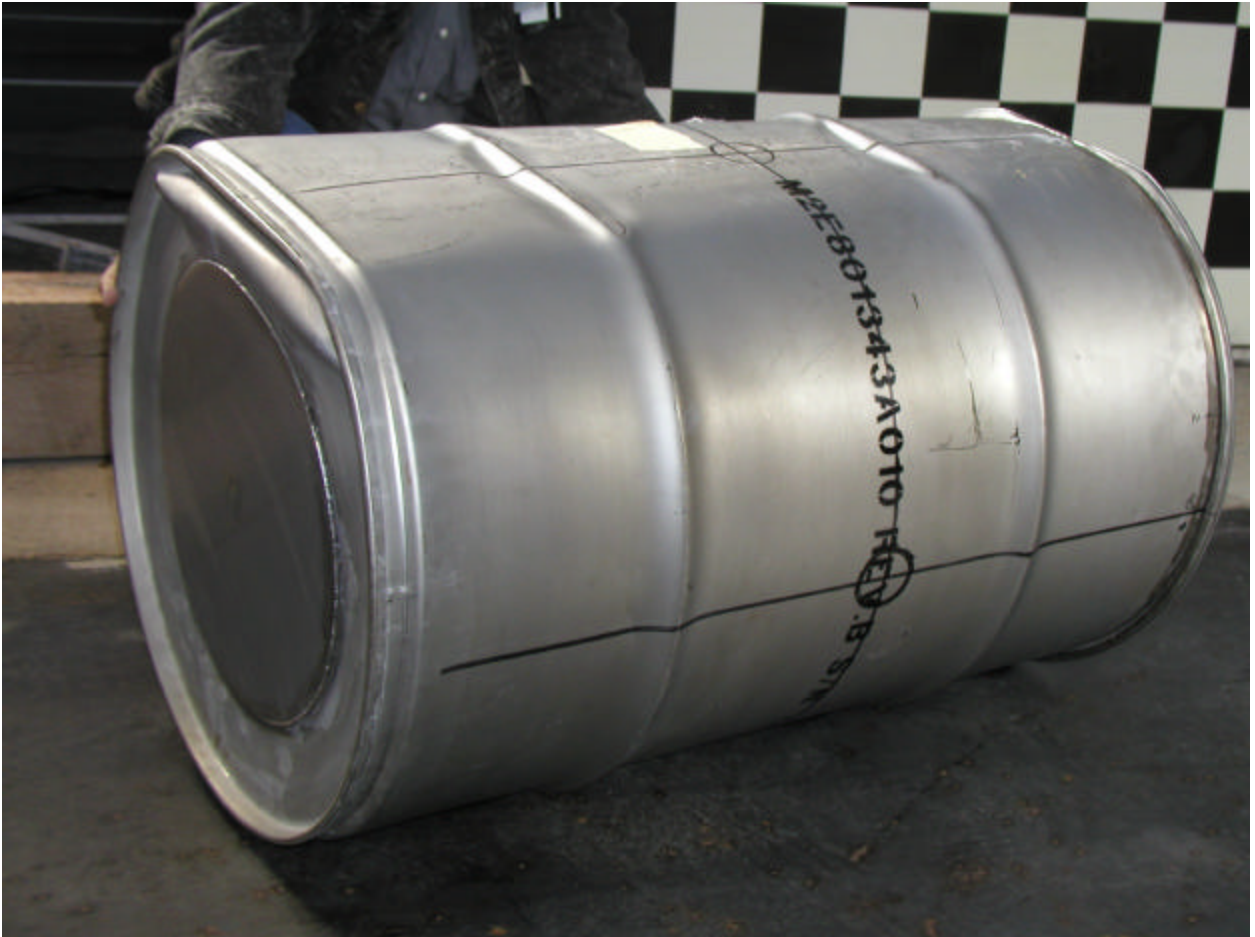
Figure 3-5 Results of dropping the TU-1 package from 9 -m onto the solid unyielding surface.

Figure 3-5 shows the package, which was rolled over following the impact, to expose the damage that was caused by the drop test. The view shows the bottom edge, which wrinkled significantly, and the flattening of the impacted side. Table 3-2 indicates the widths of the resultant flat that were measured at four different locations along the height of the package.

Note the flat produced at the bottom end of the package is over 35% greater than the similar measurement at the top ring. This difference is primarily due to the fact that the top closure is structurally more rigid than is the bottom and therefore would not be

expected to deform as much as the bottom in a horizontal impact. The diameter of the drum as measured at the top ring from the 0° line to the opposite 180° line was measured to be 22-3/4 inches as compared to the undamaged drum diameter of 23-9/16 inches.

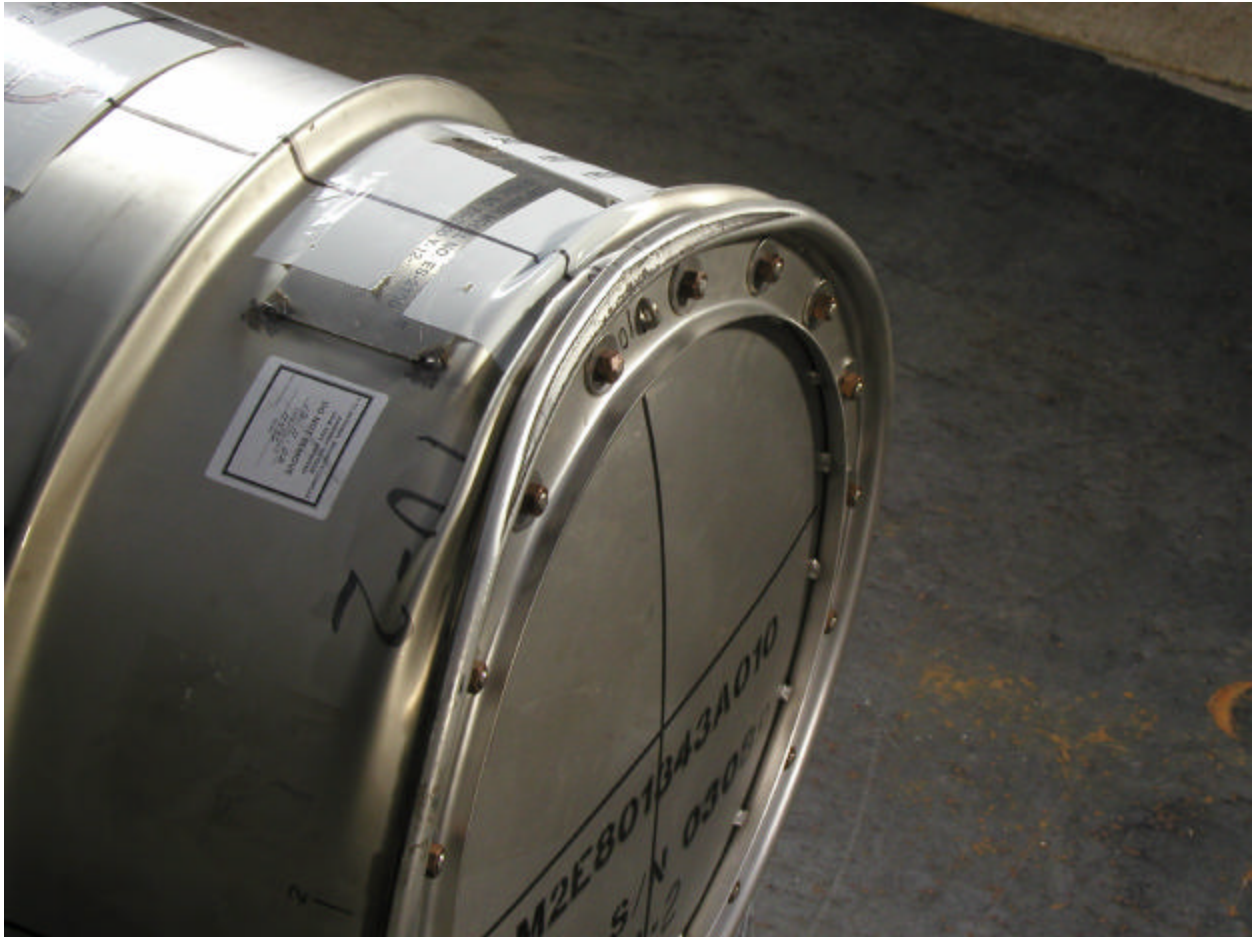
Figure 3-7 Results of dropping TU-2 in a CG-over-corner drop from 9 m.

The results of the impact when TU-2 was dropped onto the unyielding target are shown in Figure 3-7. Note that the top edge crushed down toward the bottom of the drum producing several wrinkles in the steel outer shell above the name plate that had been welded onto the package and which helped stiffen the outer shell at that point. However, the bolt ring helped stiffen the lid and the height of the drum at the 0° line was measured to be 32-7/16 inches as compared to an undamaged height of 35-1/16 inches. The imprint

of the impacting surface is clearly seen in the photo on the edge of the ring and the width of the imprint was measured to be 12-13/16 inches from end to end. In addition, all lid bolts remained in place.

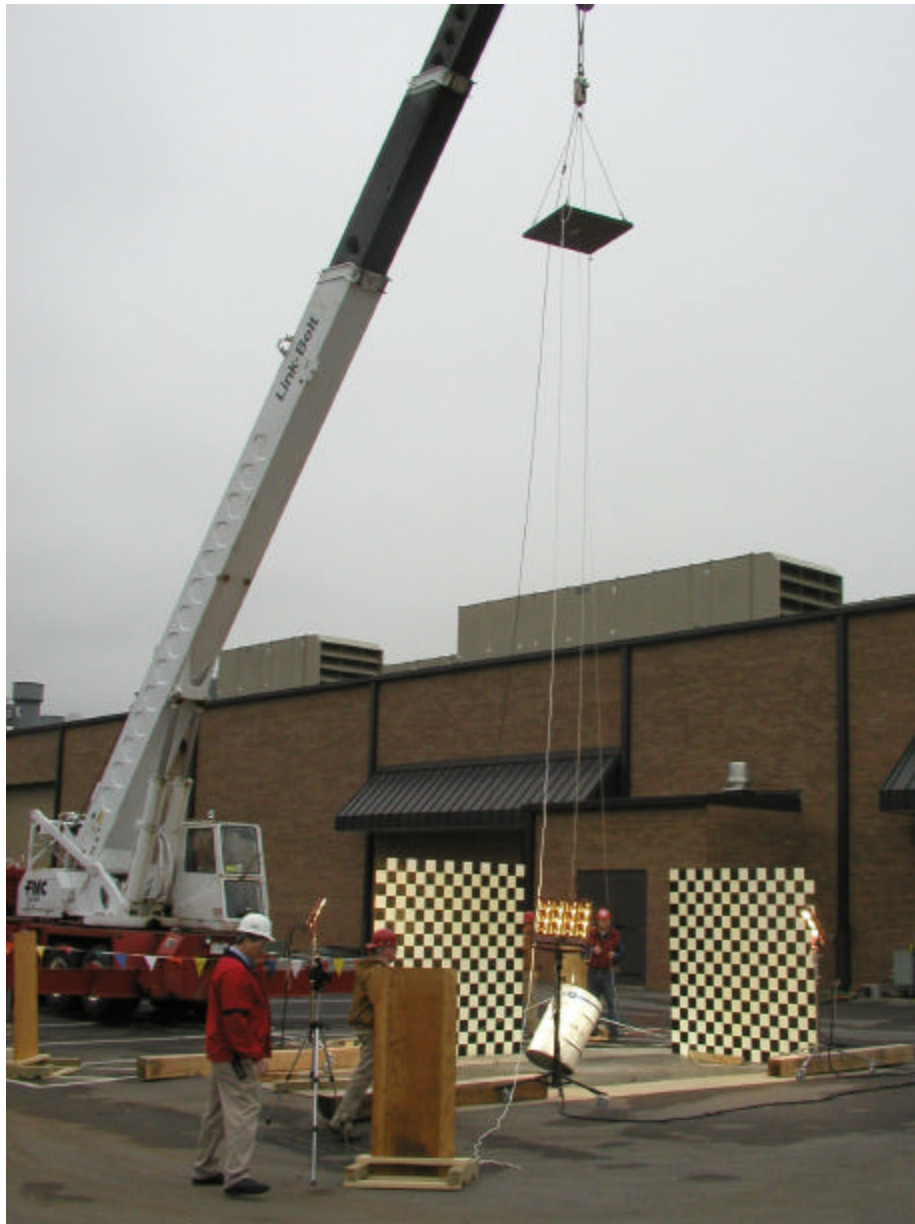
Figure 3-9 Test setup for the dynamic crush test of TU-2.

A plumb bob attached to the end of a 9-m steel wire and taped to the middle of the underside of the steel plate can be seen suspended right above the desired point of impact on the corner of the package. The plumb bob is also used to obtain the correct drop height for all 9-m drop tests.

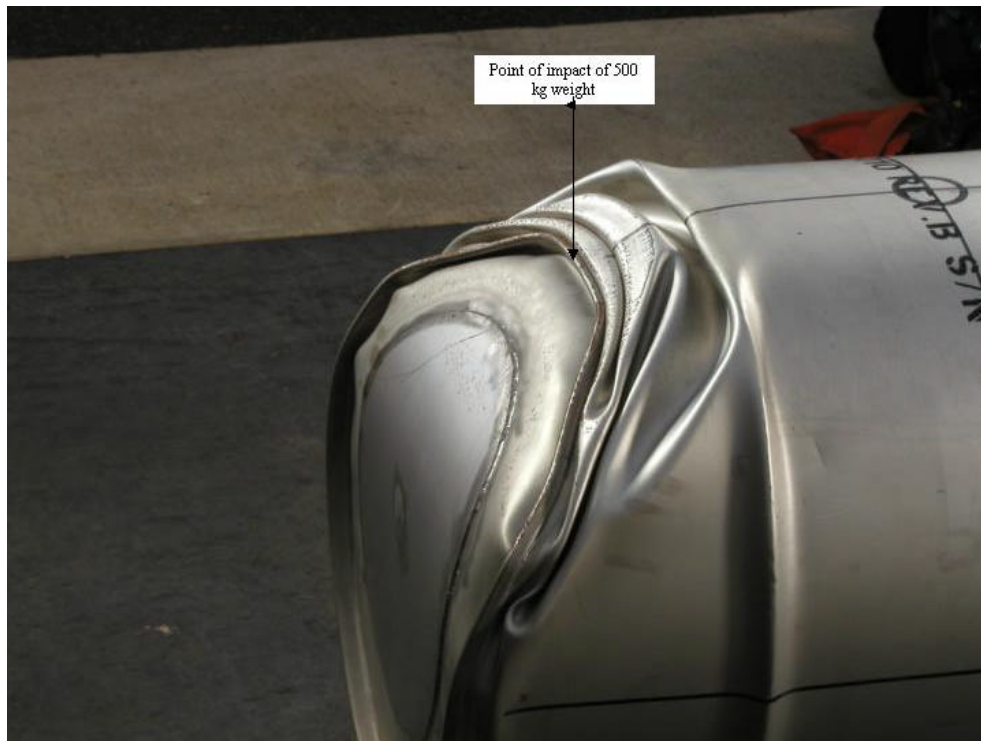
Figure 3-10 Damaged bottom of TU-2 resulting from the dynamic crush test.

The impact of the steel plate produced a flattened surface on the edge of the bottom of the package and increased the flattened area on the top of the package that was sitting on the impact pad.

The damaged area of the bottom of the package is shown in Figure 3-10. The damage extends from the bottom rolling hoop to almost the middle of the bottom of the package. That flattened dimension is approximately 14 inches.

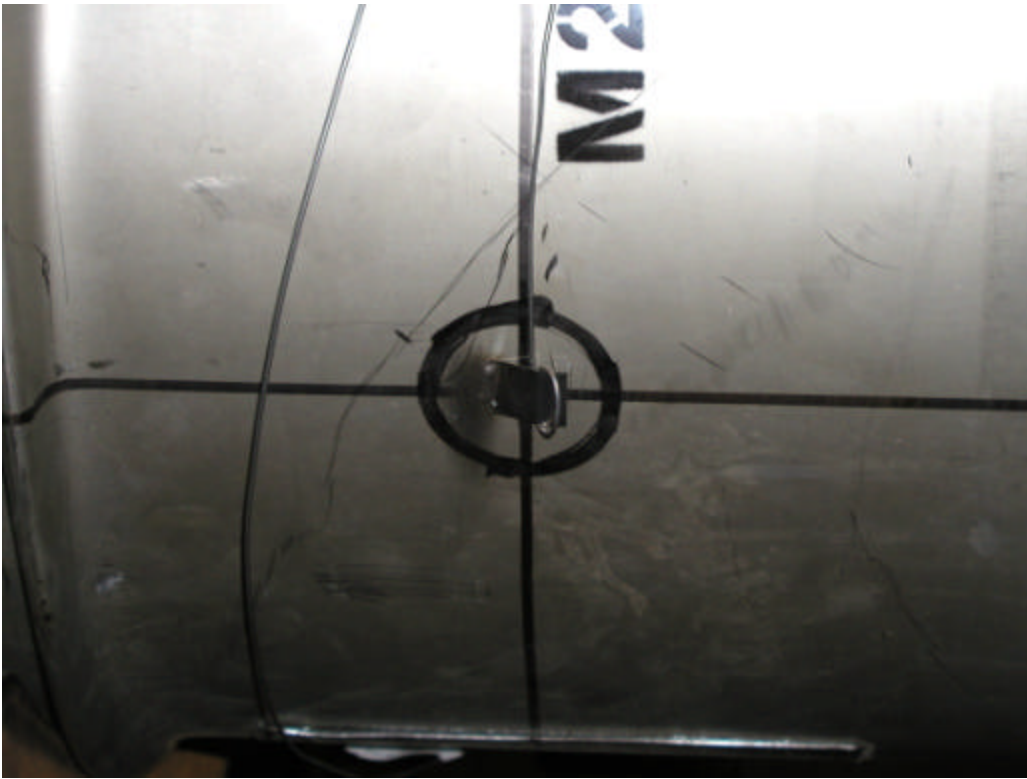
Figure 4-1 Installation of thermocouple under retainer clip.

Six thermocouples were attached to the exterior surface of each package after preheating. Metal retainer clips were welded to the drums as shown in Figure 4-1 to hold the thermocouples in place. The thermocouple tips were inserted underneath the metal clips, and the wrapped around the metal clips. In order to eliminate any radiant viewing factor between the thermocouples and the furnace walls, the tips and metal clips were covered with a ceramic coating.

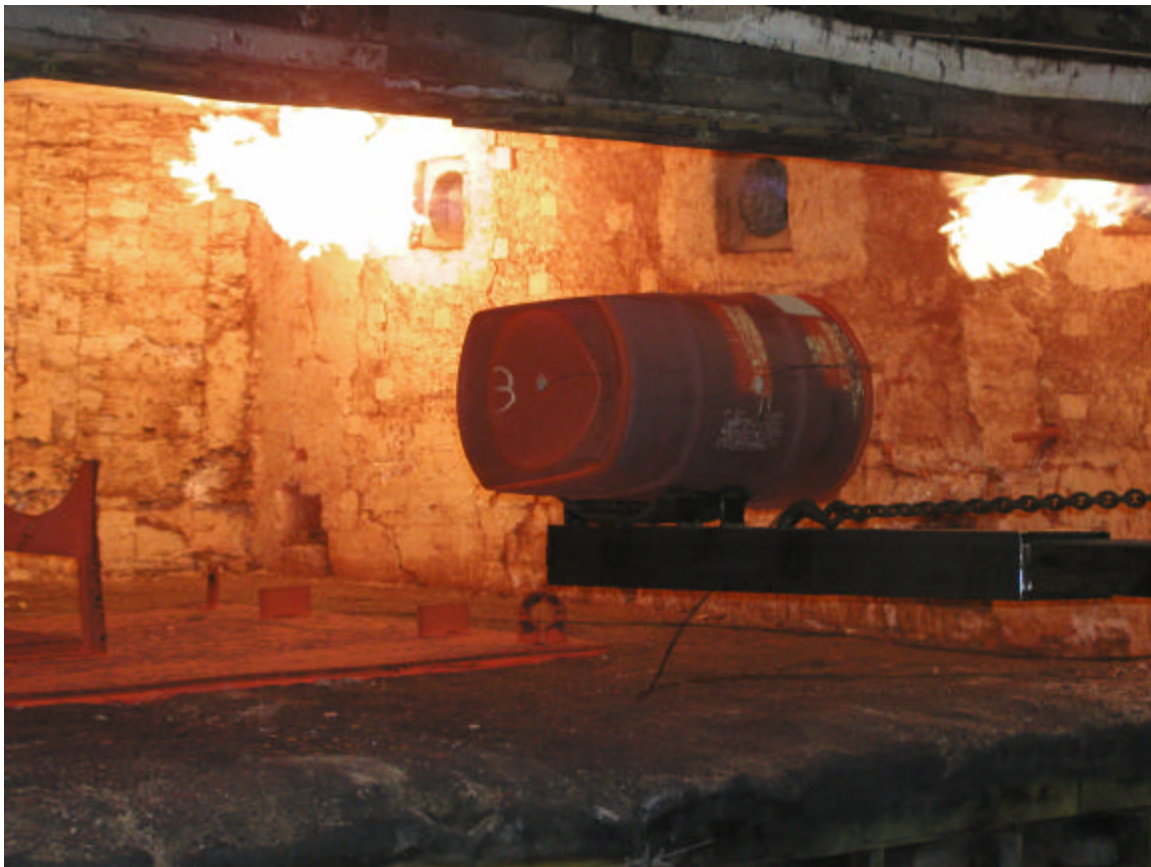
Figure 4-4 Removing TU-3 from Furnace.

Thermal testing required that the package be exposed to an 800°C (1475°F) thermal source or greater for a minimum of 30 minutes. No test unit was loaded into the furnace until 13 of the 15 thermocouples on the furnace walls and the two attached to the support stand reached a reading of 800°C (1475°F). All packages were placed in the preheated furnace on the support stand positioned with the long axis horizontal, the package lids facing the right wall of the furnace (when facing the furnace door), and the drum side-seam (0° on the package) facing down. The thermal test for each test unit did not begin until the furnace thermocouples recovered to a temperature above 800°C (1475°F) and five of the six thermocouples on the package had attained a temperature of at least 800°C (1475°F). The packages were exposed to the radiation environment for a minimum of 30 minutes and the temperature recording was set to record data every 30 seconds. Figure 4-4 shows TU-3 as it is about to be unloaded from the furnace.

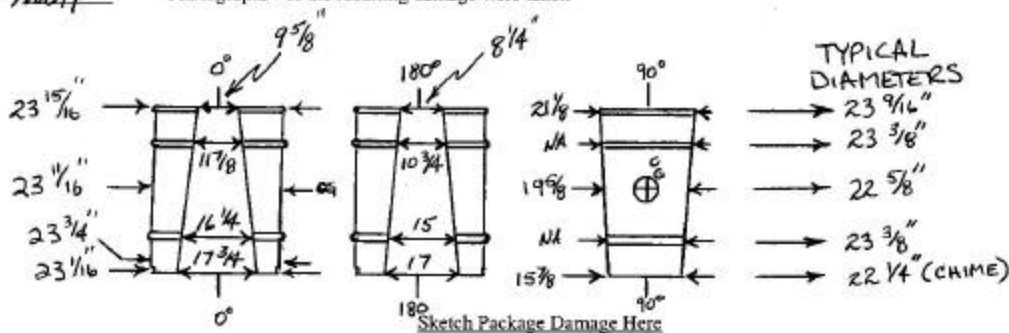
DIMENSIONS INDICATED ON 0° & 180° PROFILE VIEWS WERE TAKEN ACROSS THE DAMAGED FLAT SURFACES.

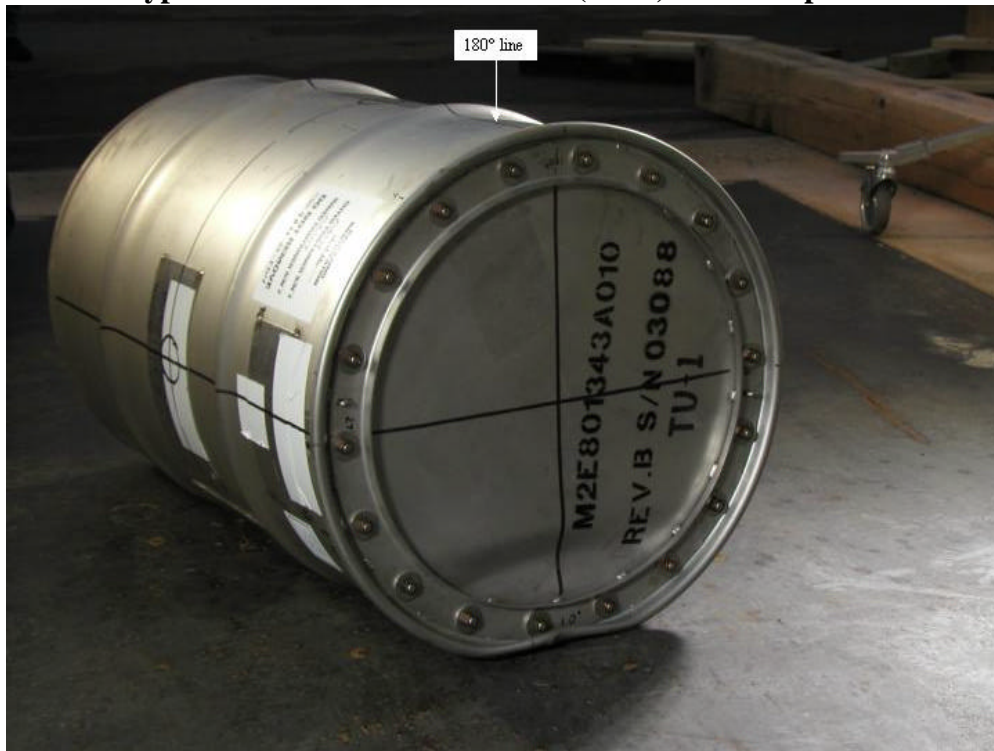
Figure E 13. End view of TU-1 lid after the HAC 30-ft drop on the 0° line.

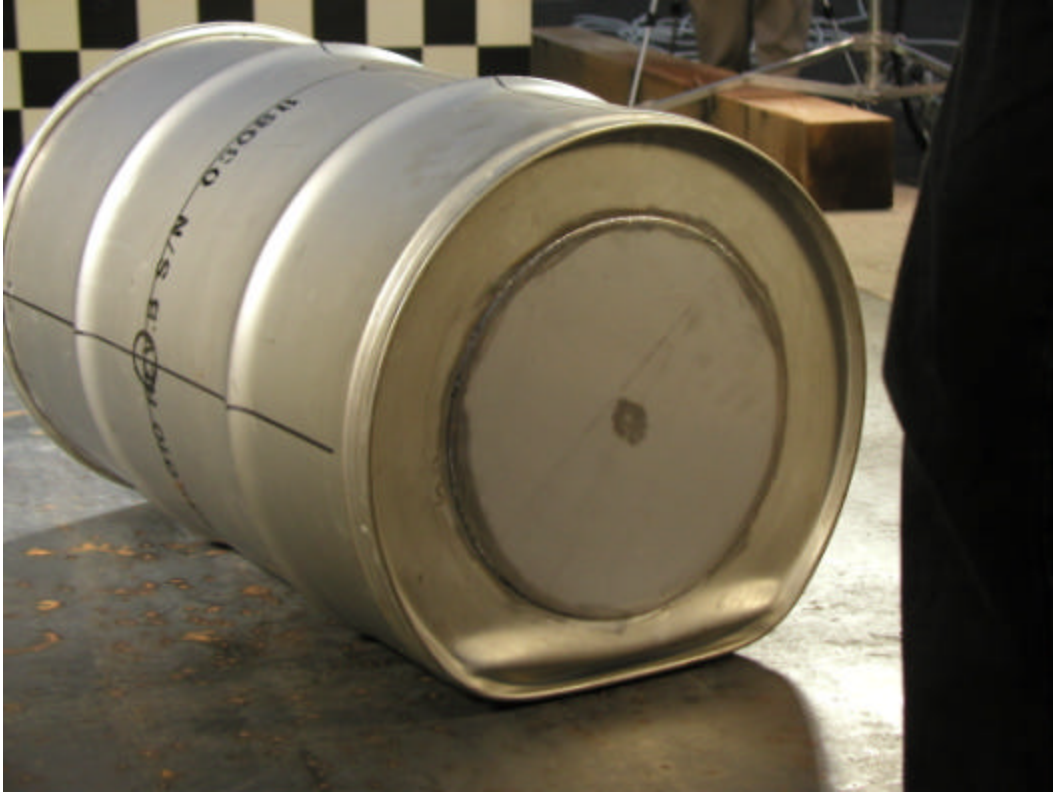
Figure E 15. End view of TU-1 bottom after the HAC 30-ft drop on the 0° line.

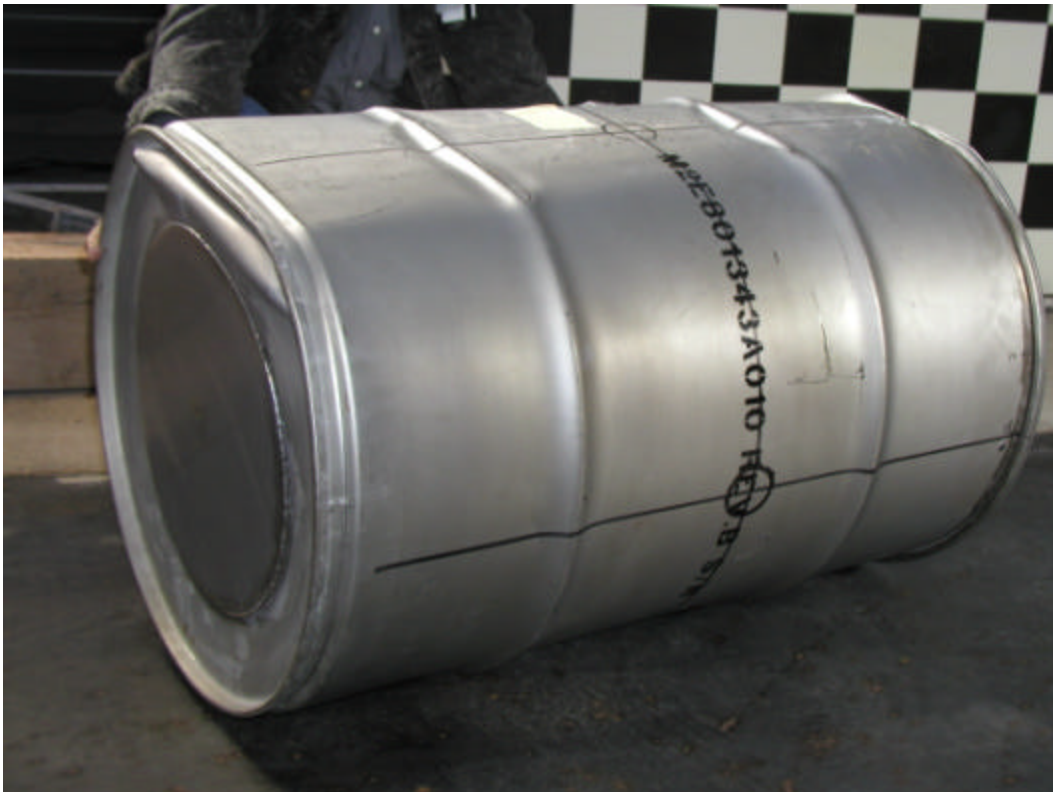
Figure E 18. View of damage on 0° line from bottom end.

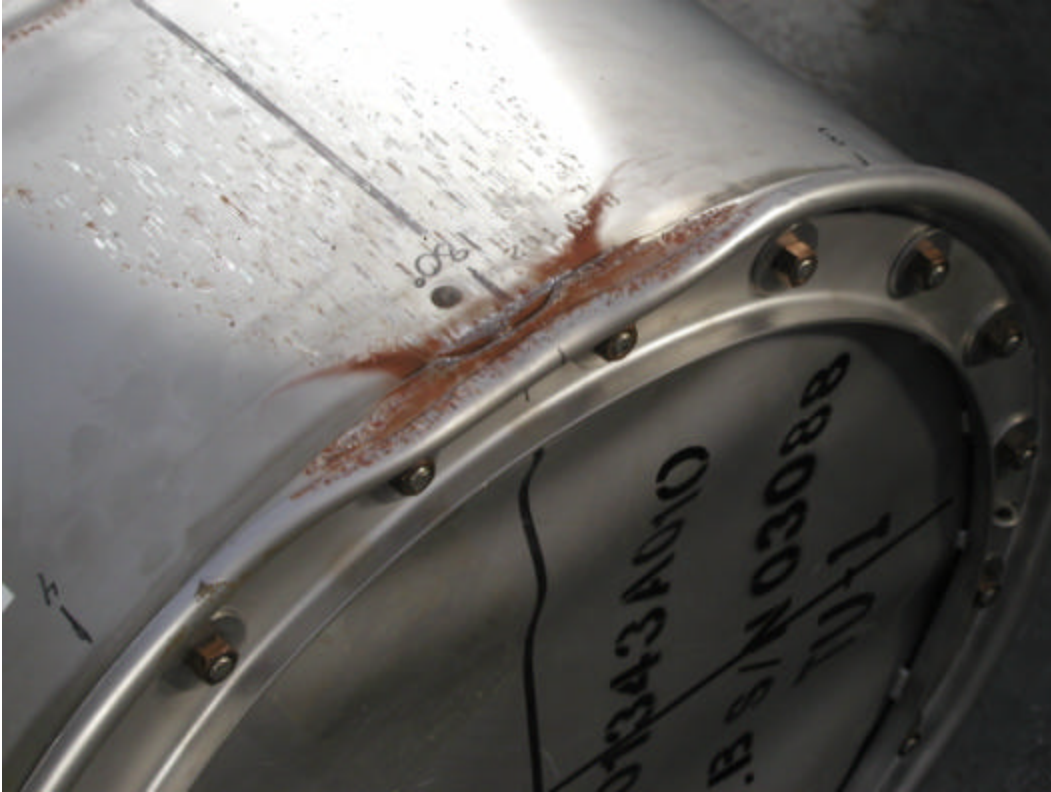
Figure E 21. Close up of damage to the lid end on the 180° line from the crush test.

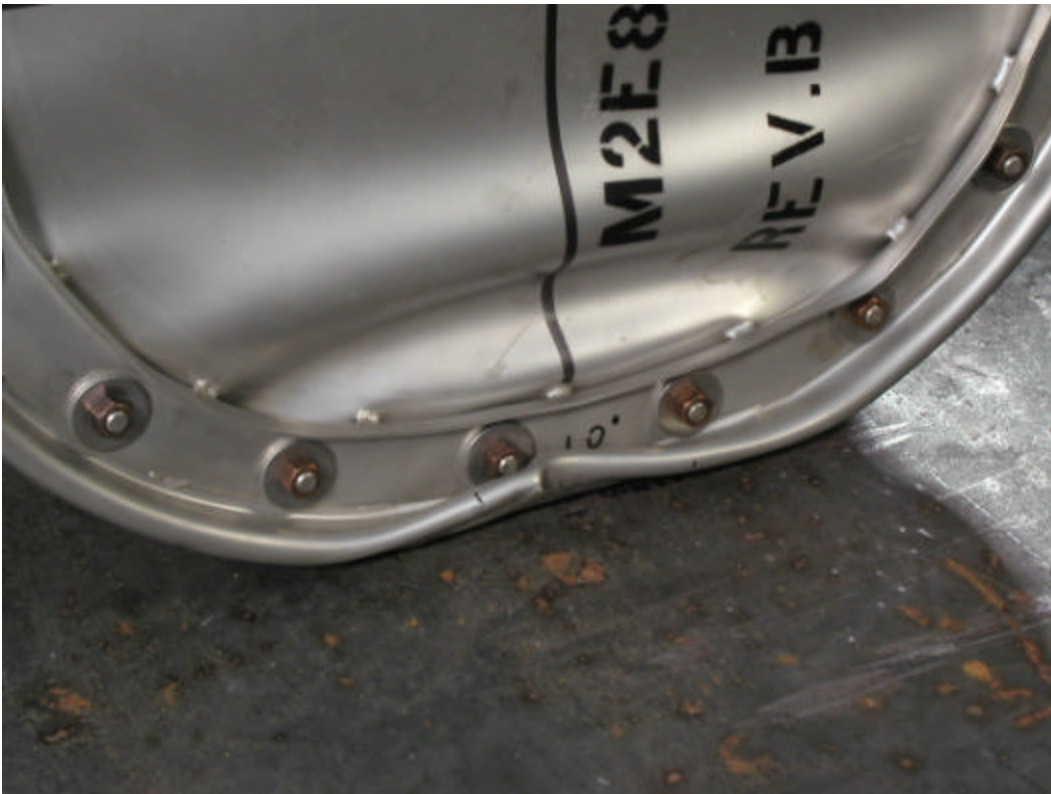
Figure E 22. Close up of damage to the lid end on the 0° line from the crush test.

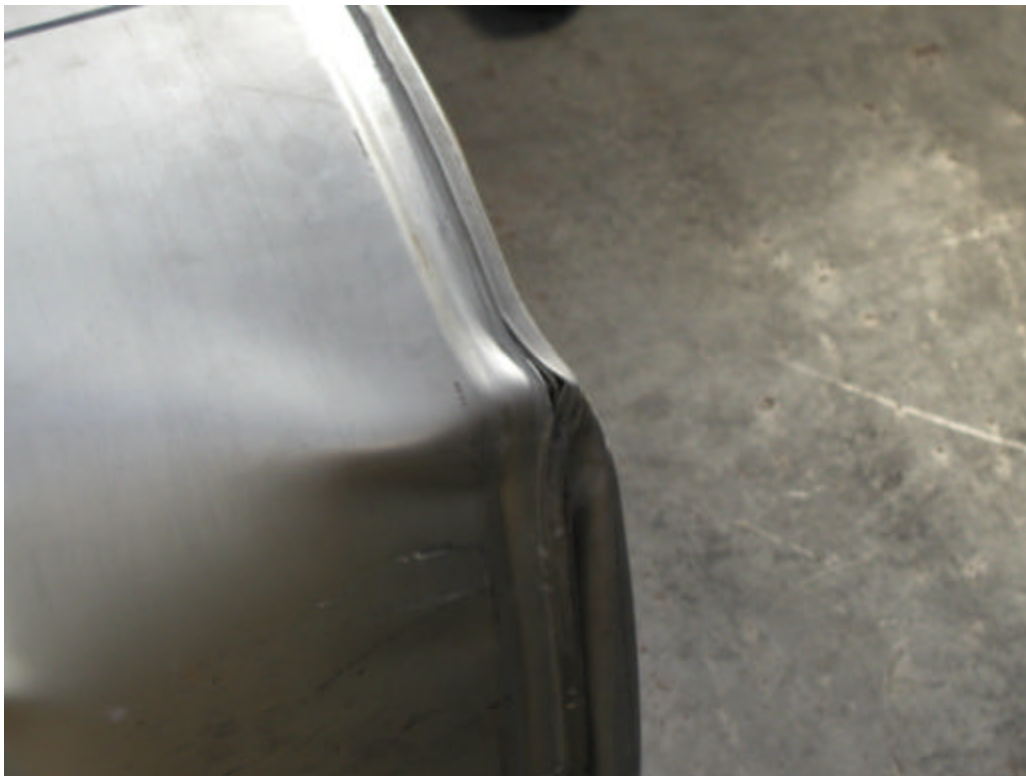
Figure E 25. Detail of damage to the bottom end of TU-1 in the area identified in Figure E.24.

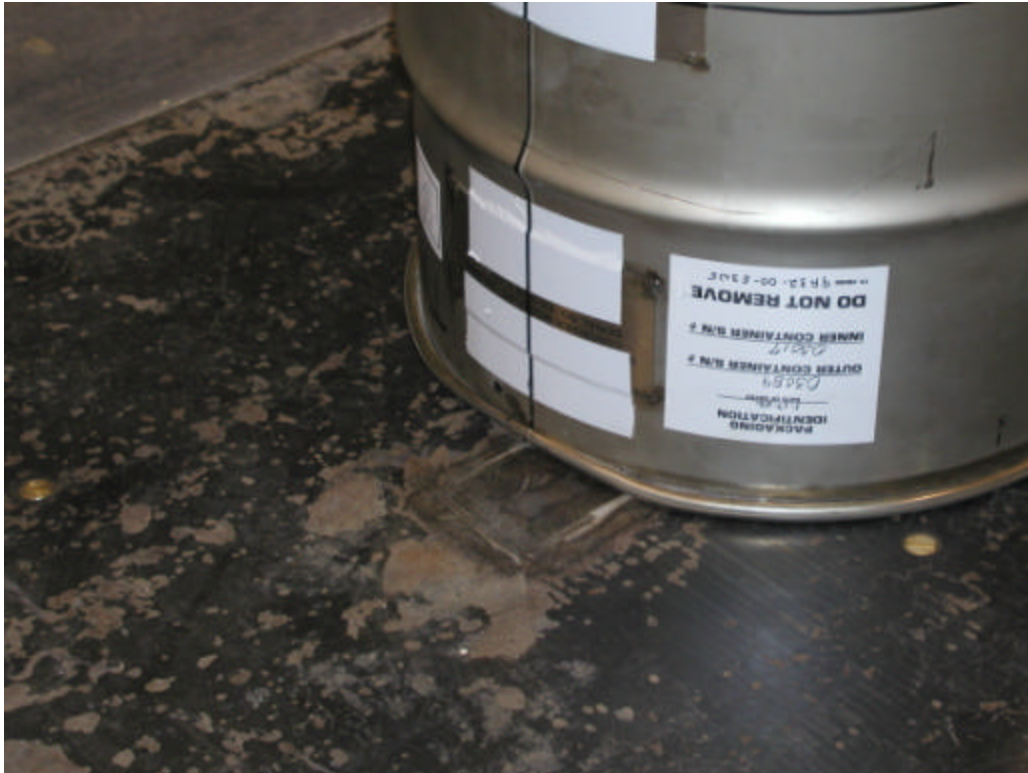
Figure F 15. Damage to the lid end from the NCT CG-over-corner drop.

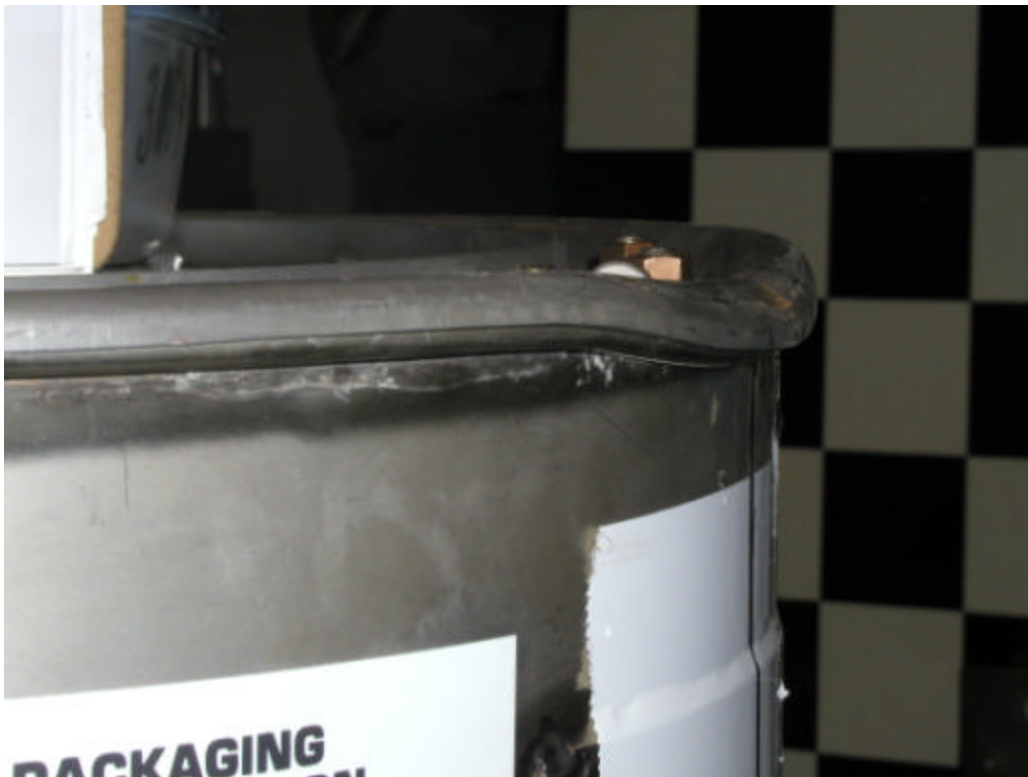
Figure F 18. Close-up of damage to edge of the lid from the CG-over-top-corner drop – side view.

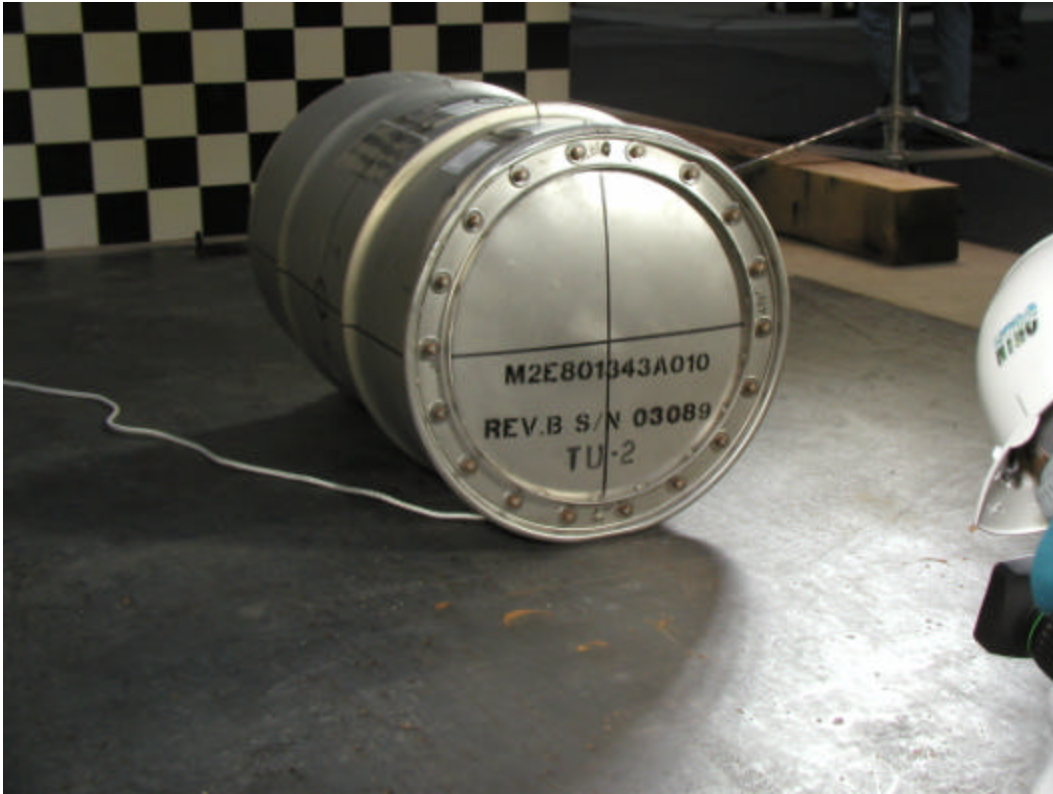
Figure F 21. End view of TU-2 lid after HAC 30-ft drop on the 0° line.

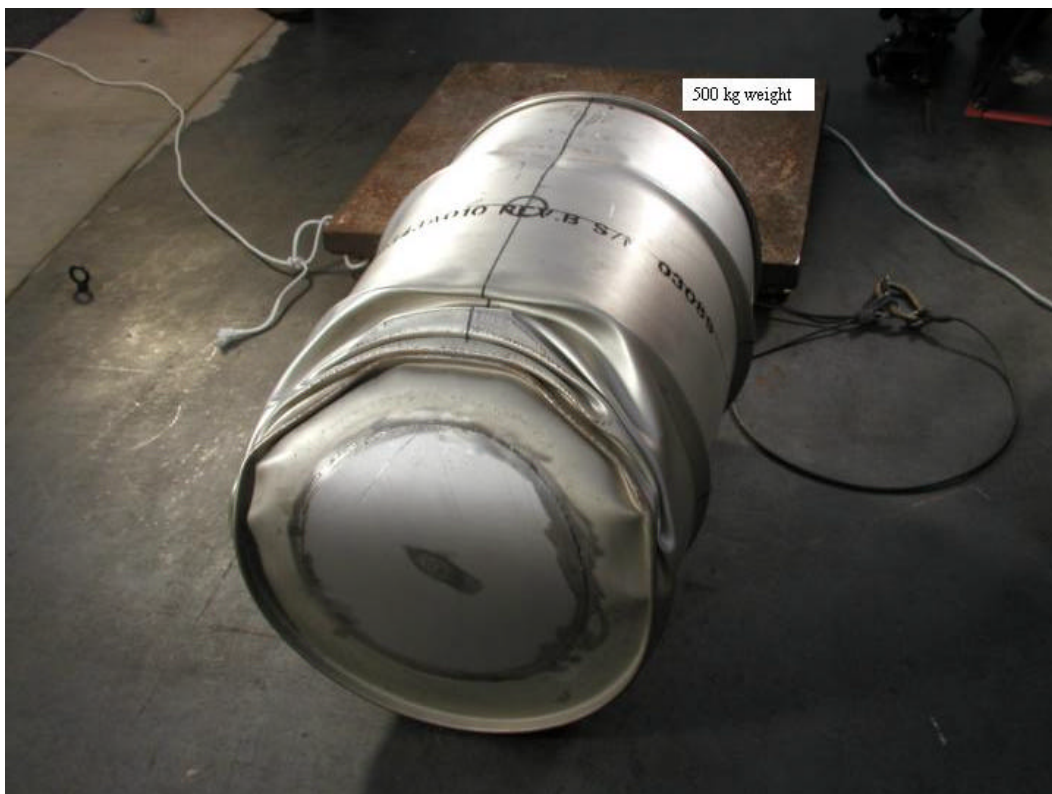
Figure F 28. Damage to the bottom edge of TU-2 after being hit with the 500 kg crush weight.

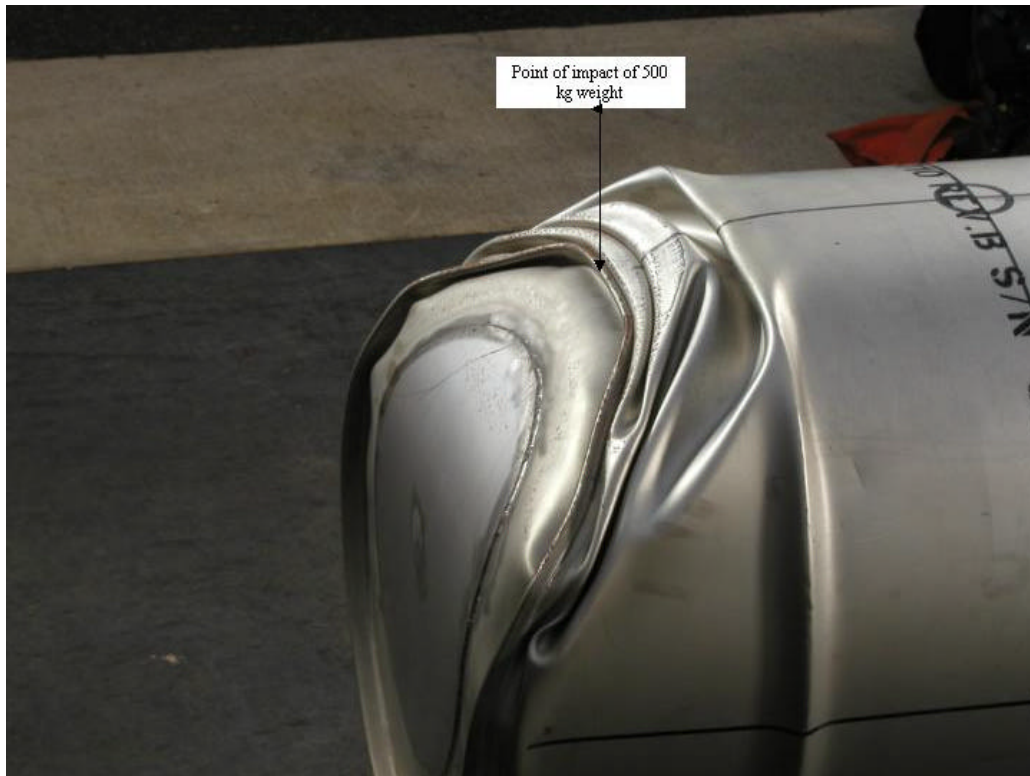
Figure F 29. Close-up of damage to the bottom of TU-2 at point of impact.

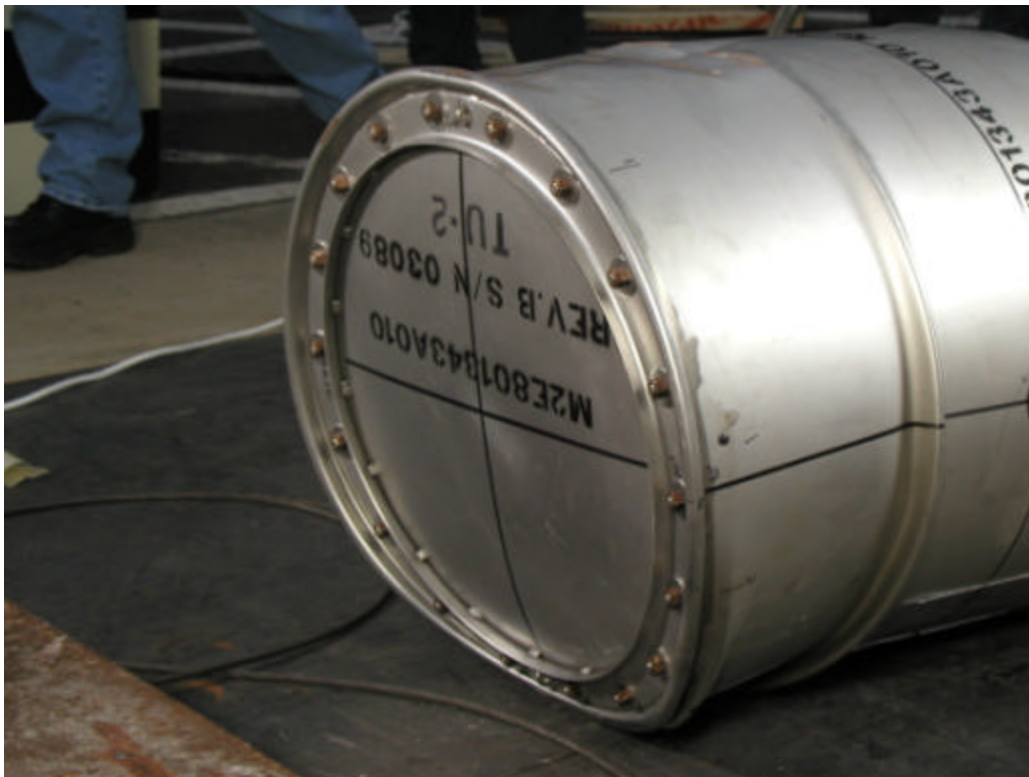
Figure F 30. View of TU-2 lid following the HAC crush test.

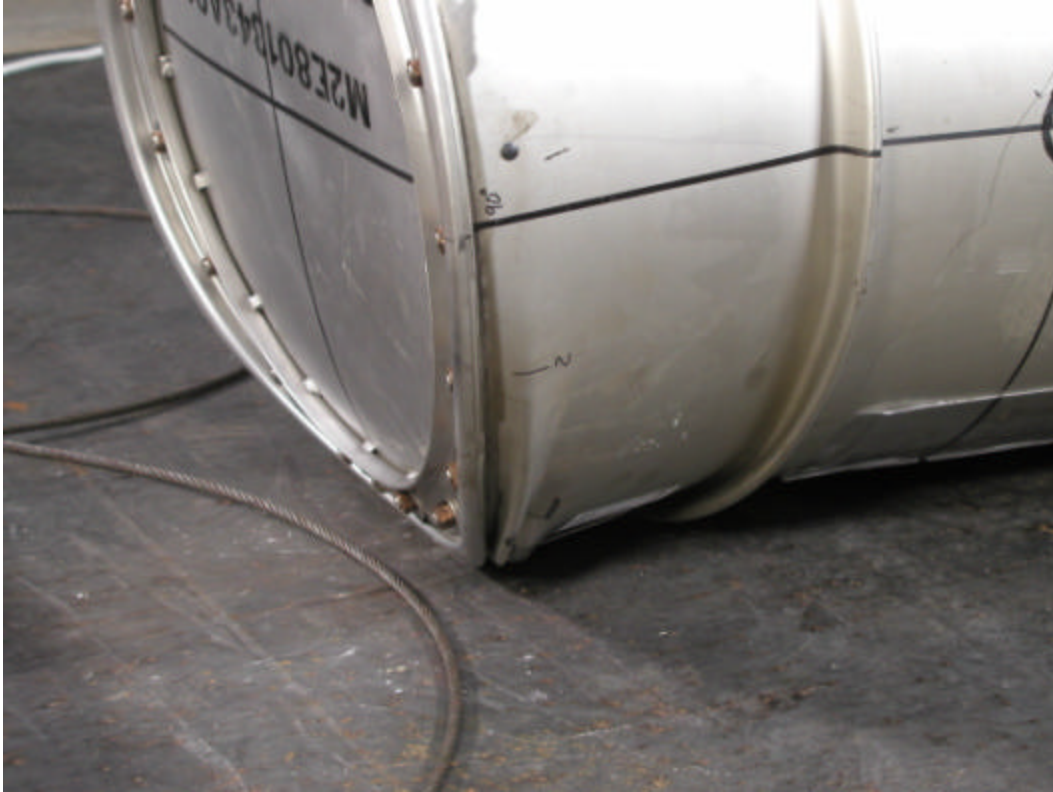
Figure F 31. Close-up of damage to lid of TU-2 following the crush test.

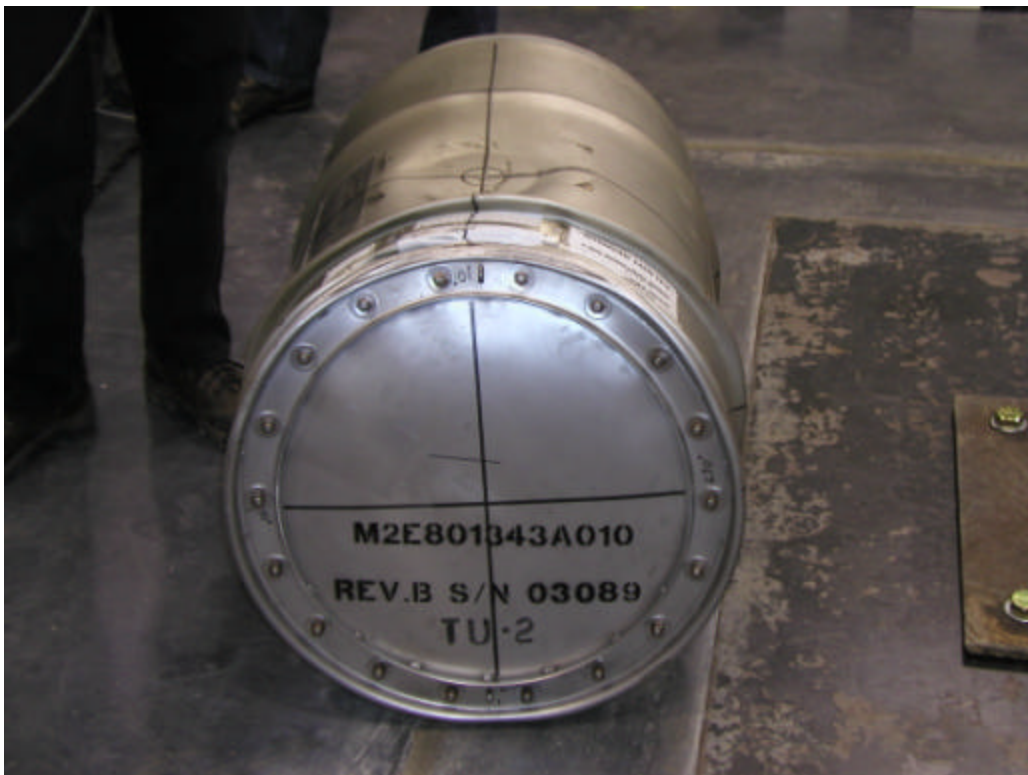
Figure F 38. Damage to TU-2 from the punch test as viewed from the top end of the package.

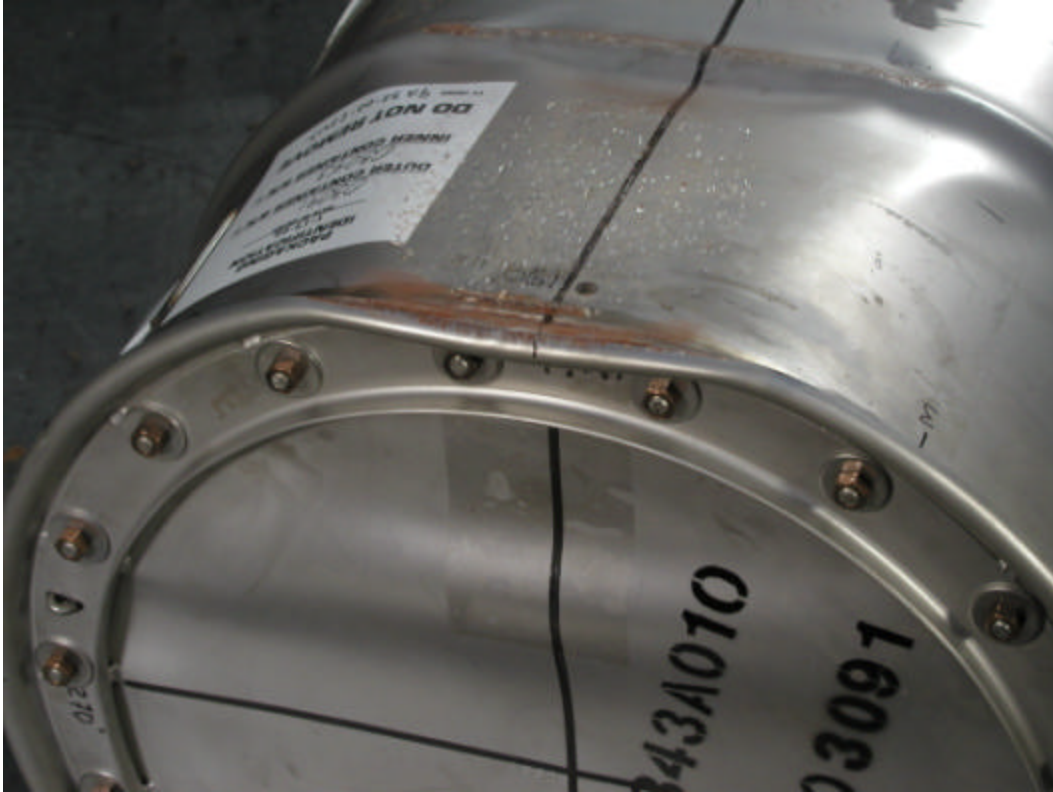
Figure G 17. Close up of damage to lid end of TU-3 along the 180° line.

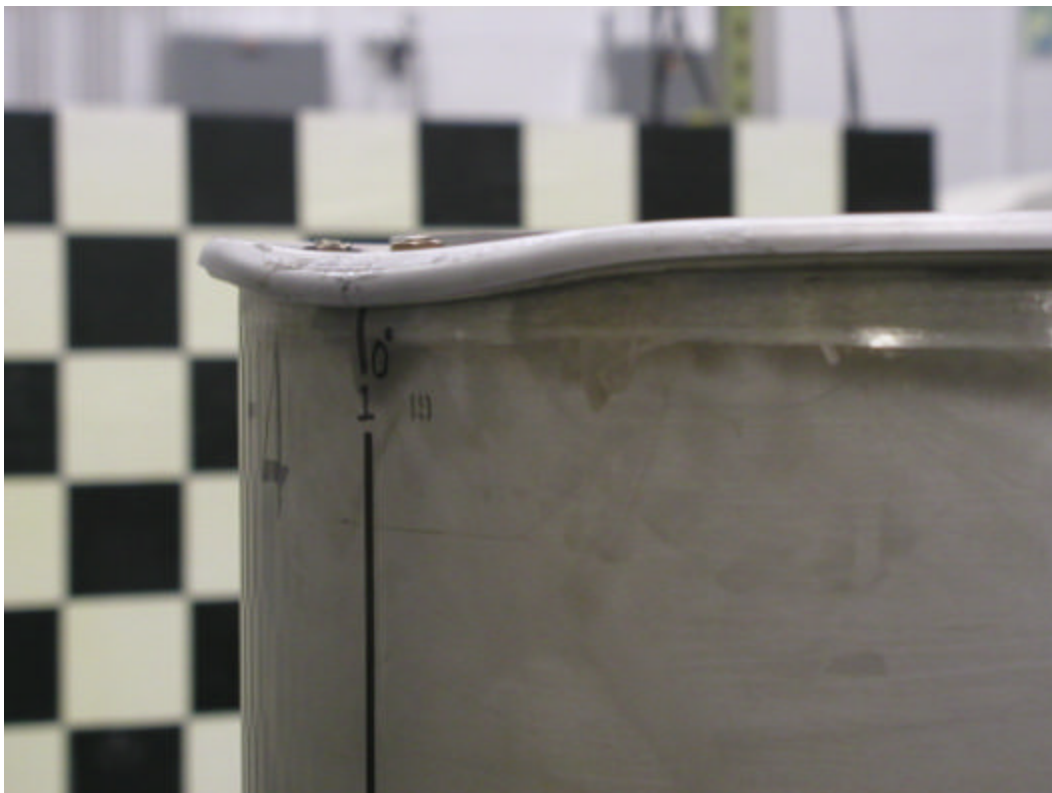
Figure H 16. Close-up of damage of the lid from the CG-over-corner drop – right side view.

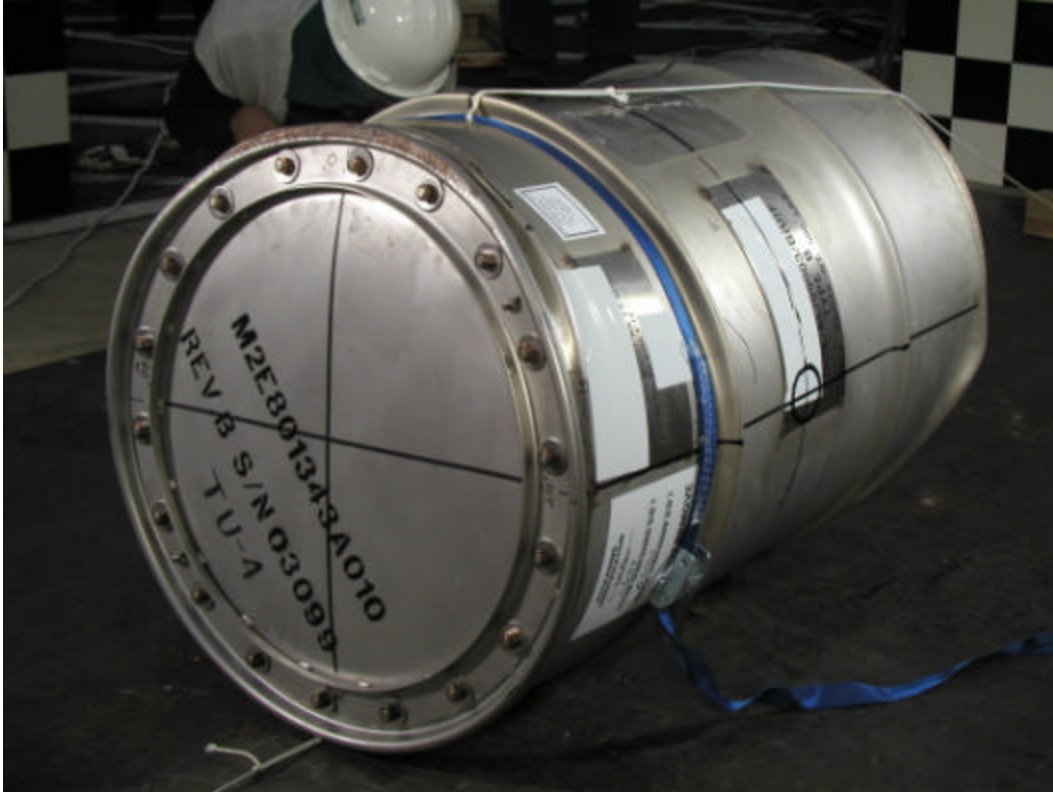
Figure H 20. View of TU-4 lid following the HAC crush test.

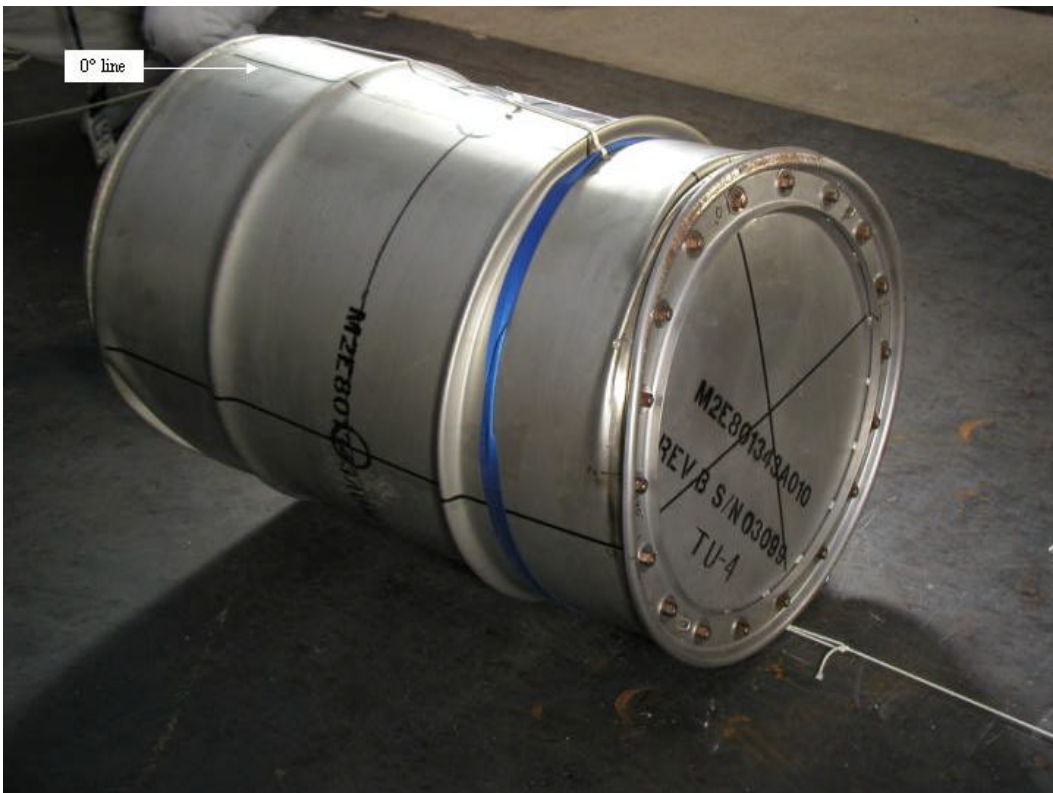
Figure H 21. Side view of TU-4 lid following the HAC crush test.
