TEST REPORT

REPORT NO. 45918-01
OUR JOB NO. 45918
YOUR P. O. NO. 84YLFP22
CONTRACT N/A
PAGE 1 of 52 PAGE REPORT
DATE February 21, 1997

VIBRATION TESTING OF AN ES-2 SHIPPING CONTAINER

Lockheed Martin Energy Systems, Inc.
Oak Ridge, TN

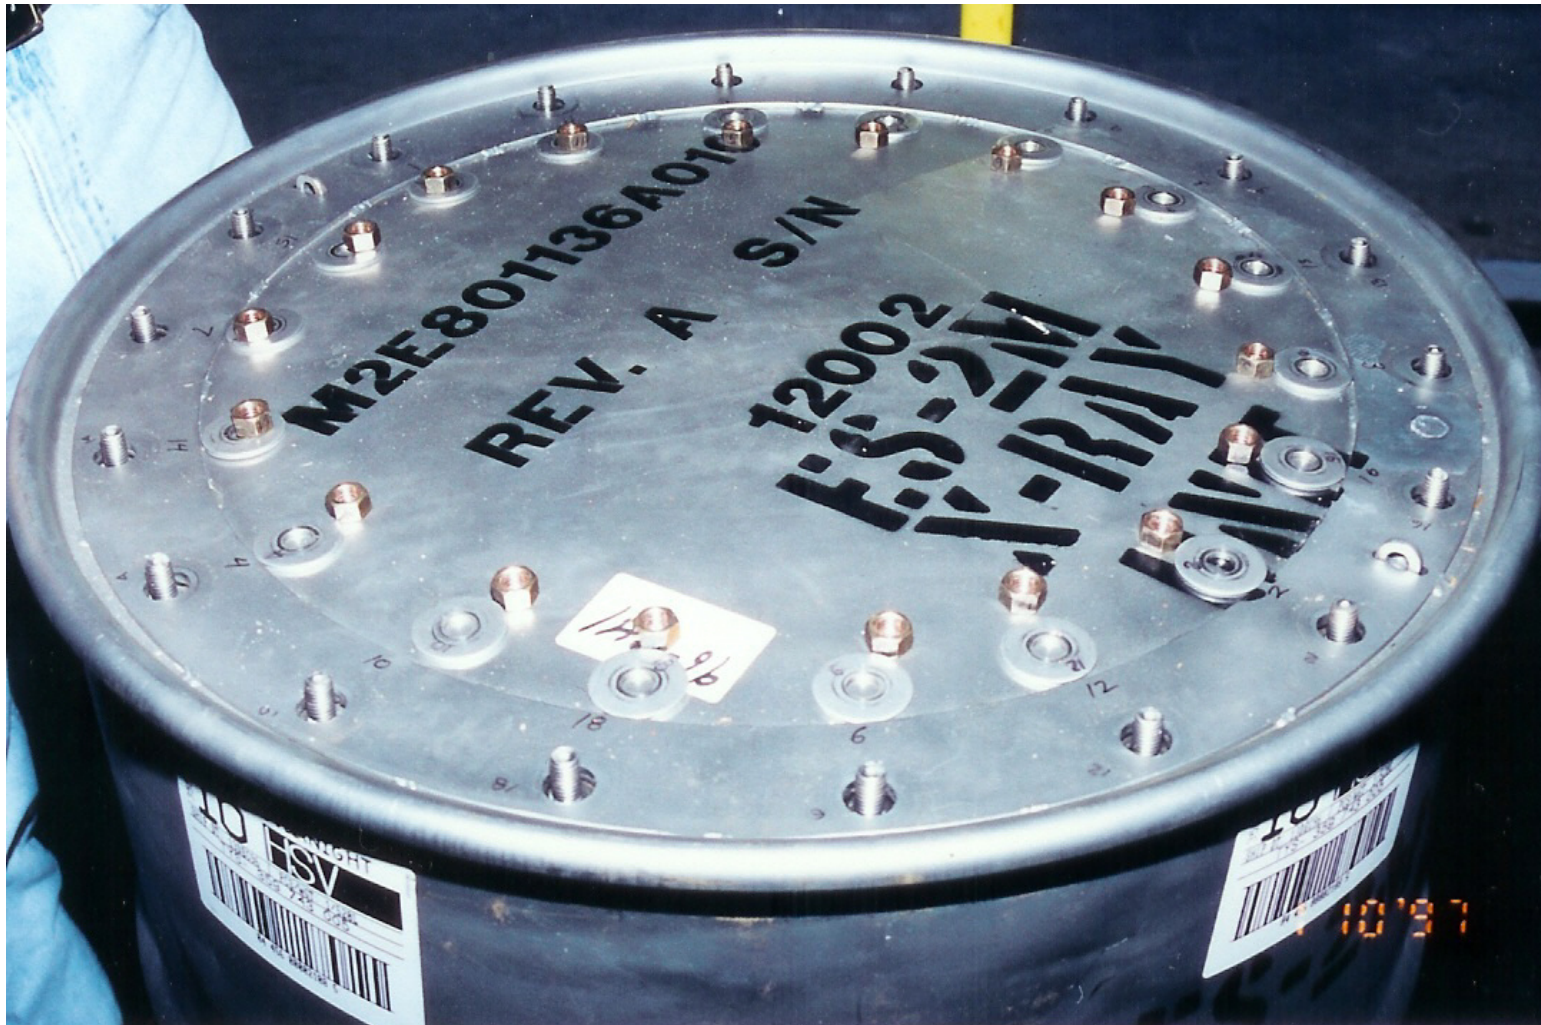
Metal Dust under the Drum Lid after 44 hours of testing

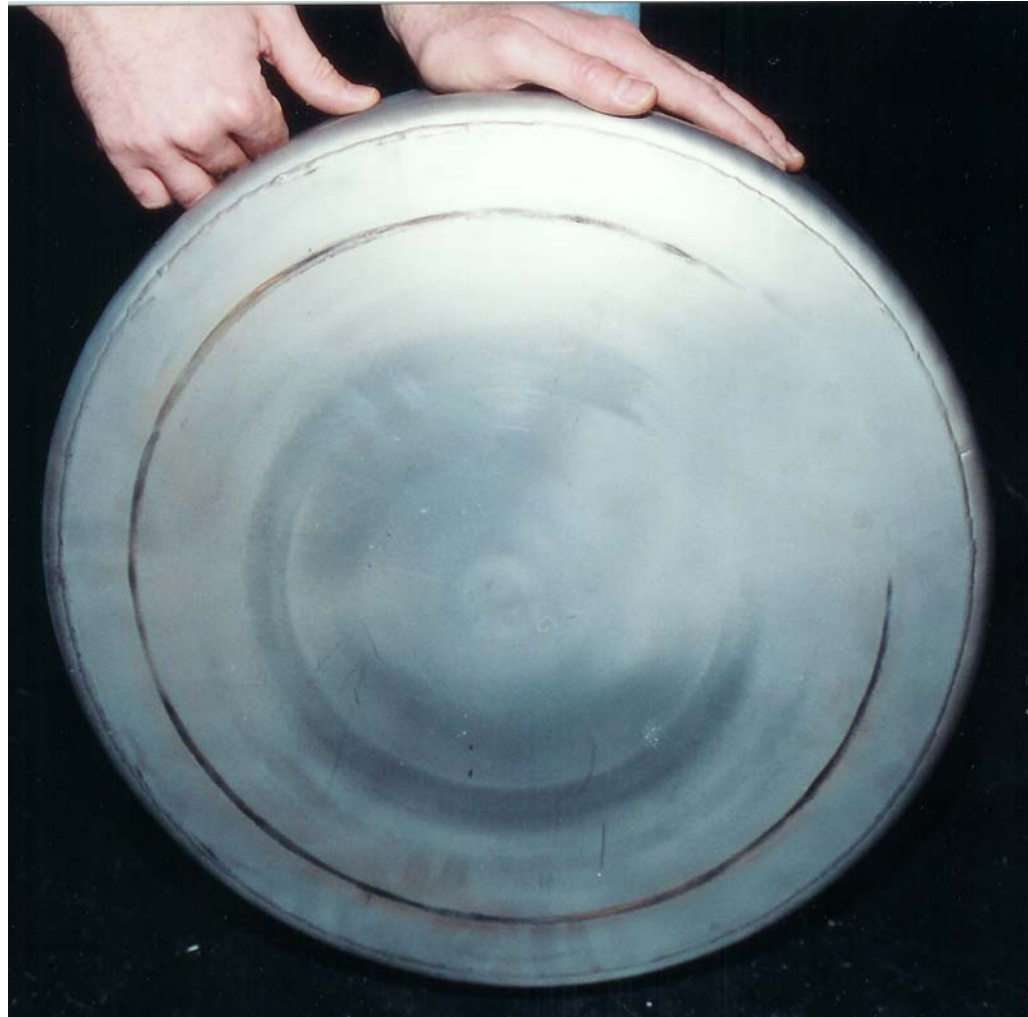
Top Foam after testing

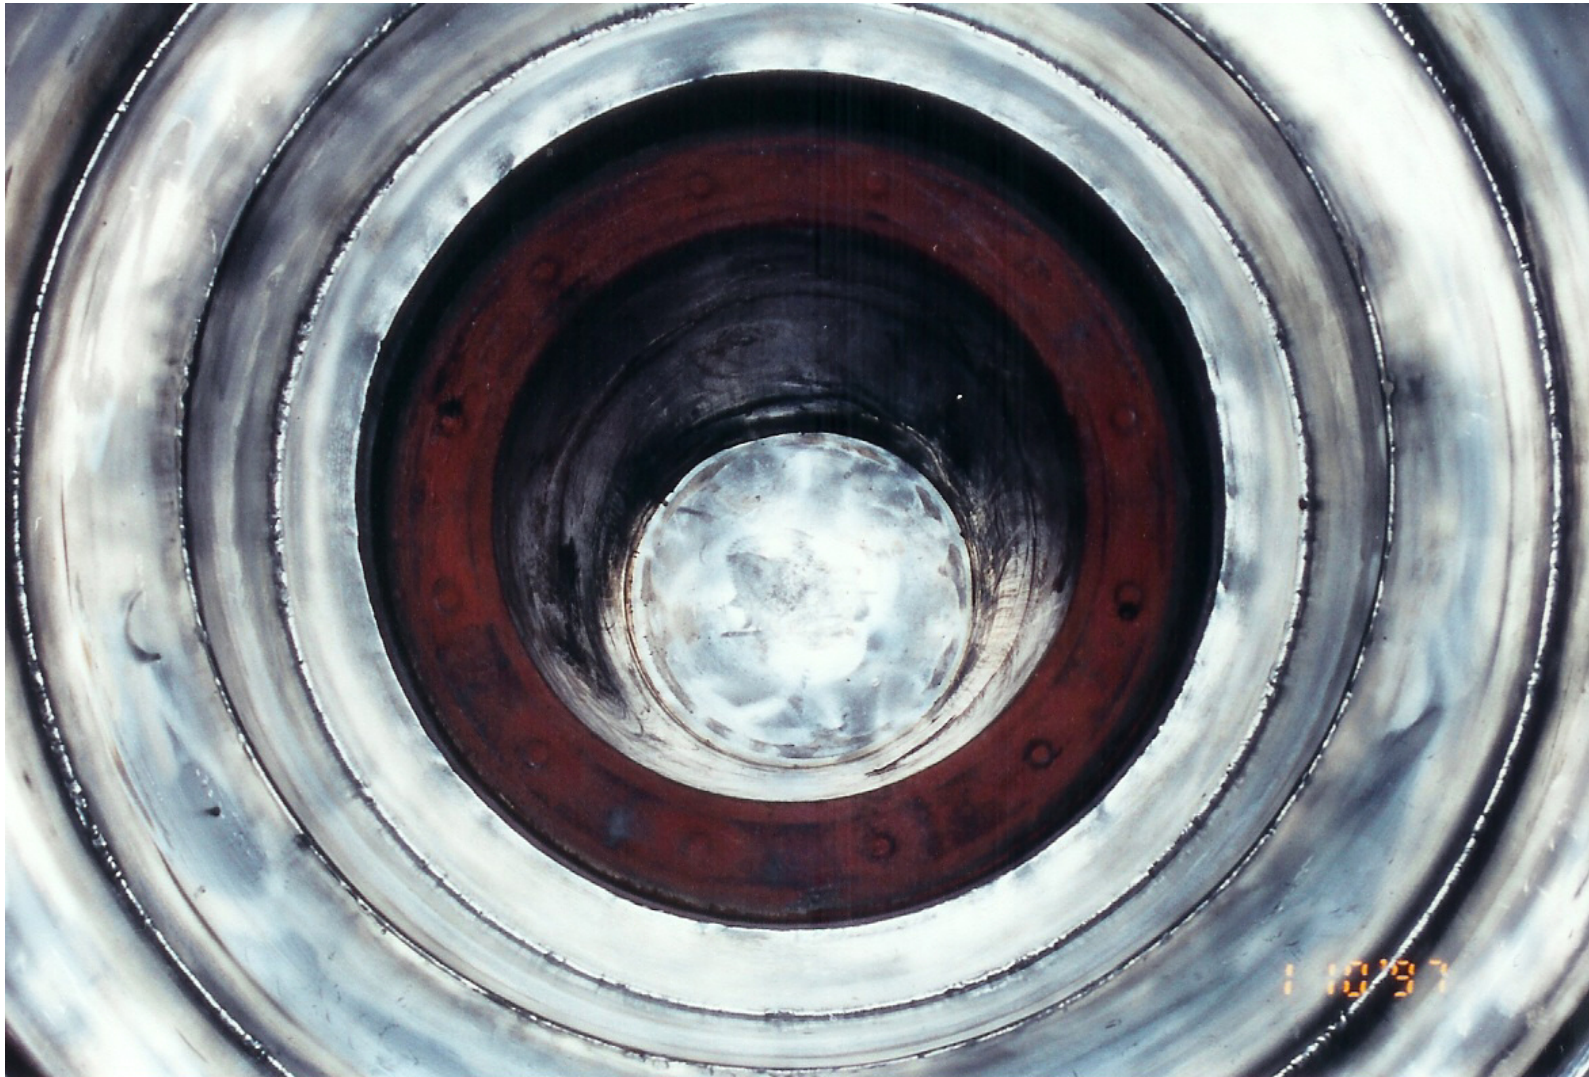
Inner Liner and Foam Tube after testing

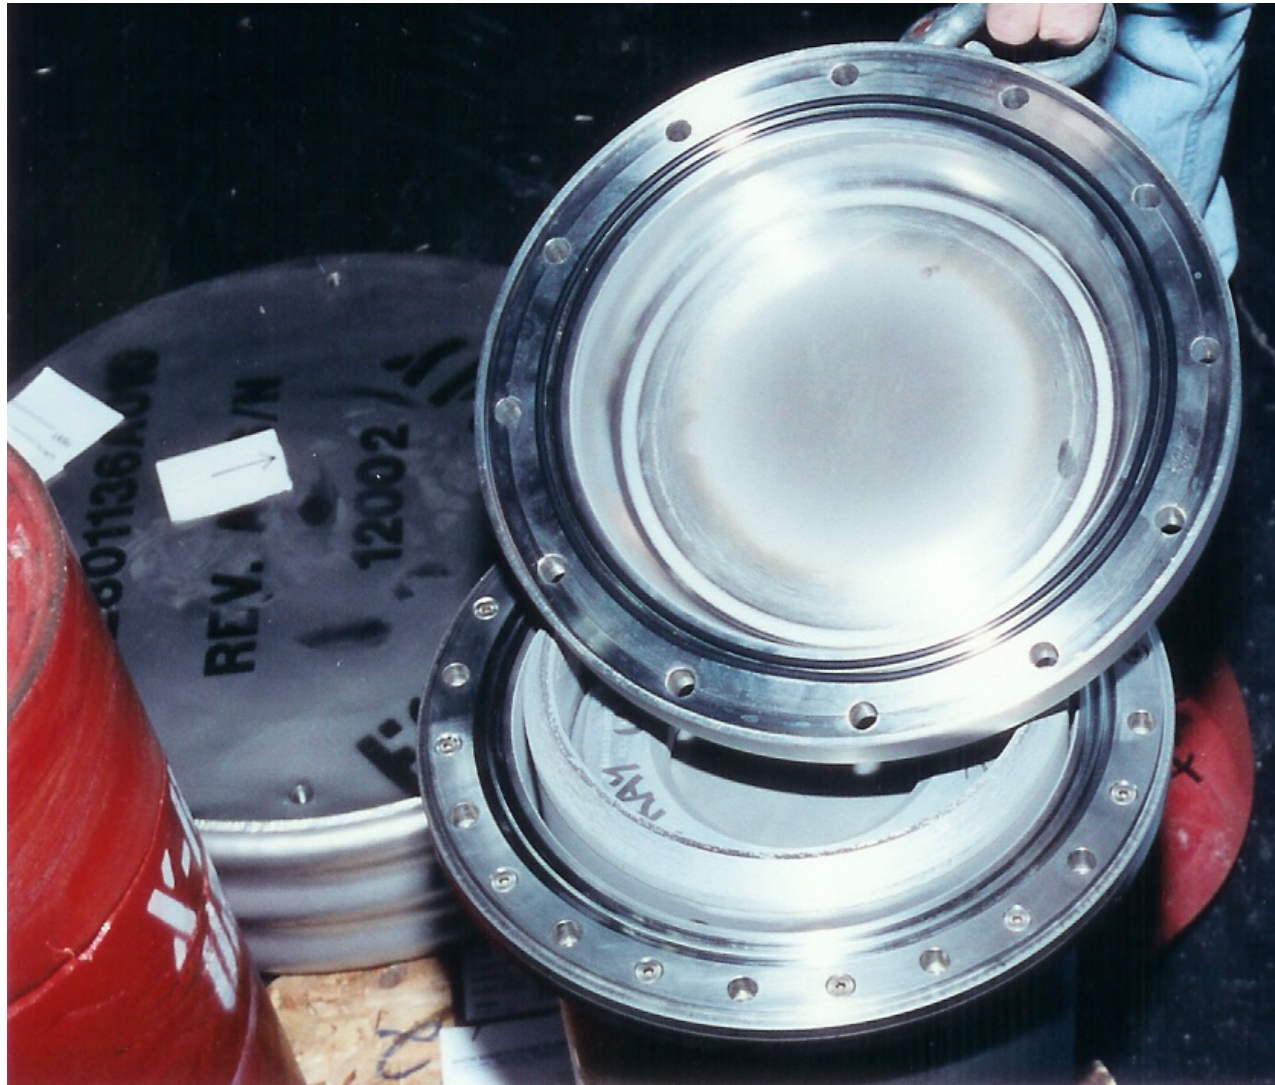
After testing shows where the Aluminum tube bounced into the bottom of CV Lid

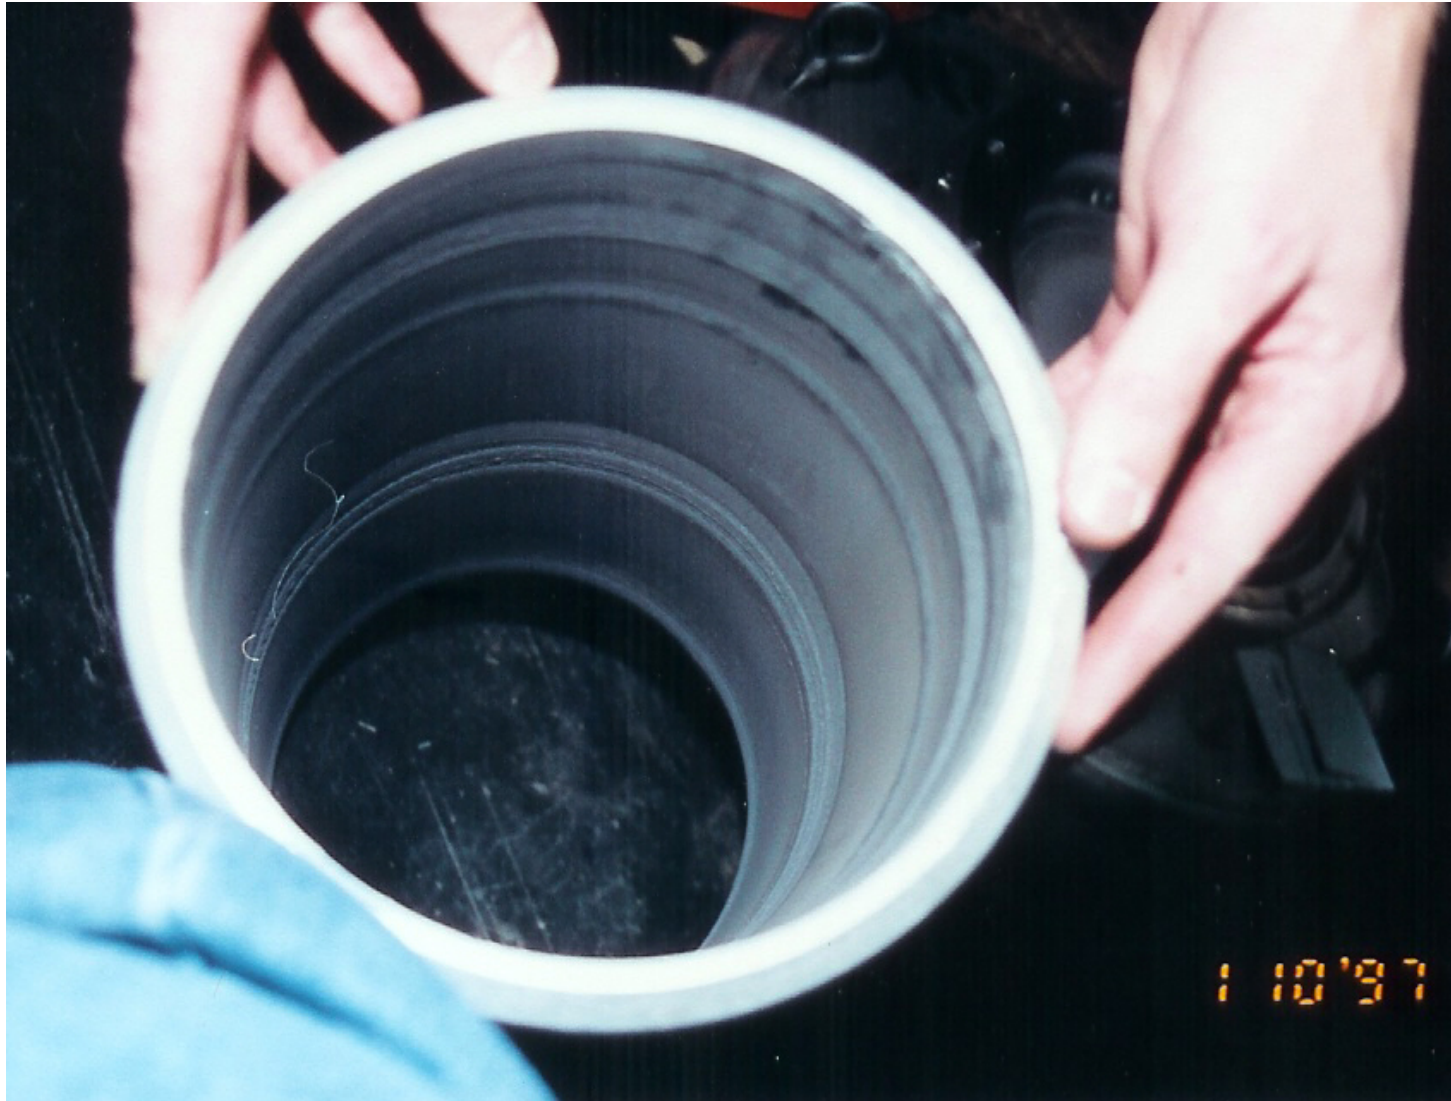
Aluminum tube removed after testing

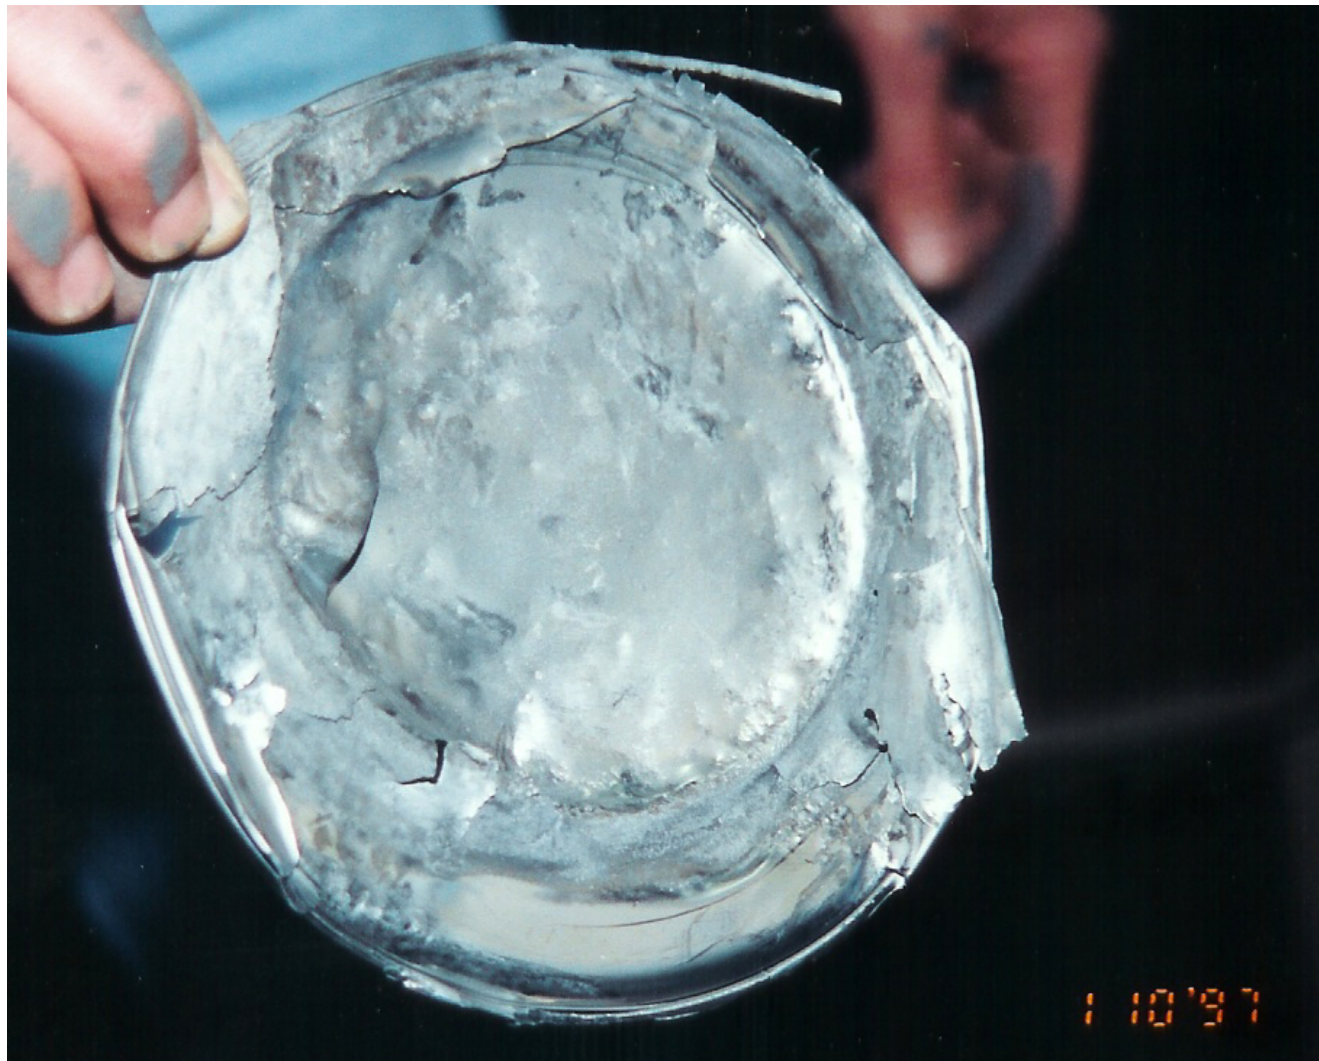
Bottom of Top Can after testing

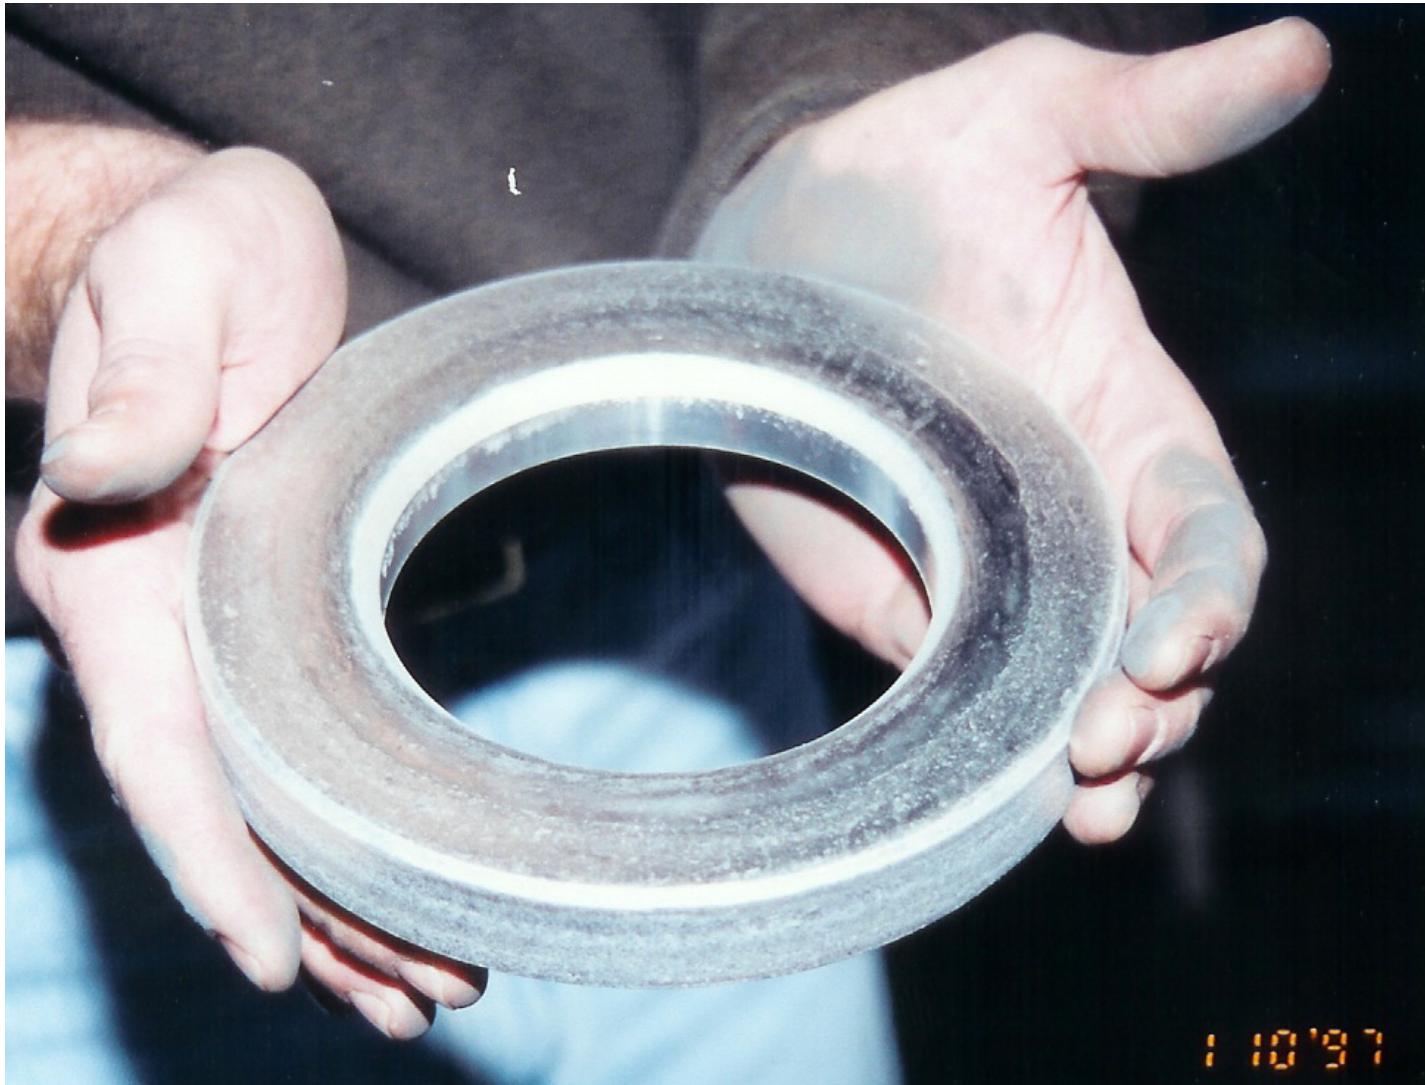
Middle Aluminum Spacer after testing

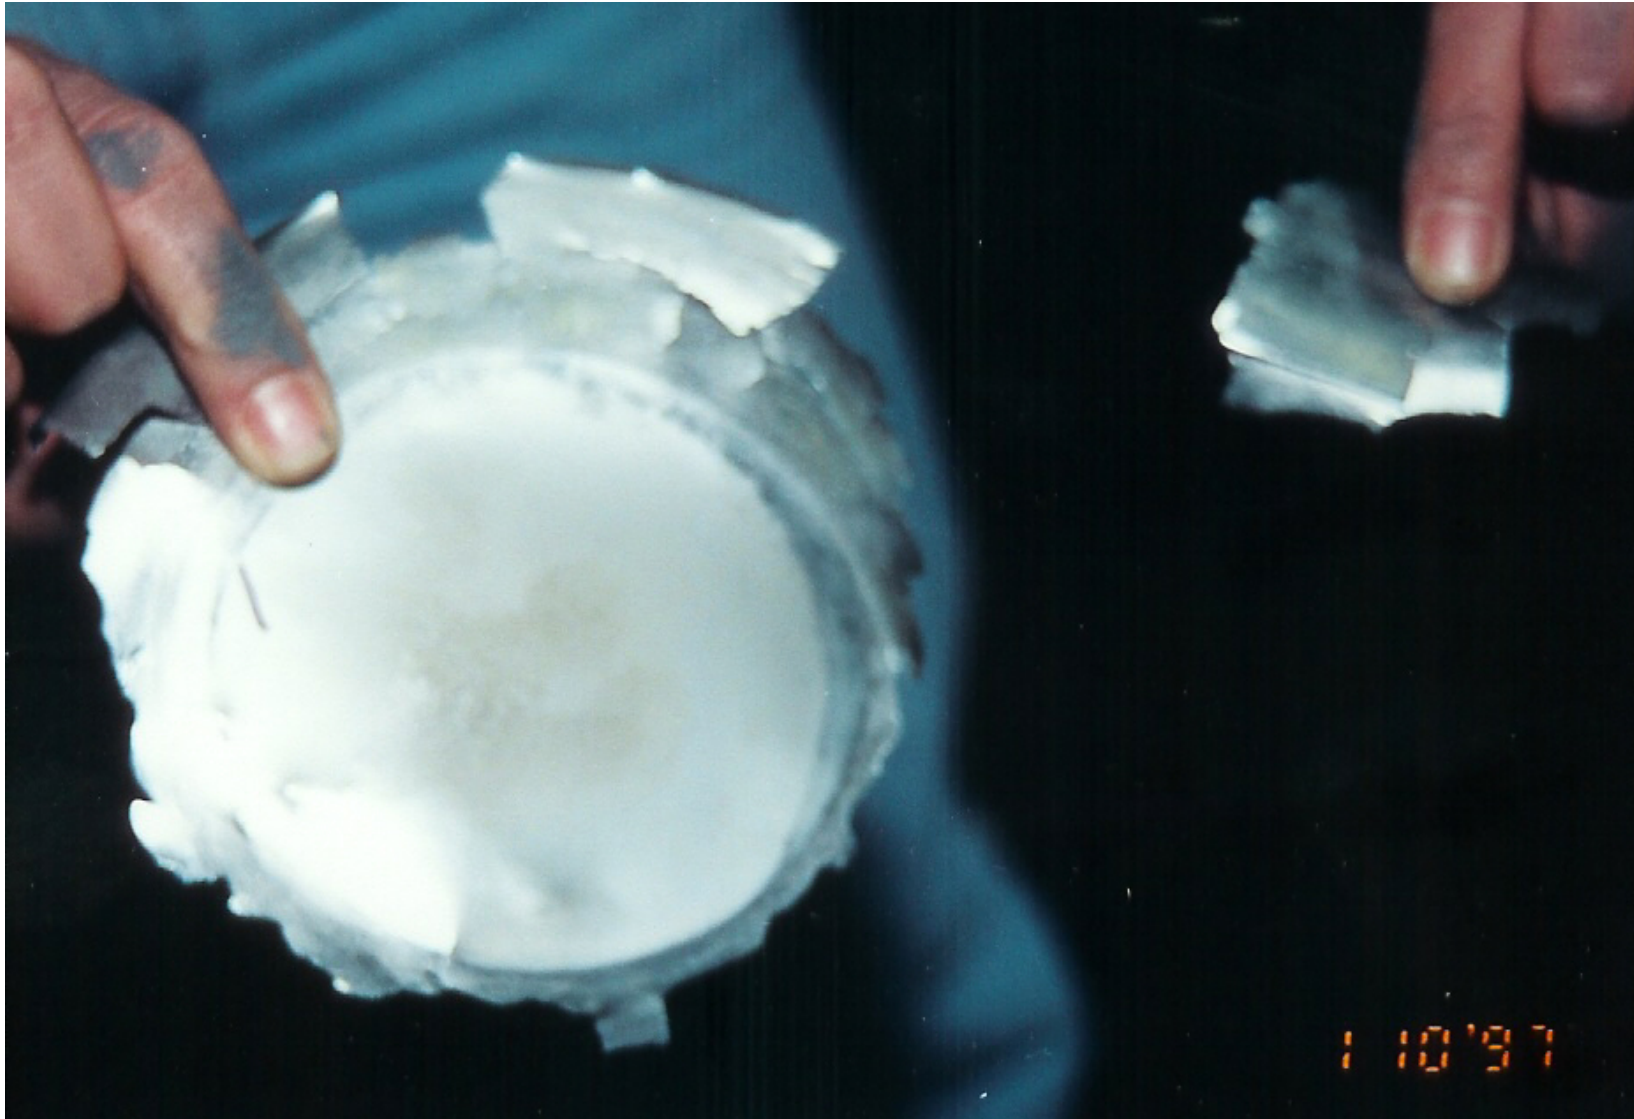
Top of Bottom Can after testing

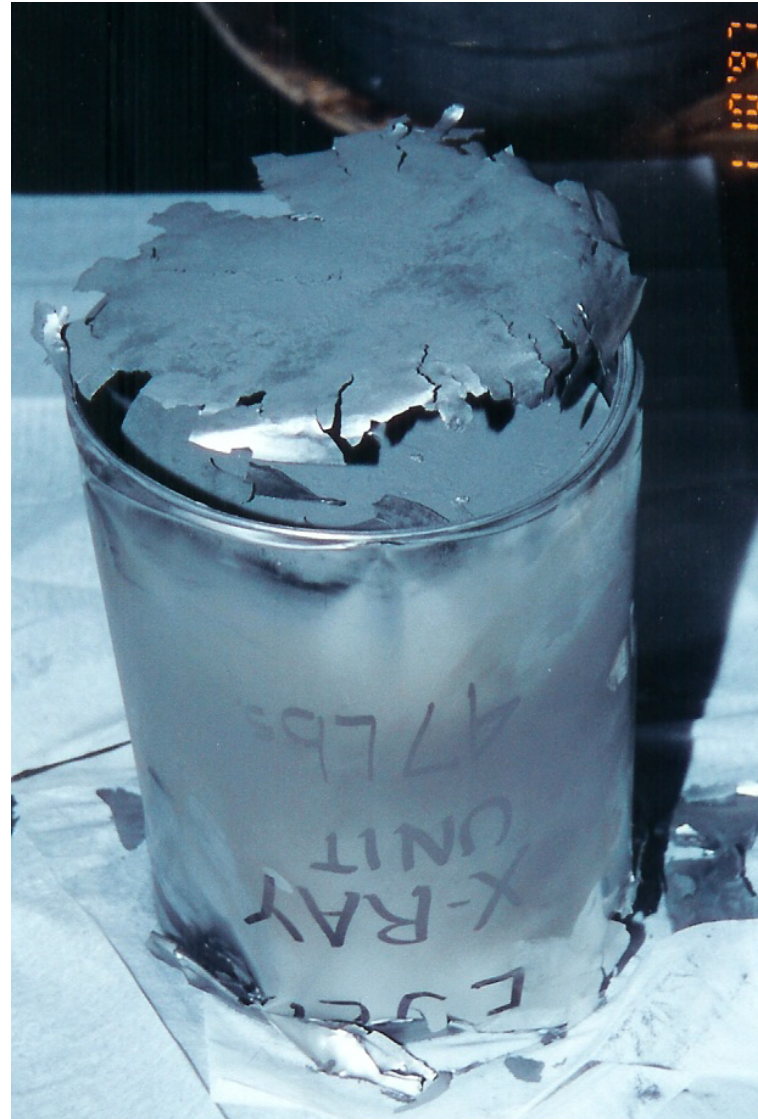
Bottom test weight after testing

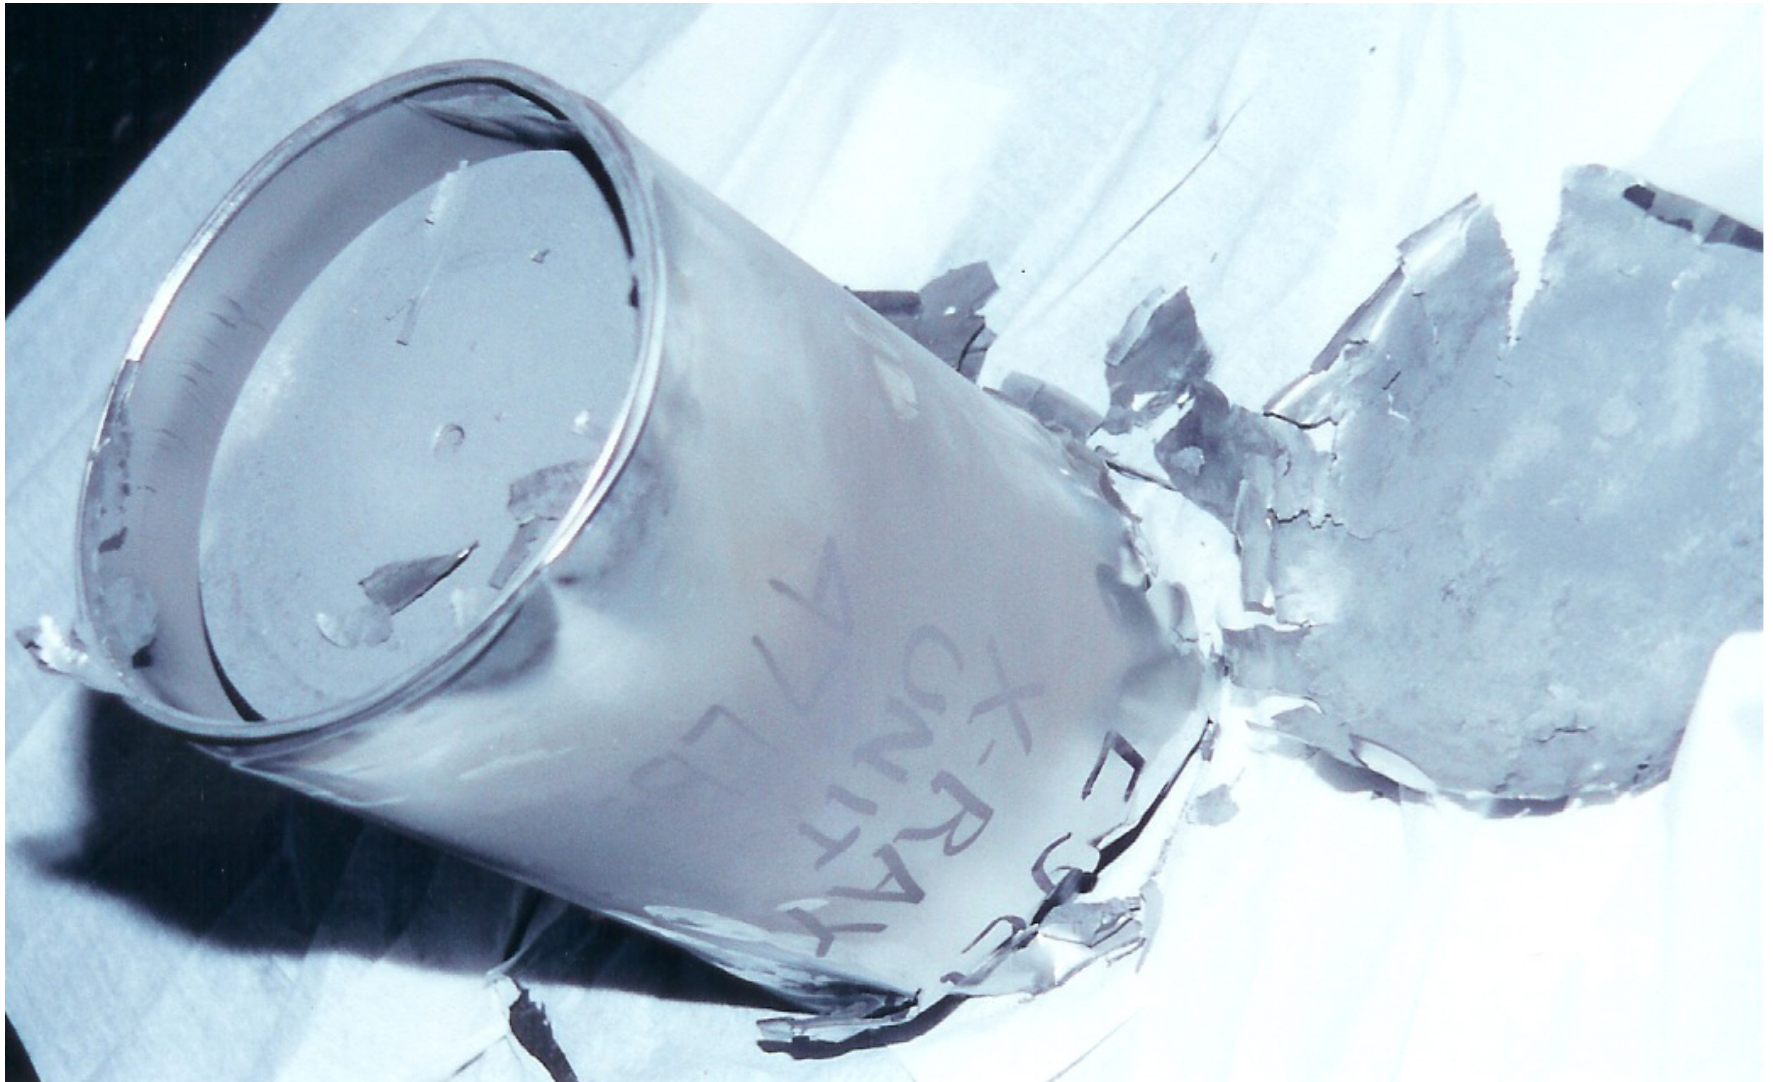
Bottom test weight after testing

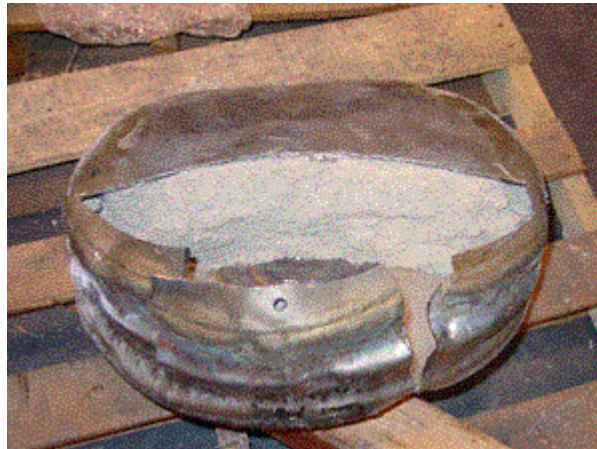
This photo shows the top plug of one of the tested DPP-2 packages. Due to the damage from the CG over corner drop and crush test, the top plug had to cut out of the package in order to extract the containment vessel. This photo shows that even after undergoing the full suite of drop, crush and thermal tests, the Kaolite in the plug, although it is cracked and broken, remains in solid form and within the plug liner.
