APPENDIX W
FILTER AND RIPRAP LAYER THICKNESSES LOGS -
DIVERSION DITCHES AND TAILING SWALE

WESTERN NUCLEAR, INC. - SPLIT ROCK MILLSITE QUALITY COMPLIANCE REPORT

Diversion Ditch Filter and Riprap Thickness Measurement Log

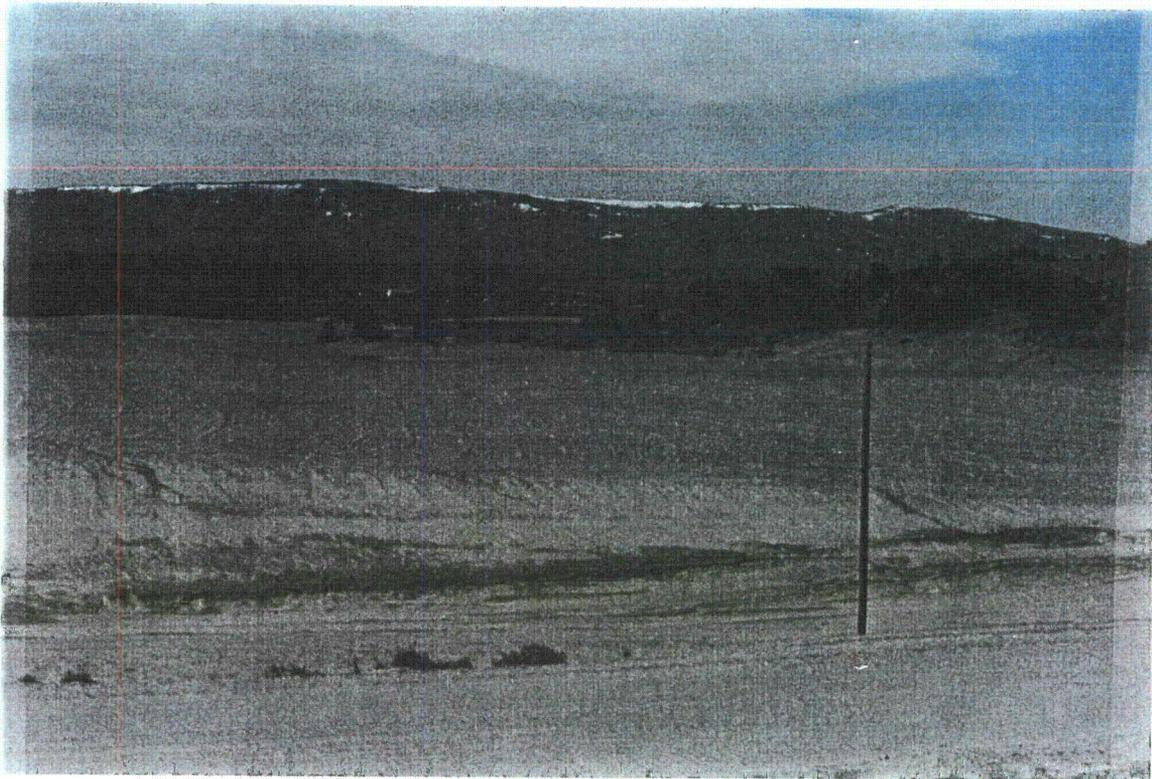
Photograph 4: Area 3B (area where mill was buried)

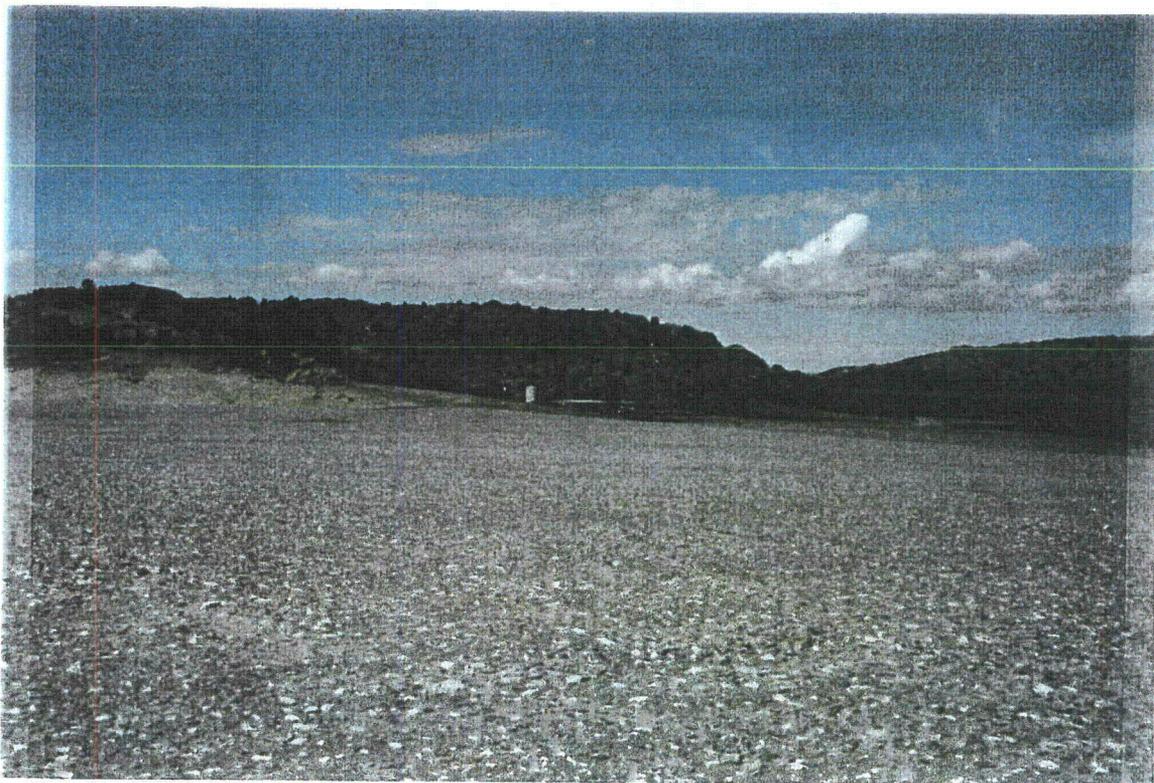
Photograph 6: Area 3A with Western Nuclear office in background

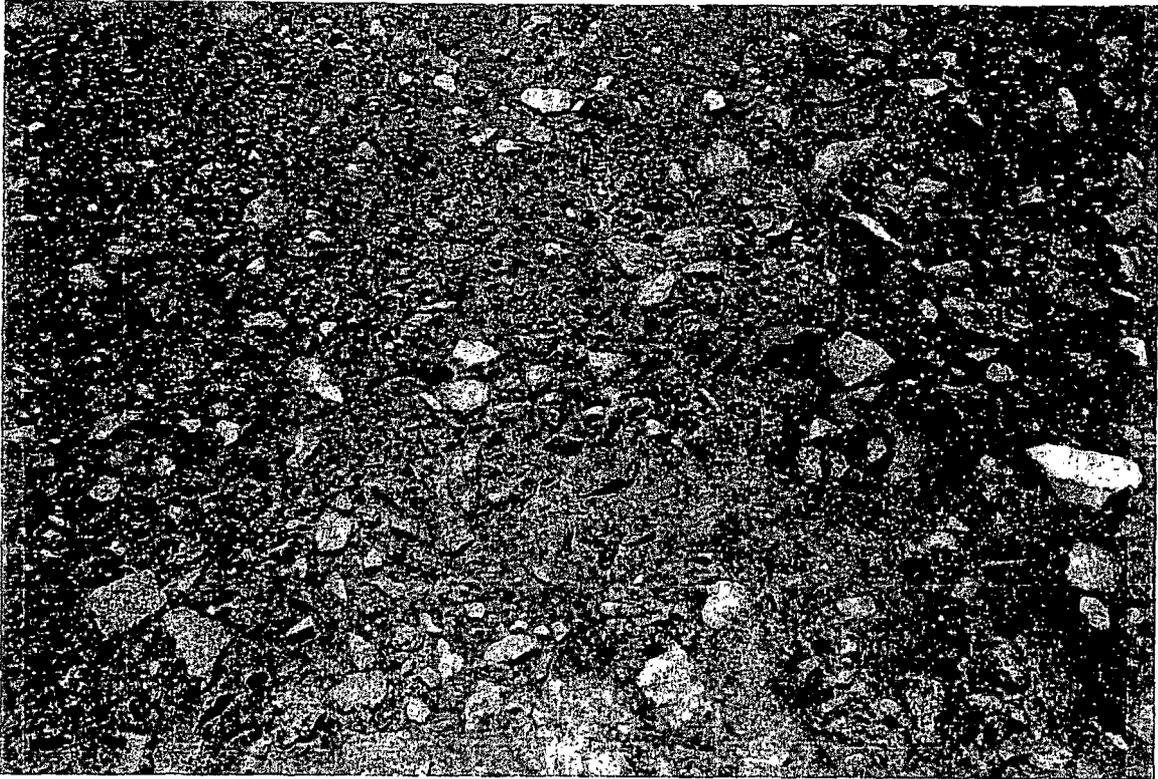
Photograph 7: Composition of final cover on Area 3A

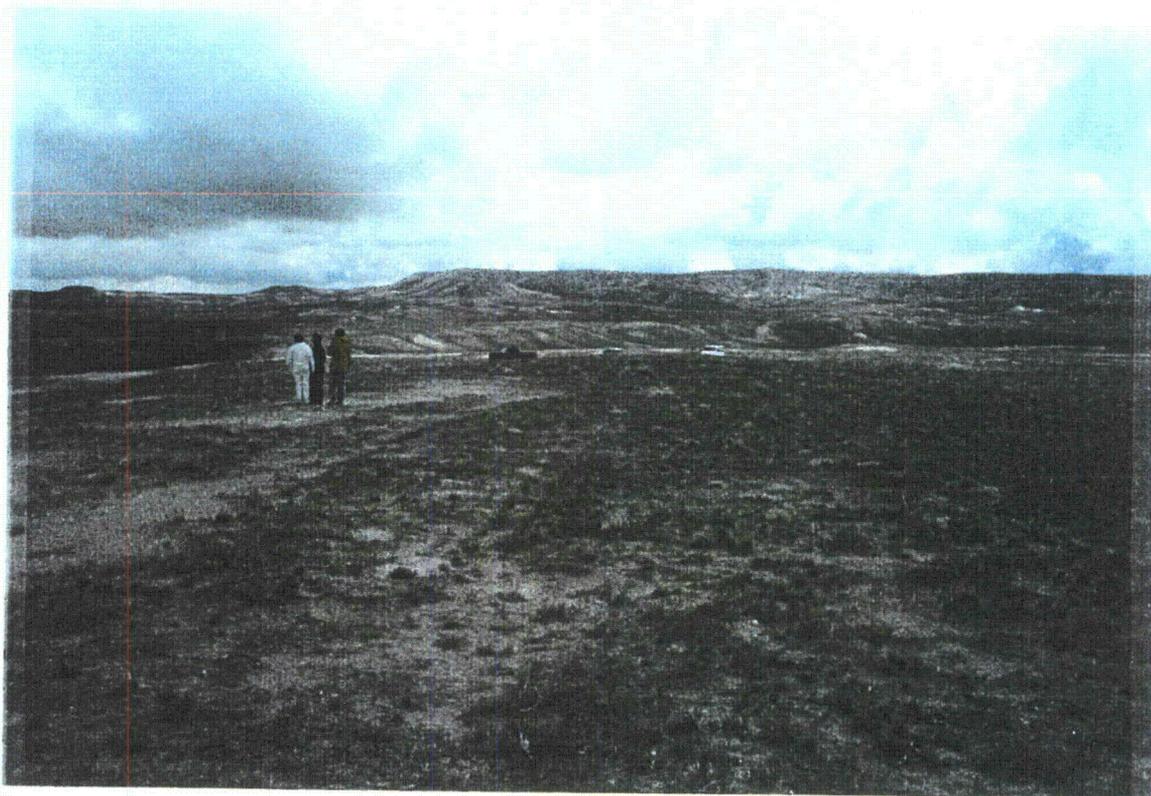
Photograph 20: Top of Day Loma Heap Leach pile

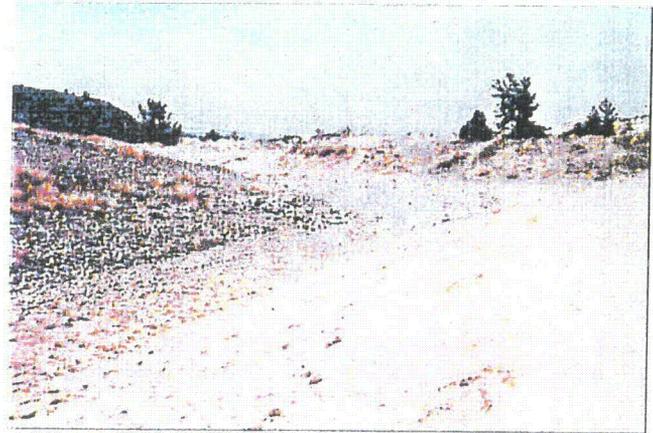
North-central diversion ditch with rip-rap.

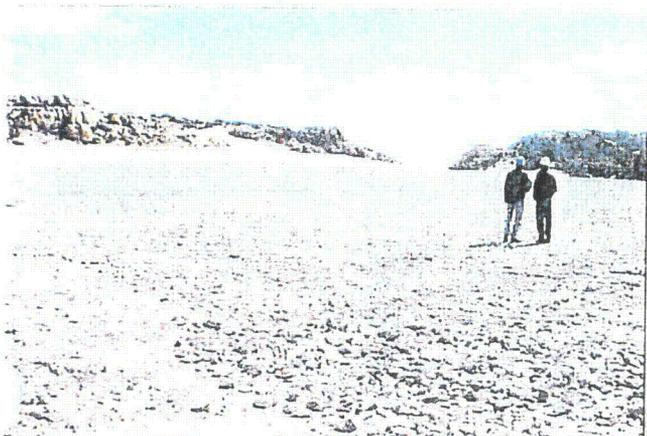
Top of tailings impoundment area reclaimed during 1997.

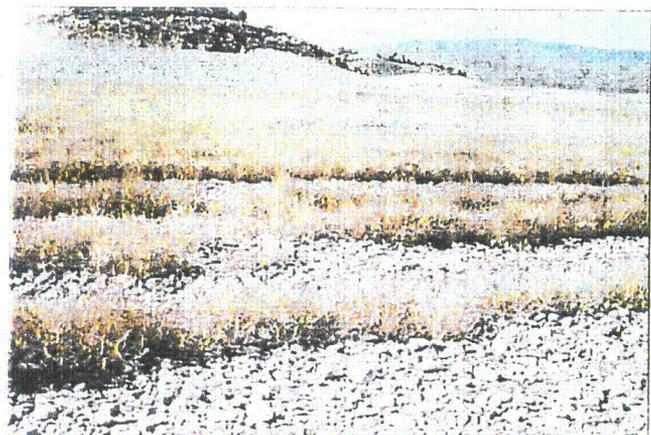
Vegetation on top of tailings impoundment area reclaimed during 1996.

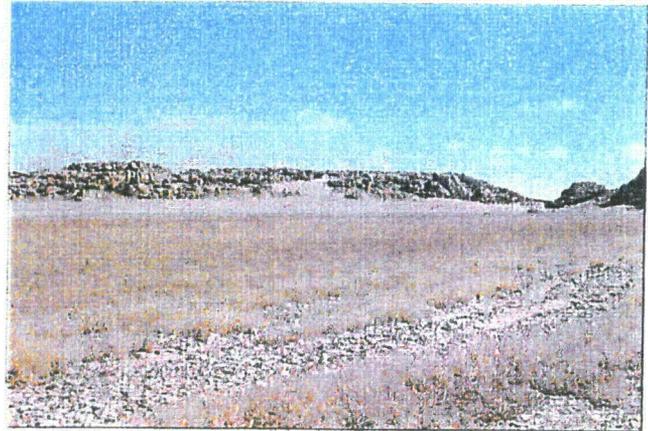
Northeast section of tailings impoundment.

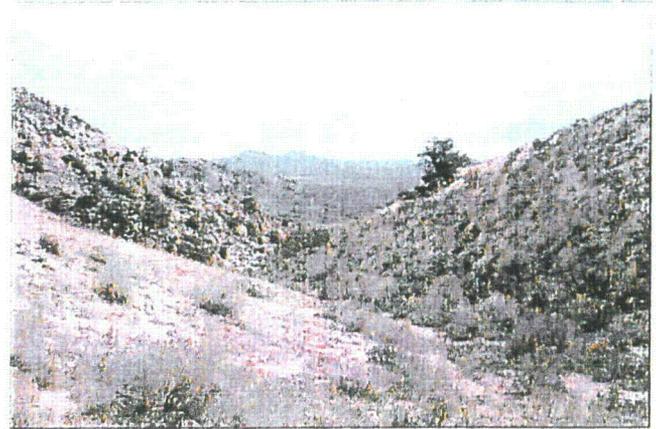
Front side of North Dune area exempted from radiological cleanup.

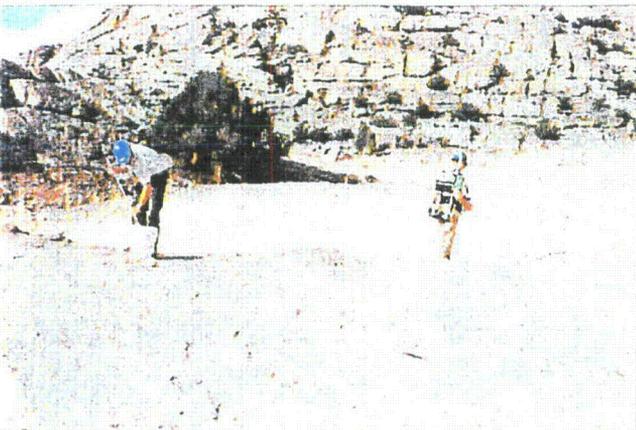
Gamma scanning and soil sampling by licensee personnel.
