Seismic Walkdown Checklist (SWC) SWEL1- 089

Equipment ID No. EJ-1051 Equip. Class¹ 20, INSTRUMENTATION AND CONTROL PANELS

Equipment Description AUX FEEDWATER CONTROLS

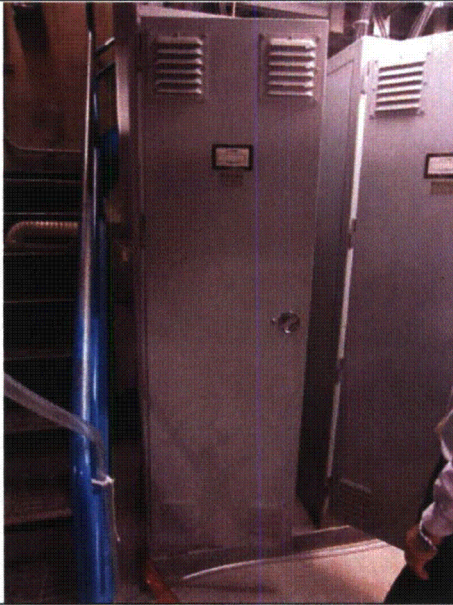
2. Is the anchorage free of bent, broken, missing or loose hardware? Y N U N/A
The equipment anchorage consists of 4" intermittent fillet welds to structural steel angles which are embedded in a concrete pedestal on the concrete floor.

3. Is the anchorage free of corrosion that is more than mild surface oxidation? Y N U N/A
No corrosion observed.

4. Is the anchorage free of visible cracks in the concrete near the anchors? Y N U N/A
There were no cracks observed in the concrete pedestal or floor.

Note: Equipment.

11. Have you looked for and found no other seismic conditions that could adversely affect the safety functions of the equipment? Y N U
There is an adjacent funnel and drip line to drain nearby. No water or drips observed, judged to be okay for seismic induced flooding concerns.

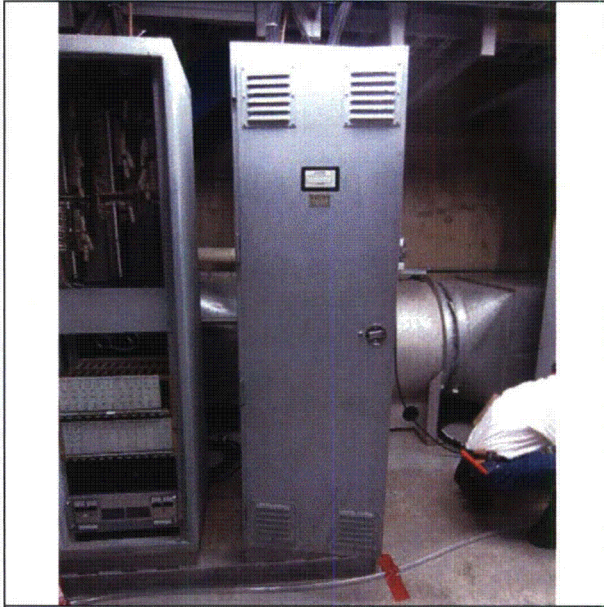
Note: *Equipment.*

2. Is the anchorage free of bent, broken, missing or loose hardware? Y N U N/A
Equipment is anchored with (4) expansion anchors to a concrete wall.

3. Is the anchorage free of corrosion that is more than mild surface oxidation? Y N U N/A
There is no corrosion. Anchors are painted.

4. Is the anchorage free of visible cracks in the concrete near the anchors? Y N U N/A
The equipment is anchored to a concrete wall. There are no cracks observed.

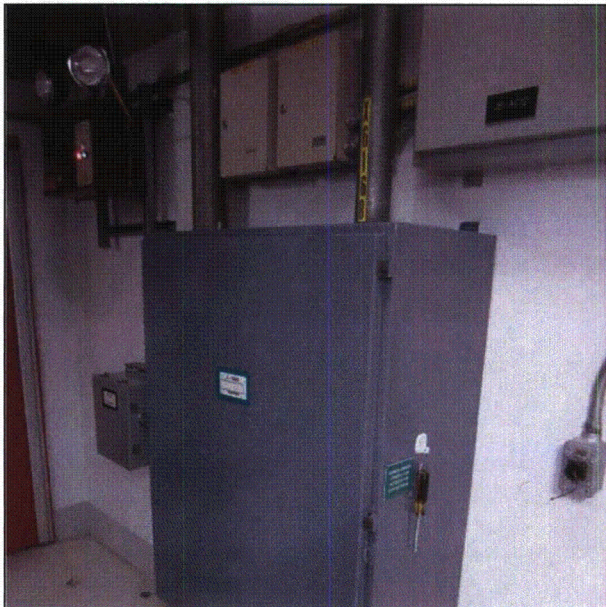
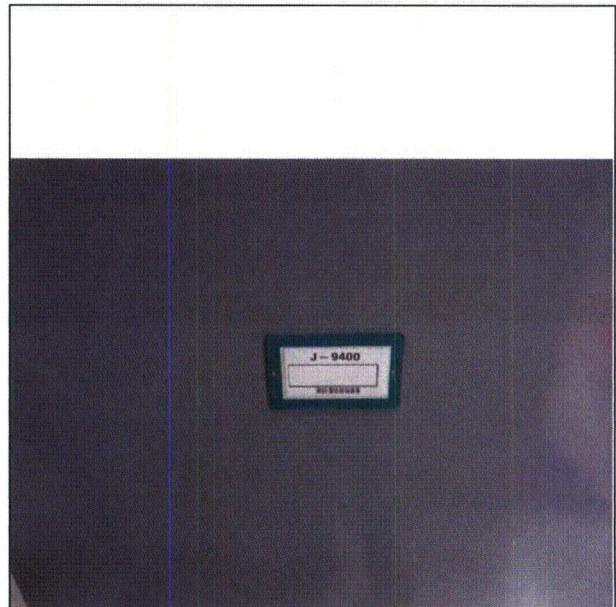
Note: Equipment.

2. Is the anchorage free of bent, broken, missing or loose hardware? Y N U N/A
The equipment is anchored to a concrete wall with 2 expansion anchors top and bottom of panel for a total of 4 anchors. The anchors are attached through tabs that extend from back of the panel.

3. Is the anchorage free of corrosion that is more than mild surface oxidation? Y N U N/A
There is no corrosion observed.

4. Is the anchorage free of visible cracks in the concrete near the anchors? Y N U N/A
The equipment is anchored to a concrete wall and there are no cracks observed in the wall.

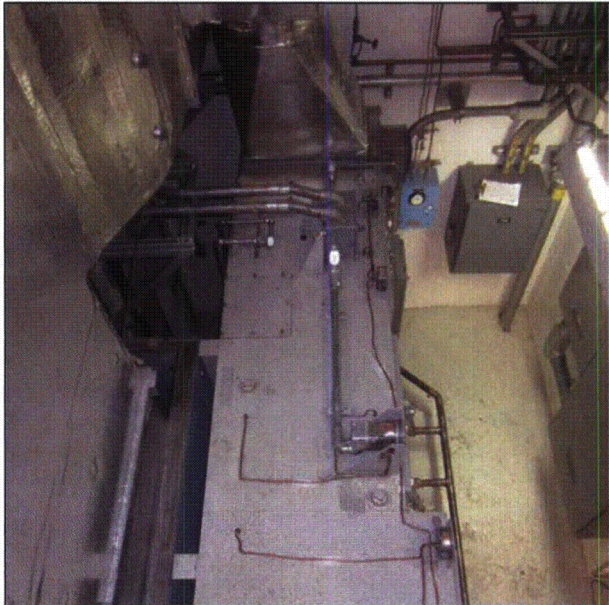
Note: *Top view of VF-26B looking south.*

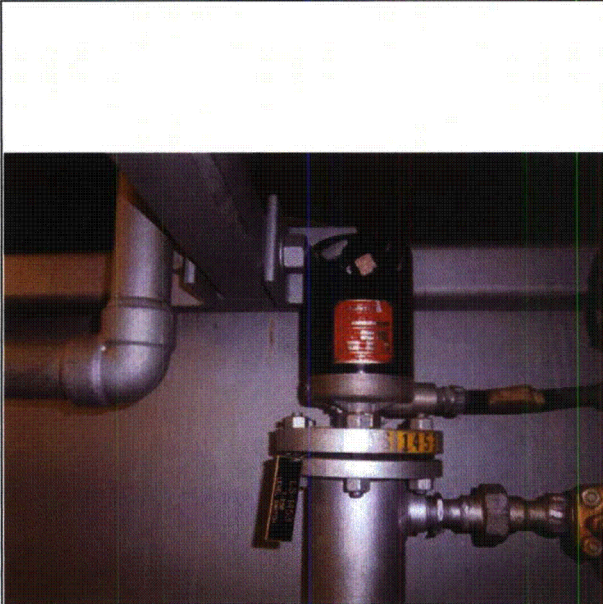
Note: LS-1453 touching bolt for seismic bracing of tank.

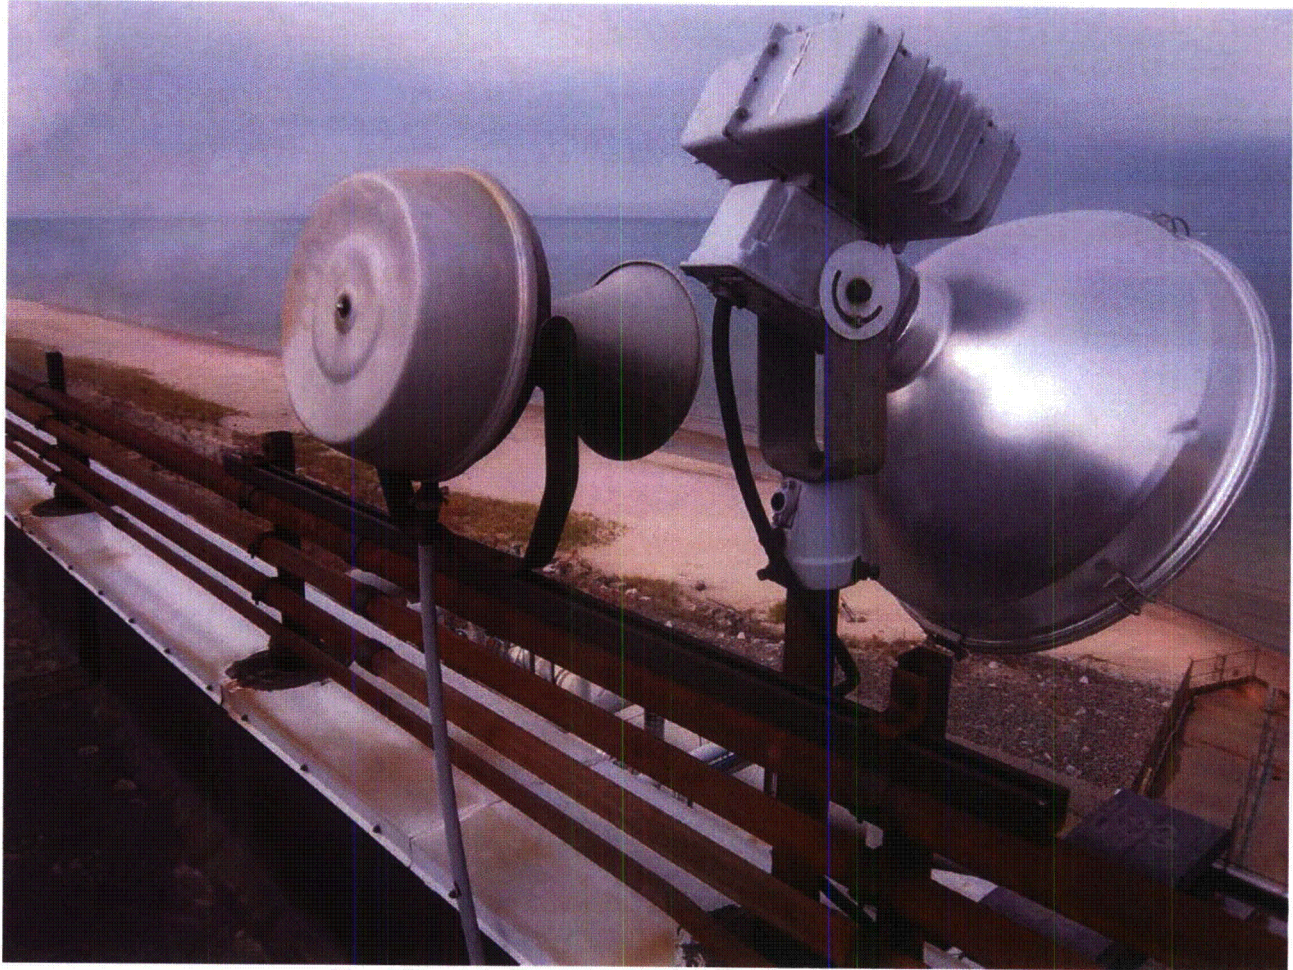
Sound and Lighting Located Above T-2, Taken From the Turbine Building.
