ATTACHMENT 9.6

SEISMIC WALKDOWN CHECKLIST FORM

IP3

Seismic Walkdown Checklist (SWC) SWEL1-092

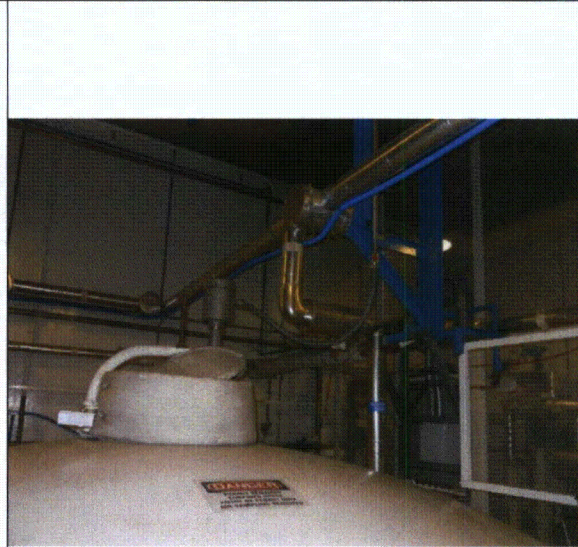
**Note:** *View of head*

*Some bolts exhibit slightly more than mild surface oxidation. The condition is not advanced and bolts should be cleaned and coated to provide protection against further deterioration. The current condition is considered acceptable. CR-IP3-2012-03236 has been issued to remedy this condition.*

*Caulking at the base of the tank is deteriorated. Recommend upgrade/replacement of caulking to prevent water intrusion under the tank. Coating of the anchor bolts is recommended to prevent further corrosion.*

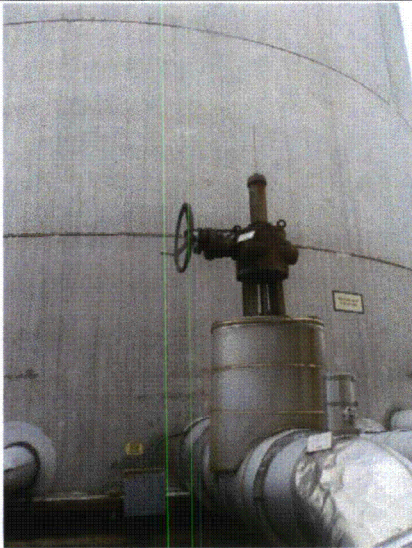
**Note:** RWST-31

*Anchor bolts show evidence of having some surface corrosion near the base before being painted. The anchors are currently well protected from corrosion by a surface coating.*

*Local concrete cracks are found in the concrete base at and away from the locations of anchor bolts. The cracks are noticeable and generally tight and closed. Structural monitoring maintenance program per EN-DC-150 for CST tank under license renewal will track these cracks.*

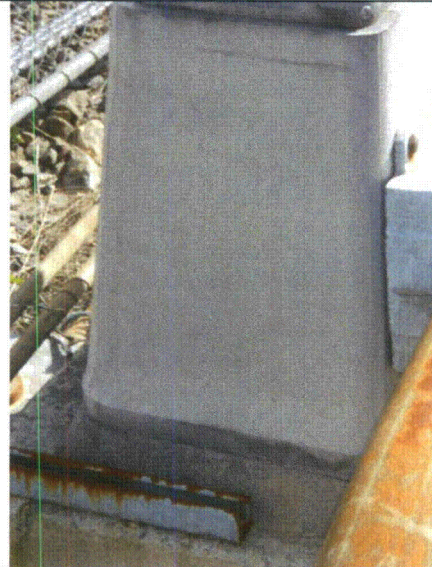
**Note:** Base of lighting pole.

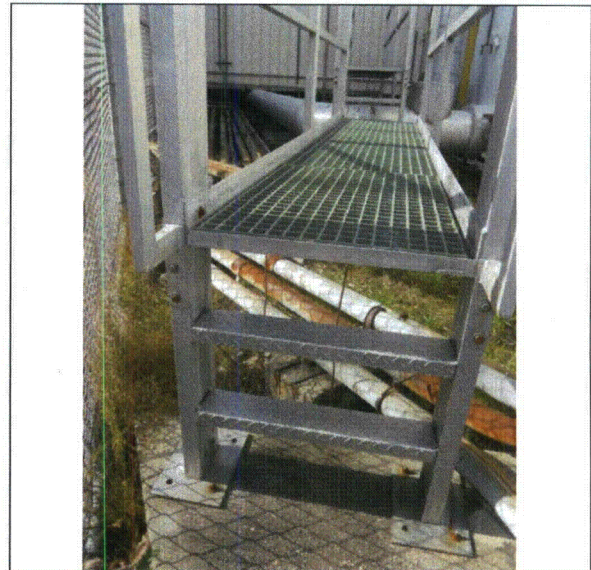
**Note:** Overview of platform

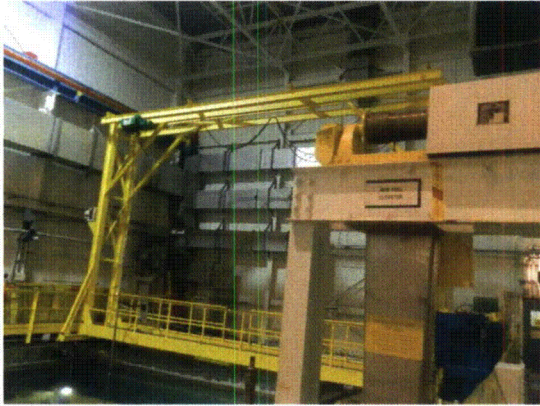
**Note:** *SFPB bridge crane*

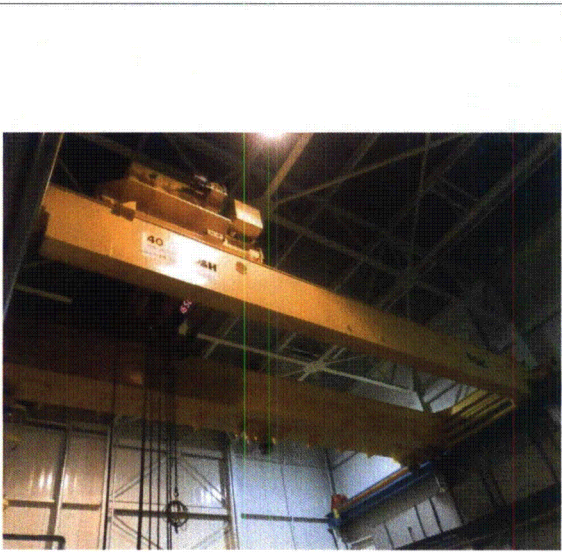
**Note:** *FSB crane*

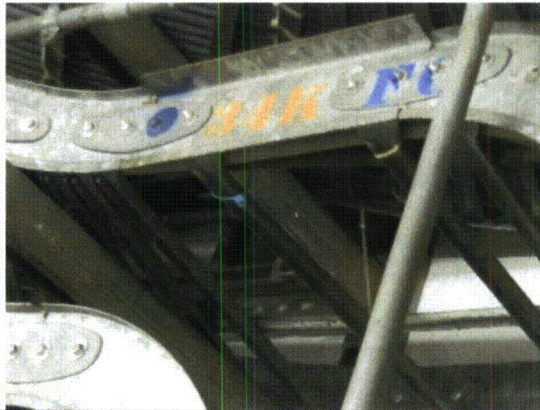
**Note:** Cable tray 34k

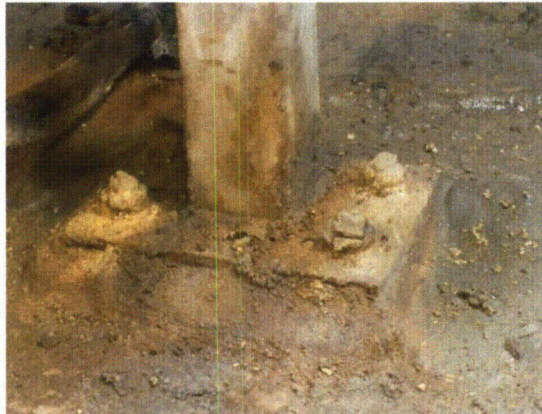
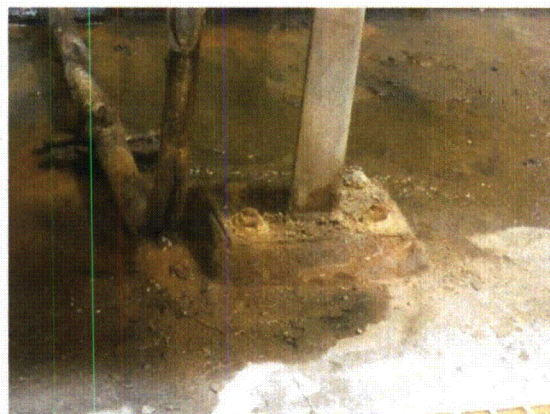
<p><b>Note:</b> Control Panel TWS #31</p>	<p><b>Note:</b> Control Panel TWS #32</p>

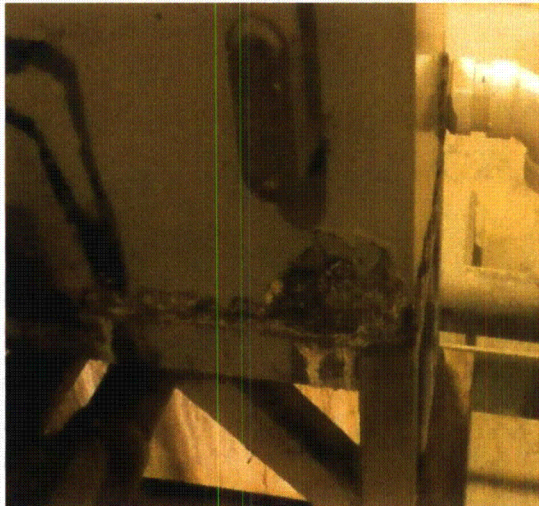
**Note:** Service Water Pumps Annubars rotted at the base.

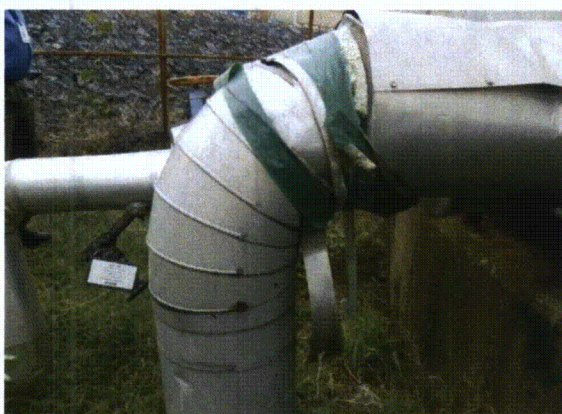
<p><b>Note:</b> <i>Piping insulation connection held with tape.</i></p>	<p><b>Note:</b></p>

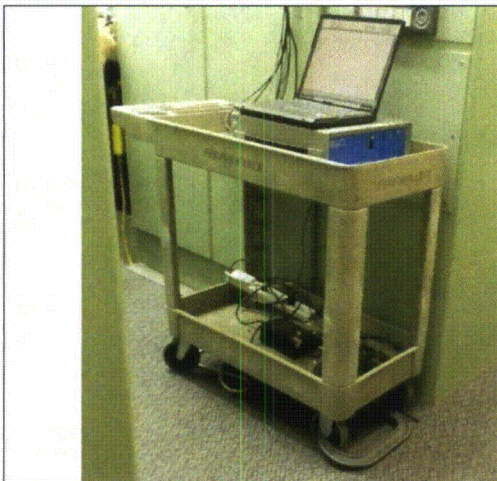
**Note:** well restrained cart by C-10.
