**ATTACHMENT 9.7**

**AREA WALK-BY CHECKLIST**

IP3

**Area Walk-By Checklist (AWC)** AWC-020

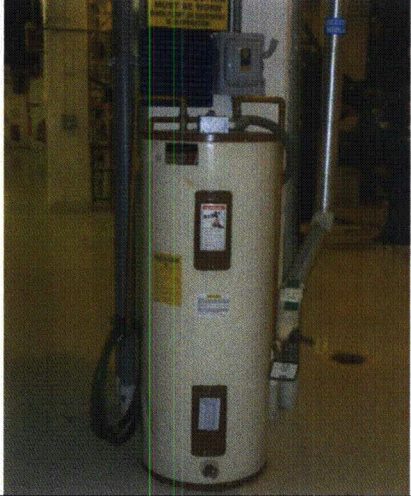
<p><b>Note:</b> Hot water heater with no apparent restraint</p>	<p><b>Note:</b> Duct work held together with vise grips</p>

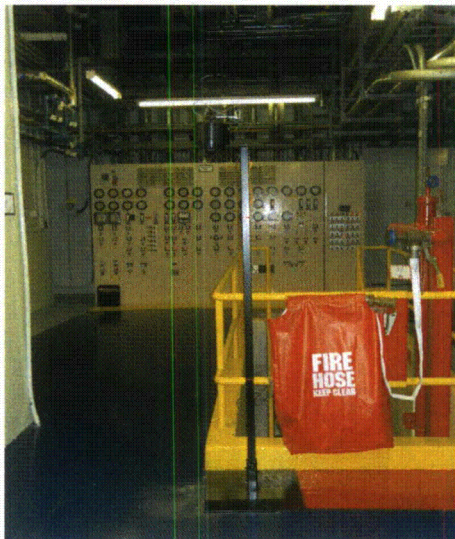
*Camera mounted on post with base plate which has no anchor bolts and stands adjacent to the stairway. CR-IP3-2012-03565 has been written to correct this condition.*

**Note:** Camera on post with unsecured base plate

*LB-12 was performed to evaluate the condition.*

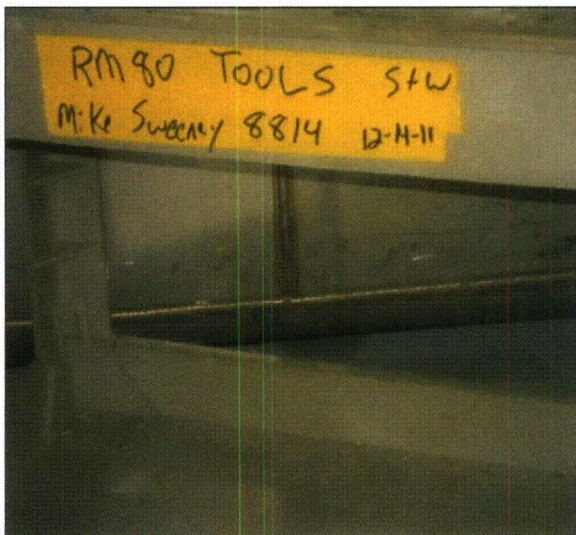
**Note:** Identification of unsecured cart
