Area Walk-By Checklist (AWC)

Area 1AB-1g Floor El. 574 Bldg. AX

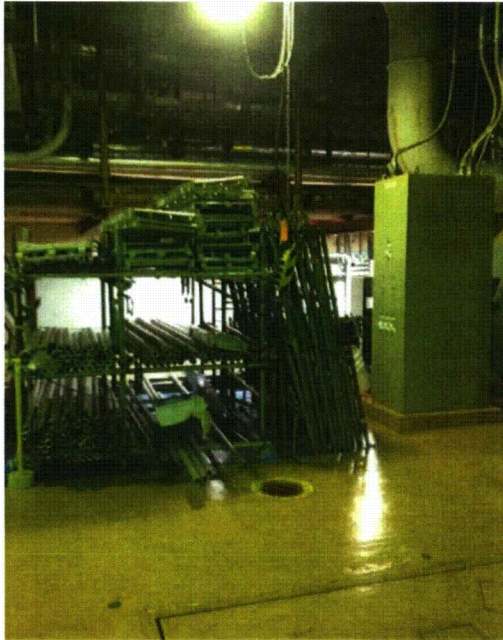
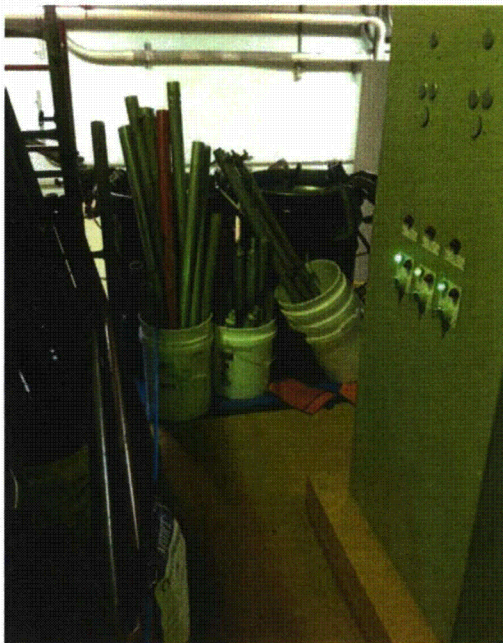
File Name: 1-59-3-1-20.jpeg
Description: View of scaffold staging area

Temporary scaffolding found to be well braced.

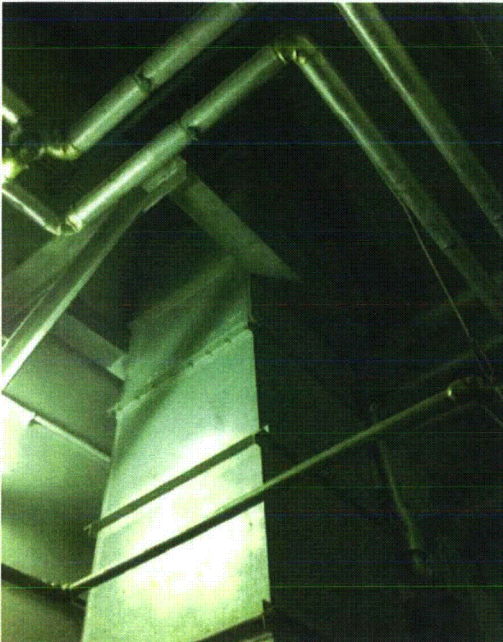
File Name: 1-60-2-1-15.jpeg
Description: View of HVAC support

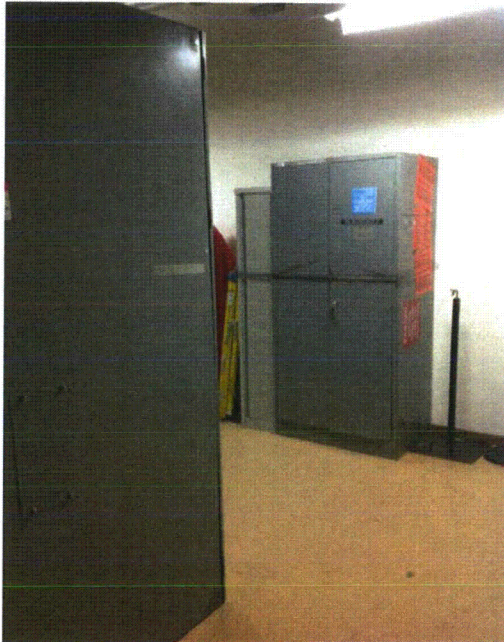
An unrestrained tool storage locker was found near components. CR 2012-12222 generated to document this situation, and the cabinet was subsequently moved. Most fluorescent lights have compression fittings. A row of twist-in style lights was observed, but it was judged to be unlikely to impact any components. Trolleys on top of switchgear were observed to be unrestrained. These trolleys were positioned in the center of the switchgear, consistent with IPEEE resolution of the issue.

File Name: 1-69-1-1-06.jpeg
Description: Tool locker not restrained behind bus/breakers

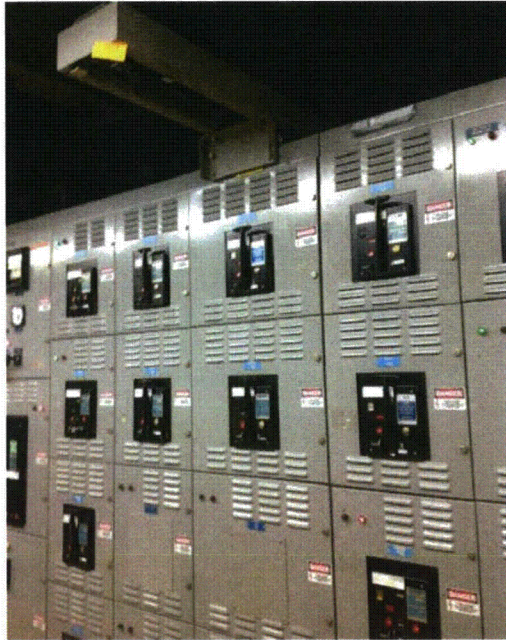
File Name: 1-71-1-1-06.jpeg
Description: View of trolley on top of Cabinet

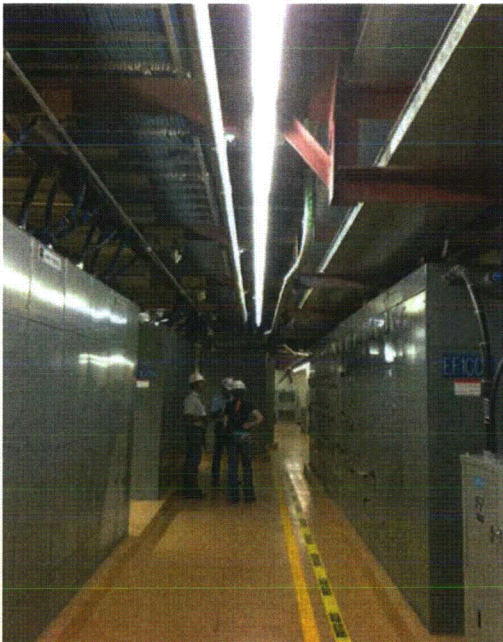
File Name: 1-75-1-1-06.jpeg
Description: View of single row of fluorescent lights

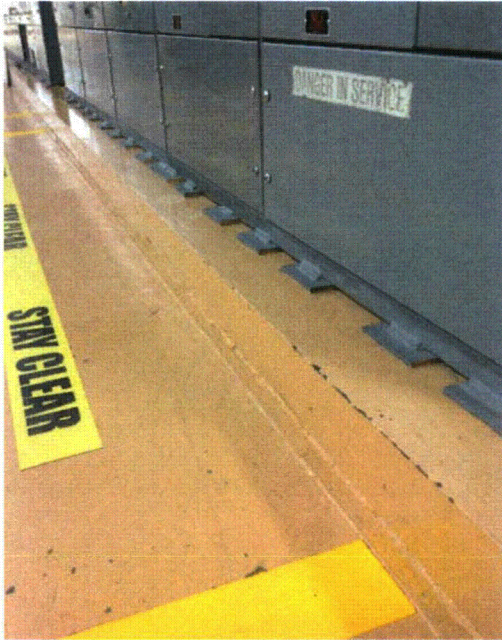
File Name: 1-69-3-1-06.jpeg
Description: Welded shims for 1R21-S0019

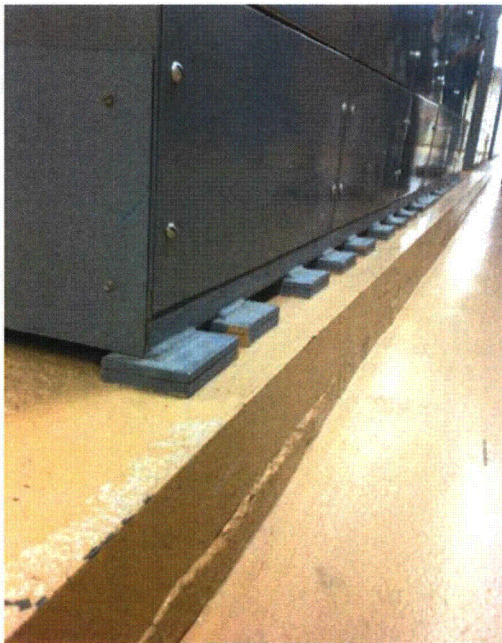
File Name: 1-70-3-1-06.jpeg
Description: Welded shims for 0R24-S0035

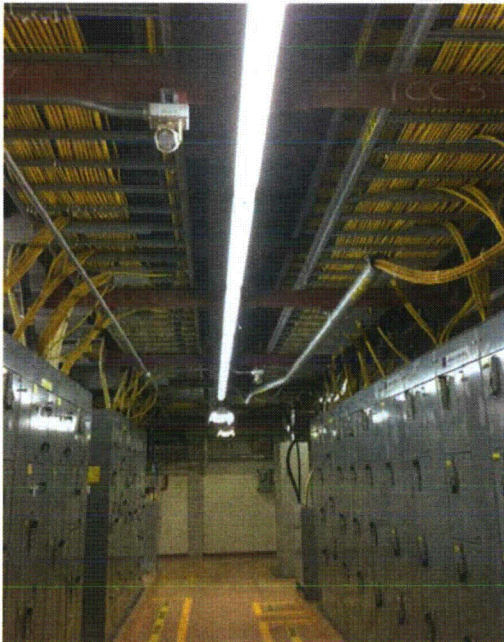
File Name: 1-72-3-1-06.jpeg
Description: View of single row of fluorescent lights

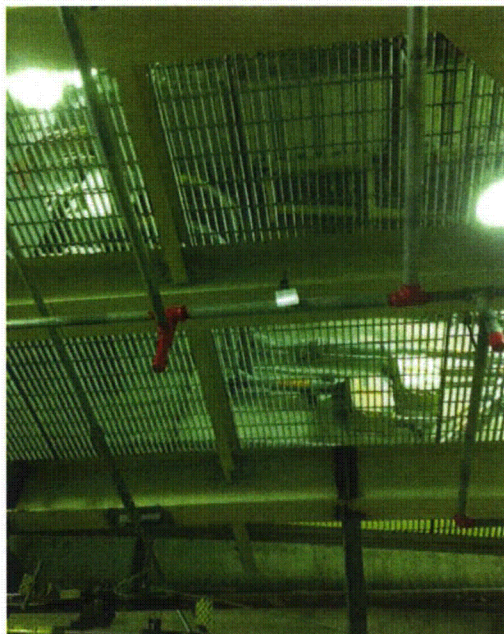
File Name: 1-60-2-1-16.jpeg
Description: Friction clip on fire protection piping

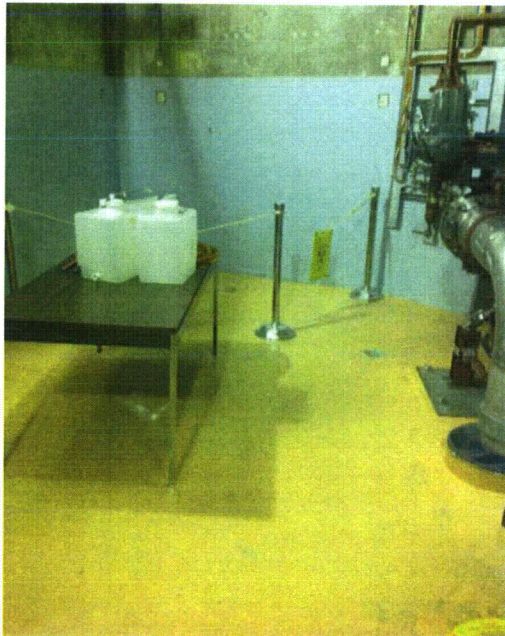
File Name: 1-66-2-1-16.jpeg
Description: Potential impact from table judged not to be significant

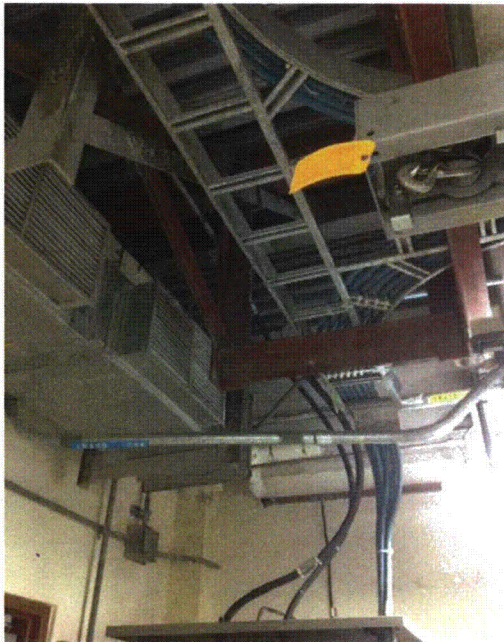
File Name: 1-60-1-1-02.jpeg
Description: Rigid support cable tray and HVAC

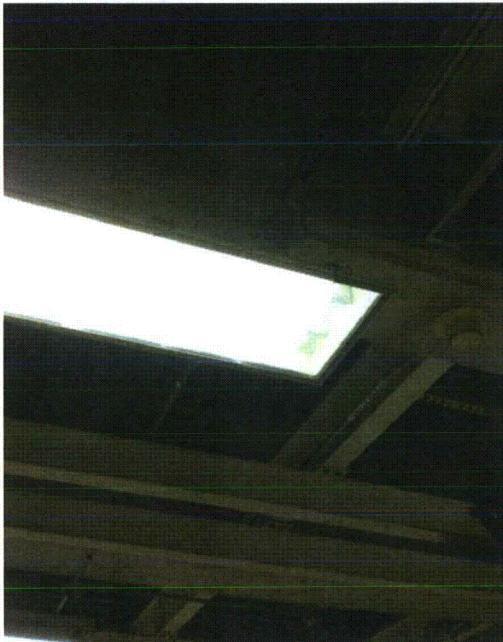
File Name: 1-60-4-1-02.jpeg
Description: Protective light cover

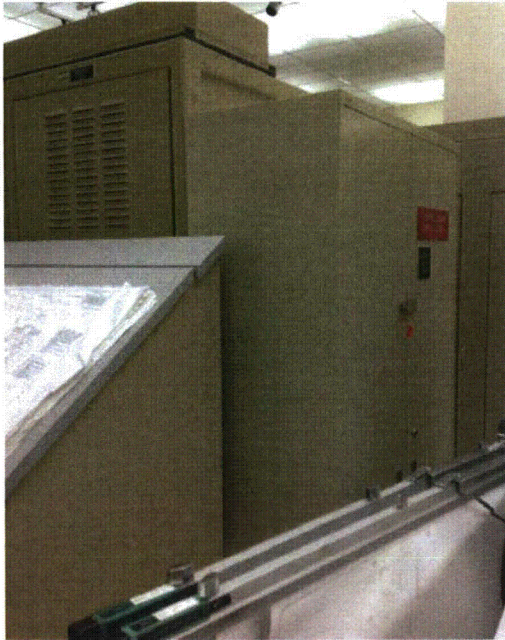
File Name: 1-59-1-1-03.jpeg
Description: Supply locker not anchored

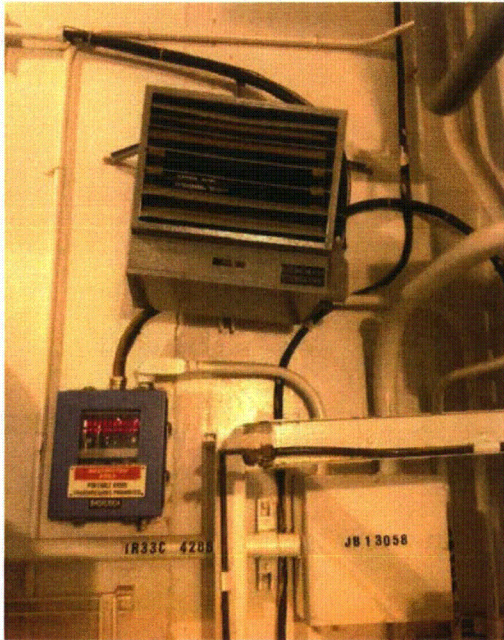
Space heater observed to be crooked, judged not to be a concern

File Name: 1-65-1-1-08.jpeg
Description: View of crooked heater. Not a concern for operability.

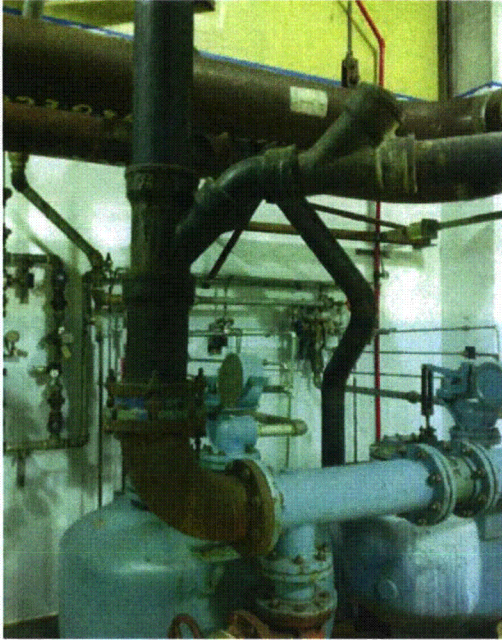
File Name: 1-71-1-1-01.jpeg
Description: Cast iron pipe

*Cast iron pipes were identified with tags reading Seismic Violation. After walkdown proceedings, it was confirmed that these tags relate back to a seismic walkdown from the past that identified issues and design engineering resolved issues. No further action was required.
1" to 3" diameters piping to water heater P71-A003 is rod hung. Judged OK as it is non-seismic and potential flooding would not impact equipment.
6 inch diameter cast iron sewage piping observed to be supported by long rod hangers. Judged OK as the piping is non-seismic and potential flooding would not impact Category I equipment.*

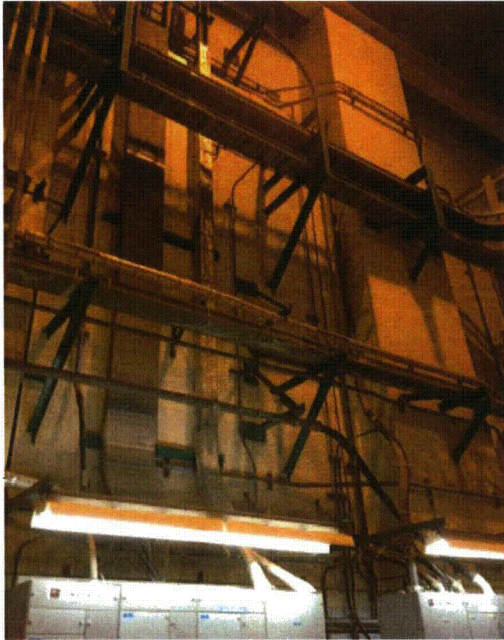
File Name: 1-59-1-1-05.jpeg
Description: Raceways rigidly supported

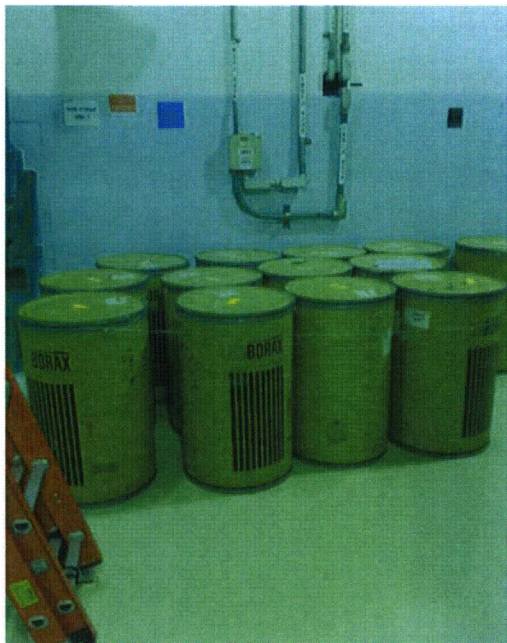
File Name: 1-60-1-1-09.jpeg
Description: View of containers in the area

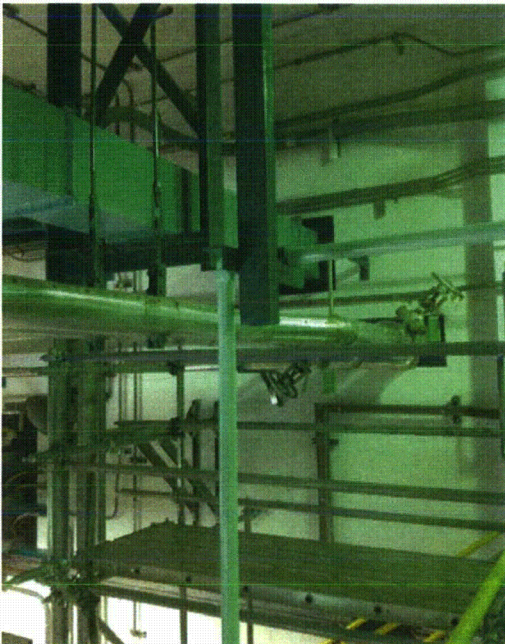
File Name: 1-60-1-1-11.jpeg
Description: View of HVAC duct wall penetration
