APPENDIX B SEISMIC WALKDOWN CHECKLISTS (SWCs)

Seismic Walkdown Checklist (SWC)

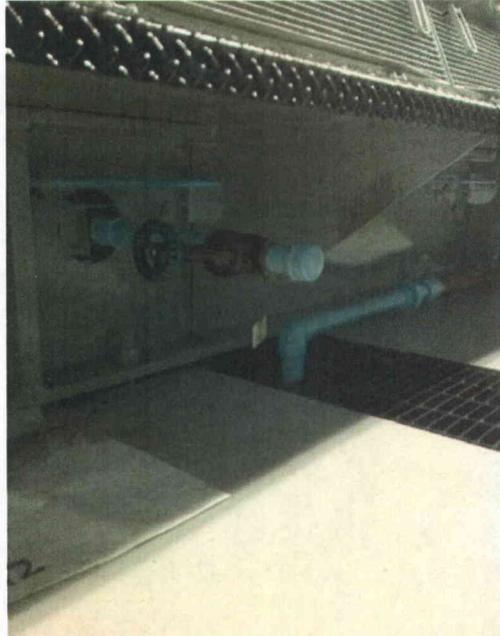
File Name: 2-73-8-1-20.jpeg
Description: View of base detail showing no grout below DG's middle section.

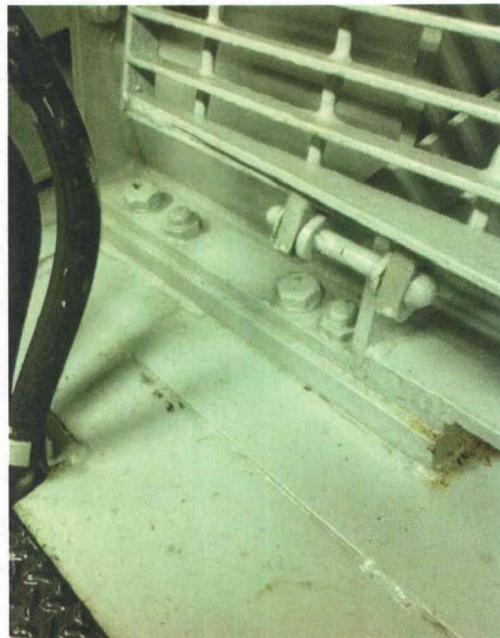
File Name: 2-64-3-1-21.jpeg
Description: Partial view of anchorage configuration

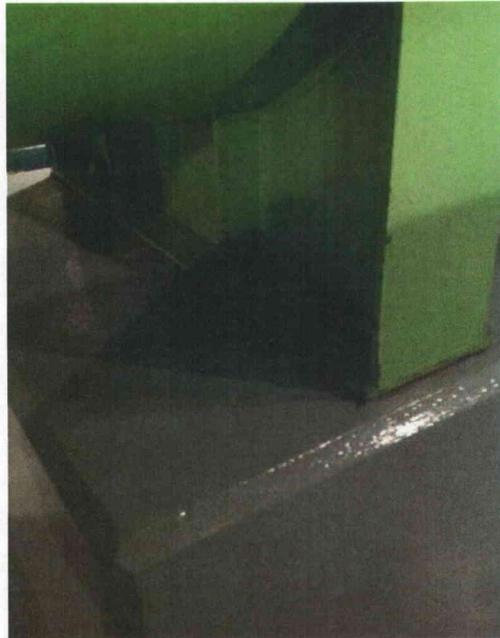
File Name: 2-63-2-1-60.jpeg
Description: View of saddle outer anchorage configuration

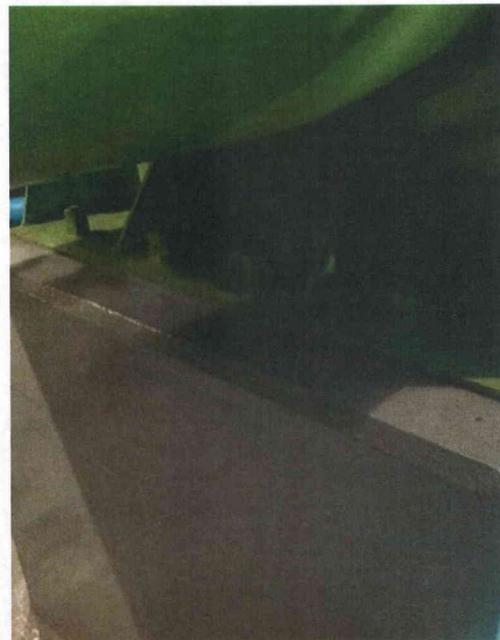
File Name: 2-64-2-1-60.jpeg
Description: View of saddle inside anchorage configuration

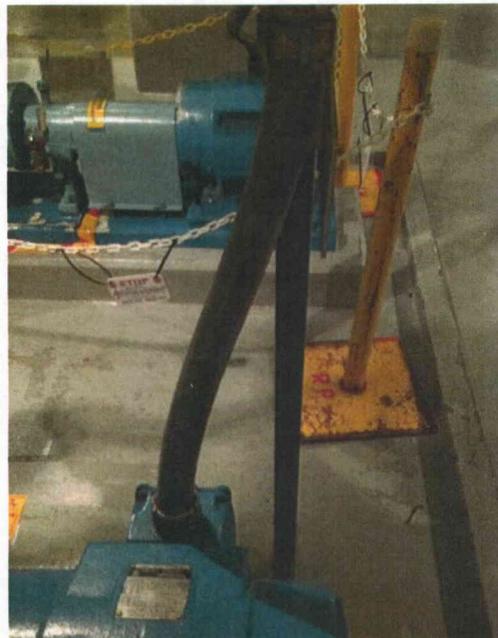
File Name: 2-64-3-1-60.jpeg
Description: Flexible attached lines

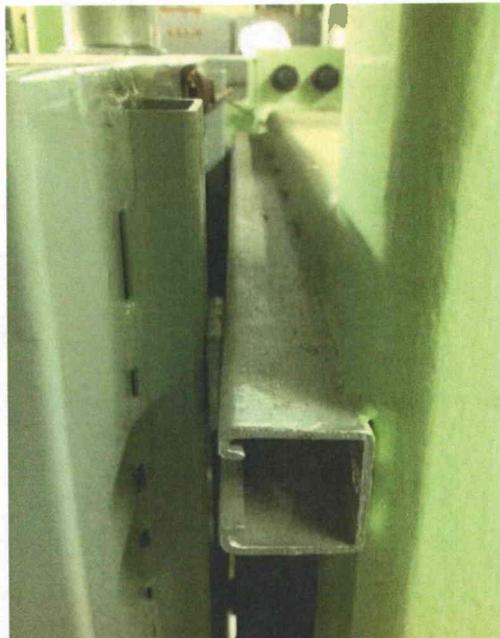
File Name: 2-64-1-1-60.jpeg
Description: View of channel struts attached to posts

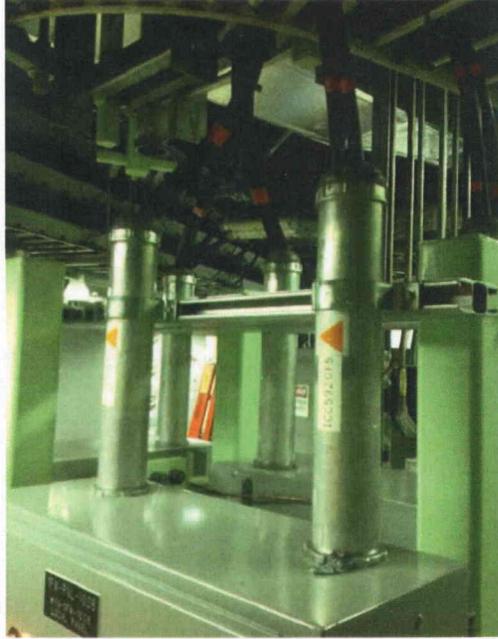
File Name: 2-73-1-1-60.jpeg
Description: View of top entry conduits

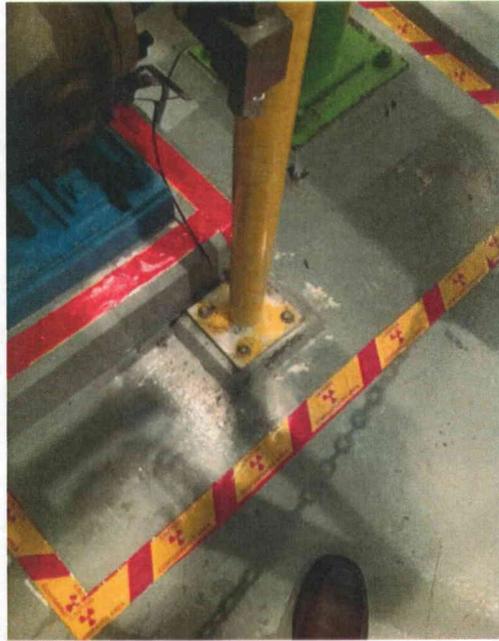
File Name: 2-63-4-1-60.jpeg
Description: Anchorage detail for post base plate

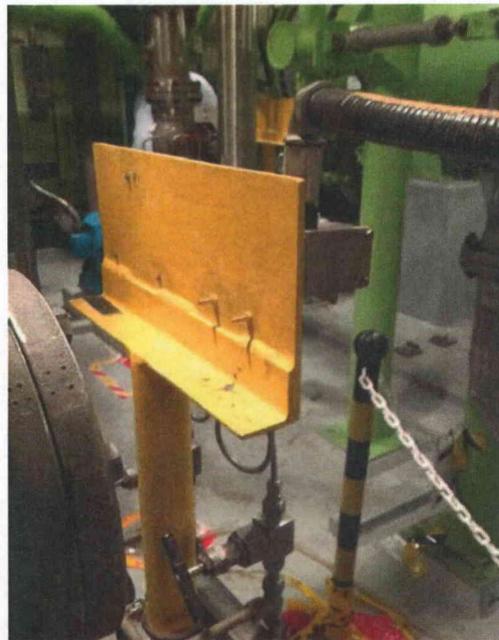
File Name: 2-64-4-1-60.jpeg
Description: View of instrument to steel plate connection

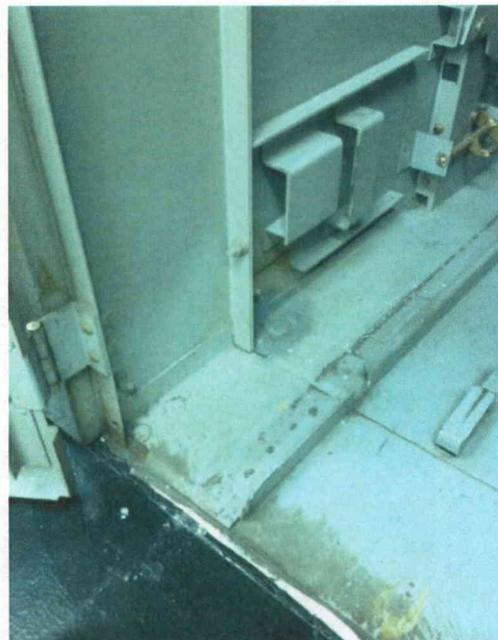
File Name: 2-62-9-1-25.jpeg
Description: Inside view of component showing base detail

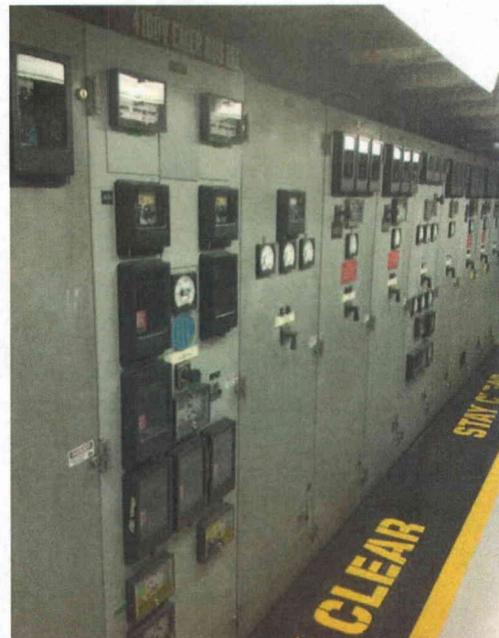
File Name: 2-64-9-1-25.jpeg
Description: General view of component

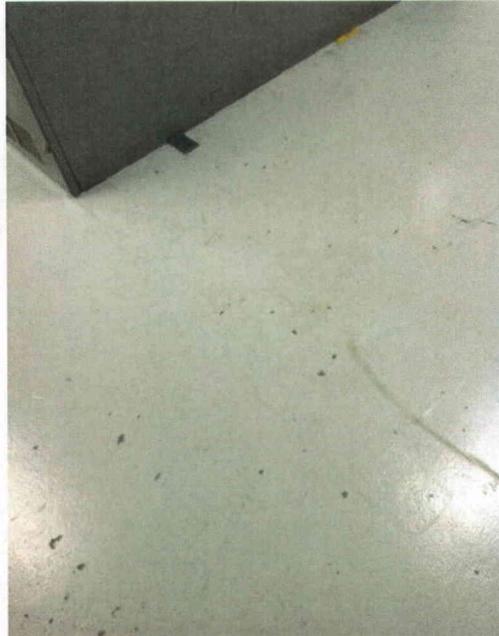
File Name: 2-73-9-1-25.jpeg
Description: View of steel floor embedment

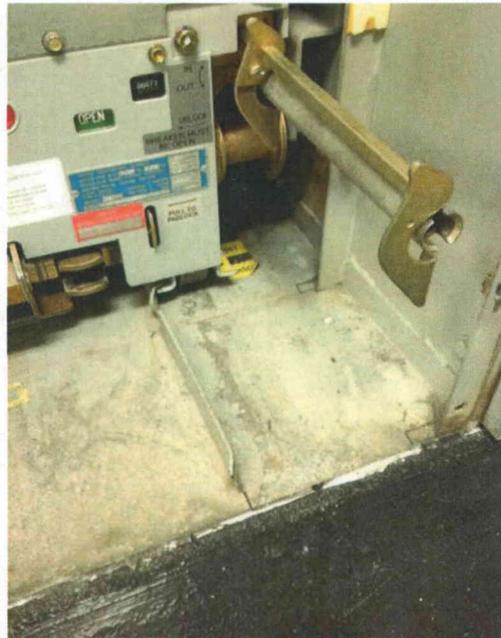
File Name: 2-64-3-1-26.jpeg
Description: Inside view of component showing base detail

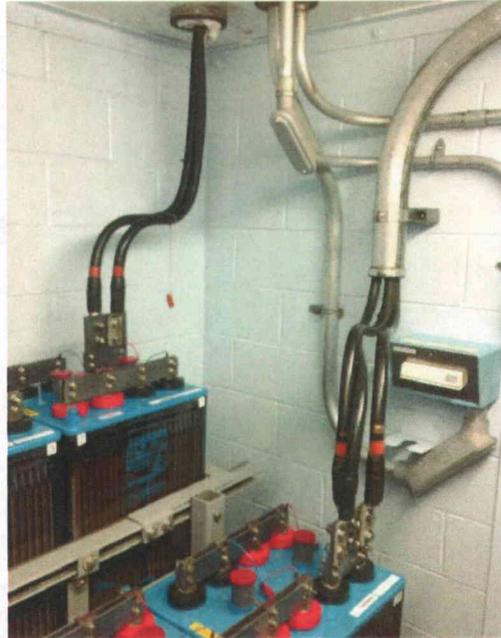
File Name: 2-62-1-1-11.jpeg
Description: View of flexible attached lines

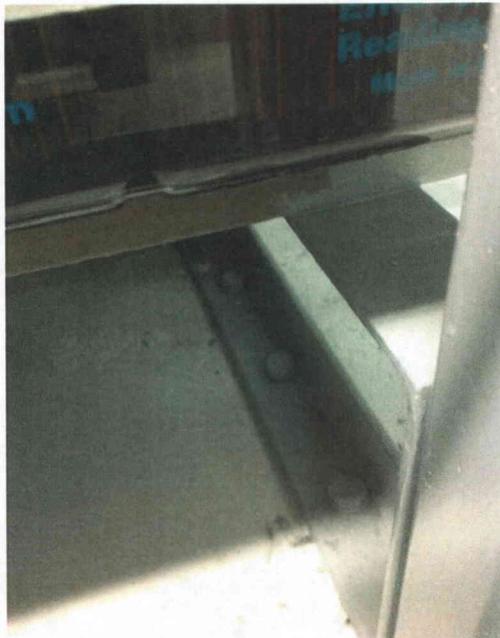
File Name: 2-63-1-1-11.jpeg
Description: Typical frame anchorage configuration

Braced rack-double wide rack composed of 6 bays. Each bay anchored with 6-1/2" diam anchors. End restraints and spacers found in adequate condition.

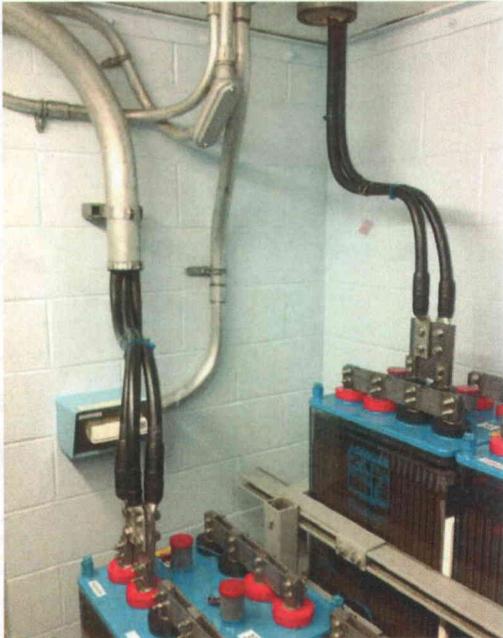
File Name: 2-62-1-1-01.jpeg
Description: Flexible attached lines

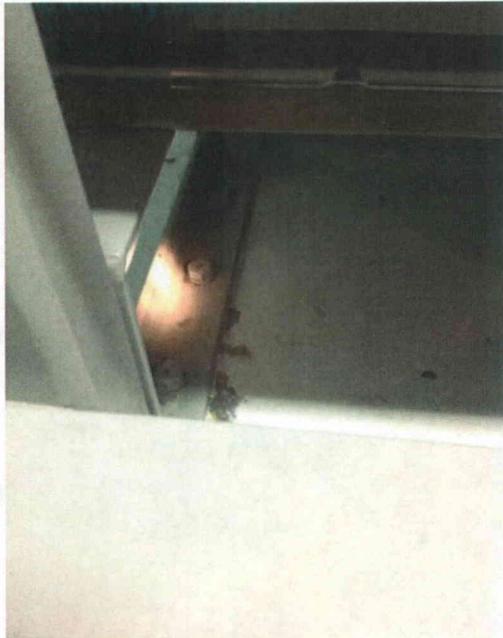
File Name: 2-63-1-1-01.jpeg
Description: Typical frame anchorage configuration

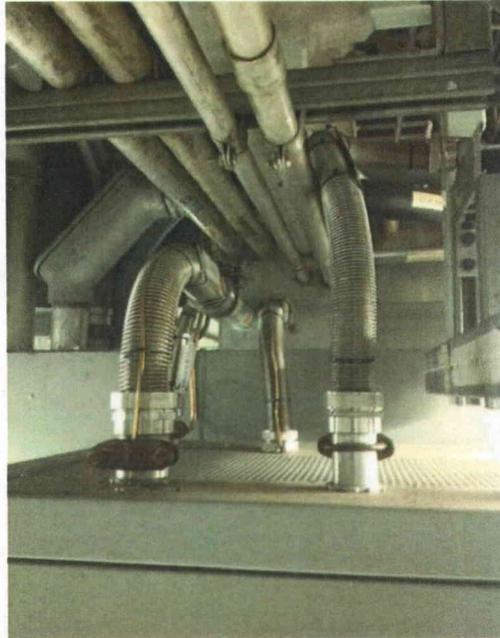
9. Do attached lines have adequate flexibility to avoid damage?
Top entry conduits found with adequate flexibility.

File Name: 2-63-1-1-03.jpeg
Description: View of top entry conduits

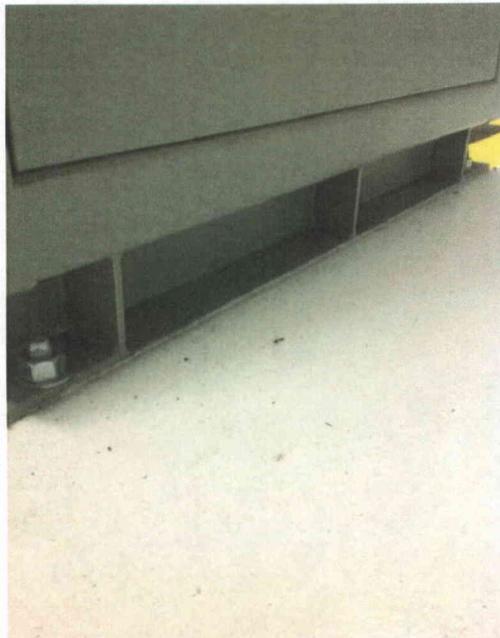
| <i>Charger anchored with 4-5/8" diam anchors. ~4" gap found to next panel judged not a concern.</i> | | | |

File Name: 2-64-1-1-03.jpeg
Description: View of component anchorage configuration

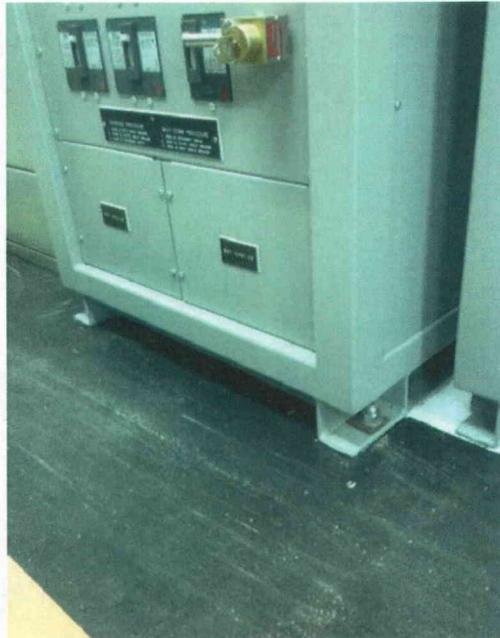
Description: View of component anchorage configuration

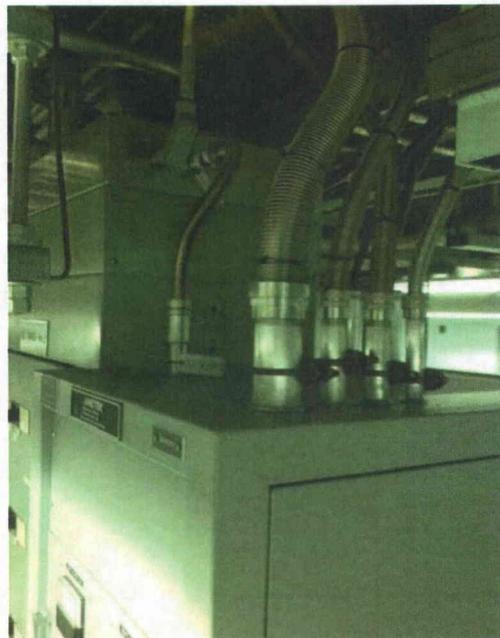
Description: View of top entry conduits

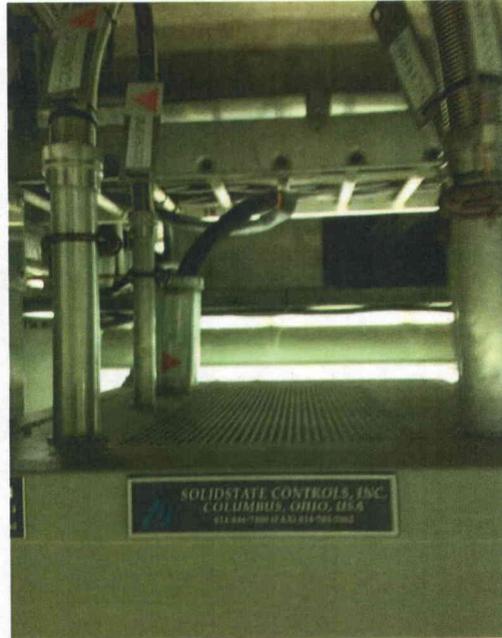
9. Do attached lines have adequate flexibility to avoid damage?
Top entry conduits found with adequate flexibility.

File Name: 2-63-1-1-02.jpeg
Description: View of top entry conduits

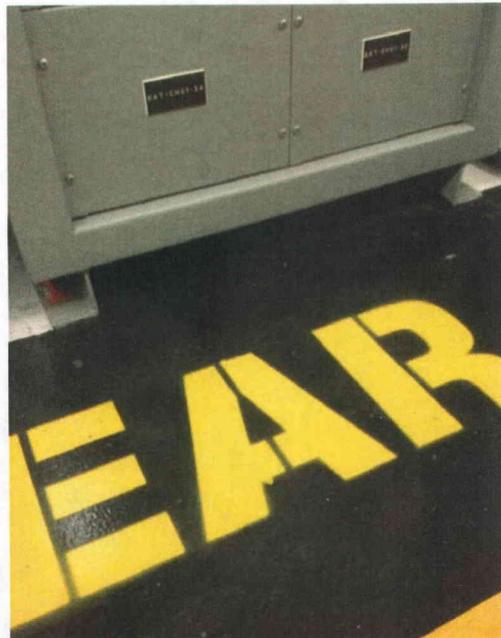
1. Is the anchorage configuration verification required (i.e., is the item one of the 50% of SWEL items requiring such verification)?
Charger anchored with 4-5/8" diam anchors. ~4" gap found to next panel judged not a concern.

File Name: 2-64-1-1-02.jpeg
Description: View of component anchorage configuration

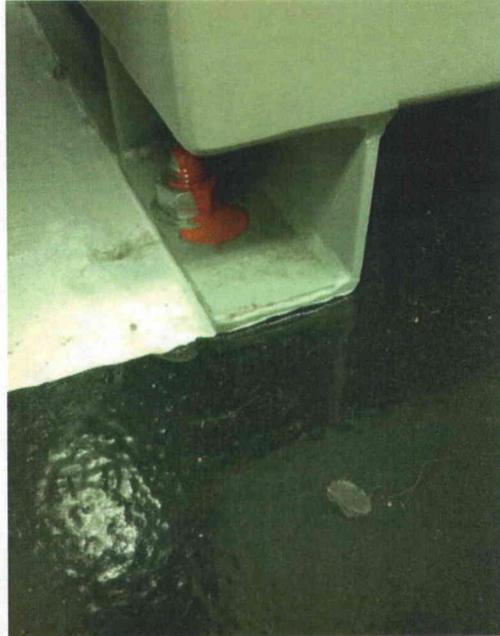
File Name: 2-73-1-1-02.jpeg
Description: Close up view of component anchorage

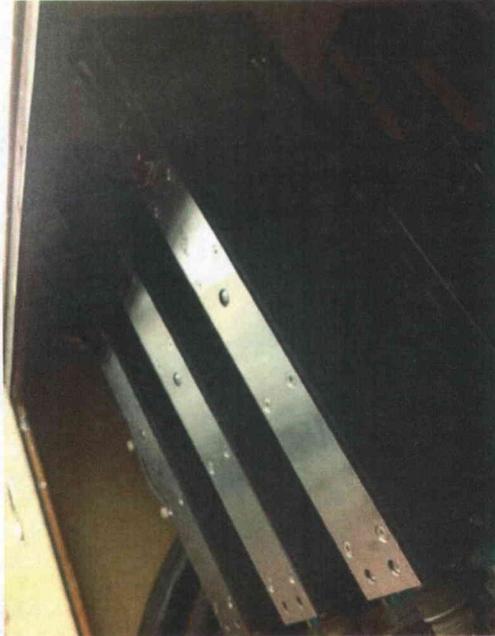
File Name: 2-63-5-1-18.jpeg
Description: View of electrical instrumentation connected to panel

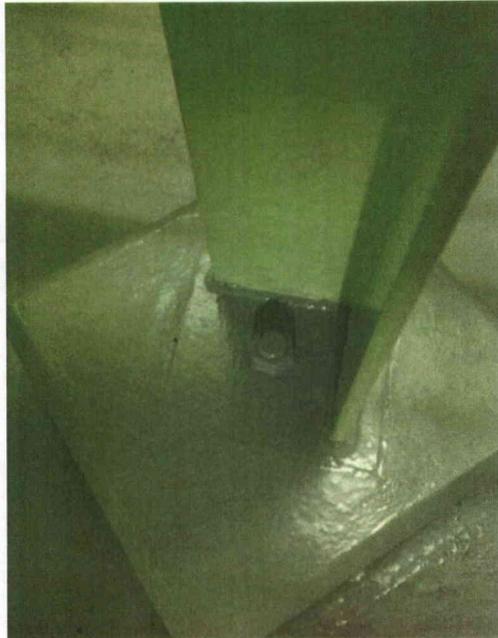
Description: View of anchorage detail for a typical tank support

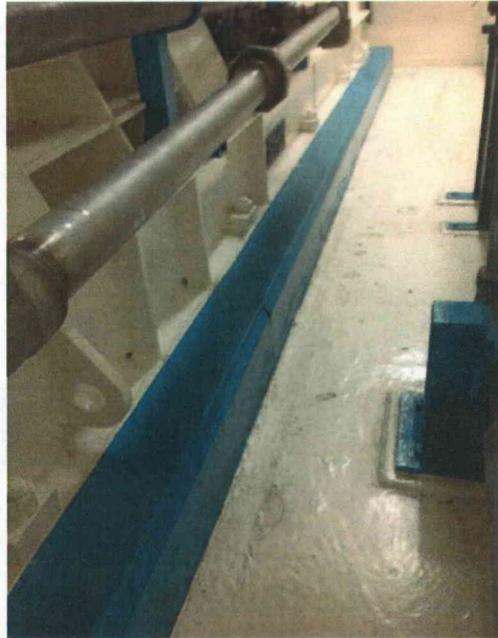
Description: View of component anchorage configuration

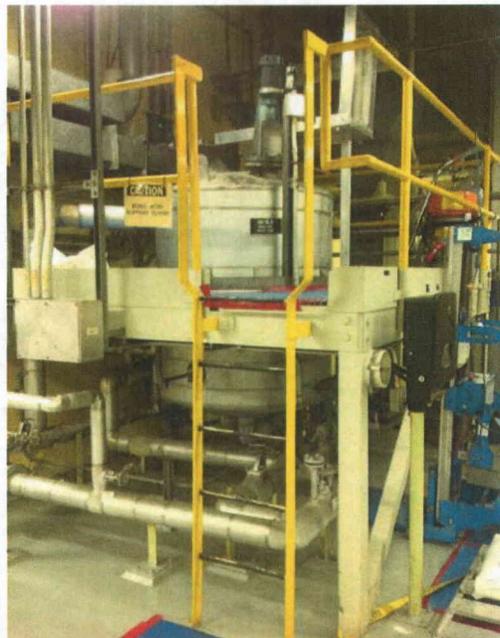
Description: View of platform surrounding Boric Acid Batch Tank

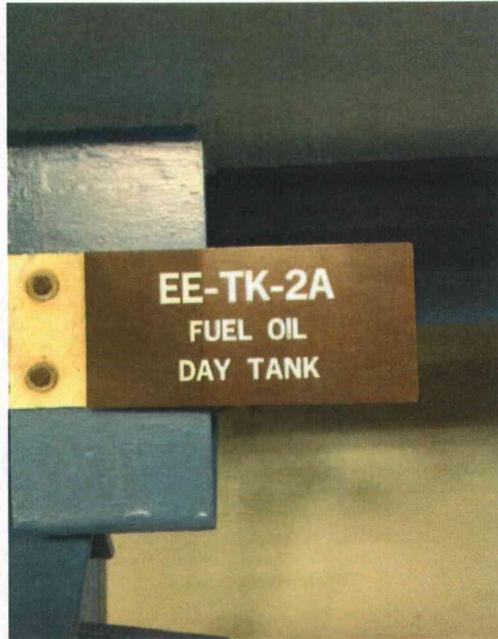
File Name: 2-61-2-1-20.jpeg
Description: Component Plate ID

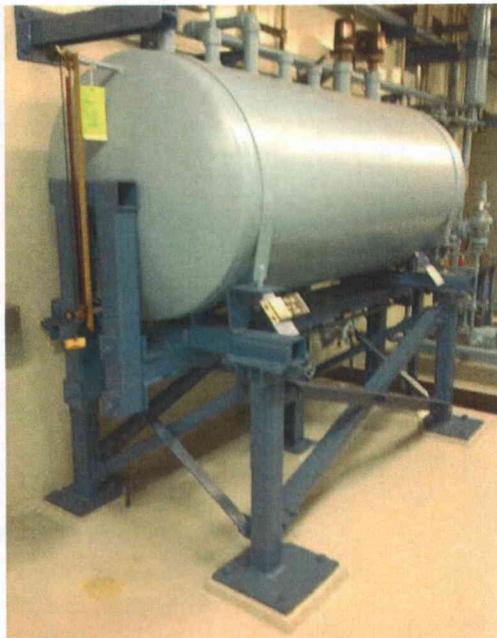
File Name: 2-62-2-1-20.jpeg
Description: General view of component

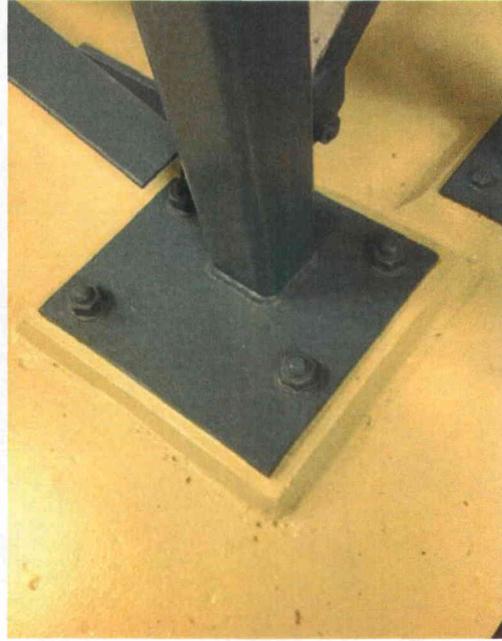
File Name: 2-63-2-1-20.jpeg
Description: View of component anchorage

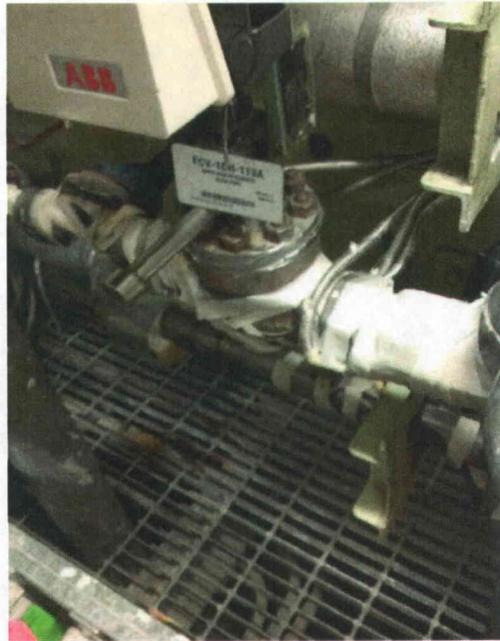
File Name: 2-61-2-1-12.jpeg
Description: Component Plate ID

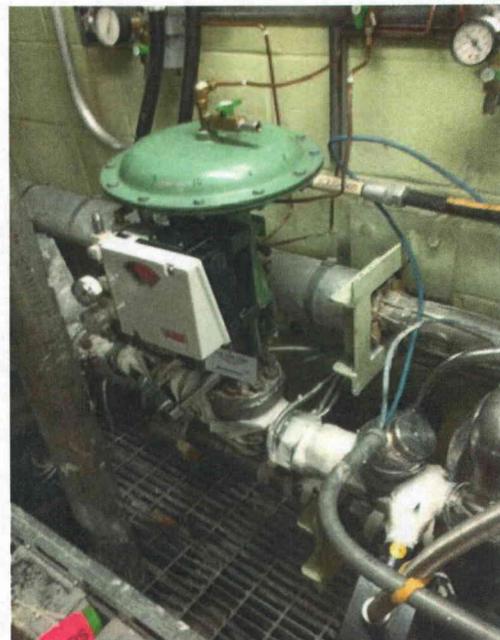
File Name: 2-62-2-1-12.jpeg
Description: General view of component

Small AOV on ~3" line well supported and found in good condition.

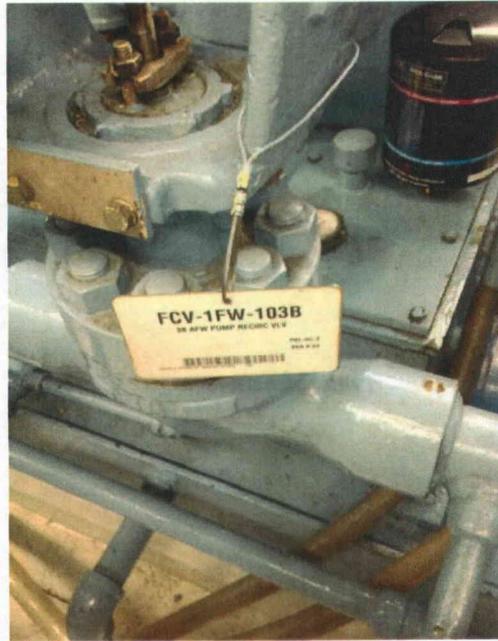
File Name: 2-61-1-1-50.jpeg
Description: Component Plate ID

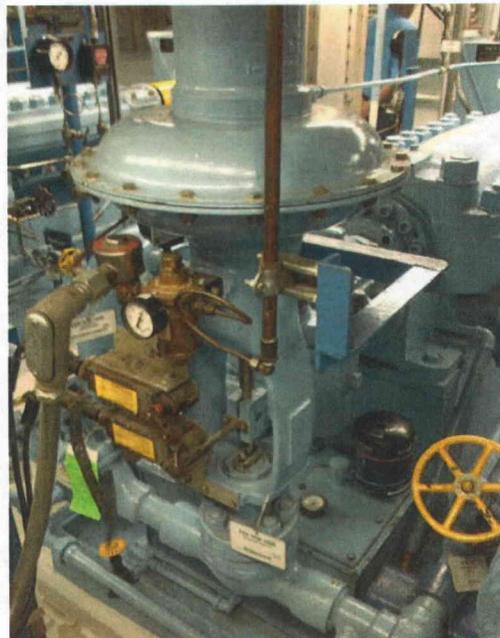
File Name: 2-62-1-1-50.jpeg
Description: General view of component

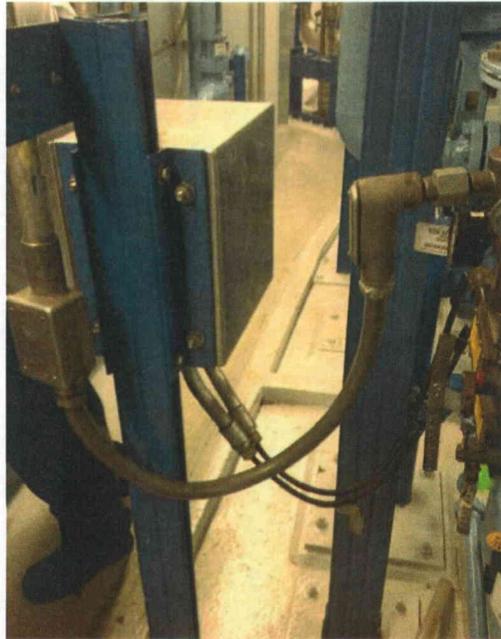
File Name: 2-63-1-1-50.jpeg
Description: View of flexible attached lines

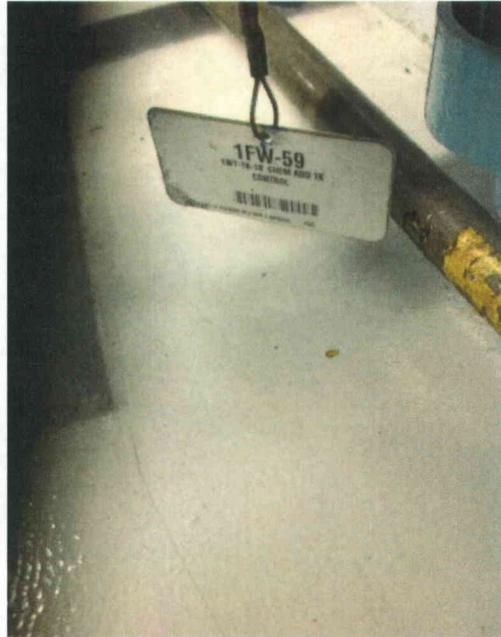
File Name: 2-61-8-1-50.jpeg
Description: Component Plate ID

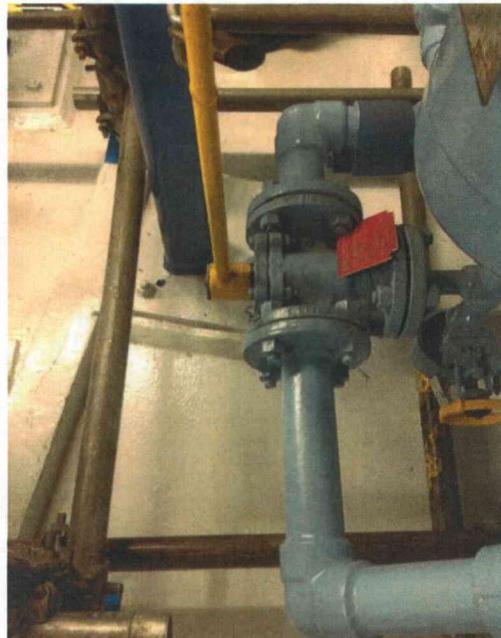
File Name: 2-62-8-1-50.jpeg
Description: General view of component

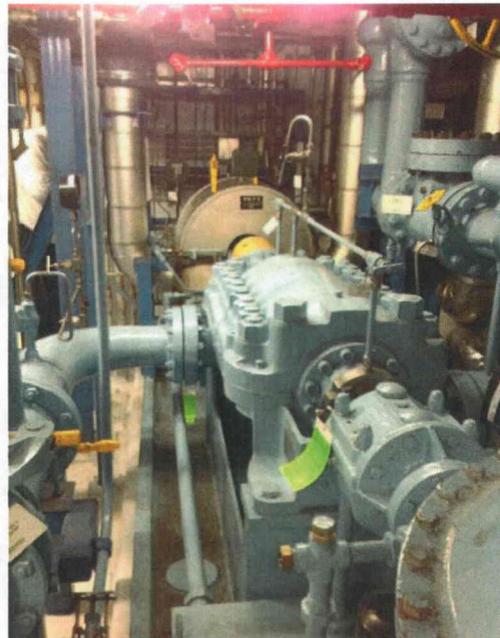
File Name: 2-62-3-1-50.jpeg
Description: General view of component

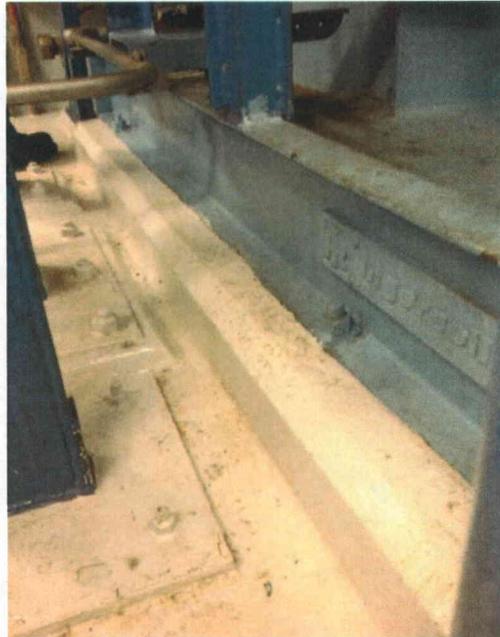
File Name: 2-64-3-1-50.jpeg
Description: View of component anchorage configuration

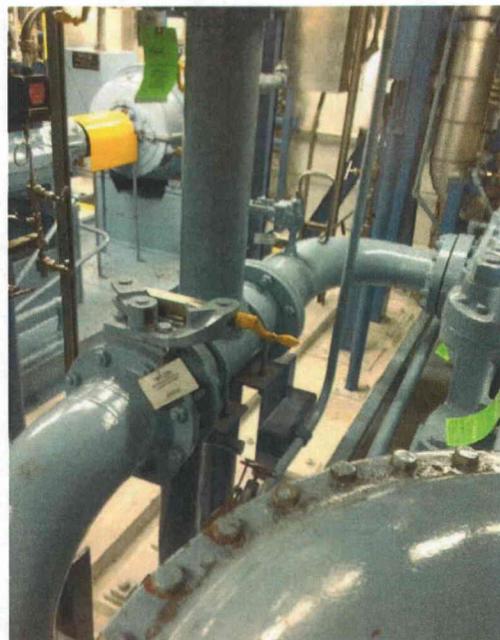
File Name: 2-73-3-1-50.jpeg
Description: View of attached pipe lines

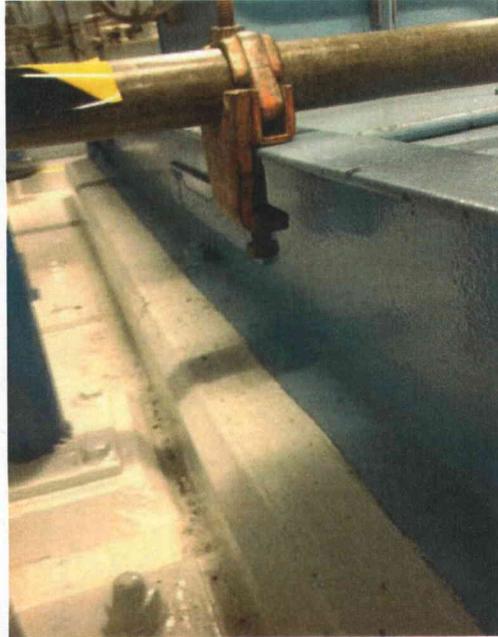
File Name: 2-63-4-1-50.jpeg
Description: View of component anchorage configuration

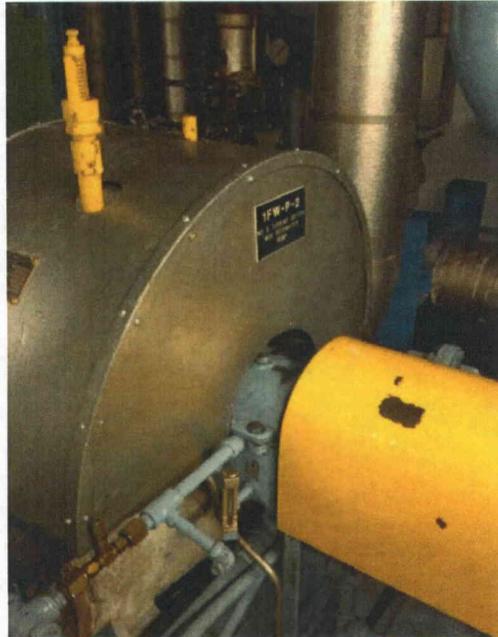
File Name: 2-61-5-1-50.jpeg
Description: Component Plate ID

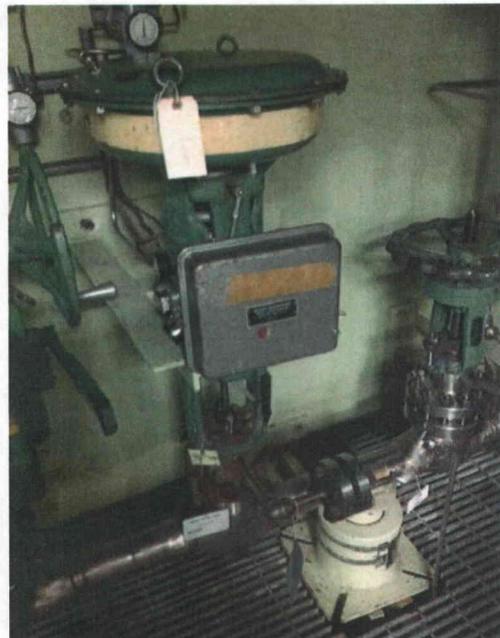
File Name: 2-62-1-1-12.jpeg
Description: General view of component

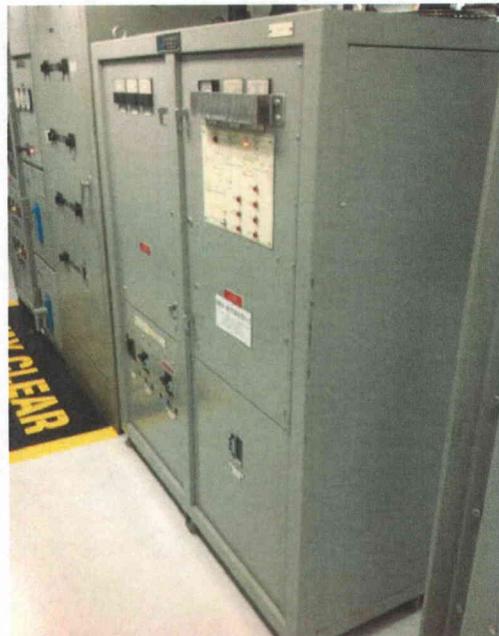
File Name: 2-62-8-1-25.jpeg
Description: General view of component

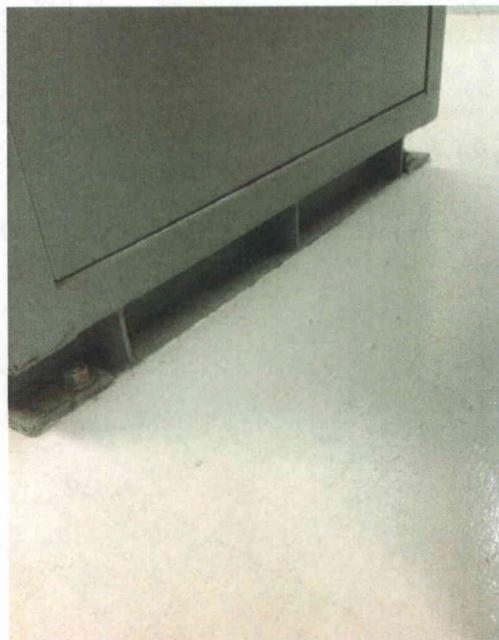
File Name: 2-64-8-1-25.jpeg
Description: View of anchorage configuration

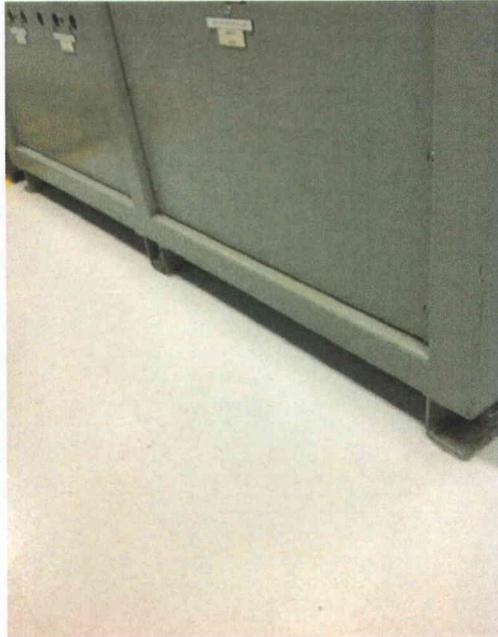
File Name: 2-73-8-1-25.jpeg

Description: Front view of base anchorage configuration

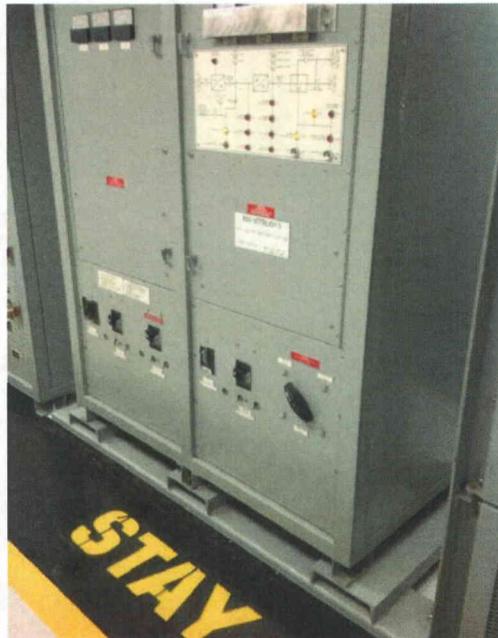
File Name: 2-62-6-1-25.jpeg
Description: General view of component

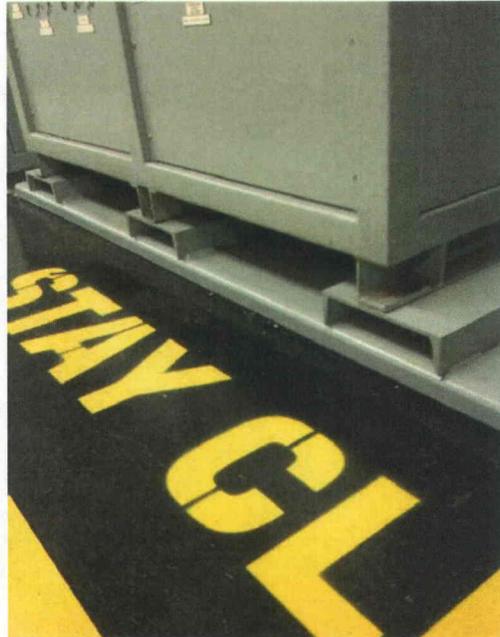
File Name: 2-63-6-1-25.jpeg
Description: Front view of base anchorage configuration

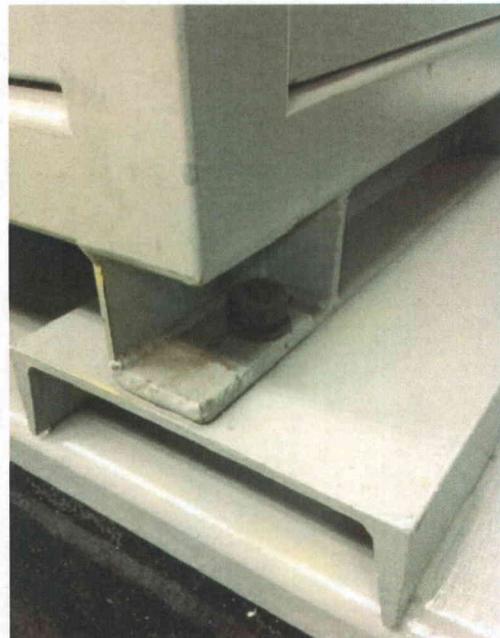
File Name: 2-64-6-1-25.jpeg
Description: Close up view of anchorage detail

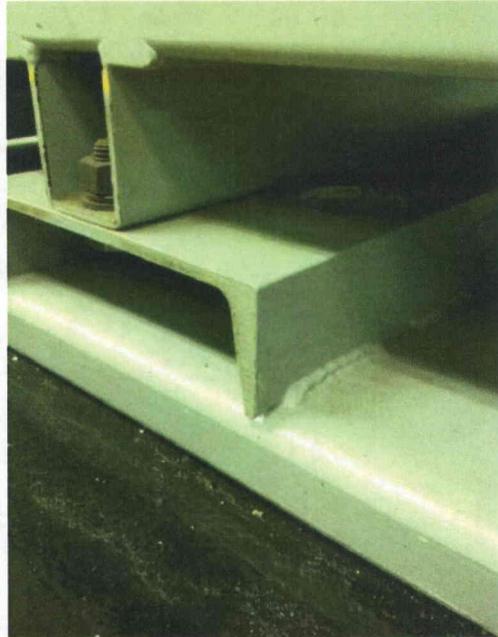
File Name: 2-73-6-1-25.jpeg
Description: View of weld detail on channel mounting base

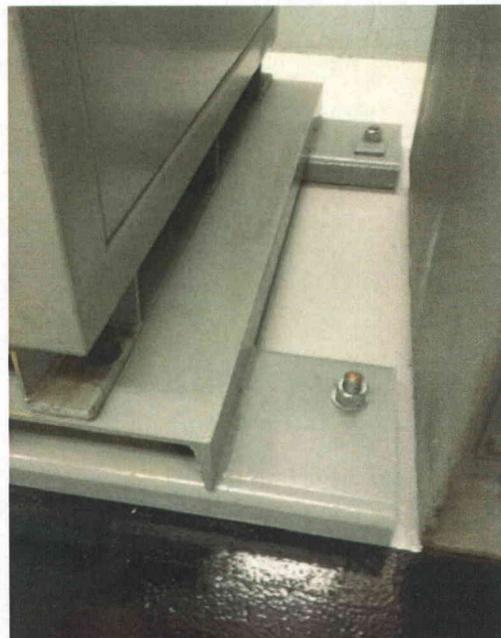
File Name: 2-94-6-1-25.jpeg
Description: General view of base configuration

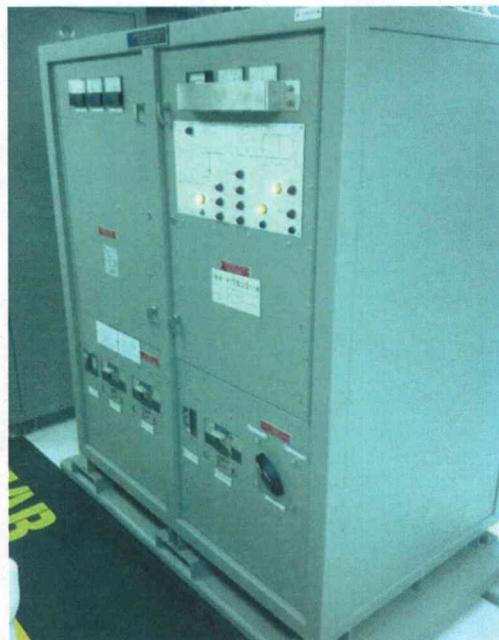
File Name: 2-62-2-1-26.jpeg
Description: General view of component

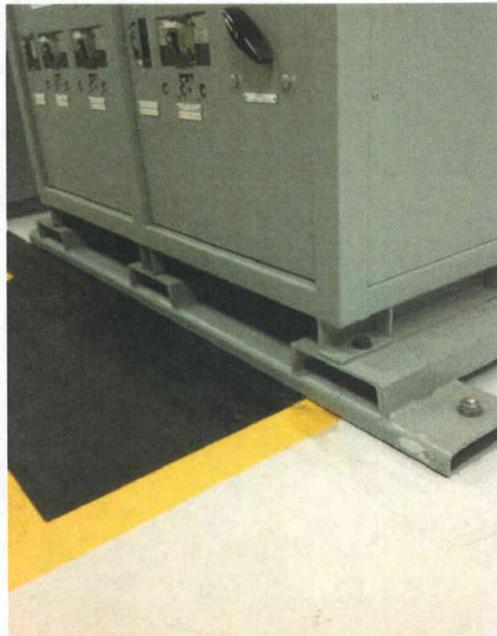
File Name: 2-64-2-1-26.jpeg
Description: Front view of base anchorage configuration

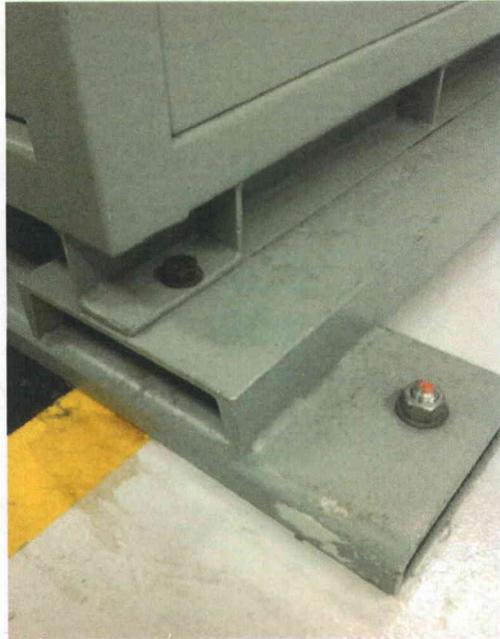
File Name: 2-73-2-1-26.jpeg
Description: Close up view of anchorage detail

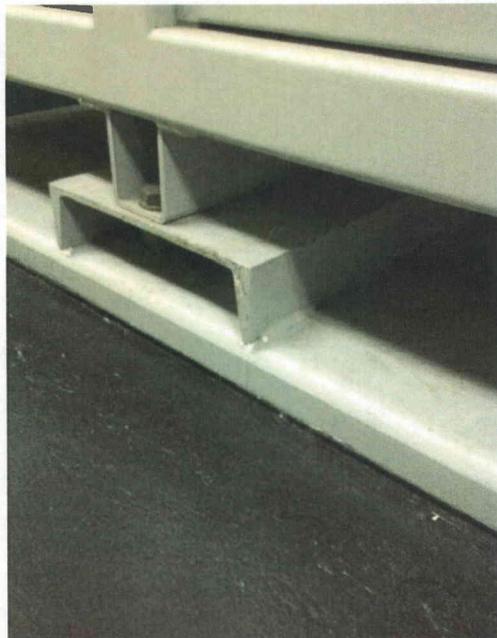
File Name: 2-94-2-1-26.jpeg
Description: View of weld detail on channel mounting base

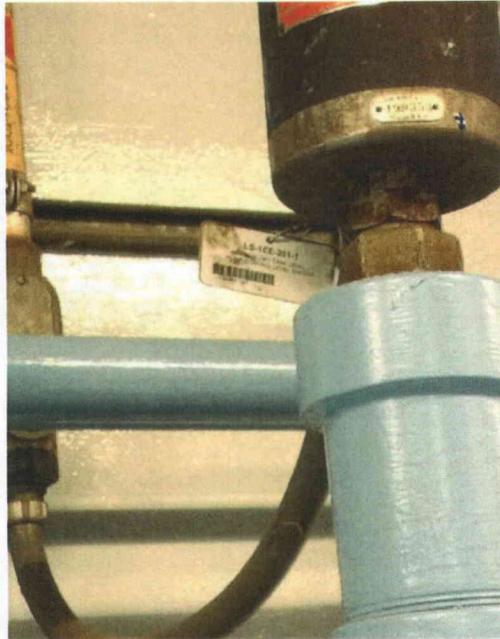
File Name: 2-61-3-1-20.jpeg
Description: Component Plate ID

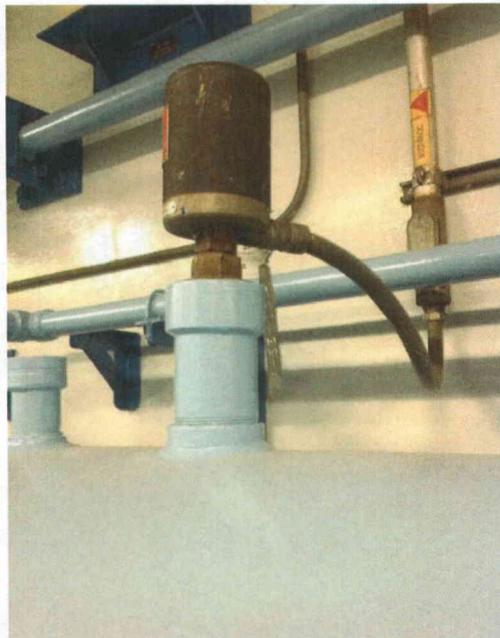
File Name: 2-62-3-1-20.jpeg
Description: General view of component

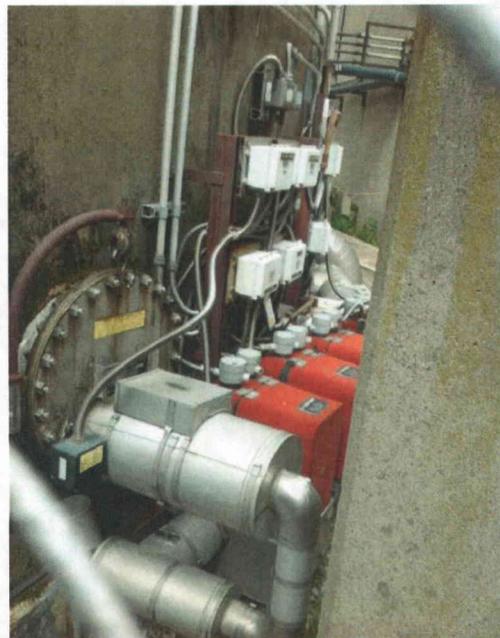
File Name: 2-62-1-1-09.jpeg
Description: General view of component

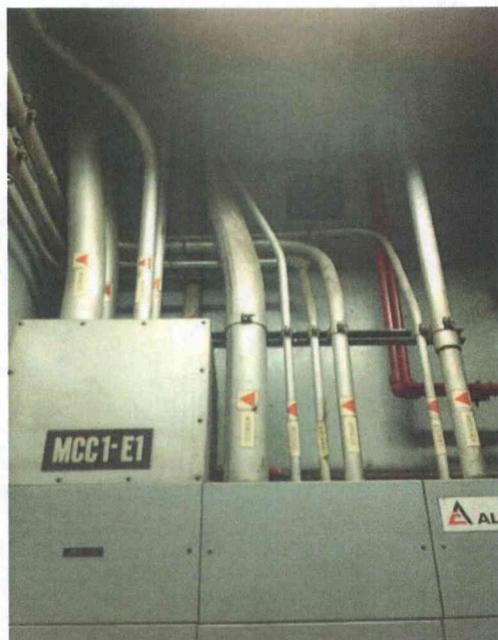
File Name: 2-64-1-1-27.jpeg
Description: View of top entry conduits

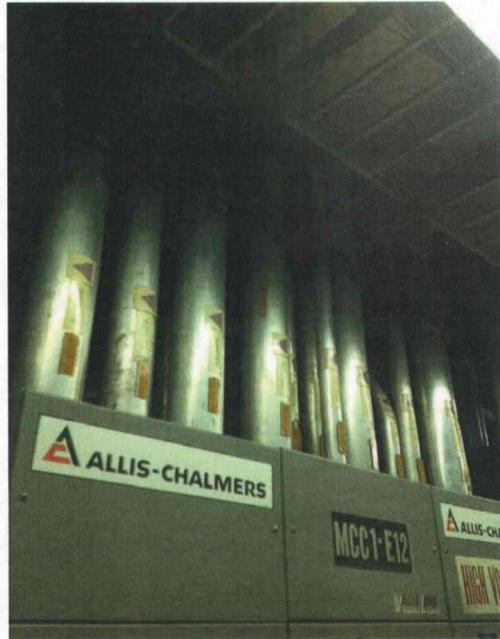
File Name: 2-63-3-1-23.jpeg
Description: View of top entry conduits

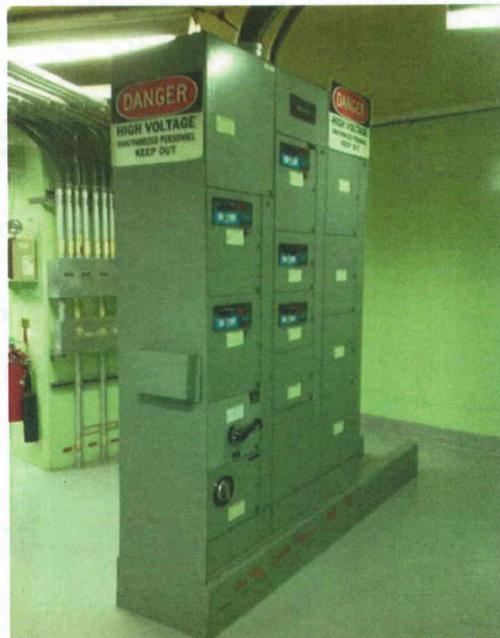
File Name: 2-62-9-1-32.jpeg
Description: General view of component

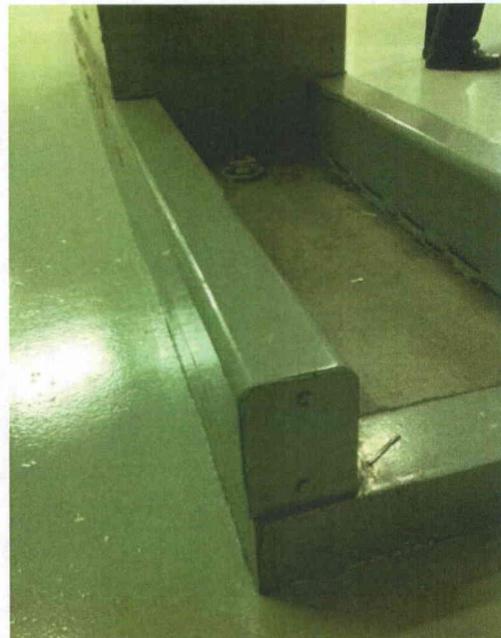
File Name: 2-64-9-1-32.jpeg
Description: General view of tube section member used for MCC base

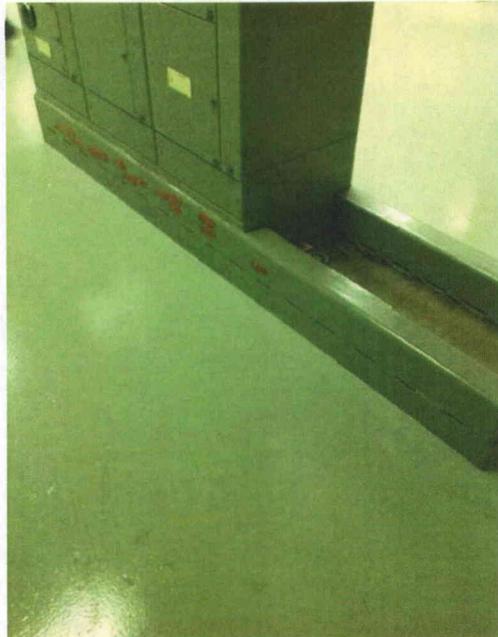
File Name: 2-73-9-1-32.jpeg
Description: General view of MCC base configuration

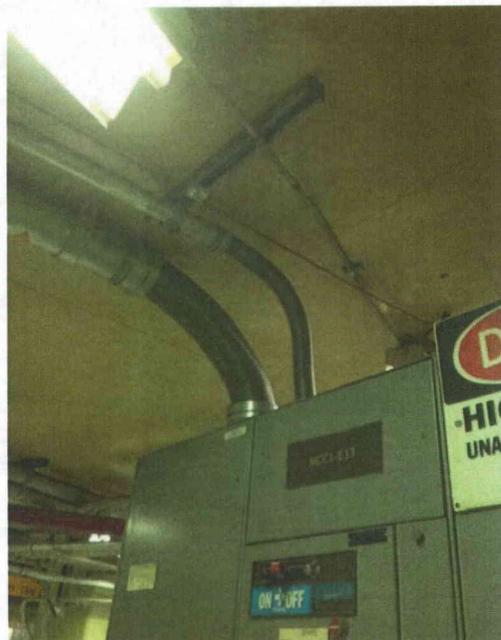
File Name: 2-94-9-1-32.jpeg
Description: View of flexible attached lines

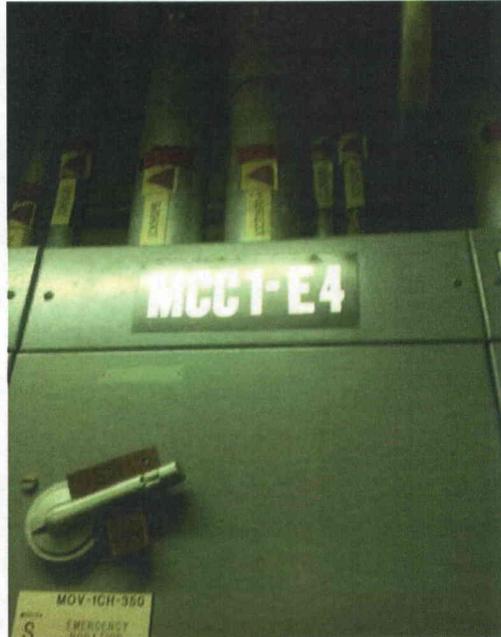
File Name: 2-61-1-1-47.jpeg
Description: Component Plate ID

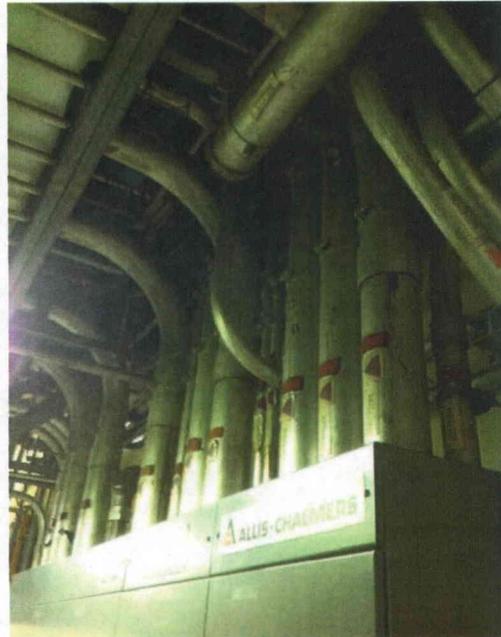
9. Do attached lines have adequate flexibility to avoid damage?
Many 4" diam conduits at top are braced back to the wall behind which would eliminate potential banging of the MCC to the back wall.

File Name: 2-63-1-1-47.jpeg
Description: View of top entry conduits
