APPENDIX B SEISMIC WALKDOWN CHECKLISTS (SWCs)

Seismic Walkdown Checklist (SWC)

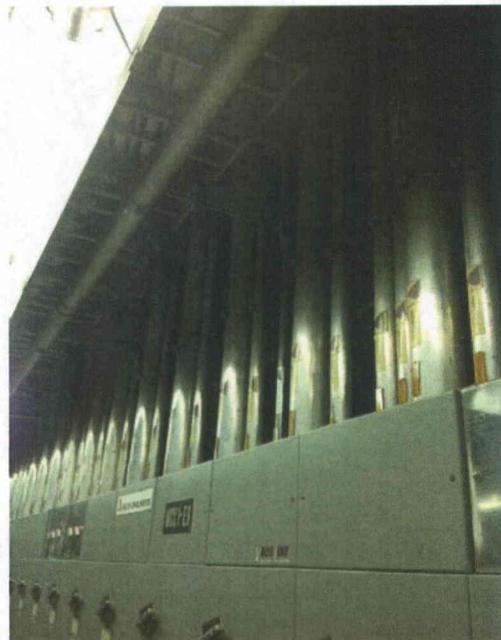
Top entry conduit found to be braced back to the wall.

File Name: 2-64-2-1-23.jpeg
Description: View of top entry conduits

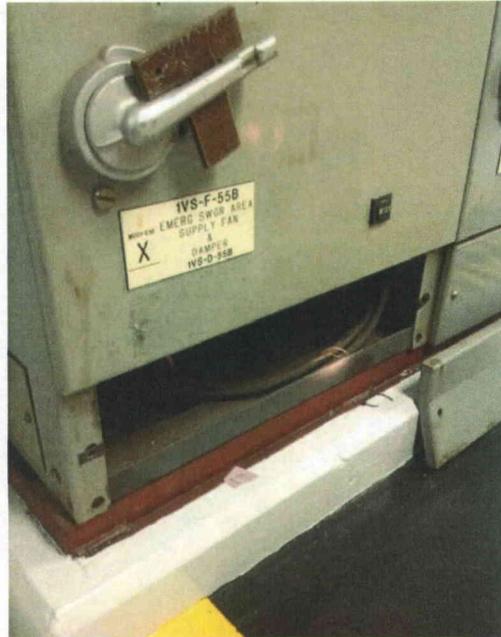
File Name: 2-73-2-1-23.jpeg
Description: View of opened cabinet section

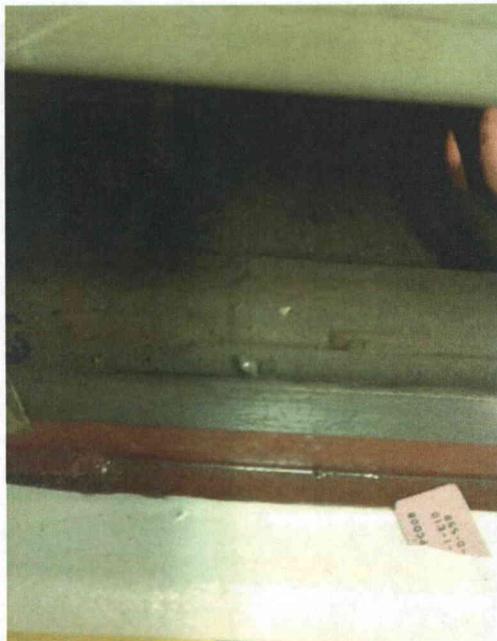
File Name: 2-94-2-1-23.jpeg
Description: Welded detail taken from front of MCC
