AREA WALK-BY CHECKLIST

IP3

Status: Y N U Area Walk-By Checklist (AWC) AWC-010Location: Bldg. IS Floor El. 15'-0" Room, Area¹ _____SWEL Components: SWEL1-030, 031**Instructions for Completing Checklist**

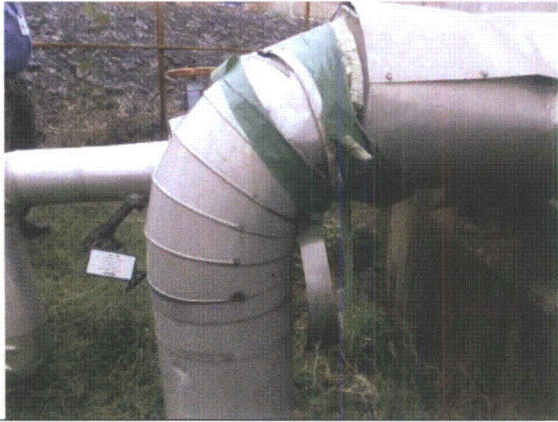
<p>Note: <i>Piping insulation connection held with tape.</i></p>	<p>Note:</p>

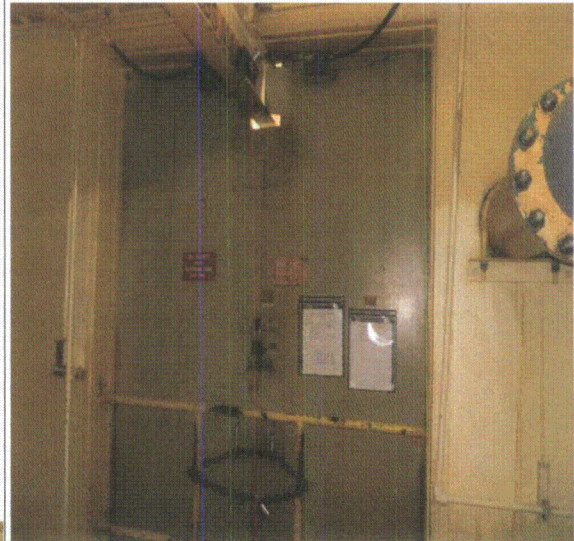
Note: Air line at Door 218

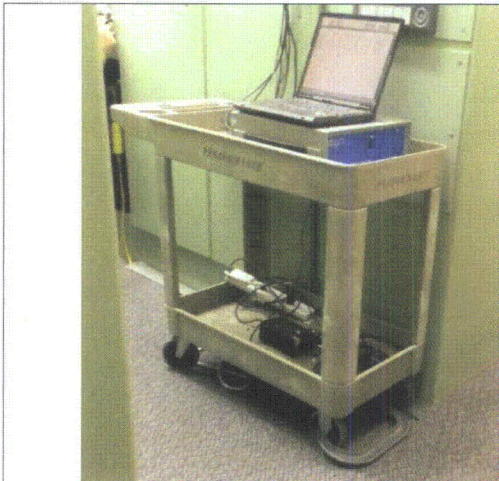
Note: well restrained cart by C-10.

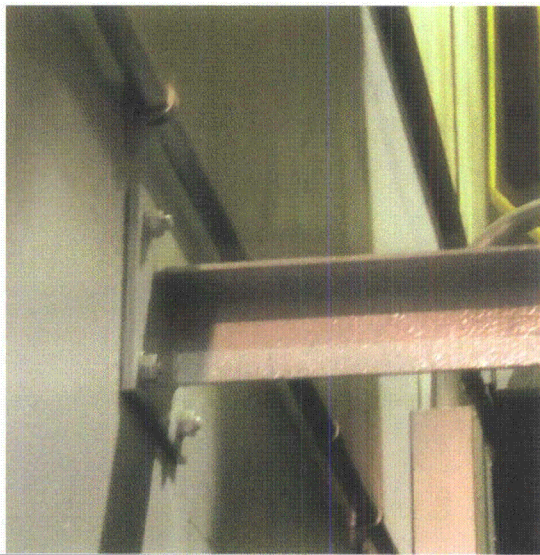
<p>Note: wide flange across the room (spanning east-west) supporting B574 duct with a gap between the base plate and the east wall</p>	<p>Note:</p>

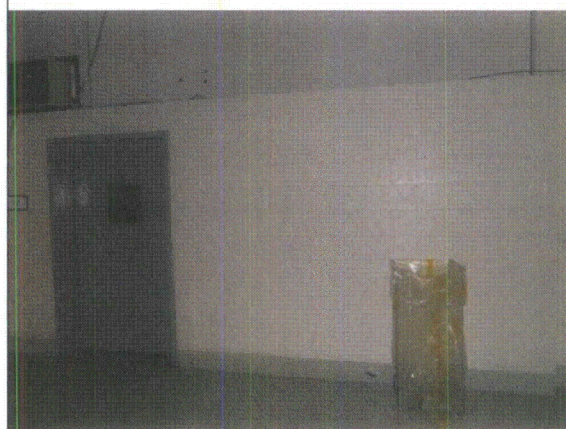
Note: Masonry wall at office section

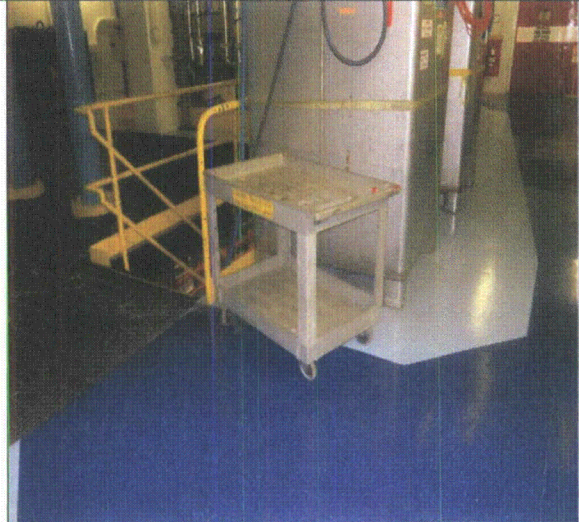
Note: Unsecured cart

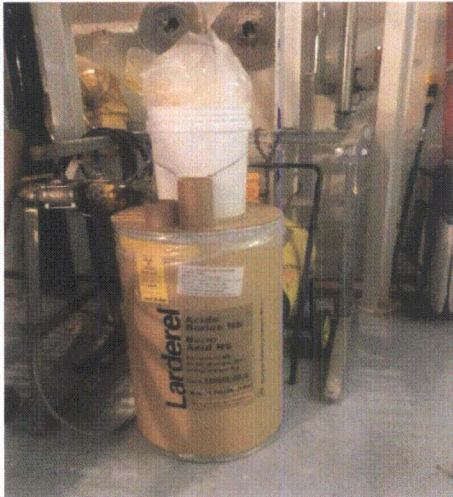
Note: Waste bucket on top of a Boric Acid container
