Seismic Walkdown Checklist (SWC) SWEL1-064

Equipment ID No. 31PP

Equipment Description 125VDC POWER PANEL 31

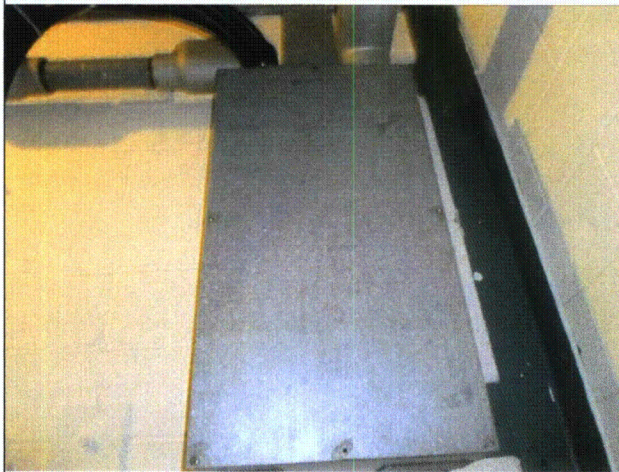
Through bolts from inside of Battery Room 31

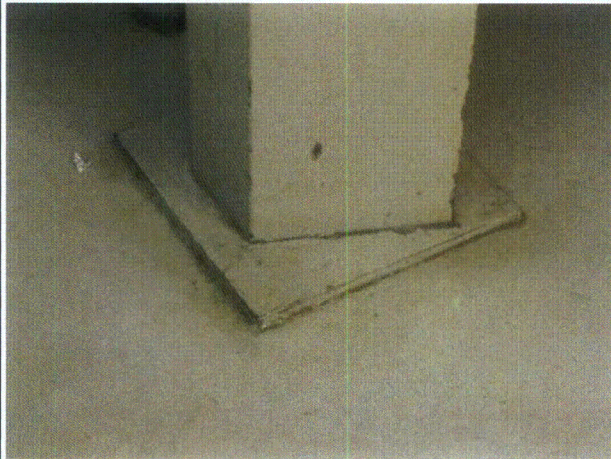
Note: *Base plate of acoustic telephone shelter*

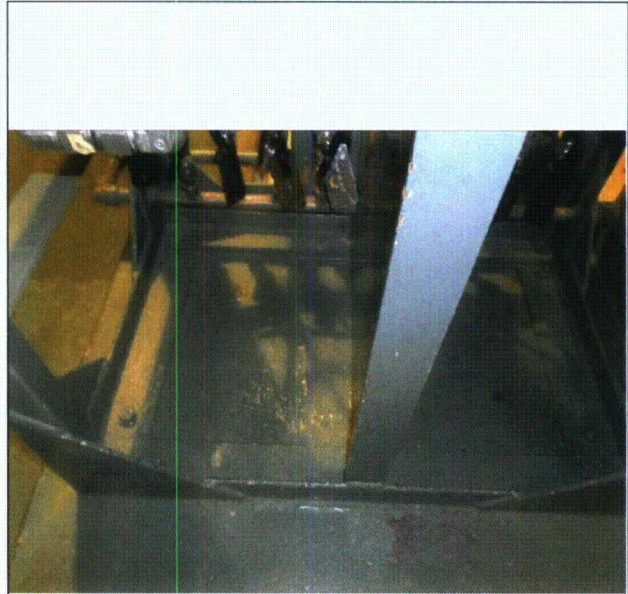
Rack 4A anchorage

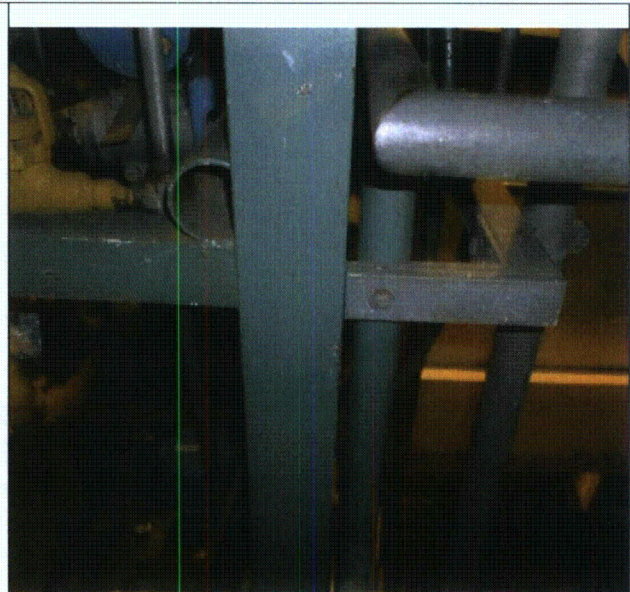
The other side of Rack 27A is bolted to the post of the handrail.

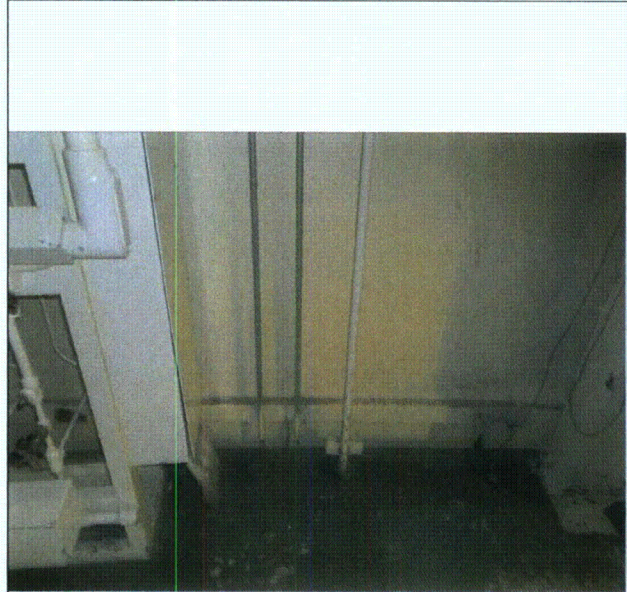
3/4" (1.05" OD) Station Air riser
