**Area Walk-By Checklist (AWC)**

Location (Bldg, Elev, Room/Area): **Area 40 - AB2, 633, 9**

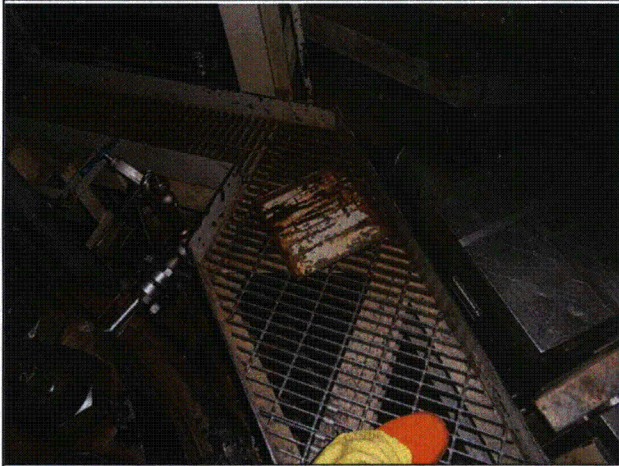
**Note:** Cover removed from termination box for the Unit 1 Cycle 25 Outage (P5081545)

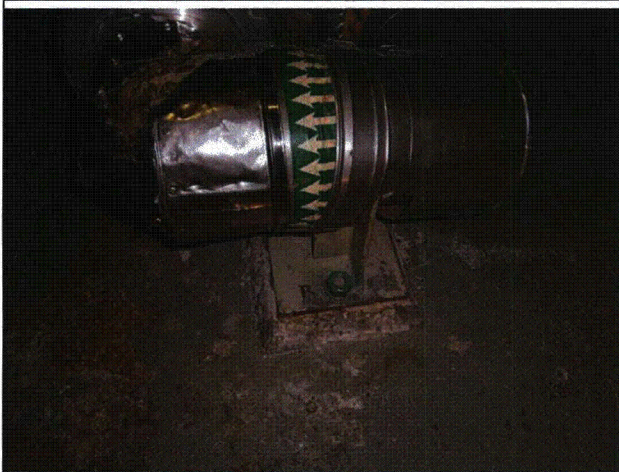
1. Does anchorage of equipment in the area appear to be free of potentially adverse seismic conditions (if visible without necessarily opening cabinets)? Y  N  U  N/A   
*There is insufficient thread engagement on an anchor bolt for a pipe support (1-GCS-R751) near 1-QRV-160 - AR 2013-4779 was issued*  
*Missing bolt on a single angle conduit support for conduits attached to 1-QRV-160 - AR 2013-4815 was issued*

**Note:** Nut with insufficient thread engagement (P4010154)

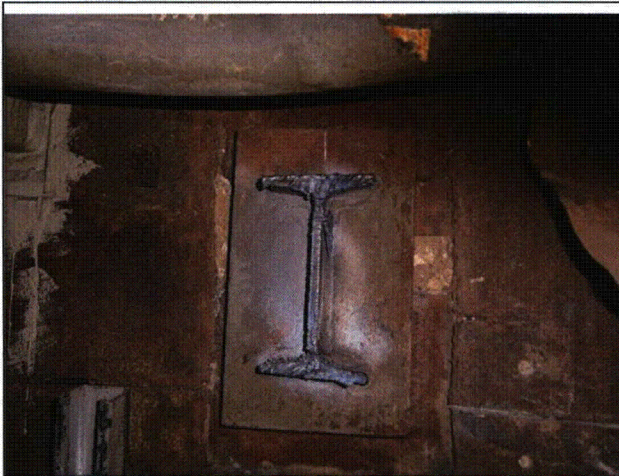
**Note:** *Abandoned support (P3280053)*

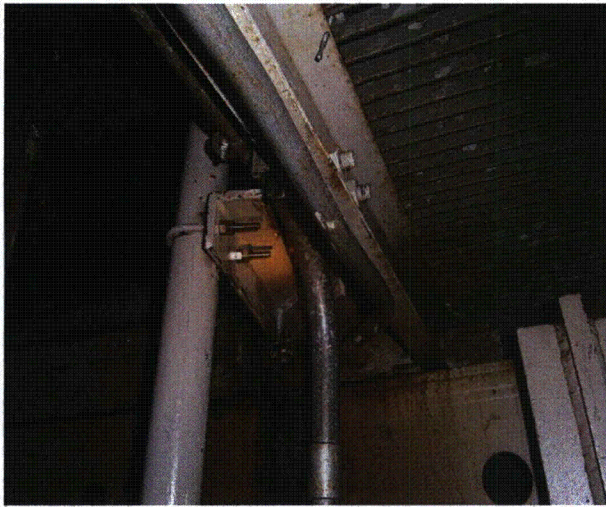
**Note:** (PA-040474) Bolt securing grating is self tapping, no nut required.

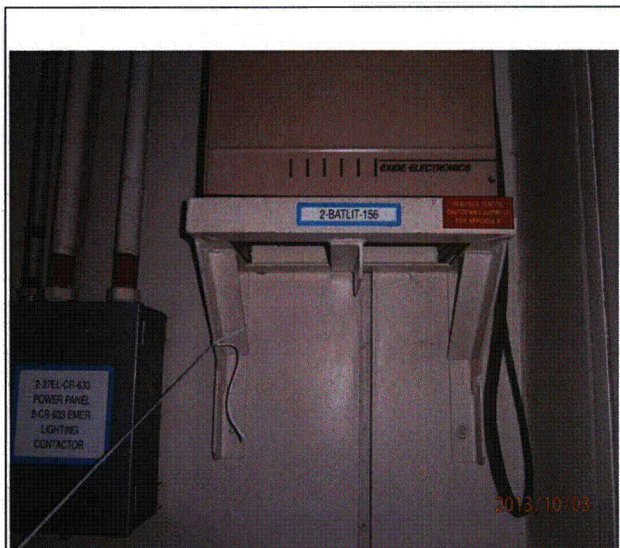
**Note:** (PA-030096) Rope used to prop door open for Unit 2 Cycle 21 Outage work.

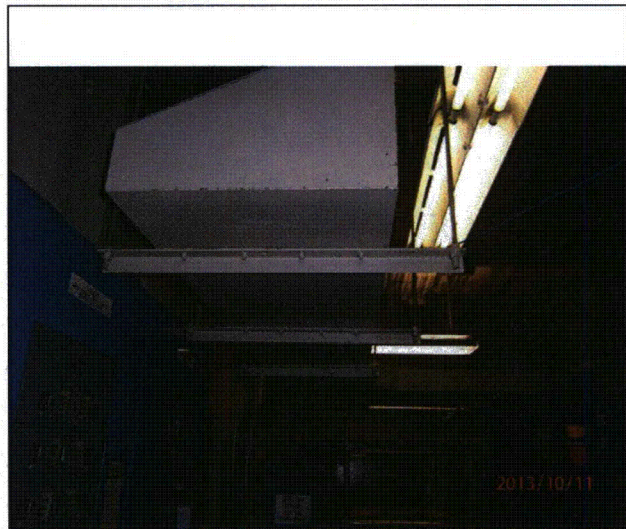
**Note:** (PA110663) Cord hung for Unit 2 Cycle 21 refueling outage.
