Status: Y  N  U **Seismic Walkdown Checklist (SWC) SWEL1-054**Equipment ID No. 0023CRFEquip. Class<sup>1</sup> 10Equipment Description CONTAINMENT RECIRC FAN 23Location: Bldg. VCFloor El. 68'-0"

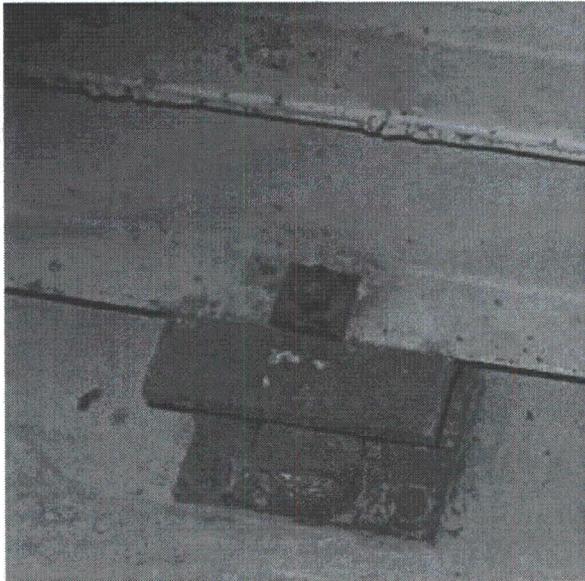
3. Is the anchorage free of corrosion that is more than mild surface oxidation? Y  N  U  N/A   
*Inside of closure observed mild oxidation on several isolator supports (see attached photos)*

**Note:** *mild oxidation on isolator*

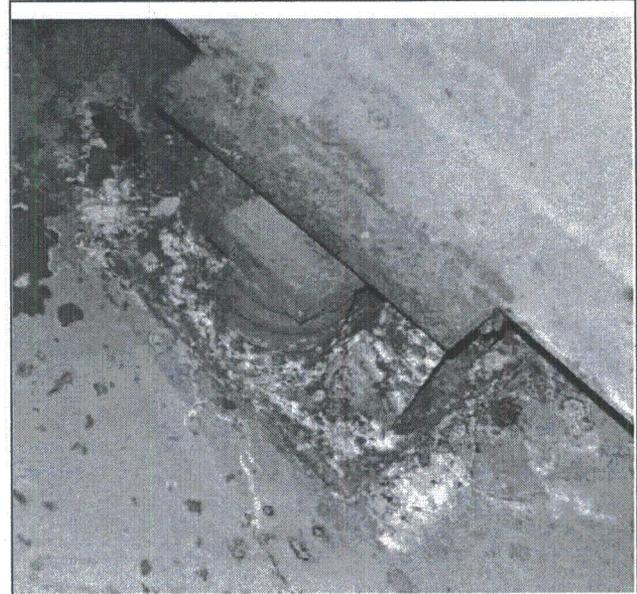
**Note:** *mild oxidation on isolator*

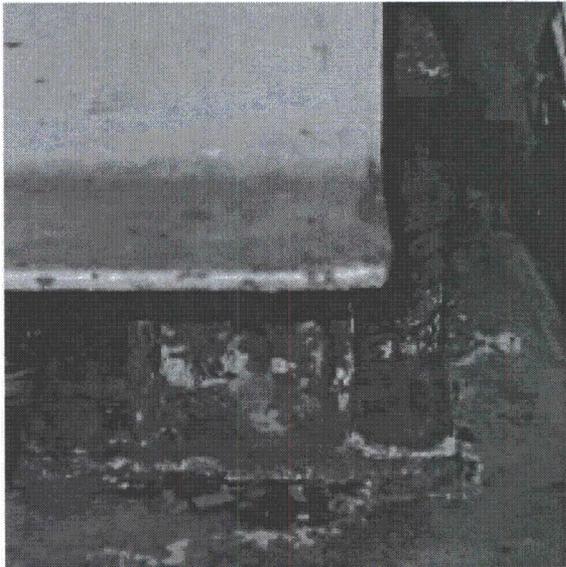
**Note:** *mild oxidation on isolator*

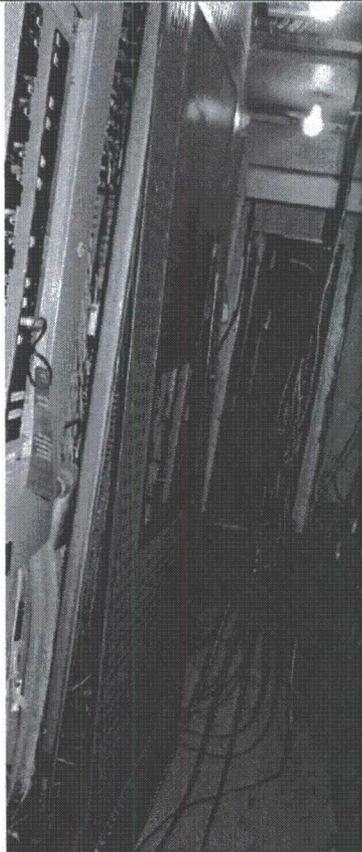
*Observed red screen door inside the supervisory panel that was not secured (see attached photo). During a seismic event, the door may move and strike the sensitive equipment inside the panel. This is documented in CR-IP2-2014-01660.*

**Note:** red screen door inside supervisory panel

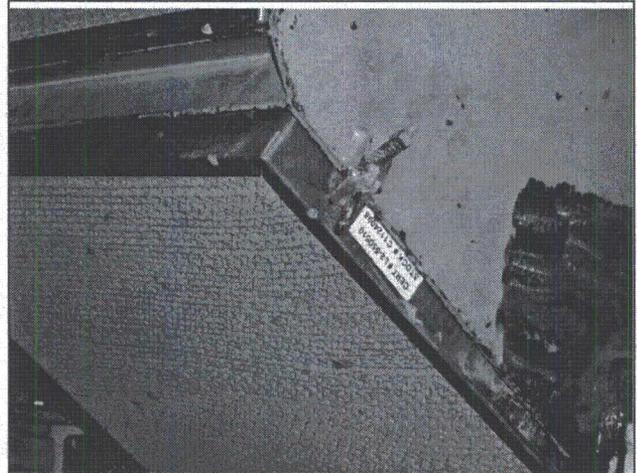
**Note:** LOWER AIR FILTER NOT FULLY LATCHED.

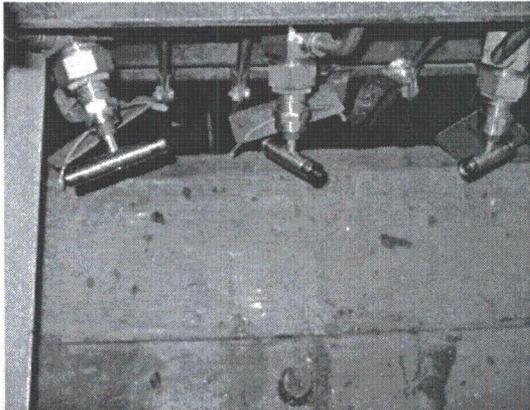
**Note:** anchor flush with angle as indicated on drawing A208288-4 and SQUG documentation

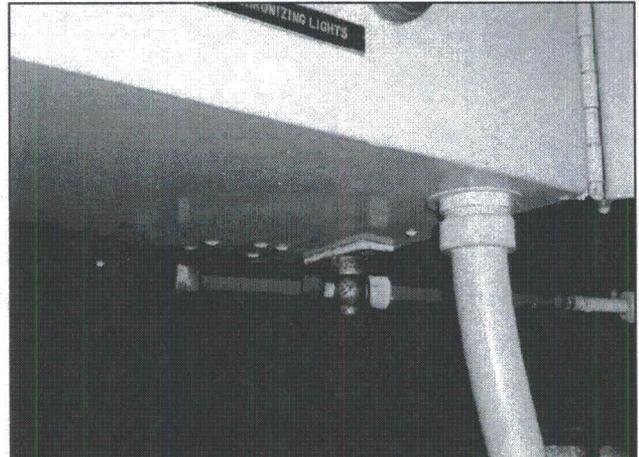
**Note:** Side synch panel is restraint by the two nuts during a seismic event and horizontal movement will be limited.

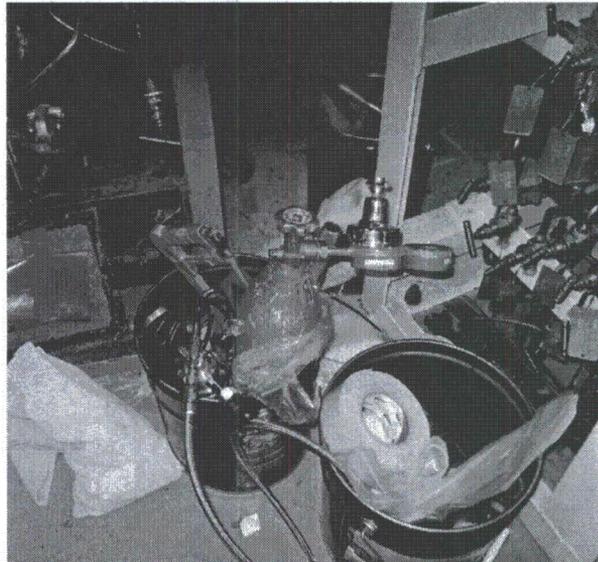
**Note:** *misc tool and buckets*
