File NC505-12 Project 84NK29824

FACT-FINDING REPORT

# AIR DUCT PENETRATIONS THROUGH ONE HOUR FIRE RESISTIVE WALL ASSEMBLY

American Iron and Steel Institute Washington, D.C.

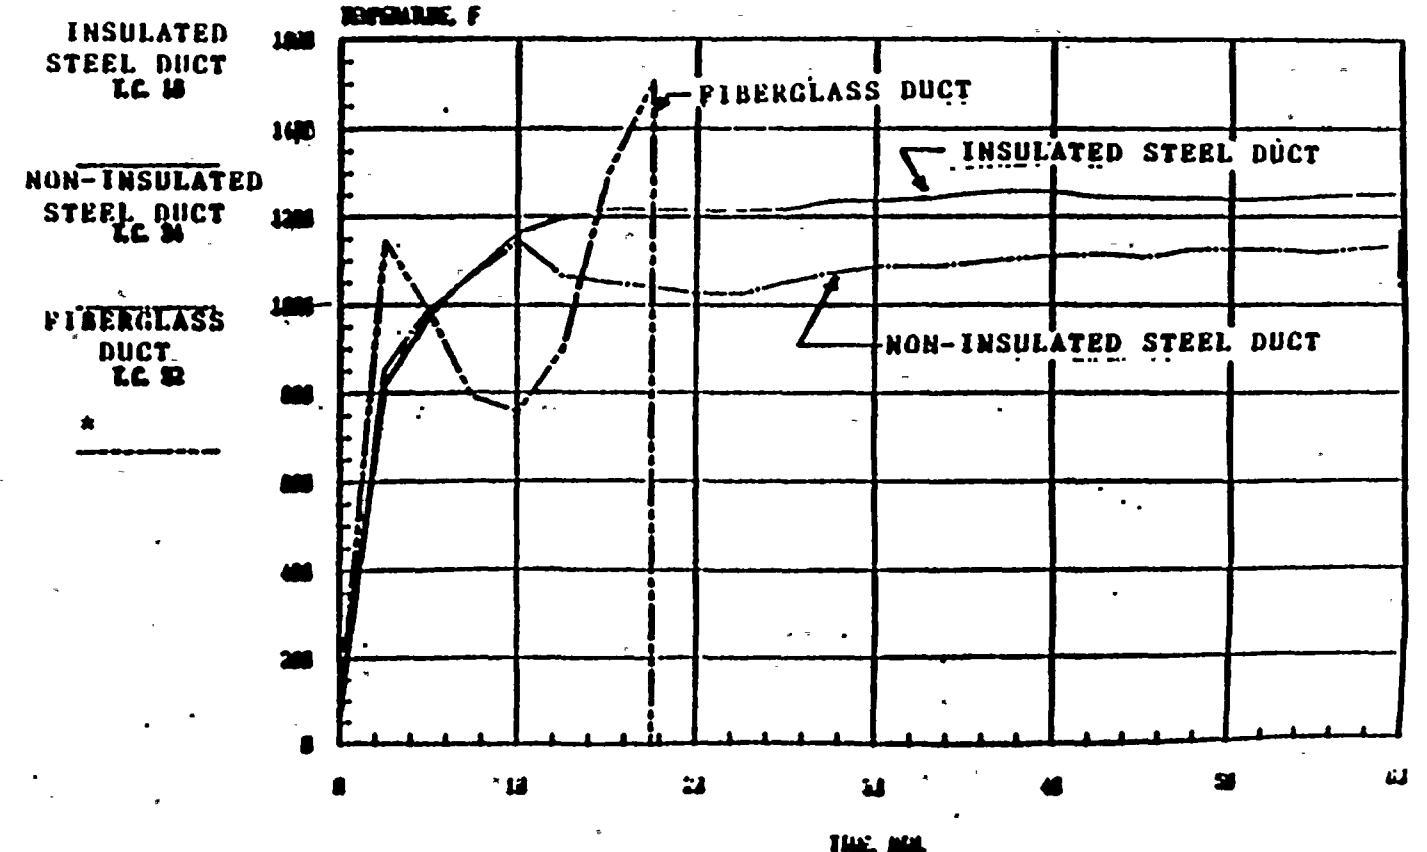
\*SECTION OF FIBERGLASS DUCT IN AREA OF T.C. 52 COLLAPSED AT 19 HIN.

TEMPERATURES WITHIN DUCT ASSEMBLIES THERMOCOUPLES LOCATED 9 FT. 3 IN. FROM UNEXPOSED SIDE OF WALL ASSEMBLY
