Subject: 2019 Annual Site Inspection and Monitoring Report for Uranium Mill Tailings
Radiation Control Act Title II Disposal Sites

Enclosed are six copies of the *2019 Annual Inspection and Monitoring Report for Uranium Mill Tailings Radiation Control Act Title II Disposal Sites*. The report covers the annual inspections of the six Title II disposal sites managed by the U.S. Department of Energy Office of Legacy Management.

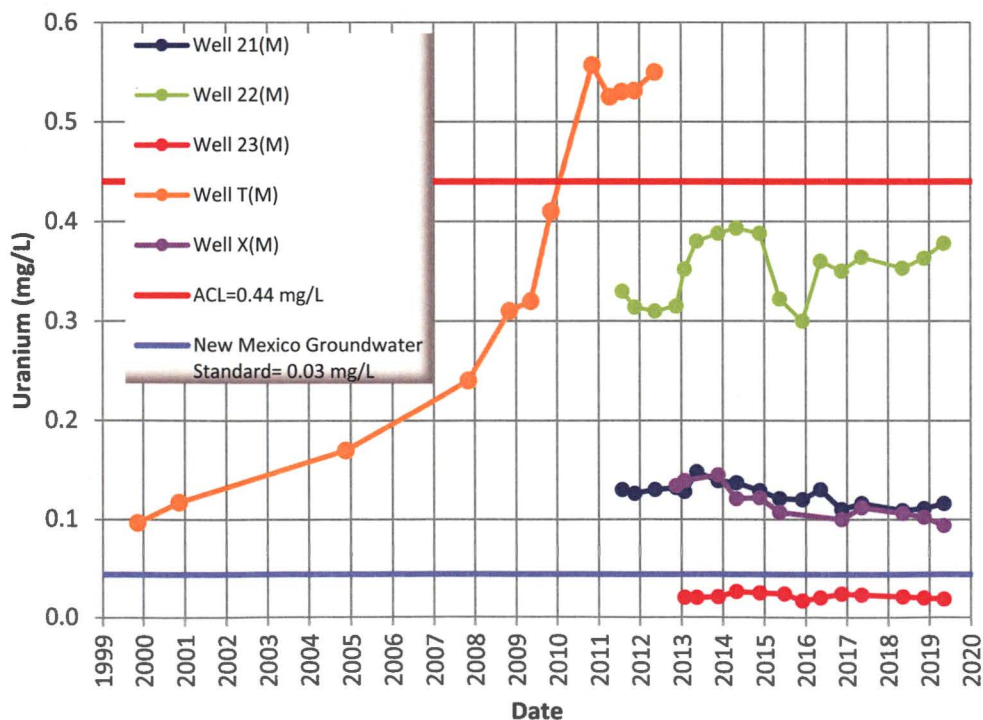
Figure 1-4. Uranium Concentrations in Alluvial Aquifer POC Well T(M) and Downgradient Wells at the Bluewater, New Mexico, Disposal Site

Figure 1-4 shows historical uranium concentrations measured at POC well T(M) and four additional wells screened in the alluvial aquifer. As this figure shows, the uranium concentration at well T(M) trended upward since LM began monitoring the well in 1999, and the November 2010 concentration of 0.557 mg/L was the first of five uranium concentrations that exceeded the ACL of 0.44 mg/L. LM notified NRC of the exceedance upon receiving the 2010 results from the laboratory. Well T(M) dried up following a May 2012 sampling because of drought and continuing declines of water levels in the well, and the well has since remained dry. Well 21(M) in the southeast corner of the site and POE well X(M) near the site's east boundary show a slightly decreasing trend in uranium concentration since 2013 (Figure 1-4). However, the elevated uranium concentrations at these two wells in recent years indicate that alluvial groundwater with uranium concentrations exceeding the New Mexico groundwater standard (0.03 mg/L) is discharging from the site toward the southeast. NRC requested that LM evaluate the performance of the main tailings disposal cell to assess whether seepage from the cell between 2005 and 2010 had increased to the extent it was responsible for the elevated uranium concentrations measured at POC well T(M) (see Figure 1-4) before it dried up. Based on an assessment of the disposal cell cover and an accompanying evaluation of the water balance for the main tailings disposal cell, the increase in uranium concentrations in well T(M) is not attributed to a compromise of the disposal cell's performance, and there was no surge of tailings-fluid seepage from the main tailings cell since it was closed (DOE 2014). It was further concluded that water levels in well T(M) decreased during the early 2000s below the contact between the alluvium and underlying Chinle Formation from 2008 to 2012. The simultaneous increase in uranium concentration was attributed to the declining water level and the influence of contaminated groundwater migrating through and interacting with weathered Chinle Formation materials, with the resulting fluids obscuring the water chemistry of groundwater in nearby portions of the alluvial aquifer that remained saturated (DOE 2014).

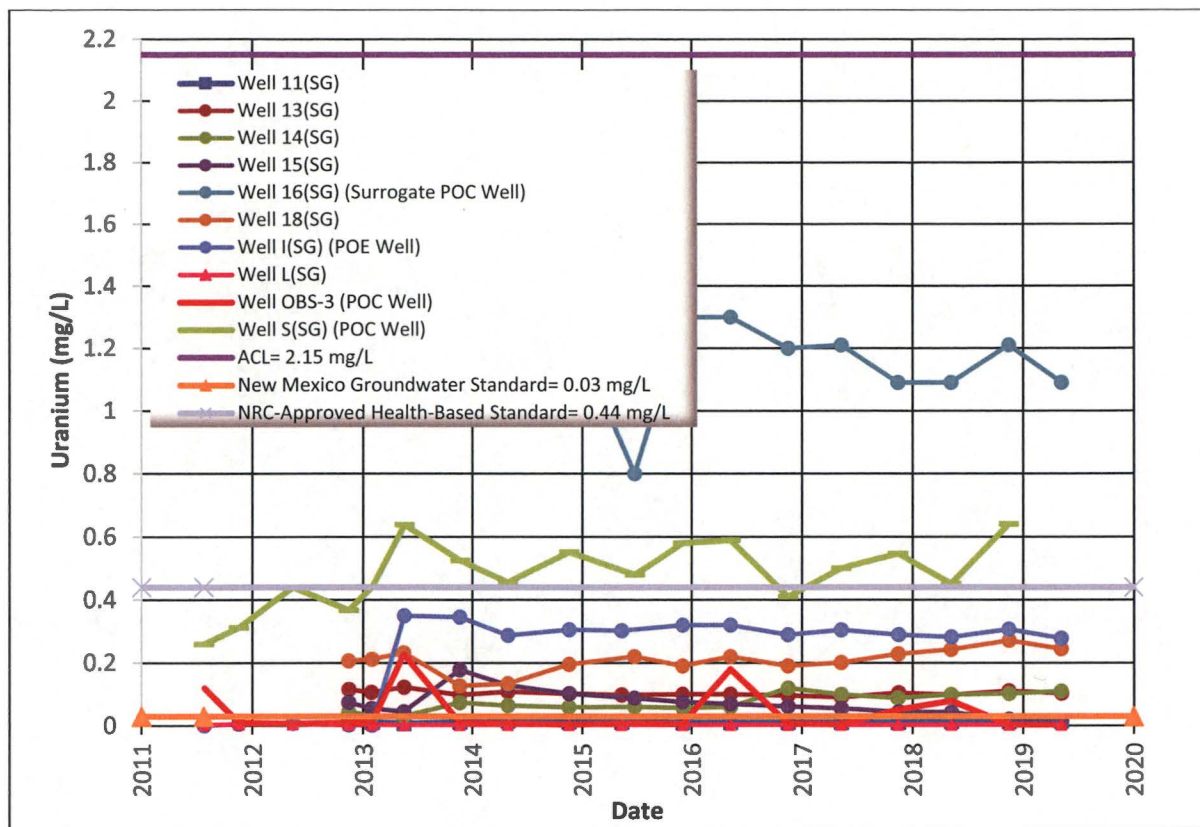
Figure 1-5. Uranium Concentrations in the San Andres/Glorieta Aquifer at the Bluewater, New Mexico, Disposal Site

Figure 1-5 shows uranium concentrations in the SAG aquifer. Uranium concentrations in well I(SG) before 2013 are not shown because they were erroneously low because of an incorrect sampling depth in the well. Uranium concentrations at POC wells OBS-3 and S(SG) are not shown in Figure 1-5 because the well screens are encrusted with iron scale that has resulted in erroneously low uranium concentrations since LM began sampling the wells.

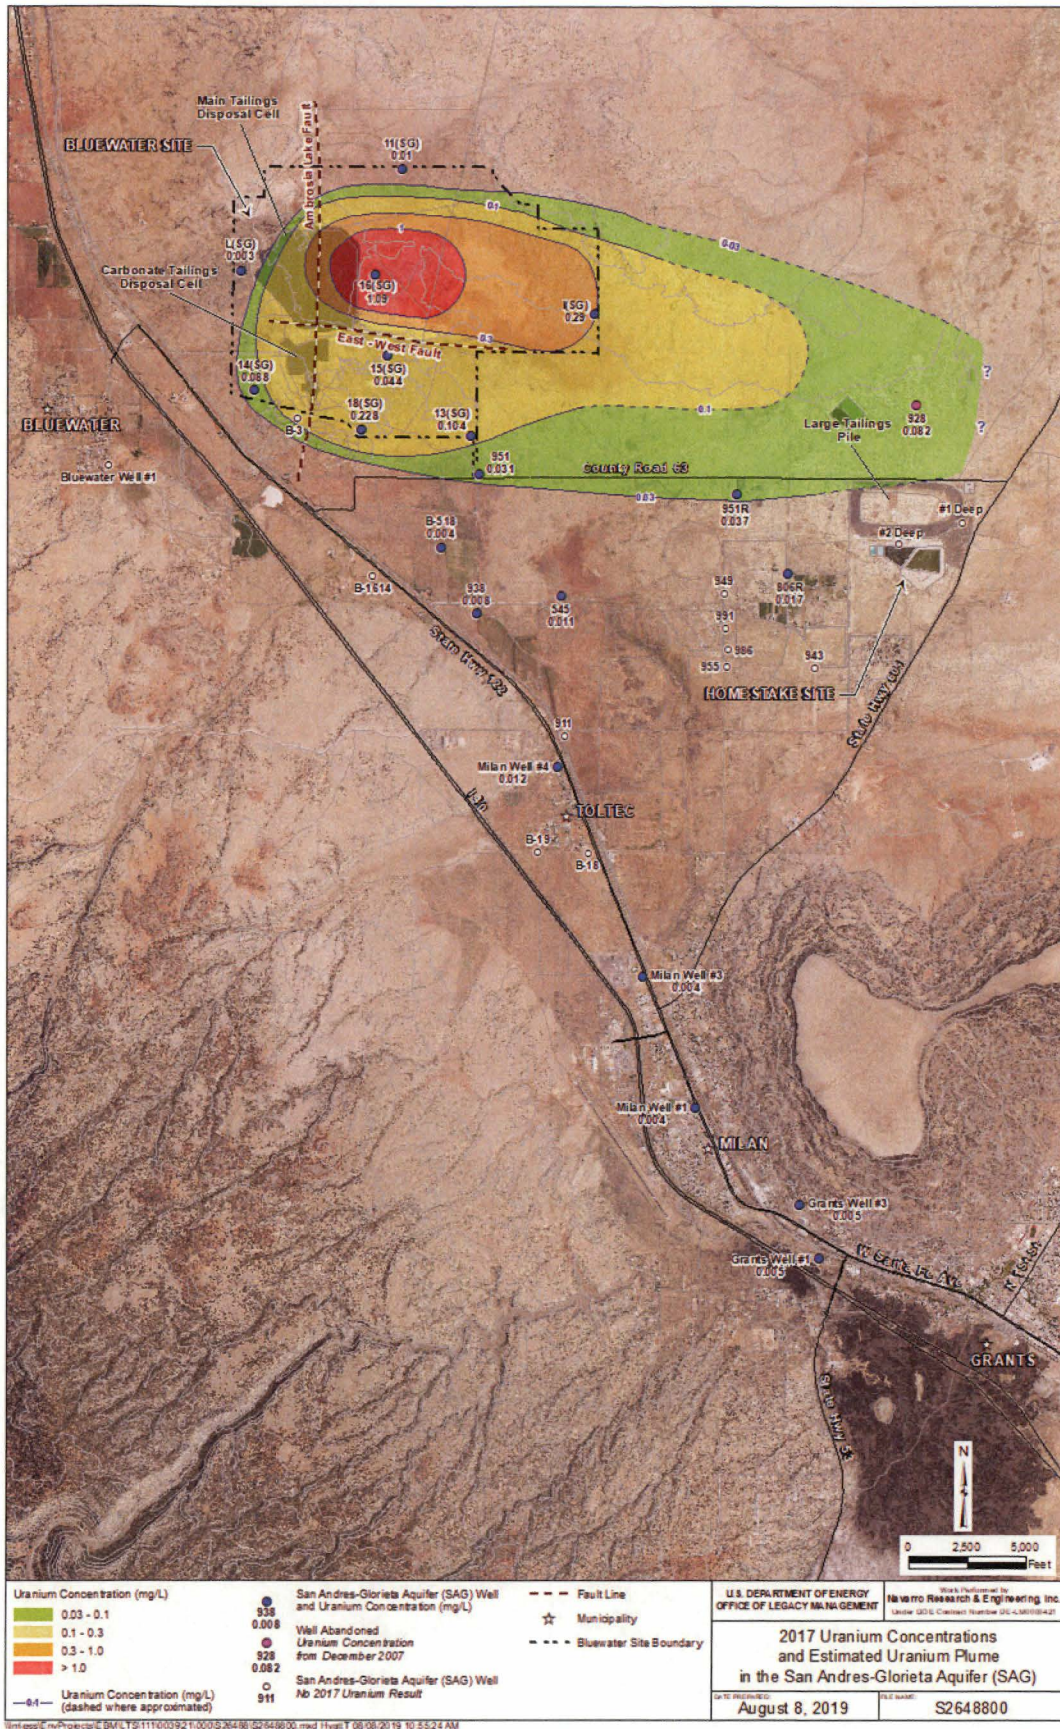
Figure 1-7. 2017 Estimated Uranium Plume in the San Andres/Glorieta Aquifer (DOE 2019)

The estimated extent of the uranium plume, described in the updated groundwater model (DOE 2019), is shown in Figure 1-7. The uranium plume follows the groundwater flow path, and the leading portion is near the Homestake site. Groundwater monitoring results obtained by various entities over the last several decades indicate that uranium contamination from Bluewater mill operations reached the Homestake site by 1980 and that the plume has essentially stabilized (i.e., it is not continuing to migrate to the east). Uranium concentrations attenuate with distance from the site primarily through dispersion instead of chemical reduction because of the absence of a reducing environment in the aquifer formations (DOE 2014). No known drinking water wells are completed within the uranium plume, and site-derived uranium contamination in the SAG aquifer is not expected to impact the Milan or Grants municipal water supplies that are pumped from SAG aquifer wells (DOE 2014; DOE 2019).

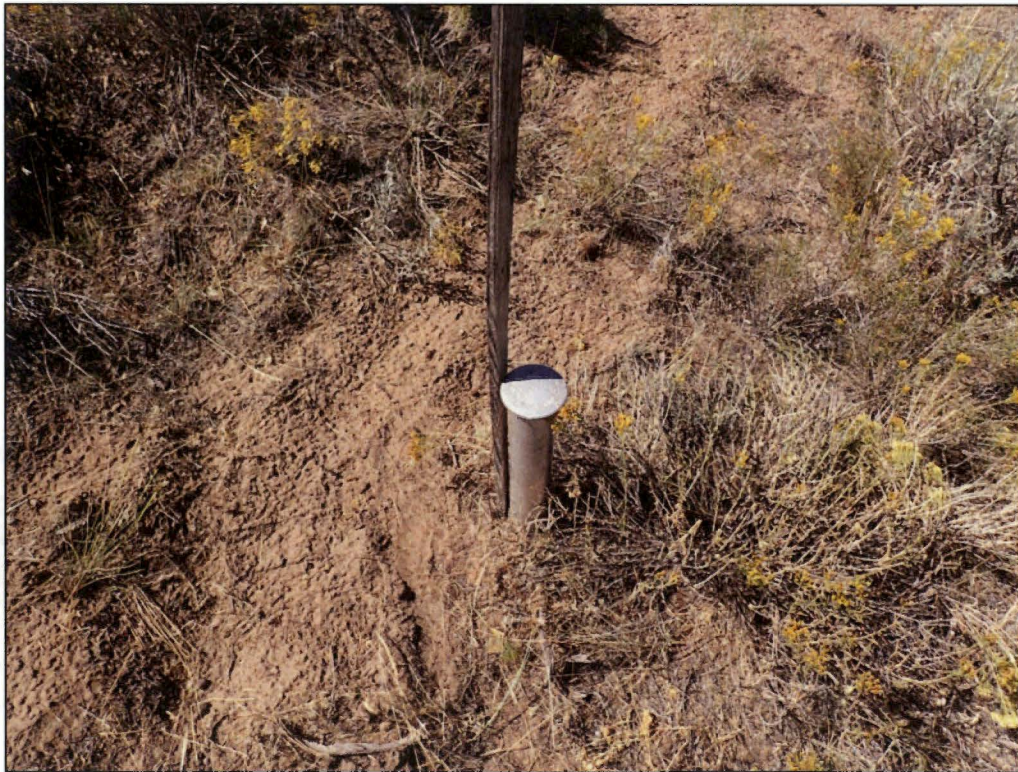
Eight boundary monuments are on the site boundary outside the fenced area (PL-4). Four of the monuments are at the property corners, and the other four define an approximate 20-foot offset along the north and south boundaries where the private land that LM acquired in fee adjoins the BLM withdrawal area on the western portion of the site. Boundary monuments BM-3 and BM-6 (capped pieces of rebar) define the two 20-foot offsets. Boundary monument BM-3 (PL-5) was first observed to be bent during the 2017 annual inspection; since then attempts to straighten the monument were not successful, and repair or replacement options are being evaluated. No other maintenance needs were identified.

PL-4. Boundary Monument BM-4

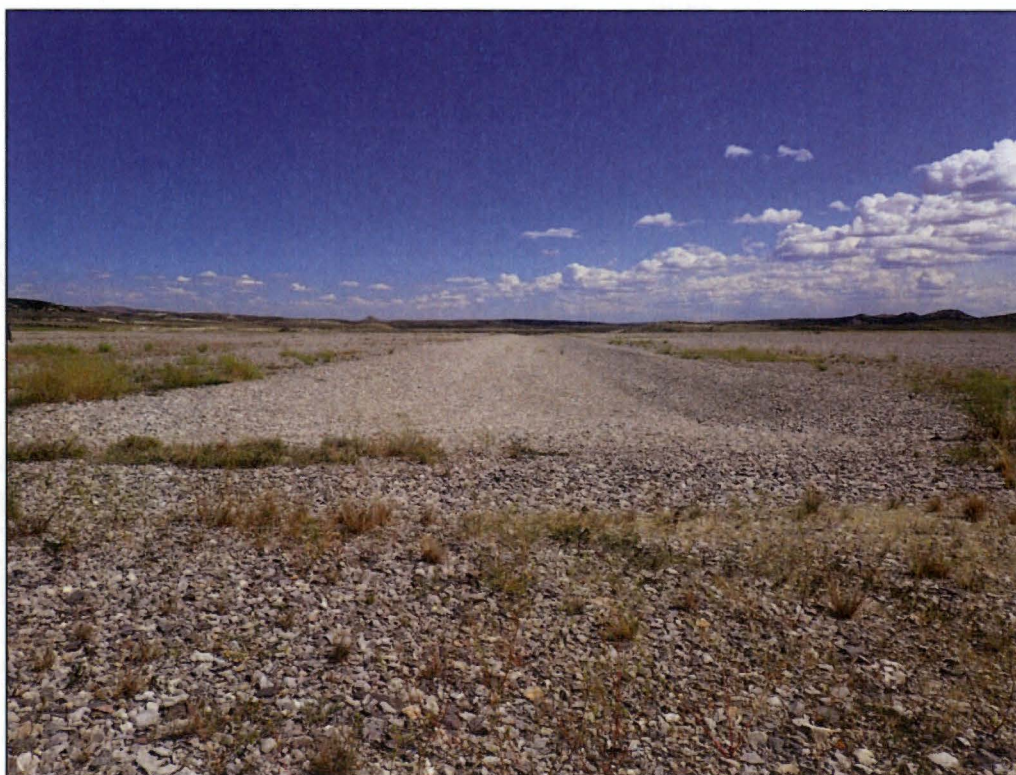
While various species of plants were present on the top slope of the disposal cell, no deep-rooted vegetation was observed (PL-8). If encroachment of deep-rooted vegetation is observed, an evaluation will be conducted as required by the LTSP to determine if any action is necessary. Noxious weeds are controlled in accordance with the LTSP.

PL-8. Vegetation on Disposal Cell Top Slope and Diversion Channel No. 1

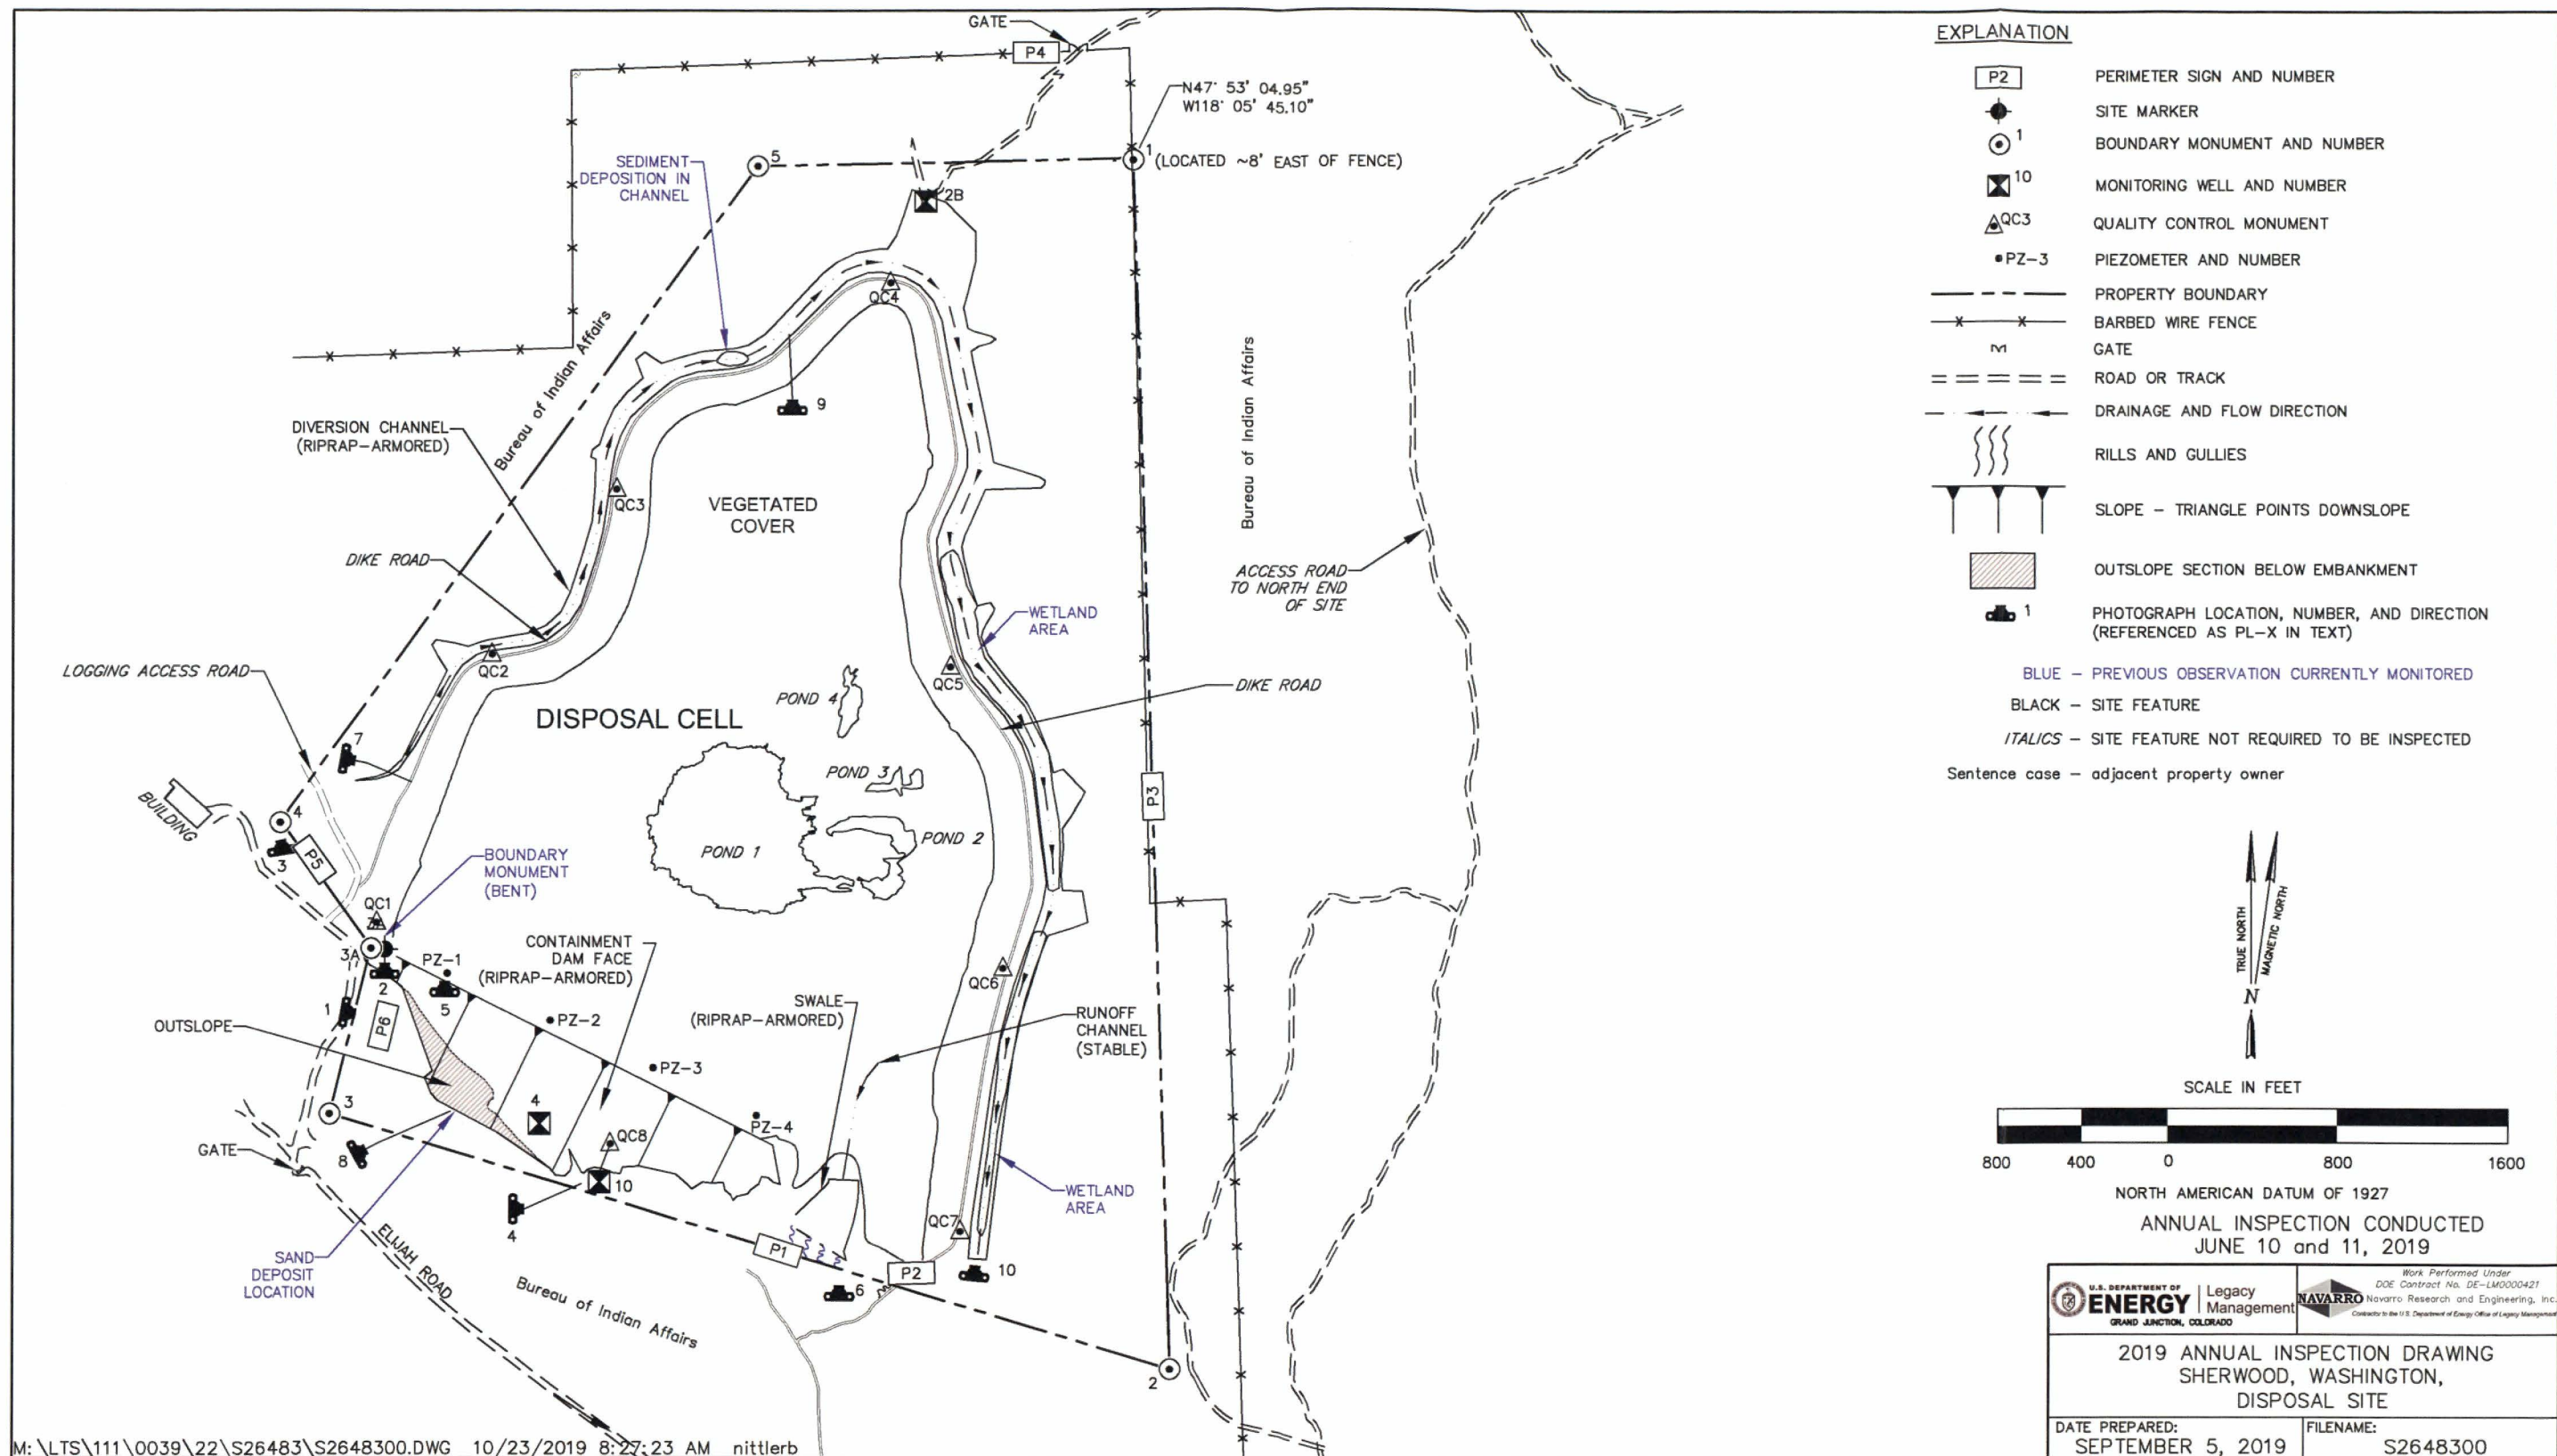
Figure 5-1. 2019 Annual Inspection Drawing for the Sherwood, Washington, Disposal Site

During the 2016 annual inspection, one location at the base of the rock-covered containment dam face was found to have a deposit of sand that had washed out from underneath the rock cover as evidenced by a shallow rock-filled gully feature upgradient of the deposit (Figure 5-1). A subsequent follow-up inspection and evaluation identified that the sandy material was the same as natural undisturbed material nearby. During reclamation, this area of the mill site was used as a source for fill material used to contour the area below the toe of the containment dam. Review of original reclamation and as-built drawings showed that the toe of the containment dam is upslope from the area of erosion, which was confirmed during the follow-up investigations. Therefore, it was concluded that the washout area is in a portion of the dam defined as the outslope in the construction completion report and does not impact the containment dam (DOE 2018b).

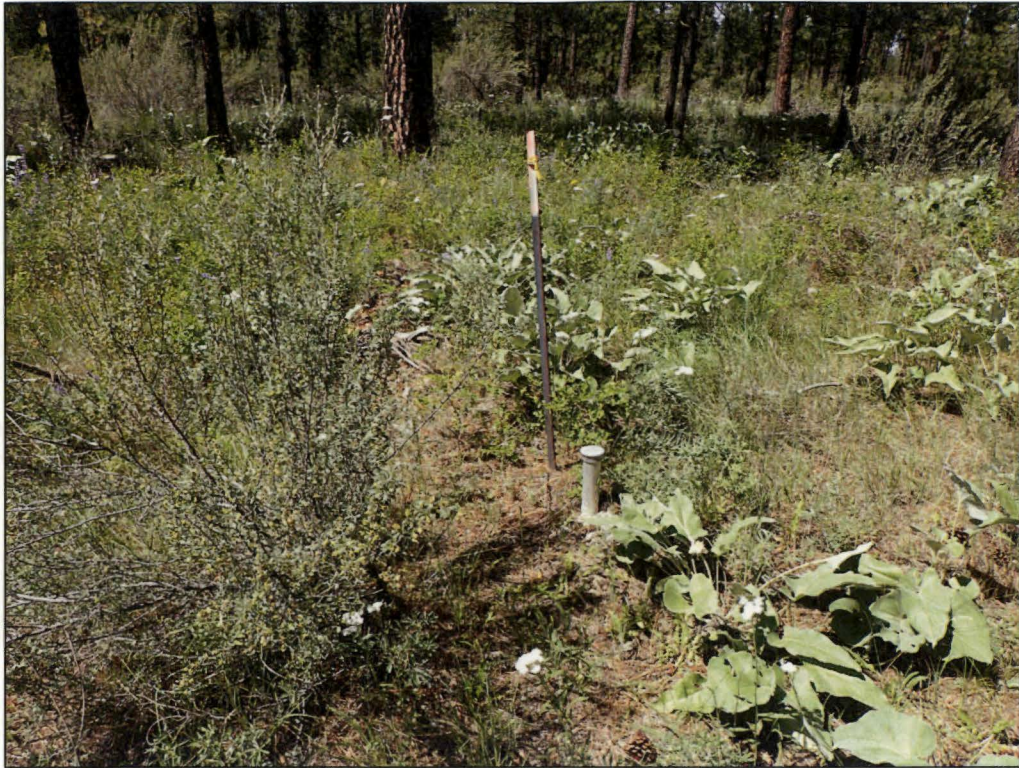
PL-3. Boundary Monument BM-4

Six boundary monuments set in concrete define the site boundary. Because surrounding vegetation has made it difficult to locate some of the monuments, metal T-posts were installed at each monument location (PL-3). All boundary monuments were inspected. No maintenance needs were identified.

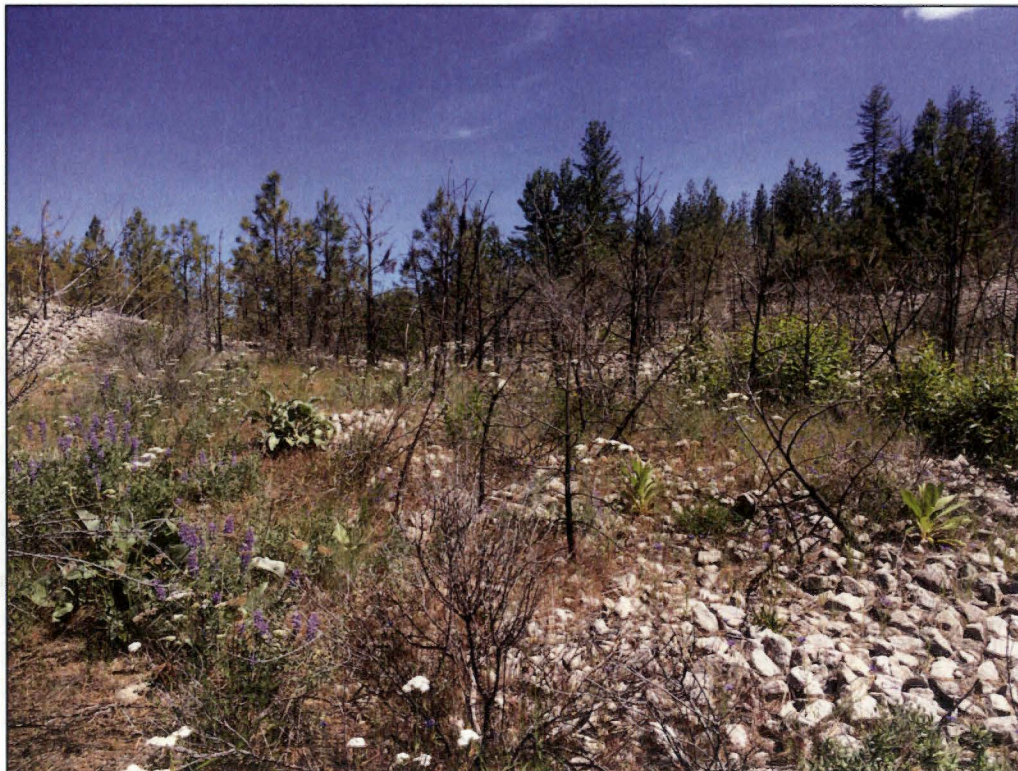
A riprap-armored diversion channel surrounds the disposal cell and diverts runoff away from the disposal cell surface. The diversion channel was designed to allow trees to grow and stabilize the surfaces, and the presence of trees in the diversion channel is not expected to hinder the diversion channel's ability to convey design flows. The intrusion of volunteer plants, including trees, is evident in most areas of the diversion channel (PL-9). Sediment deposition is found in places on the west leg of the diversion channel but does not interfere with the diversion channel's design function. Upslope areas that have contributed to the sedimentation have stabilized with vegetation. Wildlife trails cross the diversion channel at numerous locations and have displaced the diversion channel riprap in several places. These disturbances will be visually monitored for erosion but are not in areas that would impact the disposal cell. No evidence of erosion was observed downgradient of the diversion channel outlet (PL-10). No maintenance needs were identified.

PL-10. Diversion Channel Outlet

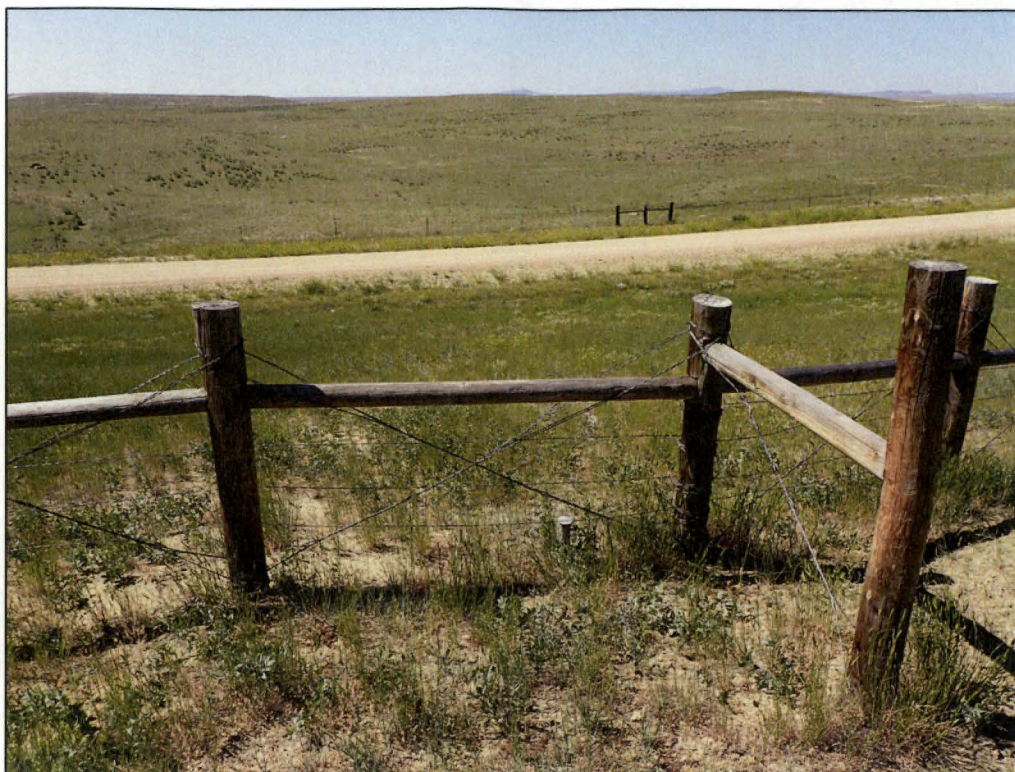
PL-5. Boundary Monument BM-15

There are 27 boundary monuments delineating the site property boundary (PL-5). All boundary monuments were inspected. No maintenance needs were identified.

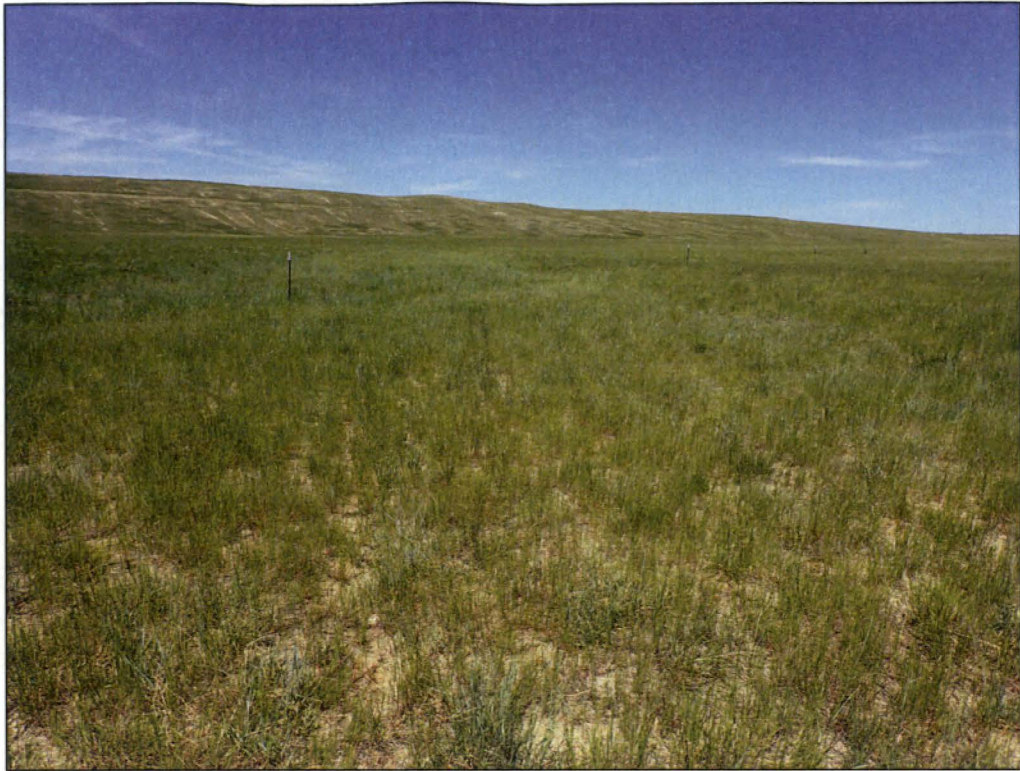
PL-11. Upgradient View of North Channel

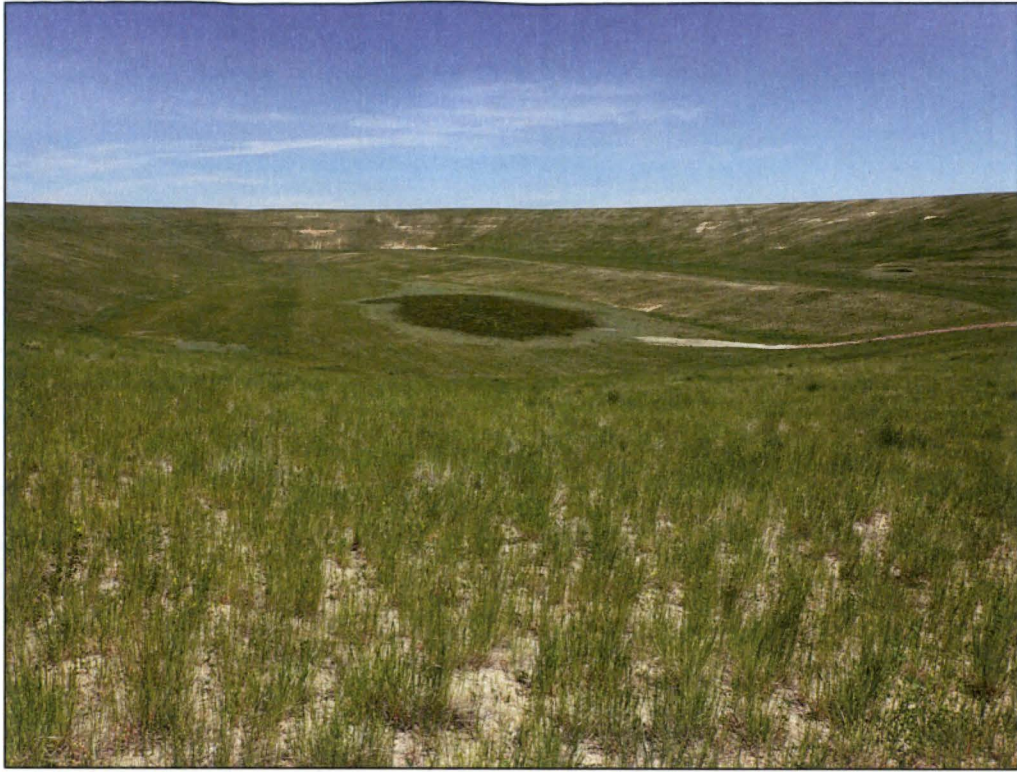
PL-15. Pit 4 and Wetland Area
