1994 Annual Prelicensing Inspection of the Salt Lake City (South Clive), Utah, UMTRA Project Disposal Site

July 1994

Prepared for
U.S. Department of Energy

Prepared by
RUST Geotech Inc.
Under DOE Contract No. DE-AC04-86ID12584
U.S. Department of Energy
Grand Junction Projects Office
Grand Junction, Colorado

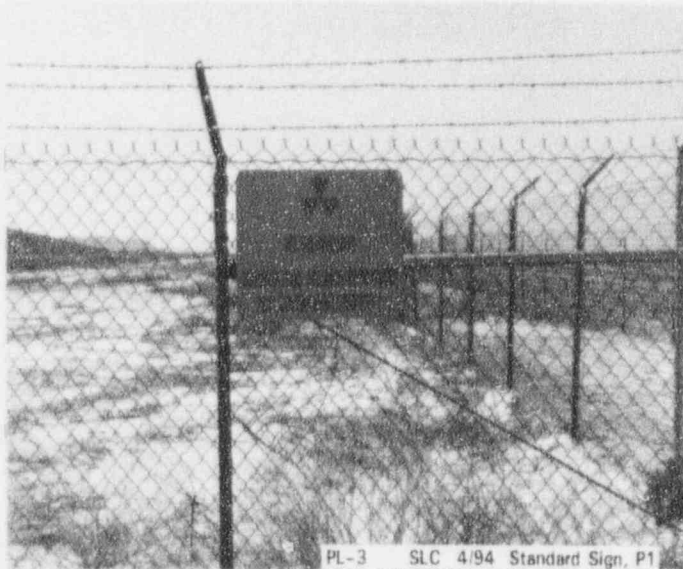
PL-3 SLC 4/94 Standard Sign, P1

In addition to the entrance sign, 16 perimeter signs are in place around the site on the security fence. All the perimeter signs are in excellent condition. Perimeter signs are designated by a "P" on Plate 1 and are numbered (e.g., P1, P2) for use as reference points in clockwise order starting at the northeast corner of the security fence. Two types of perimeter signs exist—one is in standard UMTRA format with magenta-colored lettering (PL-3) and the other is smaller and in nonstandard UMTRA format (PL-4). Only the three perimeter signs on the north security fence (P14 through P16) are in the nonstandard UMTRA format. An additional perimeter sign (P16) was found during this inspection near the east end of the north security fence. The three perimeter signs on the north security fence should be replaced during the 1995 inspection with larger perimeter signs that meet current UMTRA Project specifications (DOE 1992a).

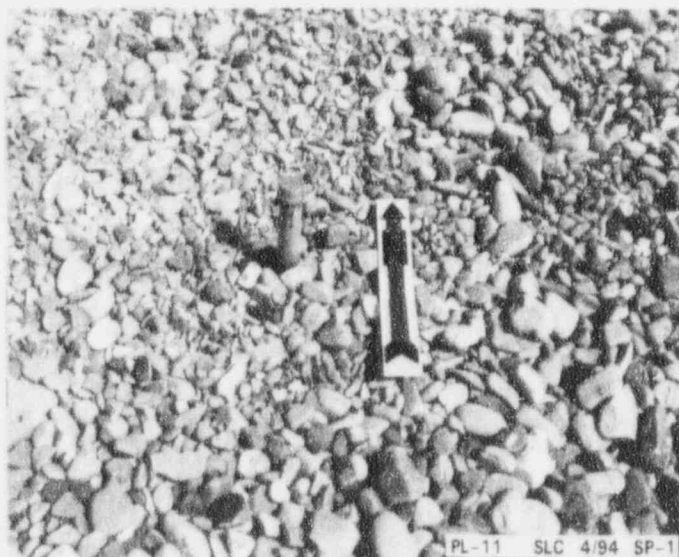
PL-11 SLC 4/94 SP-1

Nine settlement plates are present in three rows across the top of the disposal cell (Plate 1). All the settlement plates are marked by a section of galvanized pipe that rises less than 1 foot above the rock-covered surface. Each pipe is topped by a threaded cap and all pipe and caps are painted orange. The exposed portions (above ground surface) of all the settlement plates are in excellent condition (PL-11 through PL-19).

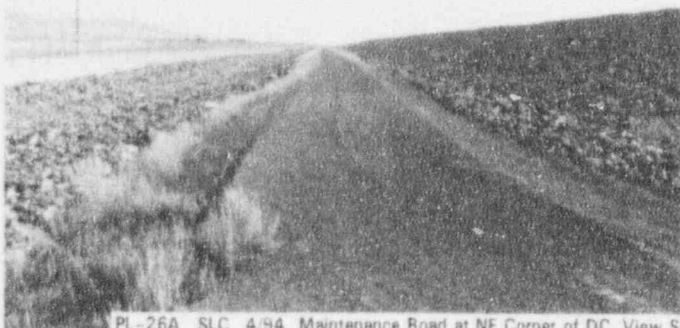
PL-24G SLC 4/94 PAN at SW Corner of Top of DC, View N

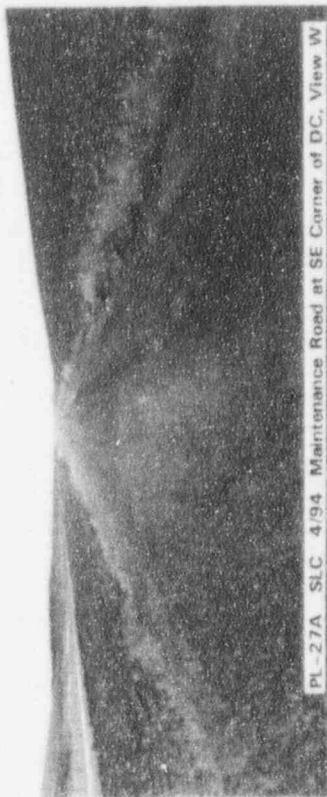
PL-26A SLC 4/94 Maintenance Road at NE Corner of DC, View S

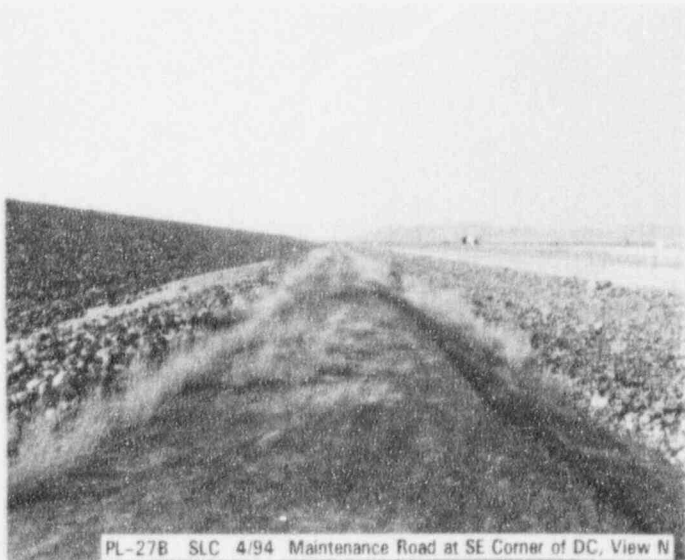
PL-27A SLC 4/94 Maintenance Road at SE Corner of DC, View W

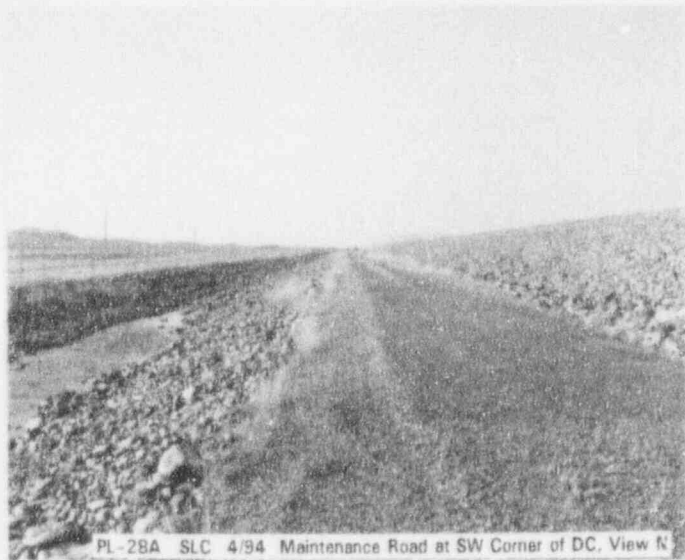
PL-26B SLC 4/94 Maintenance Road at NE Corner of DC, View W

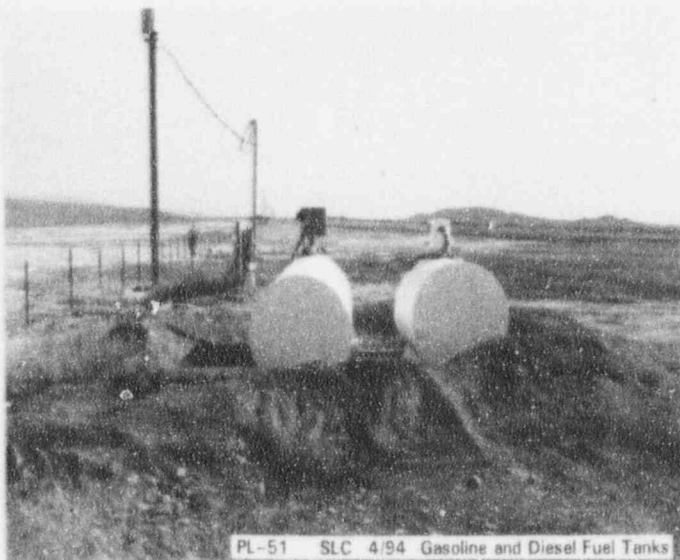
PL-51 SLC 4/94 Gasoline and Diesel Fuel Tanks

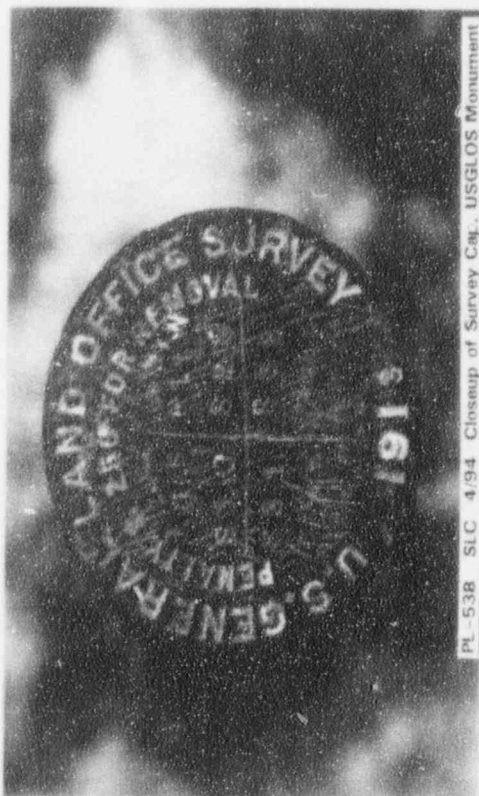
PL 53B SLC 4/94 Closeup of Survey Cap., USGLOS Monument

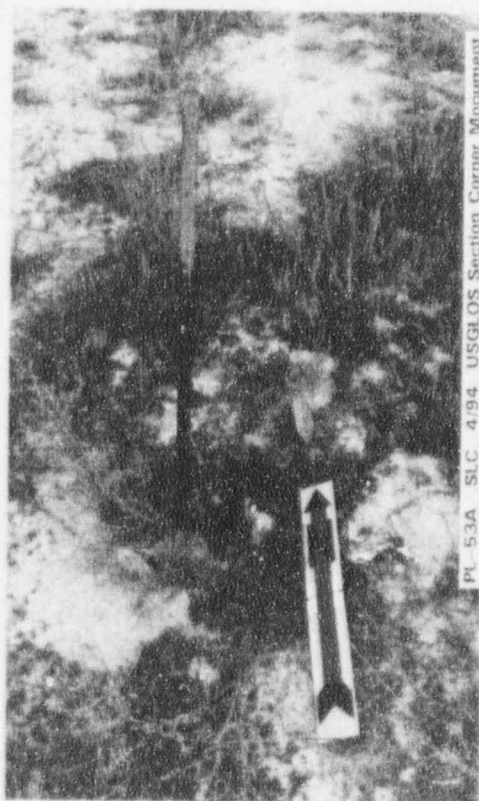
PL 53A SLC 4/94 USGLOS Section Corner Monument
