Investigation of Intergranular
Stress Corrosion Cracking at
Three Mile Island - Unit 1

Date: January 4, 1980

ABSTRACT

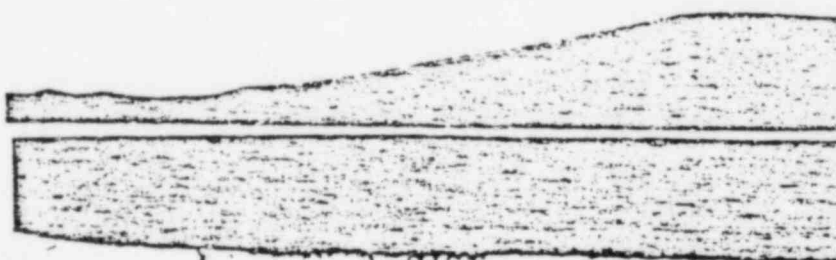
b) Transverse section through pipe/elbow. Section 3-3' Unetched 6.3X 4P 1078A

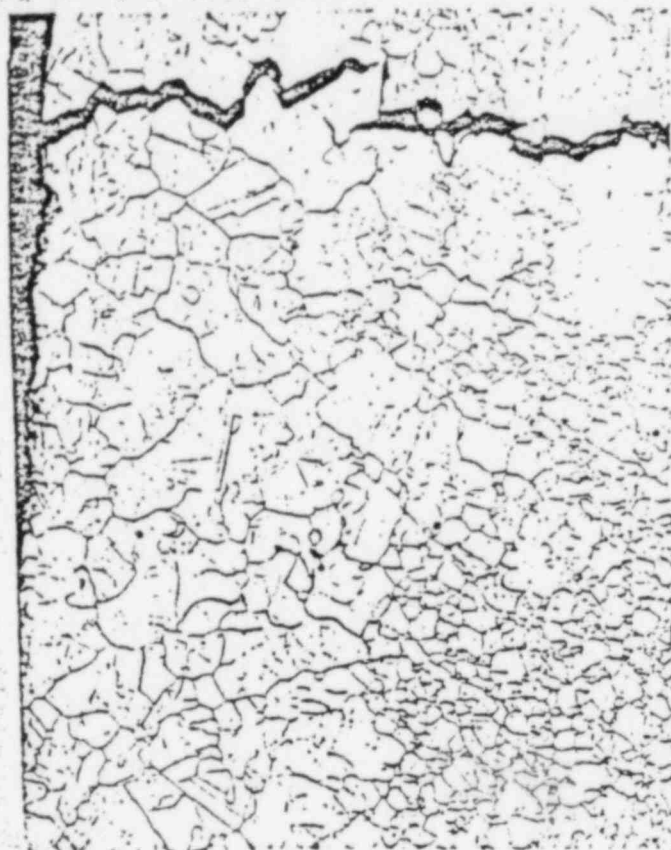
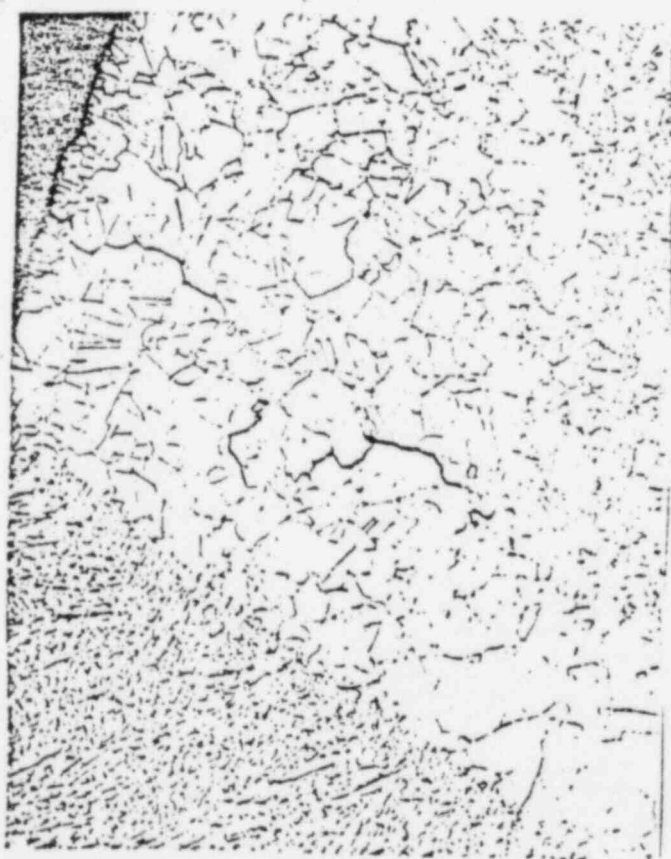
- 3) Intergranular cracks, with only a few exceptions as noted in Figure 4d.
- 4) Large density of grain boundary precipitates in the HAZ. The HAZ extended to beyond the major crack. These precipitates are presumably carbides (Figure 5).

Figure 4. Optical micrographs of section 3-3' showing cracks emanating from the ID (left) towards OD (right). 4b shows end of major crack in 4a. Transgranular corrosion or stress corrosion, 4d.

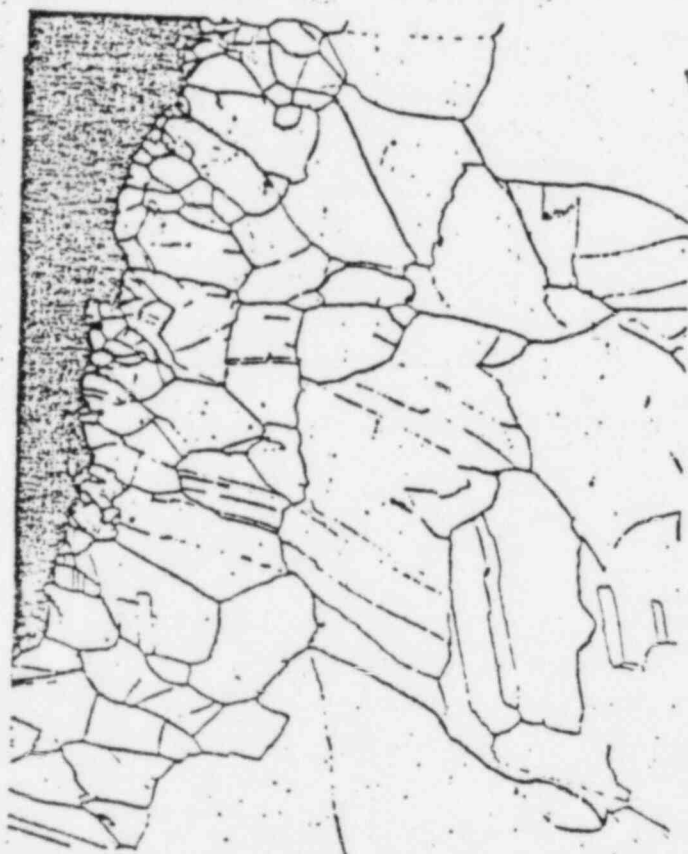
Figure 5. Optical micrographs showing grain boundary carbide precipitation at three locations relative to the weld. Section 2-21

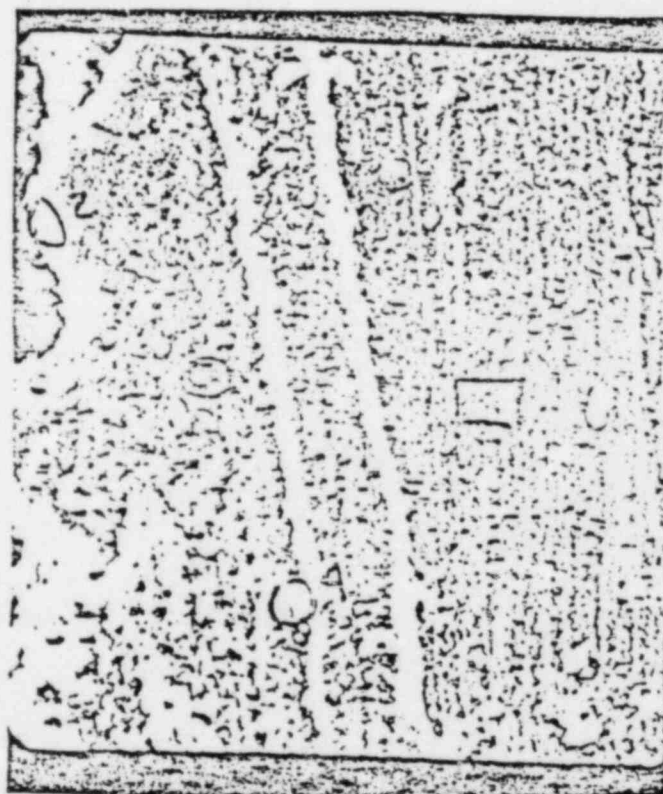
- 1) Corrosion product buildup was evident on ground inner surface of pipe near major crack and on the fracture surface (Figure 8). Energy dispersive X-ray analysis (EDX) of areas 1, 2, 3, and 4 of Figure 8C showed the following elements:
 - a) Si (small amount), Fe, Cr, Ni
 - b) Al, Si, S, Cl all small amounts, Cr, Fe
 - c) Si, Si, both large amounts, Cr, Fe
 - d) Al, Si, K, Cr, Fe, large amounts, Ni, small amount

Figure 8. Scanning Electron Micrographs of Inner Surface of Pipe
(Near the origin of the major crack)

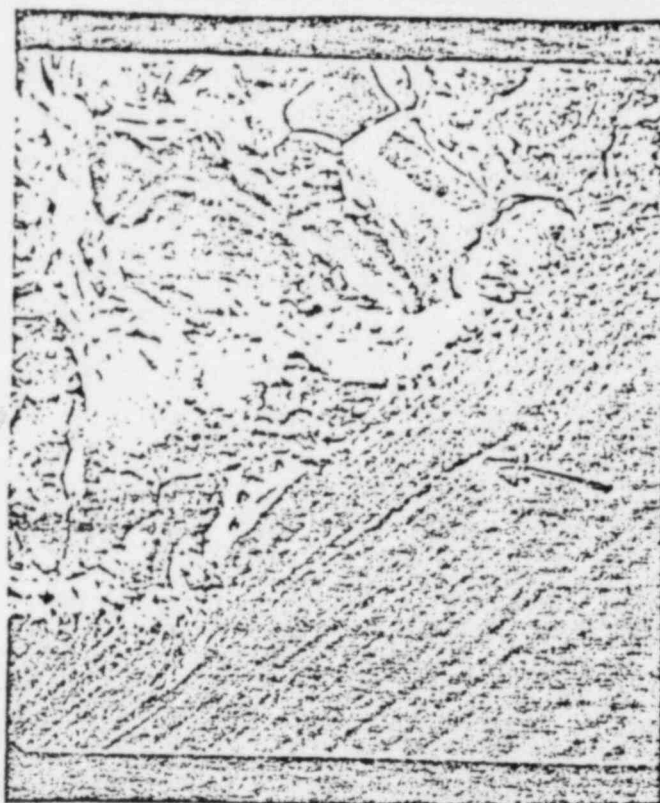
- 2) The corrosion product was the densest near the crack origin at the inner surface of the pipe. There was some evidence of crack initiation being associated with the grinding marks (Figure 9a arrow). The elements detected with EDX on the fracture surface of Figure 9b were:
 - a) Fe, Cr with a little Ni
 - b) Fe, Cr with a little Ni
 - c) Al, Si, S, Cr-small amounts, Fe large
- 3) Deeper within the crack the fracture surface was much freer of deposits (Figure 10). The intergranular nature of the fracture is very evident.
- 4) The inner surface (ID) of the pipe away from the circumferential weld showed features which are associated with the pickling and grinding of the longitudinal pipe weld (Figure 11).

Figure 9. SEMs Showing Inner Surface and Crack Origin (a) and Corrosion Product Buildup

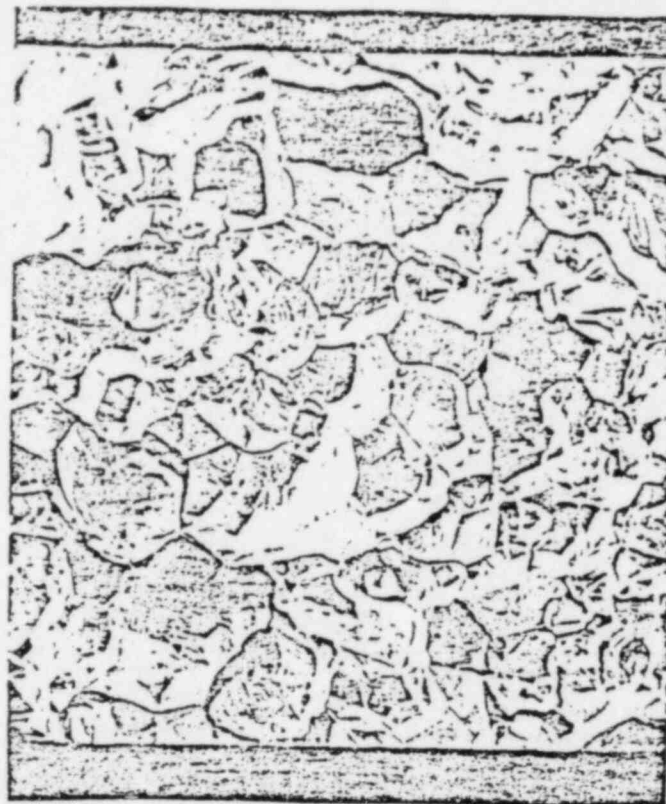
Figure 10. SEMs of the Fracture Surface far Removed
From the ID

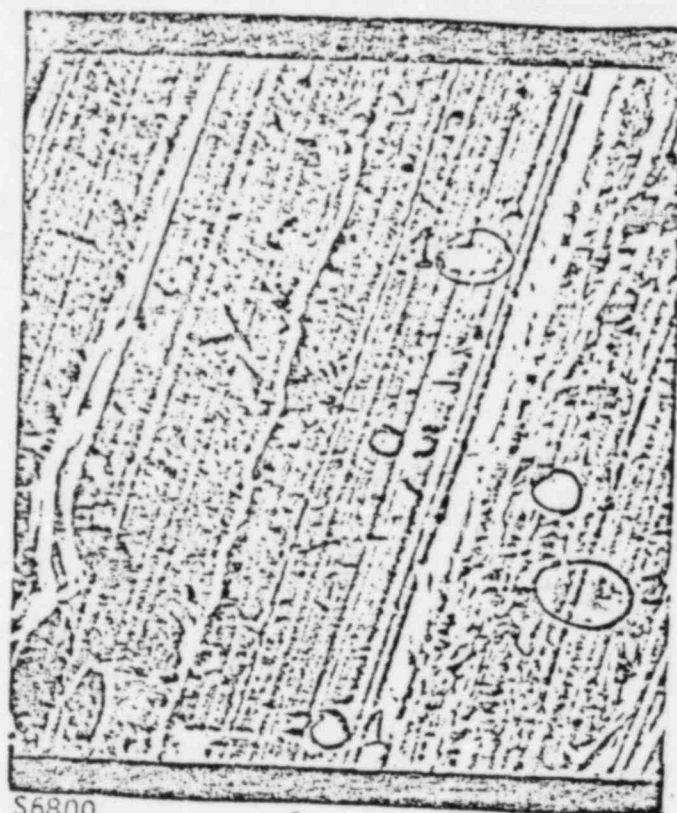
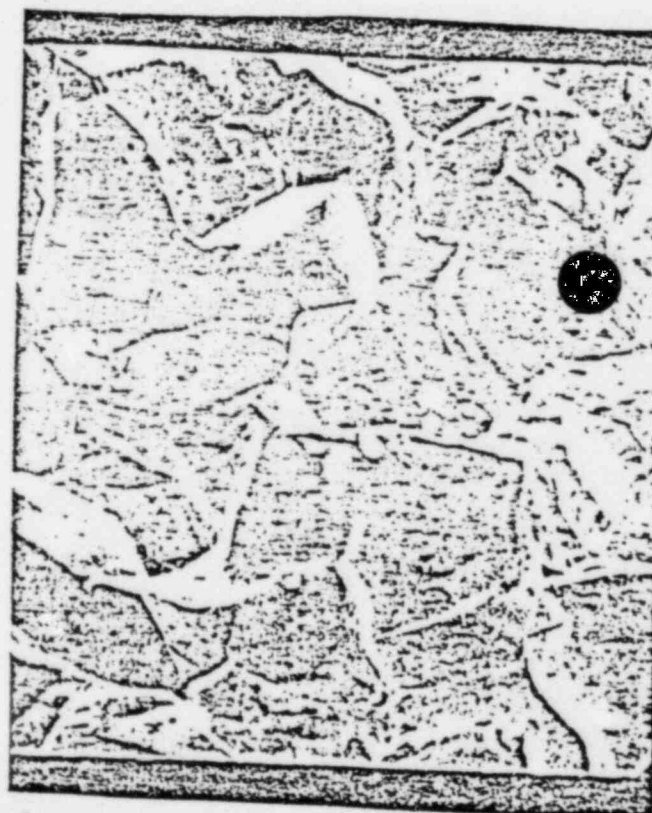
Figure 11. SEMs of the Inner Surface (ID) of the Pipe Away From the Circumferential Weld

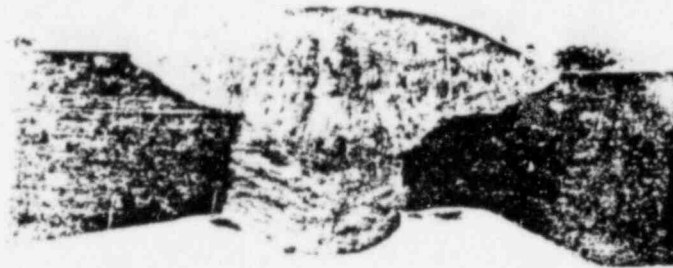
FIGURE 11

Joint geometry and UT screen presentation produced by weld root irregularity.

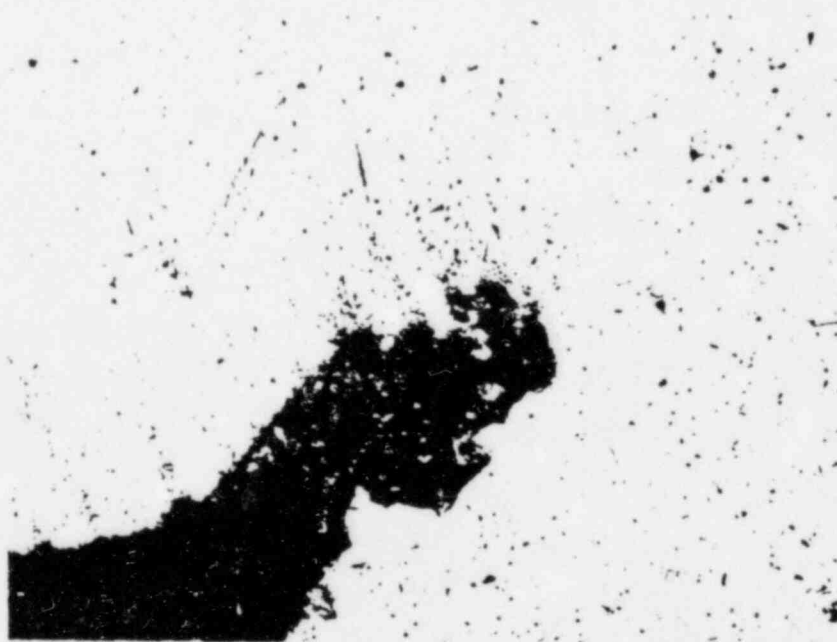
FIGURE 12

Weld root irregularity most likely responsible for UT indications.

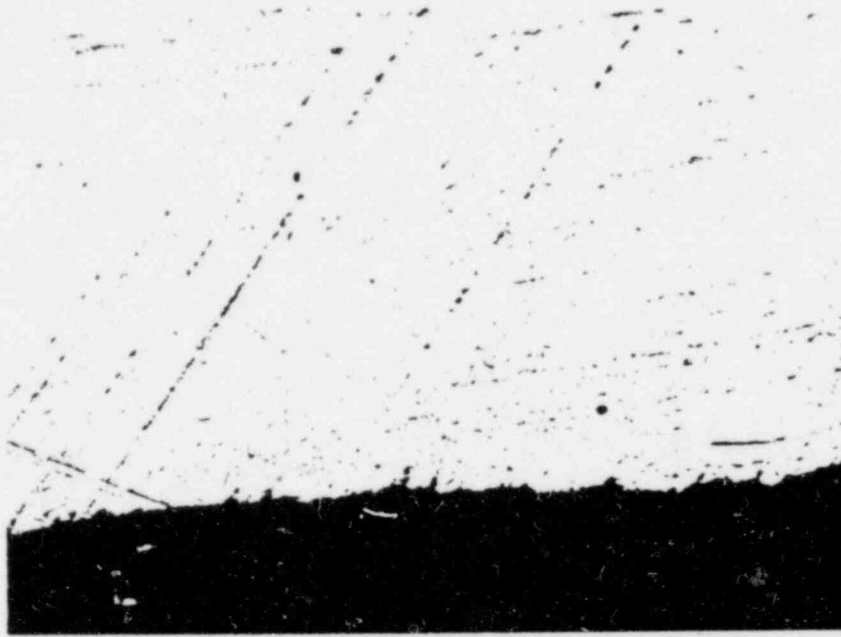
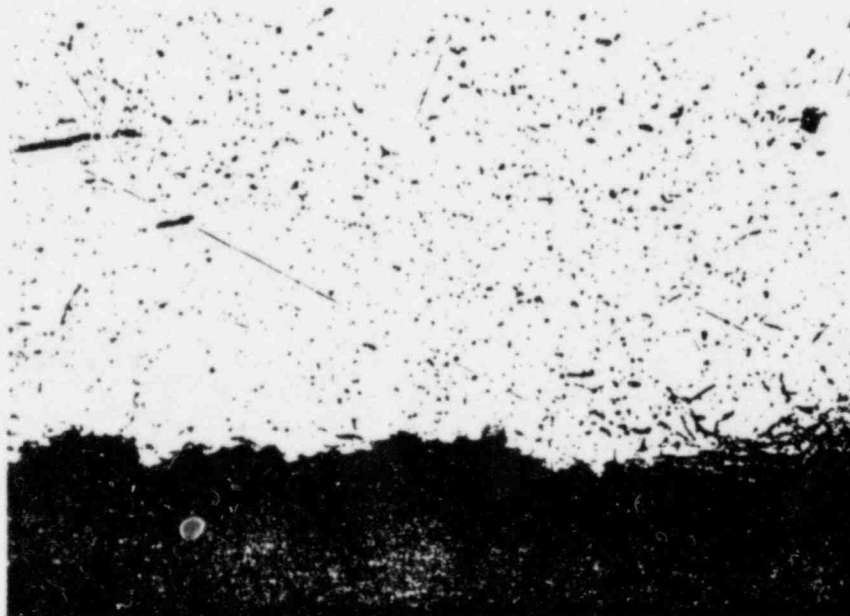
FIGURE 20

No defects were found other than surface roughness in counter-bore on fitting side shown above.

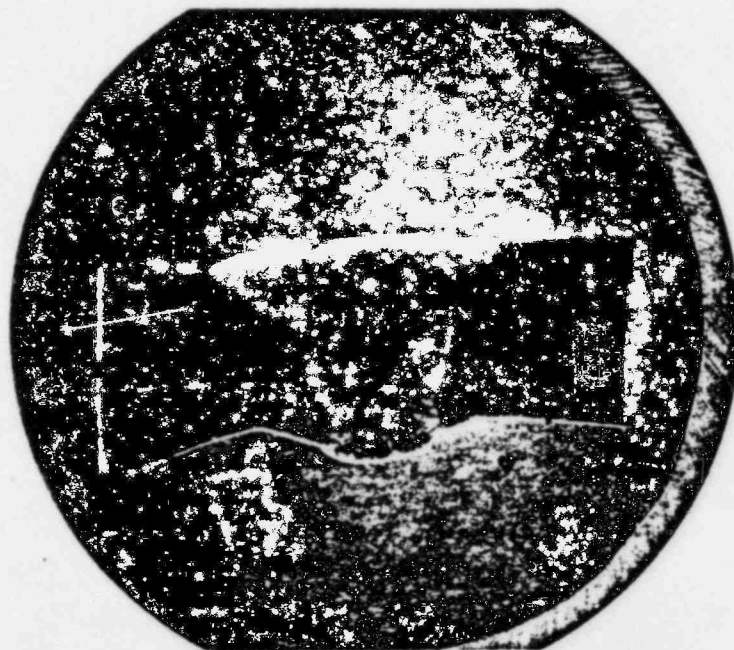
3 I 2

Joint geometry and UT screen presentation for .062" deep crack on pipe side.
Note sharp angle on pipe side counterbore.

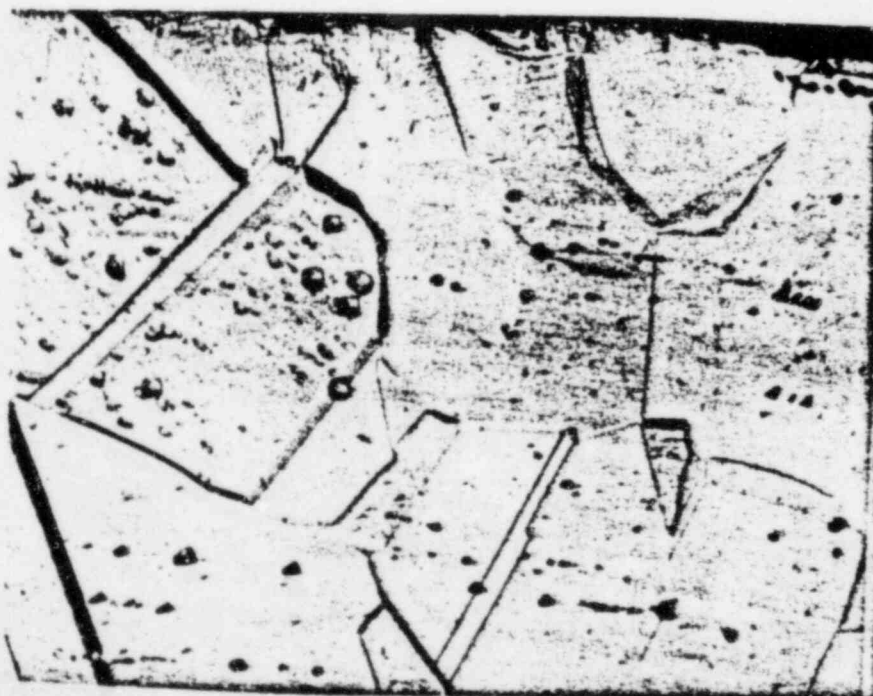
FIGURE 4

Sample #3
Mag 500X
Etch: Oxalic Acid
304 L SS HAZ on
I.D. surface.
Step structure,
no ditching

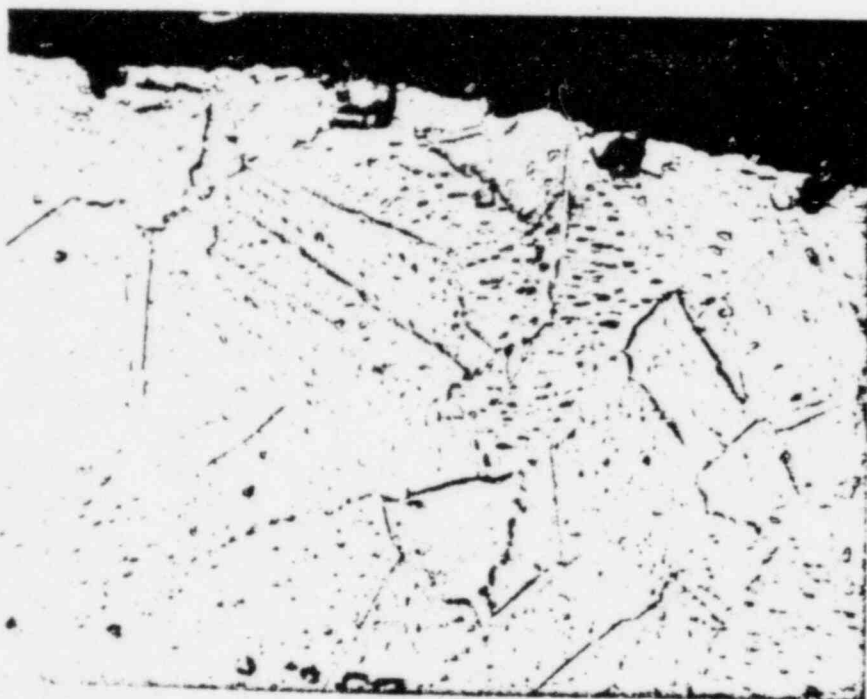
FIGURE 7

Sample #1
Mag 500X
Etch: Oxalic Acid
304 SS HAZ at I.D.
surface. Step
structure plus some
ditching

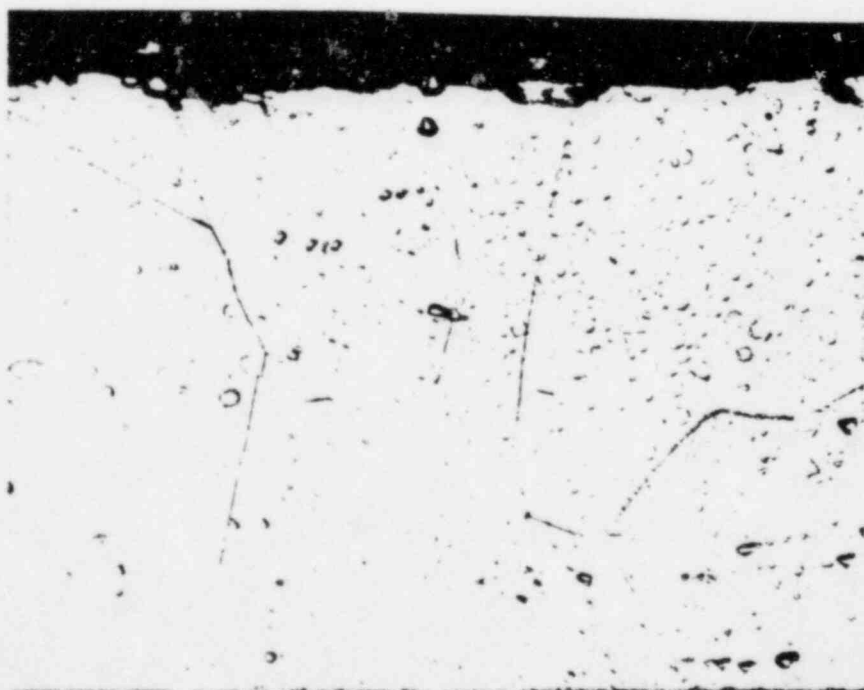
FIGURE 8

Sample #1
Mag 500X
Etch: Oxalic Acid
304 L SS HAZ at
I.D. surface.
Step structure,
no ditching

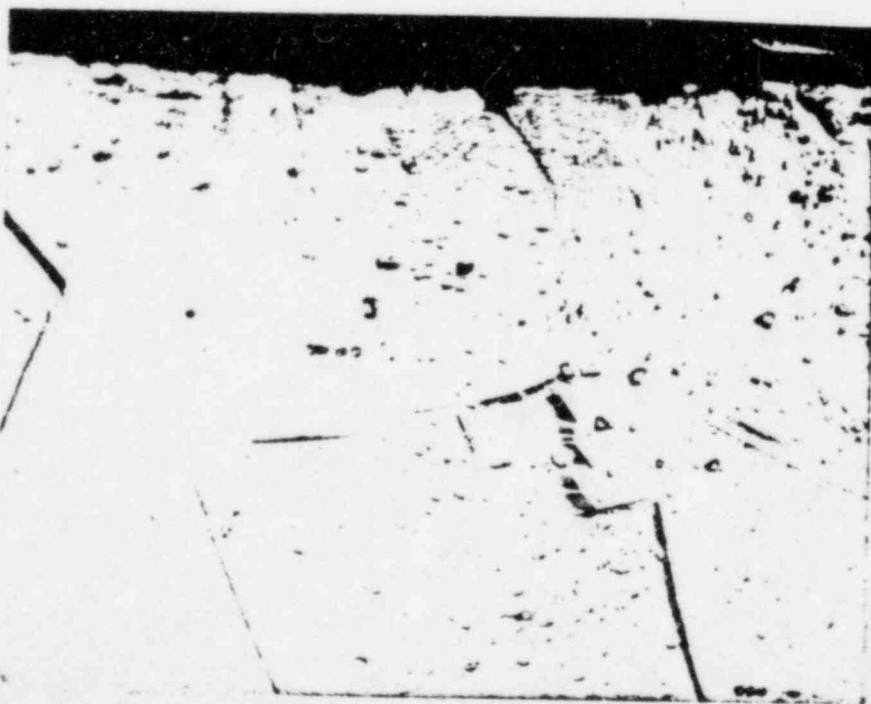
FIGURE 10

Sample #2
Mag 500X
Etch: Oxalic Acid
304 L SS HAZ at
I.D. surface.
Step structure,
no ditching
