SUBJECT: PALO VERDE VIBRATION PROBLEMS - REQUEST FOR
ADDITIONAL INFORMATION

REPORT ON
PALO VERDE UNIT 1
SAFETY INJECTION NOZZLE
THERMAL LINER

Prepared by: COMBUSTION ENGINEERING, INC.
WINDSOR, CONNECTICUT

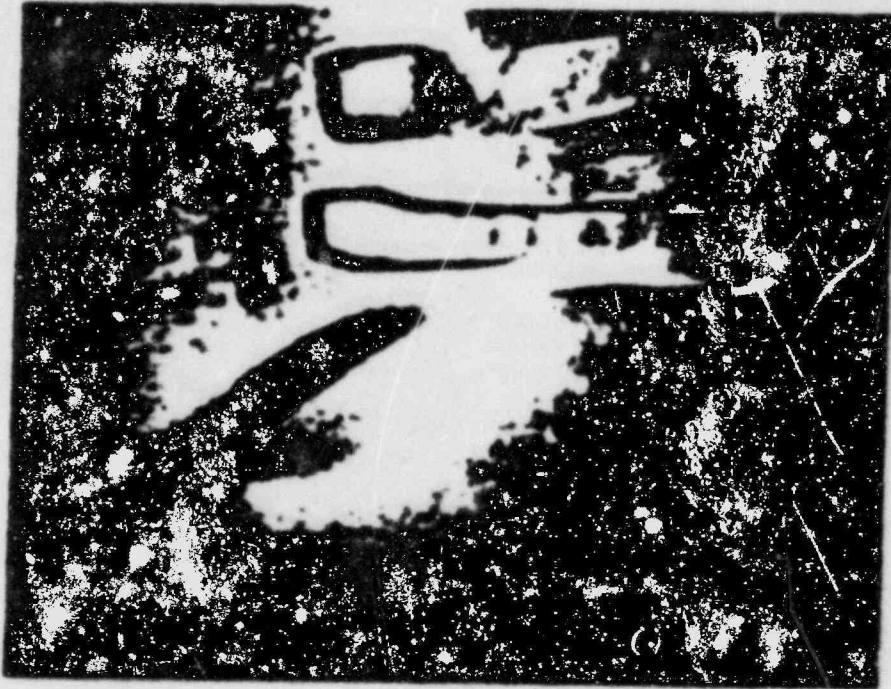
FIGURE 6

The failure mechanism is further substantiated by the indentations observed in the nozzle clad at the liner tab locations. Figure 6 shows photographs of the clad surface in nozzle 1A. Apparently, the liner vibrated against the nozzle wall and then dropped a short distance where both vibration and rotation within the expansion groove occurred. As the liner rotated, more of the liner end protruded into the fluid flowing in the main pipe. Ever increasing flow induced forces impacted the liner and was magnified by the cantilevered design. Eventually, the combination of vibration and flow load caused the liner to "lose its grip" at the expansion groove and fall into the main pipe.

CLAD DAMAGE ON S.I. NOZZLE 1A

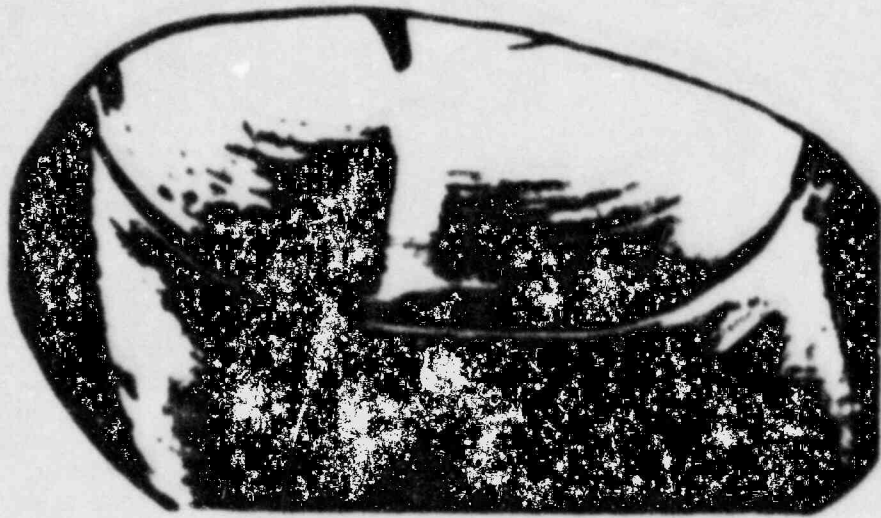
THERMAL LINER
EXPLANSION GROOVE

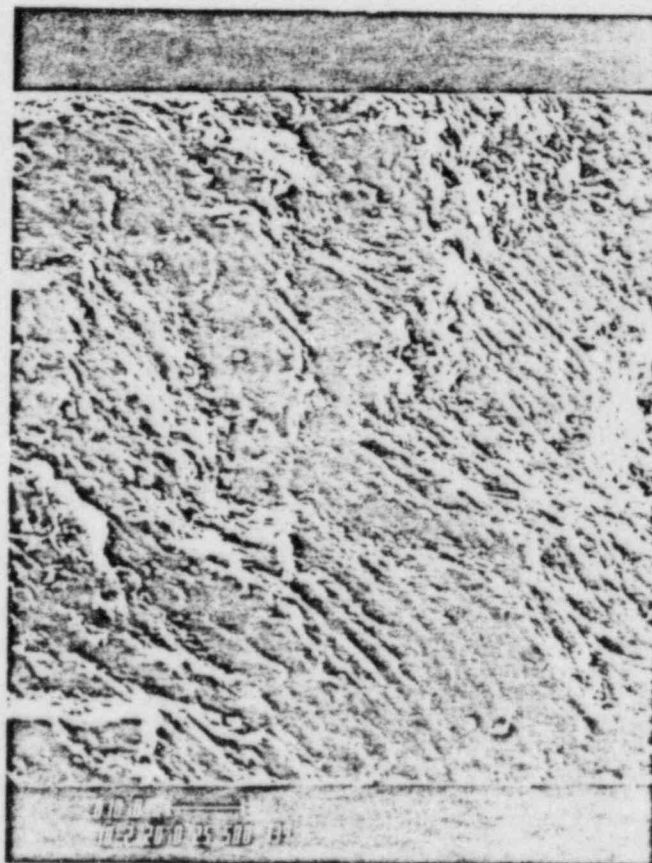
Figure 3:2-30 62566
Areas 4 and 5 of
Thermowell No. 112CD

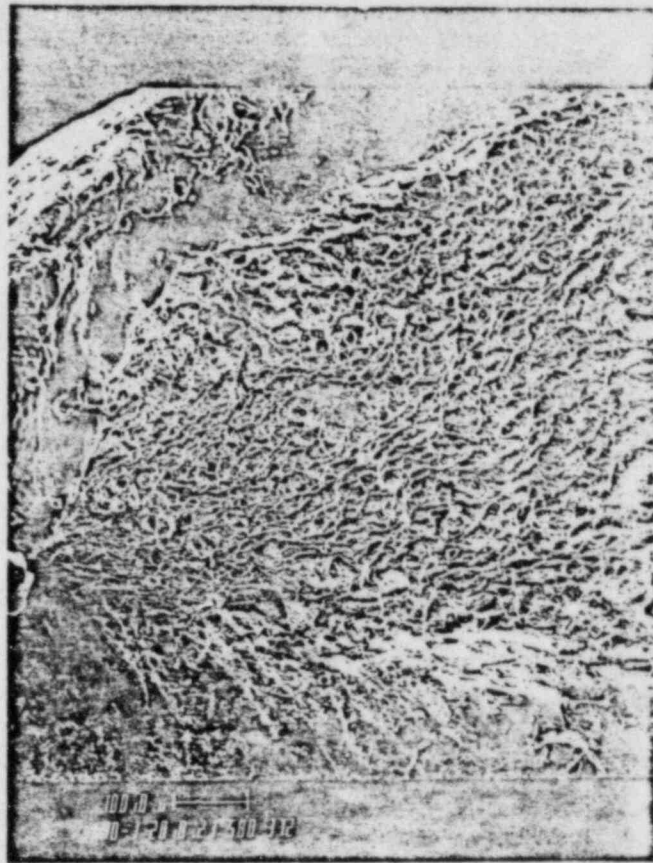
Figure 3.2-36 62550
Higher Magnification
of Area 1 of Thermowell
No. 111Y, Showing
Ductile Tearing

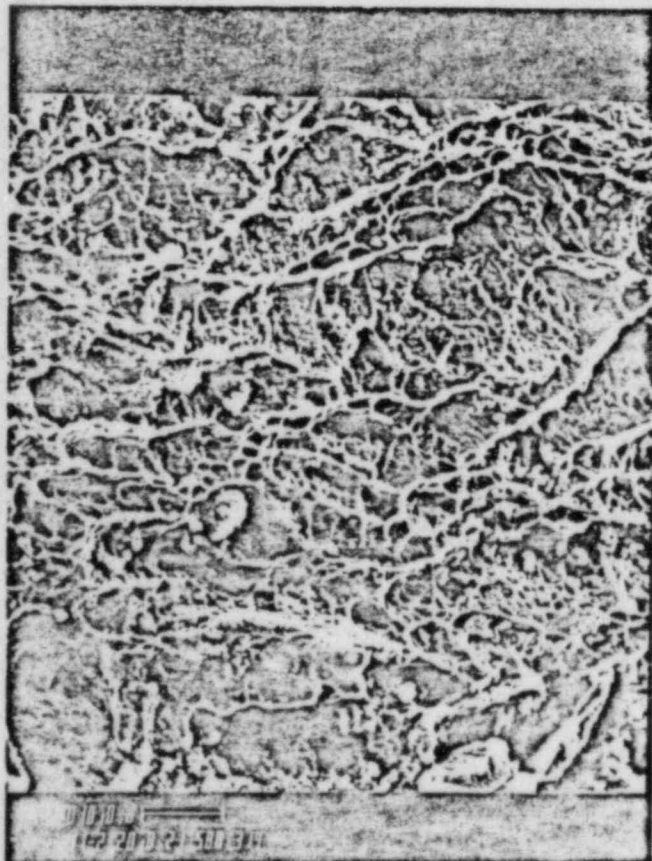
Figure 4 3.2-38 62551
Striations in Area 2
of Thermowell No. 111Y
