PRELIMINARY NOTIFICATION OF EVENT OR UNUSUAL OCCURRENCE--PNO-III-87-138 Date November 3, 1987

Subject: SHUTDOWN BECAUSE OF EXCESSIVE MSIV CLOSURE TIMES

This letter confirms the telephone conversation on November 3, 1987, between Mr. Greenman and others of this office and Mr. A. Kaplan of your staff regarding the Main Steam Isolation Valve (MSIV) failures occurring at the Perry Nuclear Power Plant Unit 1 on November 3, 1987. With regard to the matters discussed, we understand that you will:

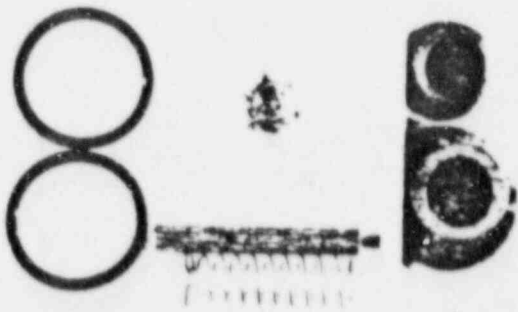
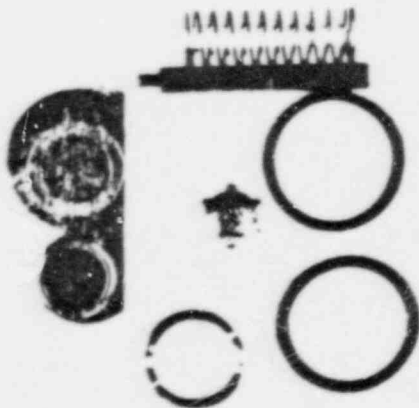
Figure 4.

The compression set and hardness of the o-rings and seats progressively increased from control to nonfailed to failed valve components. This indicated that the EPDM components became less elastic. The indentations in the energized solenoid elastomer seats were deeper in the failed MSIV valves than in the nonfailed valve. The outside (100-150 micrometers) layer of the failed o-ring had changed and appeared more porous than the outside layer of either the nonfailed or control o-ring.

Energized Elastomer Seat
Doughnut Shaped
Indentations

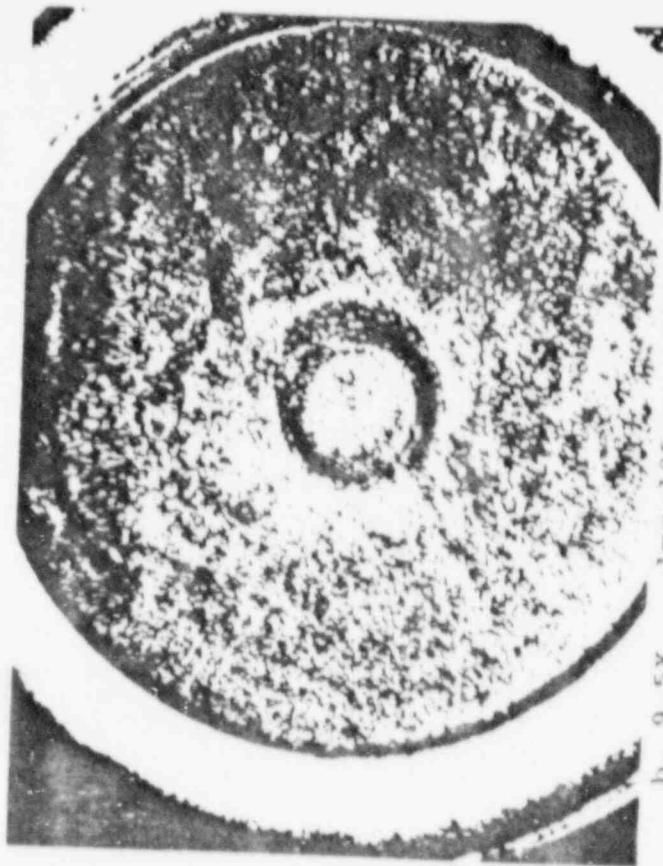
Figure 6.

De-energized Elastomer
Seat Indentations

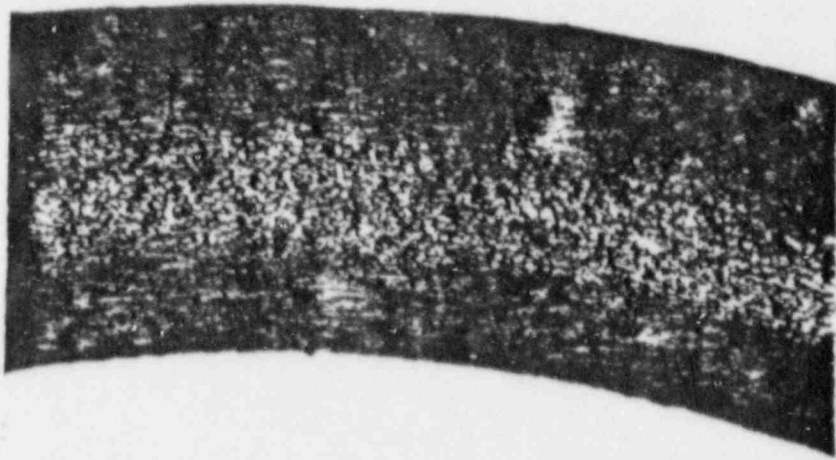
Figure 8. O-ring

The control o-rings are rounded and smooth (Figure 8).

a. 24.6X
Control

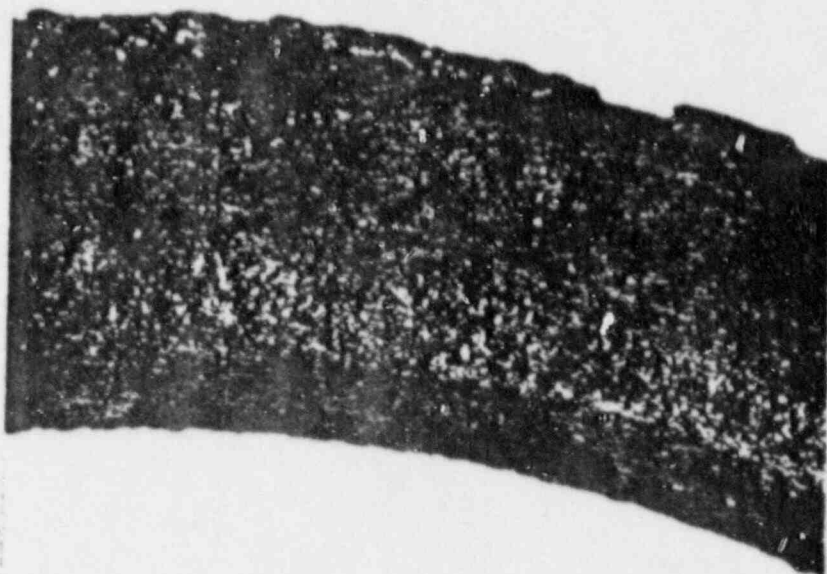
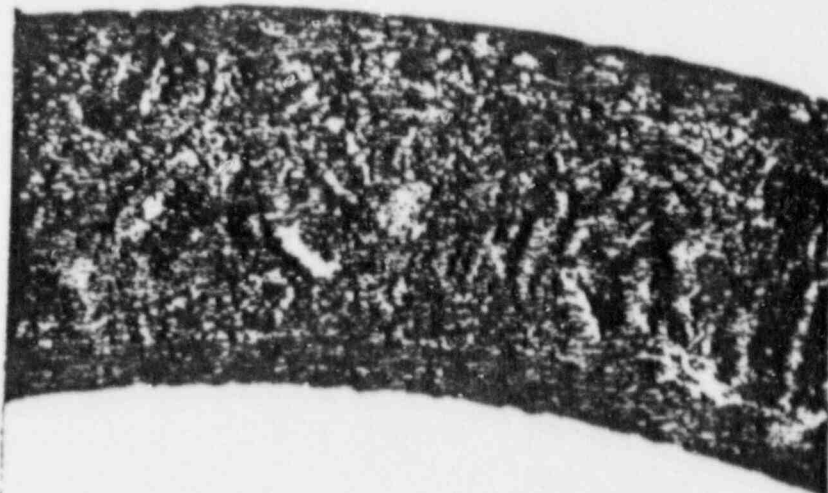
Figure 9. O-rings

1. Flattened with little or no distortions (Figs. 11a & b).
2. Flattened with distortion of the o-rings' edges (Figs. 9a, 10a, 12b).
3. Flattened with major changes at the o-rings' edges and center (Figs. 9b, 10b, 12a & c).

a. 24.6X 1mm=41µm
Side 1 (of o-ring 1) MSIV 22

b. 24.6X 1mm=41µm
Glassy Edge, Folded Center
Side 2 (of o-ring 1) MSIV 22

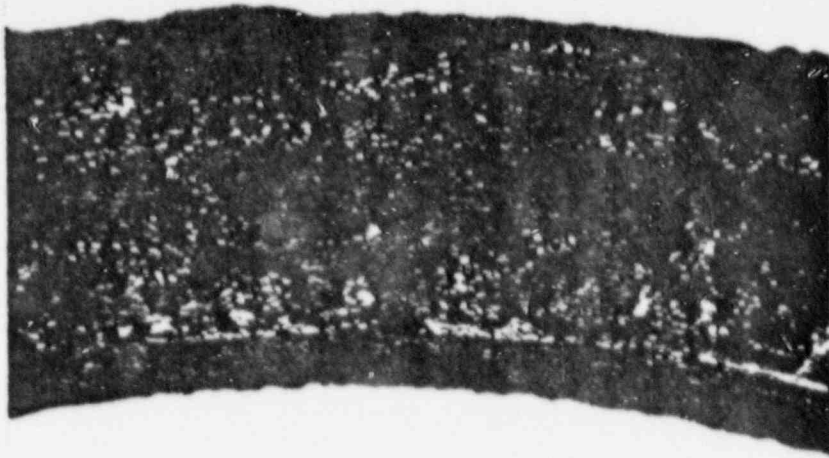
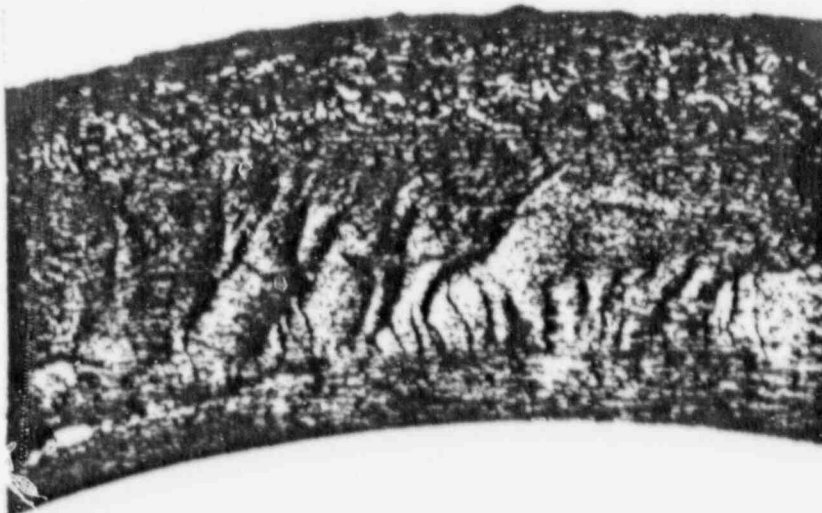
a. 24.6X
1mm=41µm
MSIV 27
Glassy Edges,
Folded Center

b. 24.6X
1mm=41µm
Side 1 (of o-ring 1)
MSIV 28

c. 24.6X
1mm=41µm
Glassy Edges,
Folded Center
Side 2 (of o-ring 1)
MSIV 28

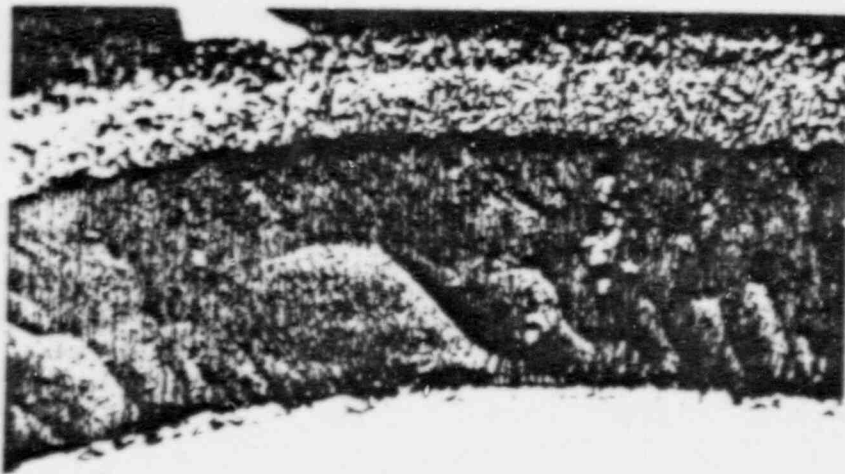
a. 24.6X
Side 1 MSIV 20 1mm=41 μ m

b. 24.6X
Side 2 MSIV 20 1mm=41 μ m

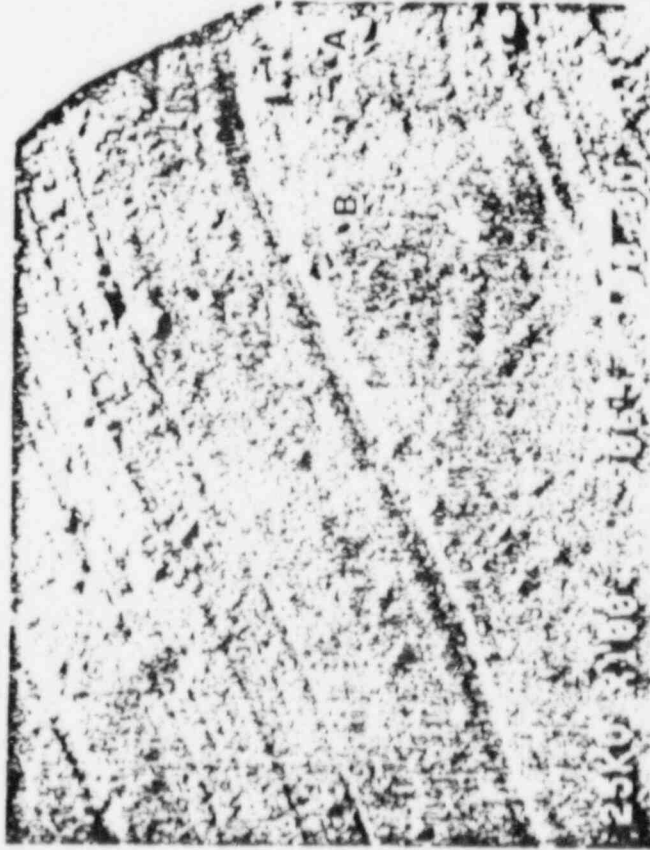
Figure 11. MSIV Control O-ring Cross-section

<u>Control</u>	<u>C</u>	<u>N</u>	<u>O</u>	<u>Si</u>	<u>S</u>	<u>Ca</u>	<u>Cu</u>	<u>Zn</u>
Area A (Figure 11c)	5,057	0	0	11	118	91	26	47
Area B (Figure 11c)	4,896	0	7	10	111	76	24	49
<u>MSIV24</u>								
Area A (Figure 13c)	NA	NA	NA	89	74	7	97	48
Area B (Figure 13c)	NA	NA	NA	70	78	6	66	27
<u>MSIV26</u>								
Area A (Figure 15c)	4,381	0	0	103	89	5	66	25
Area B (Figure 15c)	3,834	0	0	91	87	9	64	25
<u>MSIV27</u>								
Area A (Figure 17c)	NA	NA	NA	186	66	5	124	58
Area B (Figure 17c)	NA	NA	NA	95	97	7	40	12
<u>MSIV28</u>								
Area A (Figure 19c)	4,584	0	281	177	77	5	159	84
Area B (Figure 19c)	4,576	0	52	89	82	3	42	14

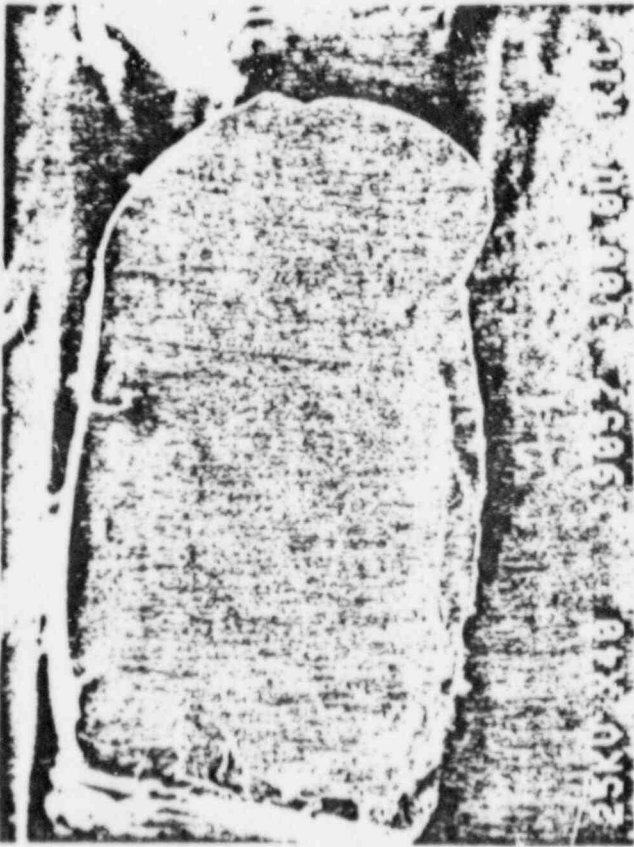
Inside the valves (MSIV 20, 21), a dark ring of deposits can be seen visually. Examination of these rings (Fig. 13) reveals the complement of a degraded o-ring, such as that in Figure 12c. The o-ring residue appears to have adhered to the brass body of the valve. The opposite side of the valve also has a deposit, but it is less predominant.

Figure 13. MSIV24
O-ring Cross-section Failed

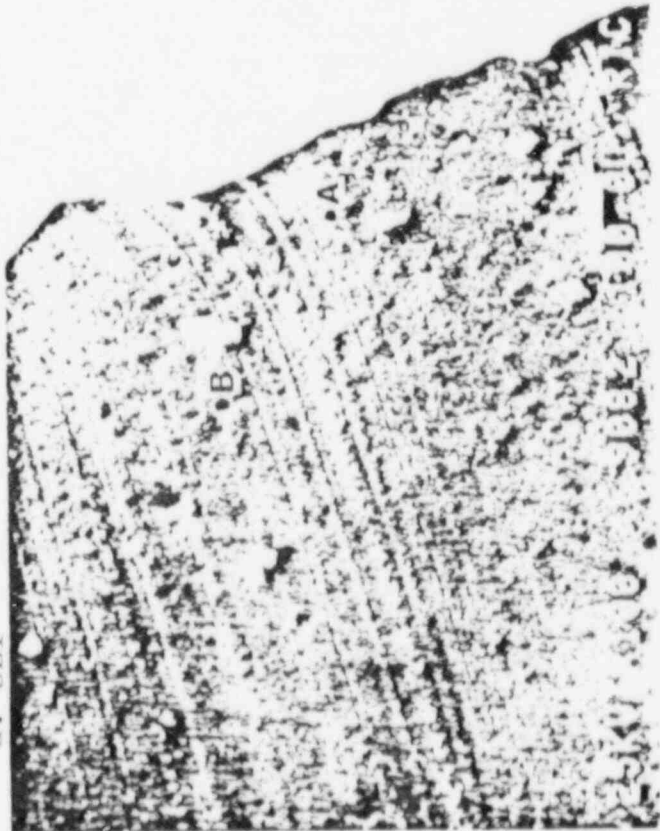
The EDS/WDS data are located in Table II. No elemental differences were noted between areas A & B (Figure 15c). Both areas had major quantities of C, Si & S, and minor quantities of Ca, Zn & Cl. The number of Cu counts is significantly higher in sample MSIV26 than in the control. The Ca counts are significantly lower than in the control.

Figure 15. MSIV26
O-ring Cross-section; Not Failed

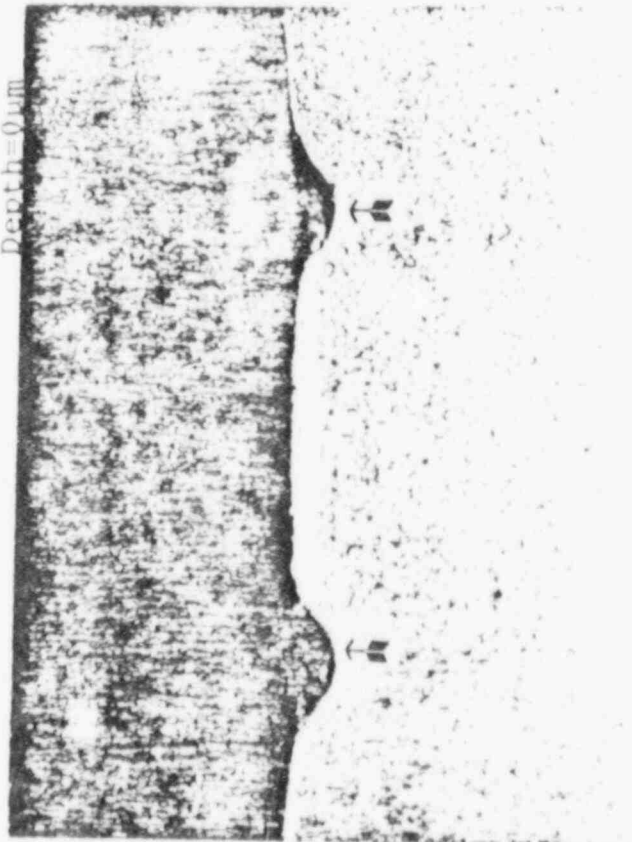
Figure 8. Optical Microscopy; Energized Elastomer Seats; Cross-section

a. 30.7X Control

b. 30.7X MSIV24

c. 30.7X MSIV26

d. 30.7X MSIV27

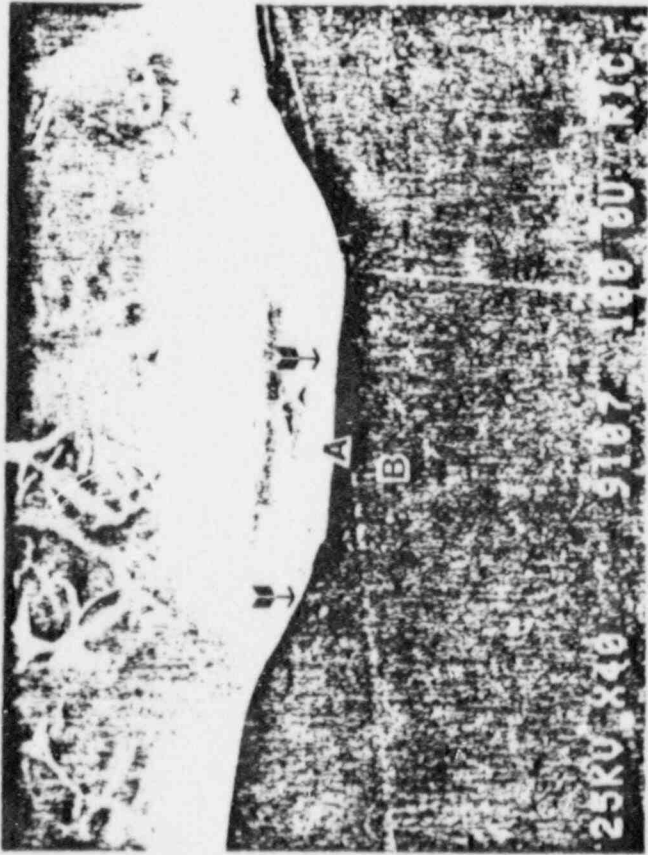
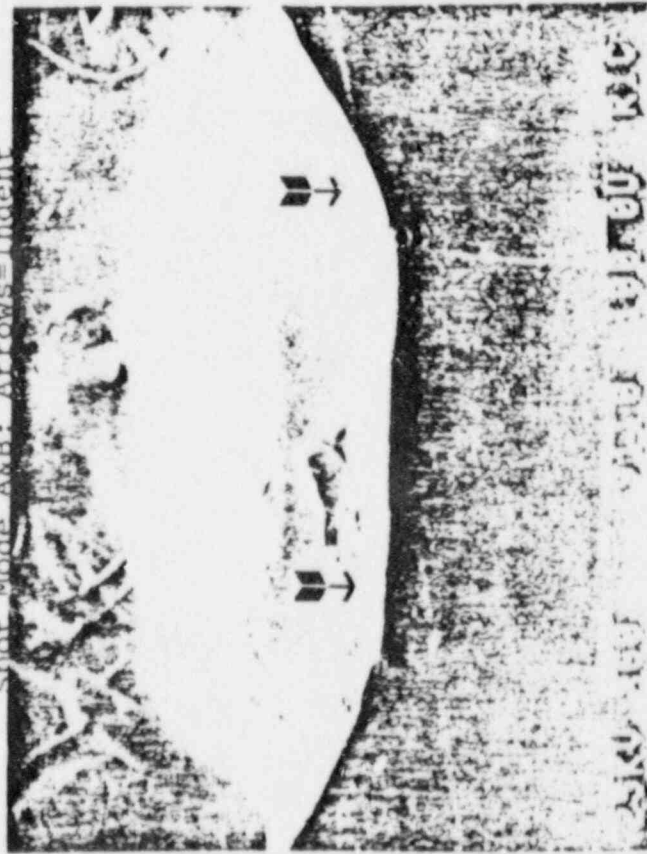
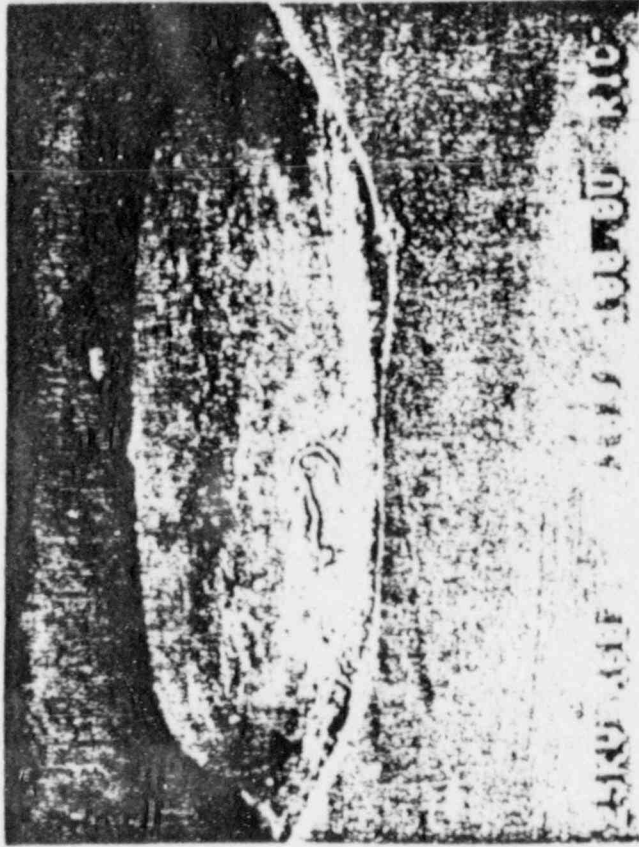
Figure 10. MSIV24; Energized Elastomer Seat; Cross-section

a. See Table II
Spot Mode A&B; Arrows=Indent

c. Arrows = Indent

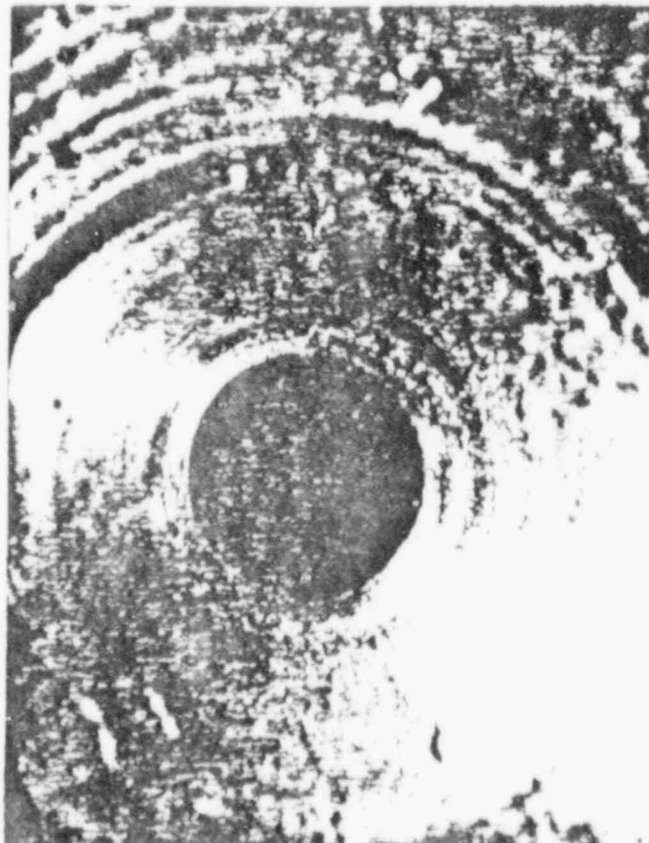
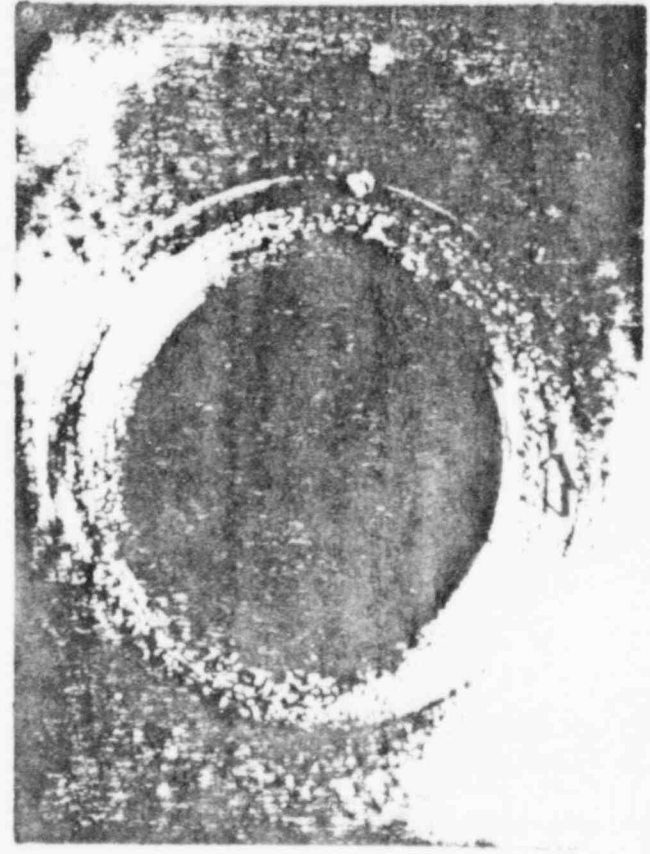
Figure 15. Optical Microscopy; Flow Control Valve; MSIV20; Center Cone

Figures 15a & b, and 16a & b have areas (arrows) where pieces of material appear to have adhered to the lip of the cone.

a. 18.8X Side 1
Imm=5.3µm
Arrows = Material

b. 30.7X Side 1
Imm=3.3µm
Arrows = Material

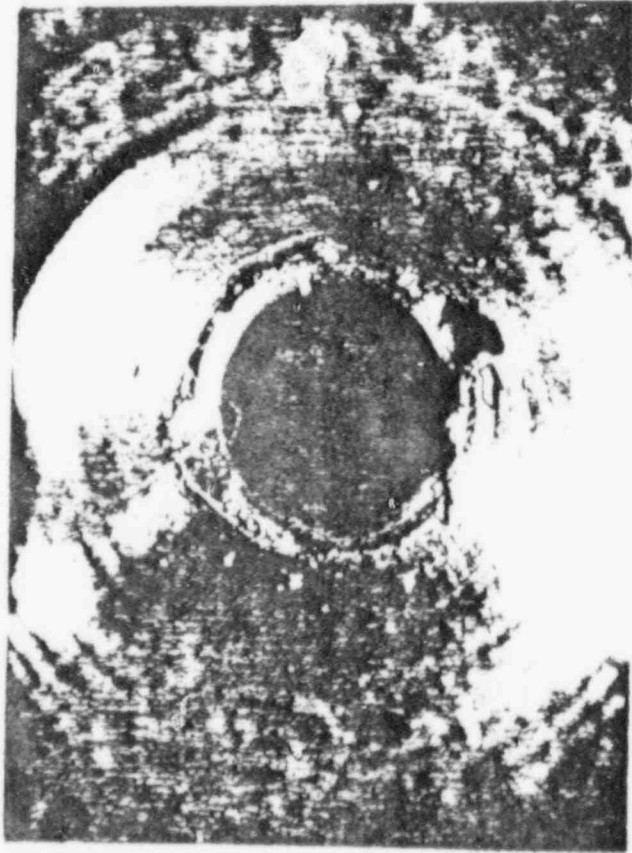
Figure 16. Optical Microscopy; Flow Control Valve; MSIV21; Center Cone

a. 18.8X Side 1
Arrows = Material
Imm=53 μ m

b. 30.7X Side 1
Arrows = Material
Imm=33 μ m
