2021 Annual Site Inspection and Monitoring Report for Uranium Mill Tailings Radiation Control Act Title II Disposal Sites

December 2021

L-Bar, New Mexico, Disposal Site

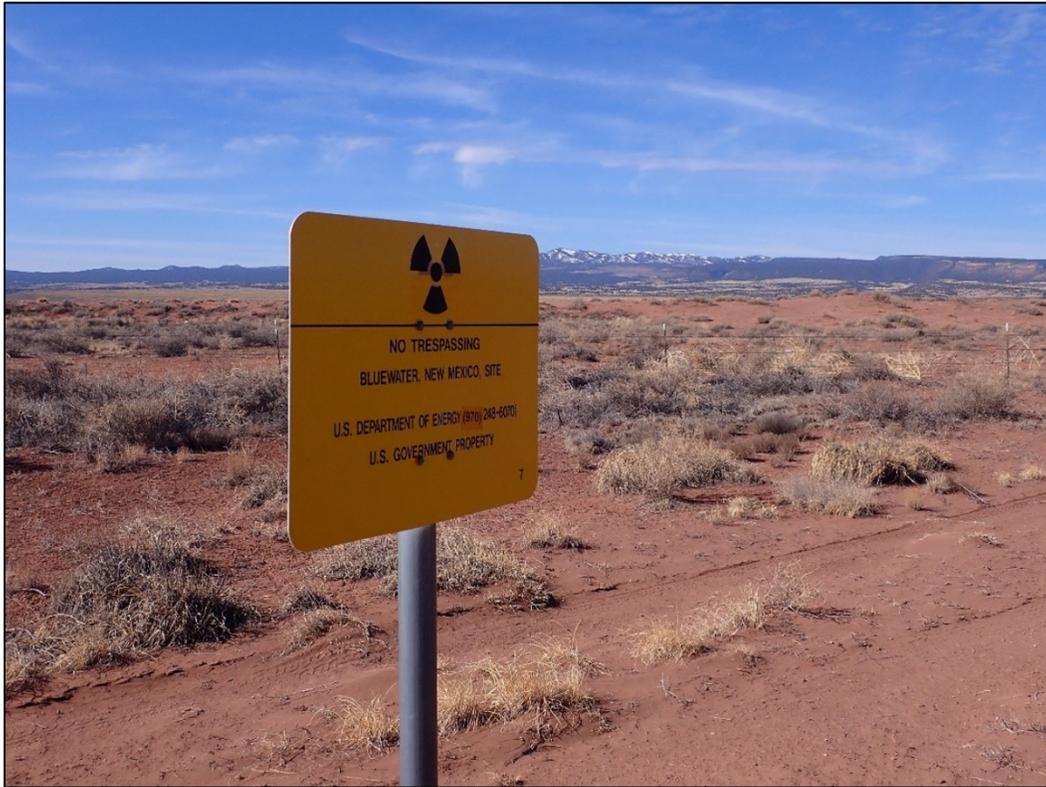
PL-5. Perimeter Sign P7

Fifty-five perimeter signs (warning and no-trespassing signs) are mounted on steel posts along the site boundary and around the main and carbonate tailings disposal cells (PL-5). Perimeter sign P8 was out of the ground (PL-6) and the base of perimeter sign P16 was loose (PL-7); both were repaired in a subsequent maintenance trip. Perimeter signs P3 and P10 have bullet hole damage but are legible. No other maintenance needs were identified.

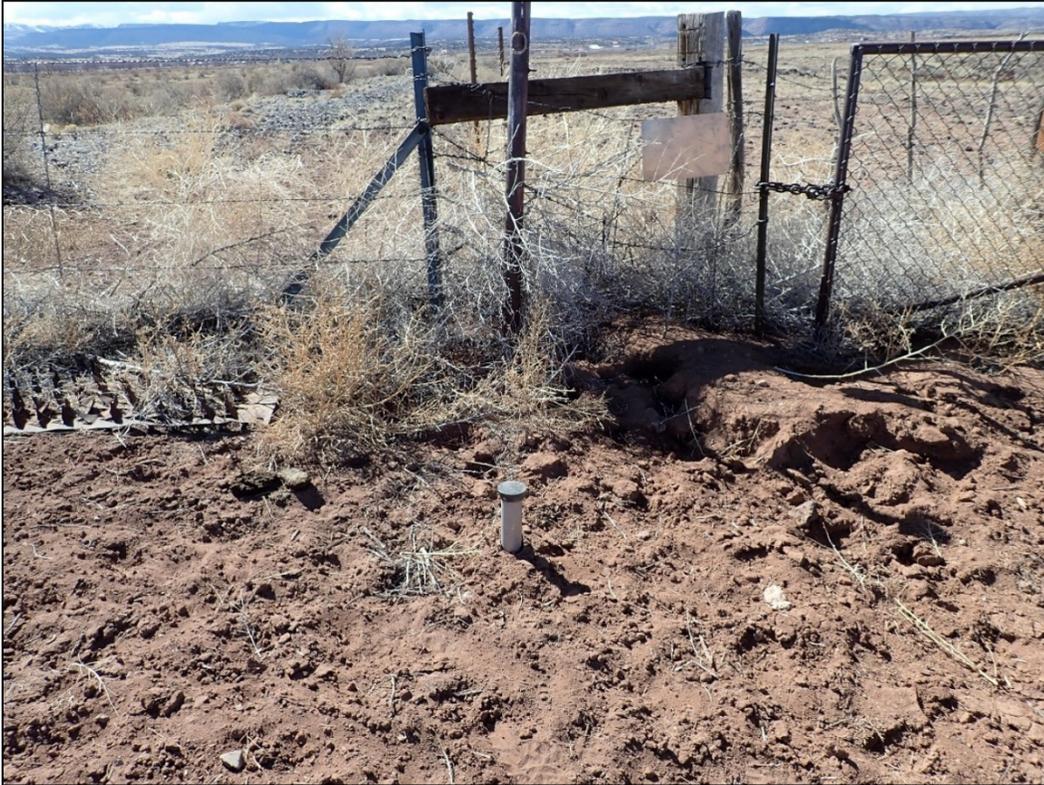
PL-9. Boundary Monument BM-2

Twenty-four boundary monuments define the site boundary (PL-9). These monuments are typically inside the perimeter fence and several feet inside the true corner or boundary line. Some monuments become covered by drifting sand, and metal T-posts have been driven at those locations to help inspectors find them. Other monuments are in remote sections of the site and cannot be observed from site access roads. All boundary monuments were inspected during the 2021 inspection. No maintenance needs were identified.

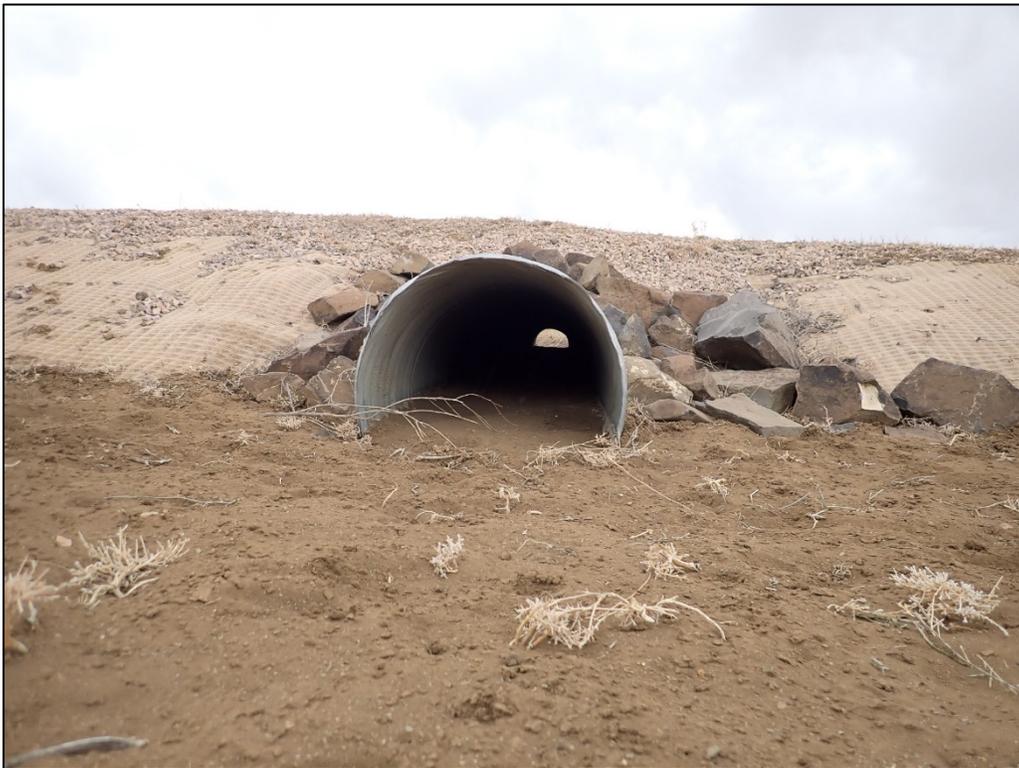
PL-2. Sedimentation in Eastern-most Culvert (Installed in 2016)

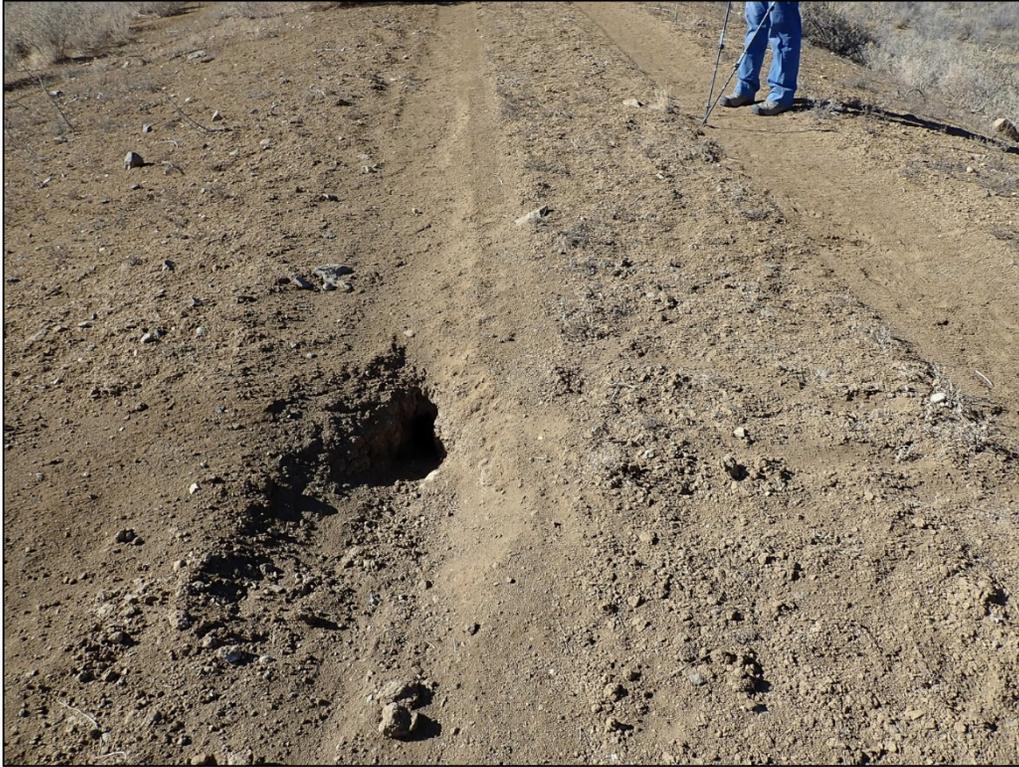
PL-3. Animal Burrow on Access Road

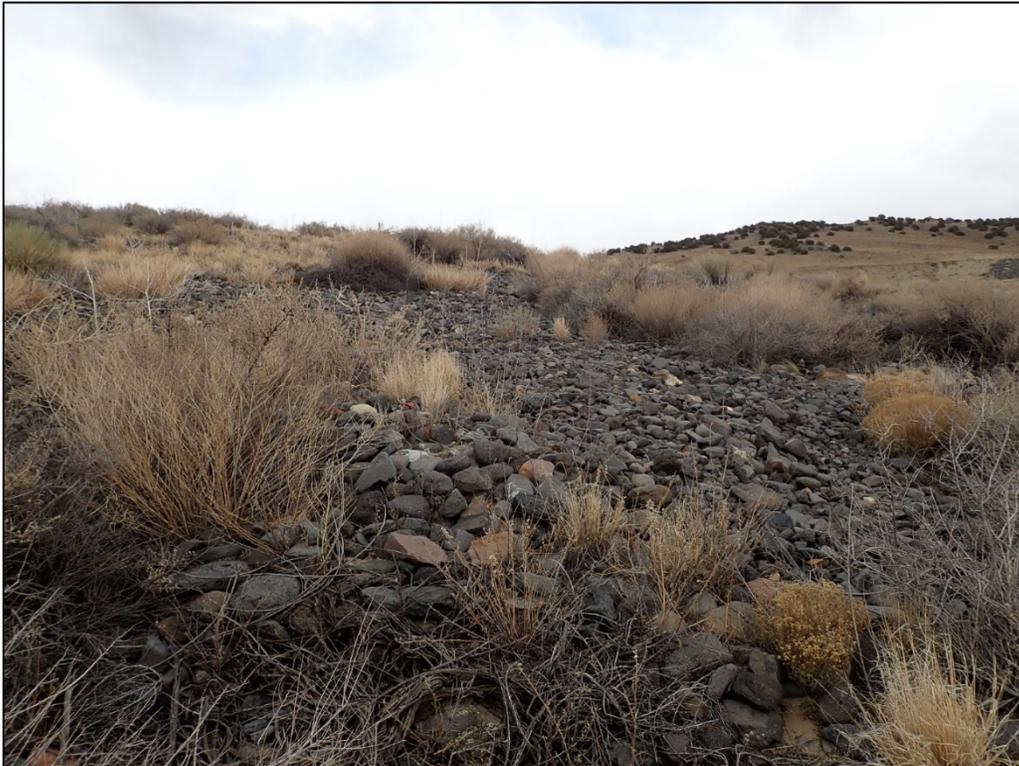
PL-12. Potential Stormwater Flow Path Along Containment Dam Spillway

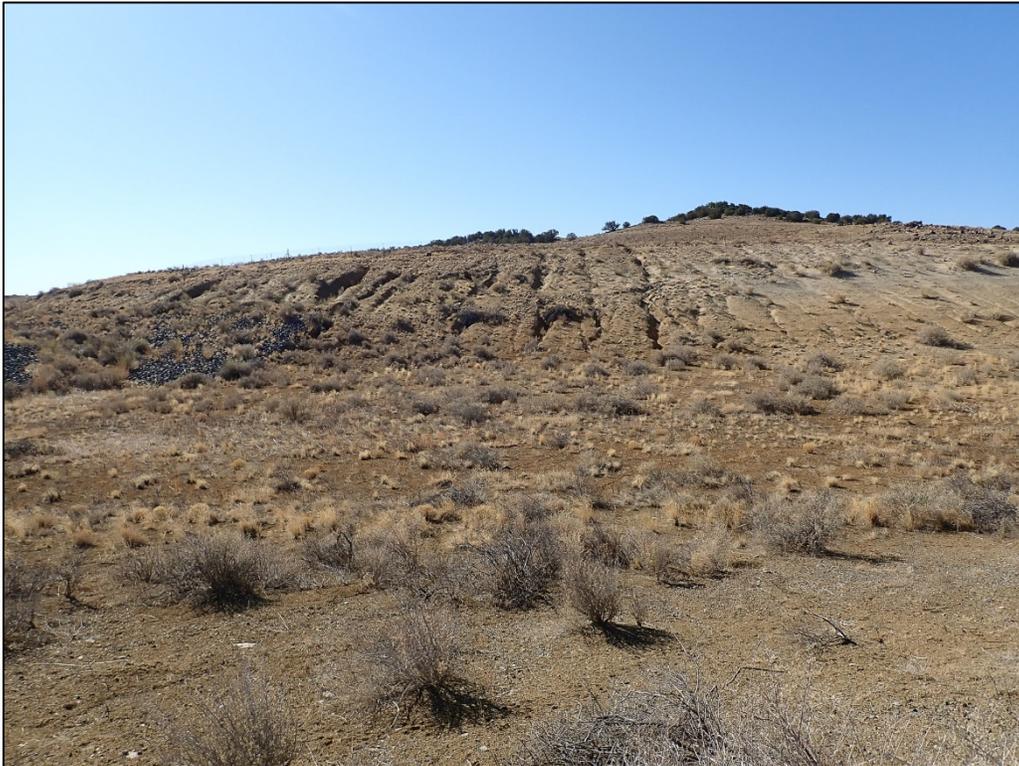
PL-16. Minor Rilling Near North Channel Cutoff Wall

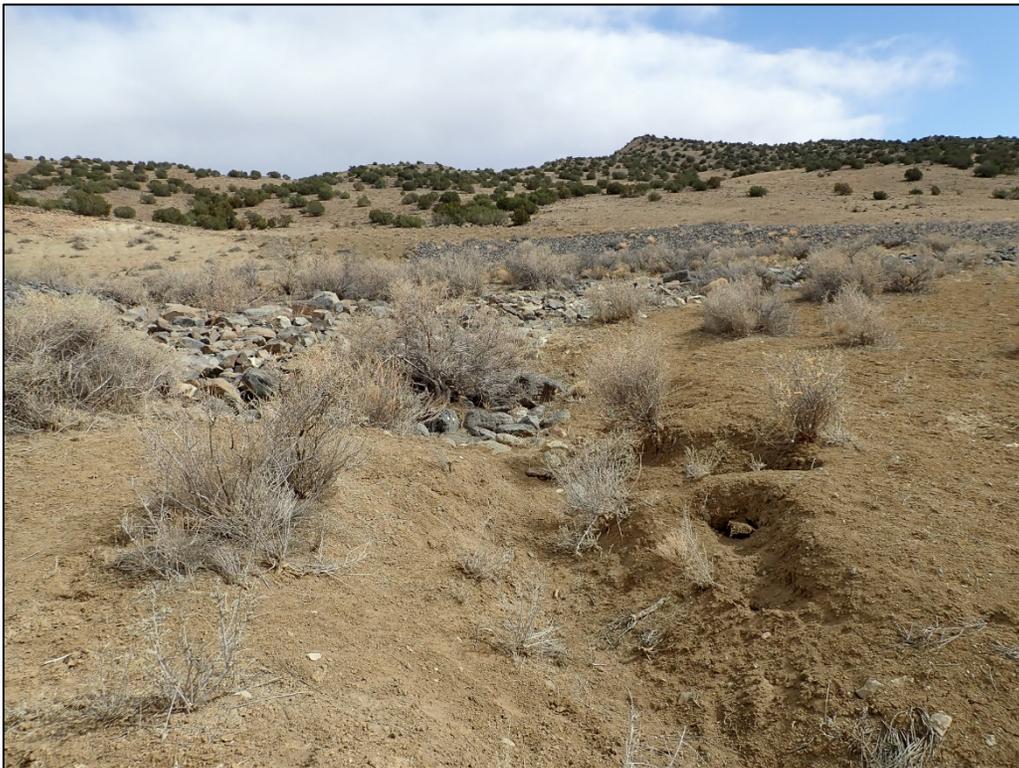
PL-17. Erosion on South Side Slope of South Diversion Channel

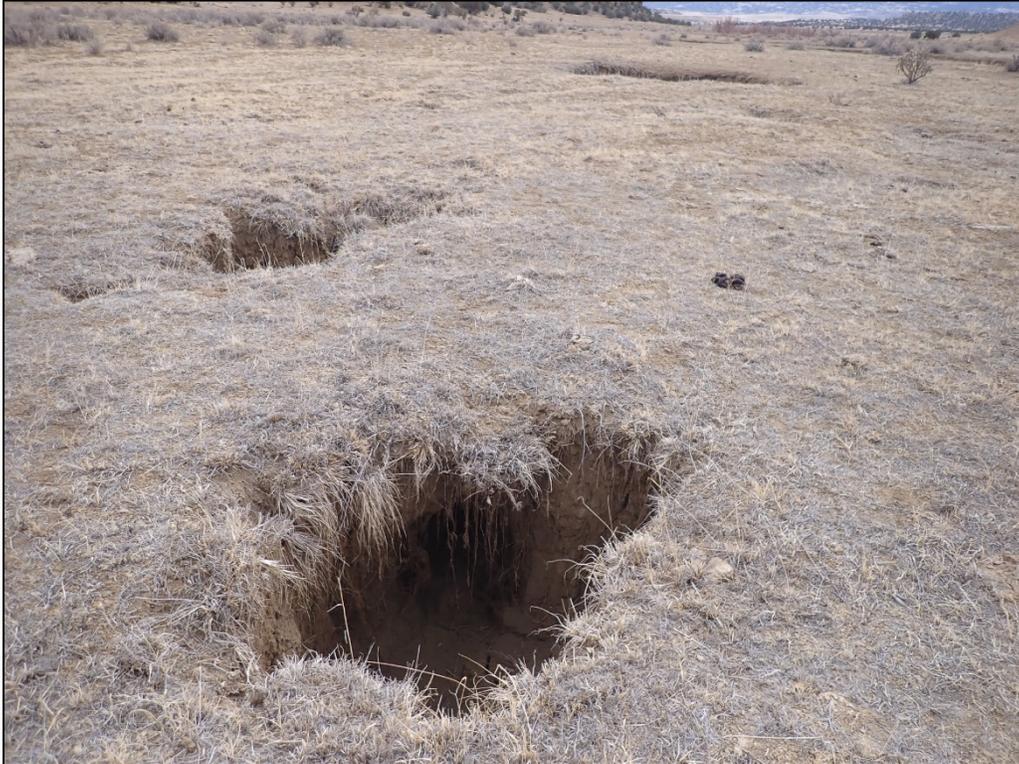
PL-18. Minor Rilling Downgradient of South Diversion Channel Cutoff Wall

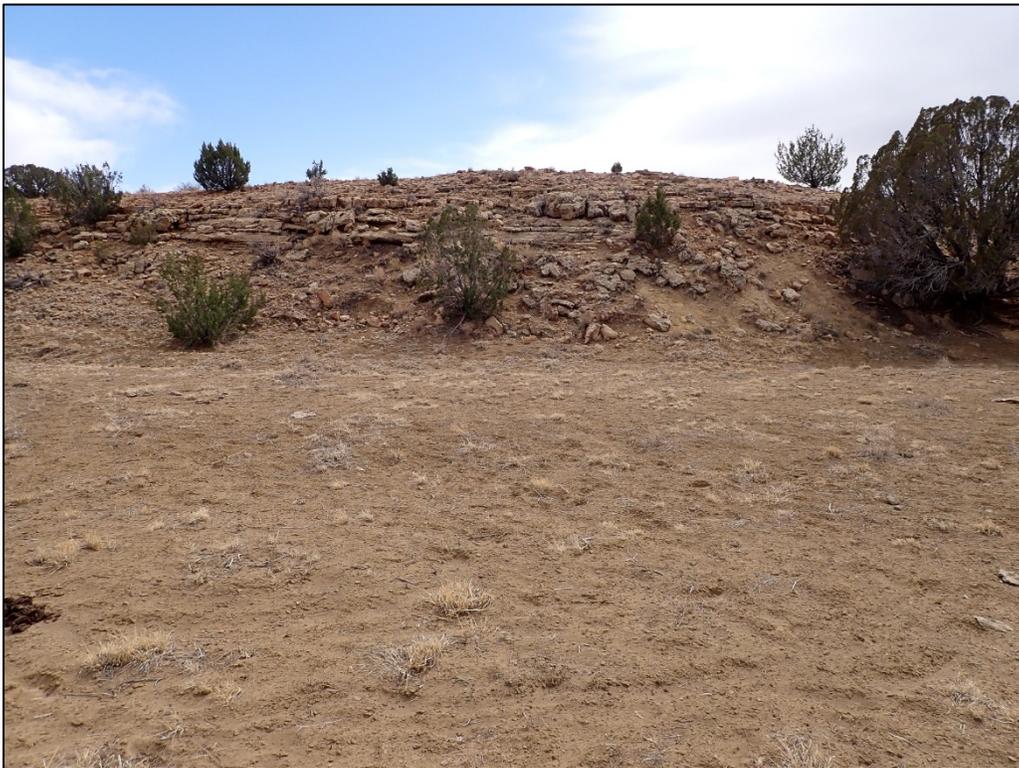
PL-19. Soil Piping Near Southwest Corner of Site Boundary

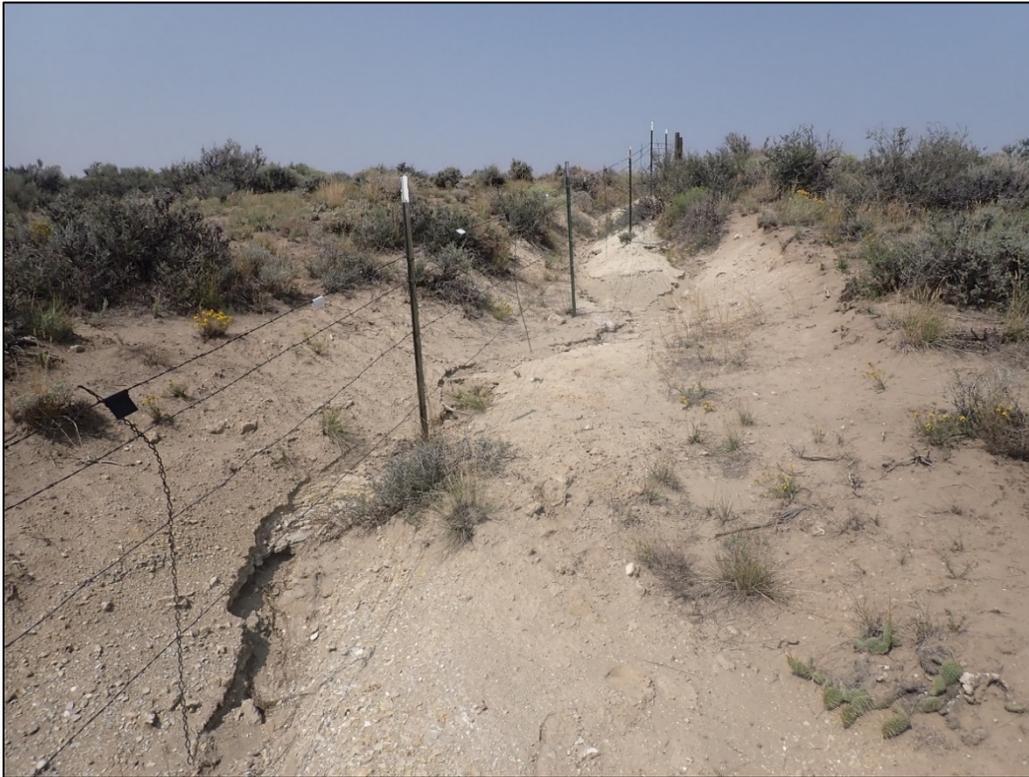
Gullies were observed west of Diversion Channel No. 2, and slight rilling under the northern and southwestern perimeter fence was also observed. None of this erosion threatens the integrity of the main disposal cell, ancillary cell, or associated surface water diversion structures; monitoring of this erosion will continue. No new observations or maintenance needs were identified for 2021. Inspectors identified no cause for a follow-up inspection. Groundwater monitoring is not required at the site.

PL-1. Erosion Under the Perimeter Fence Southwest of the Disposal Cell

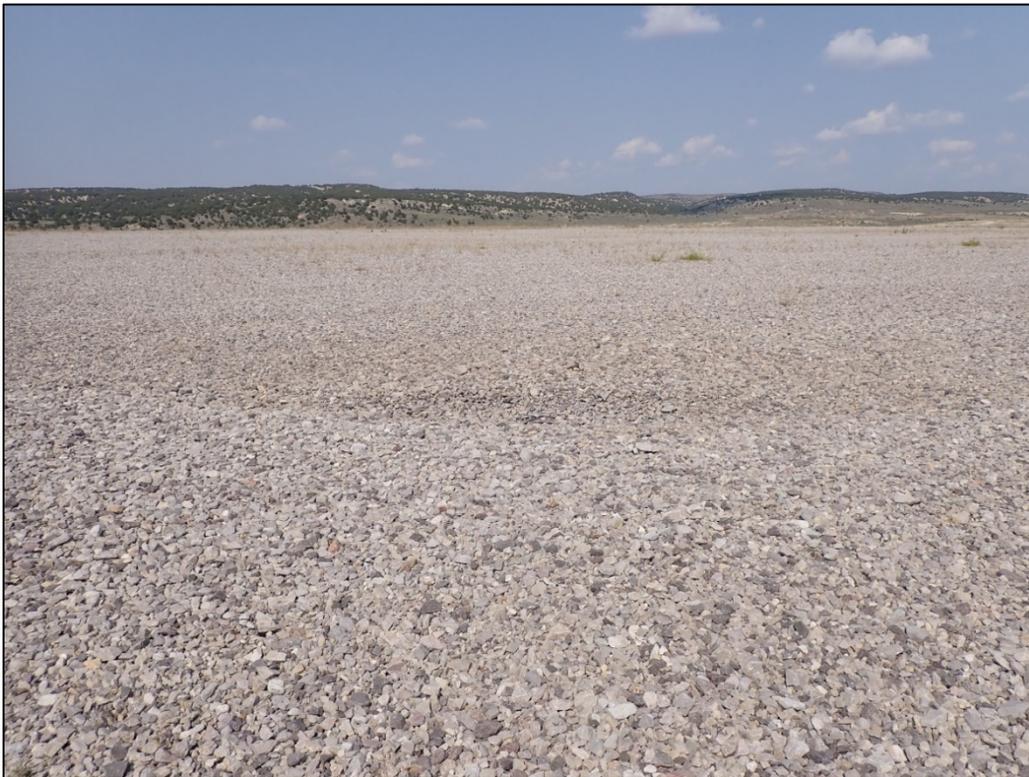
No standing water was observed in any of the depressions during the inspection. These depressions currently do not threaten the integrity or performance of the disposal cell. No maintenance needs were identified.

PL-8. Shallow Depression No. 1

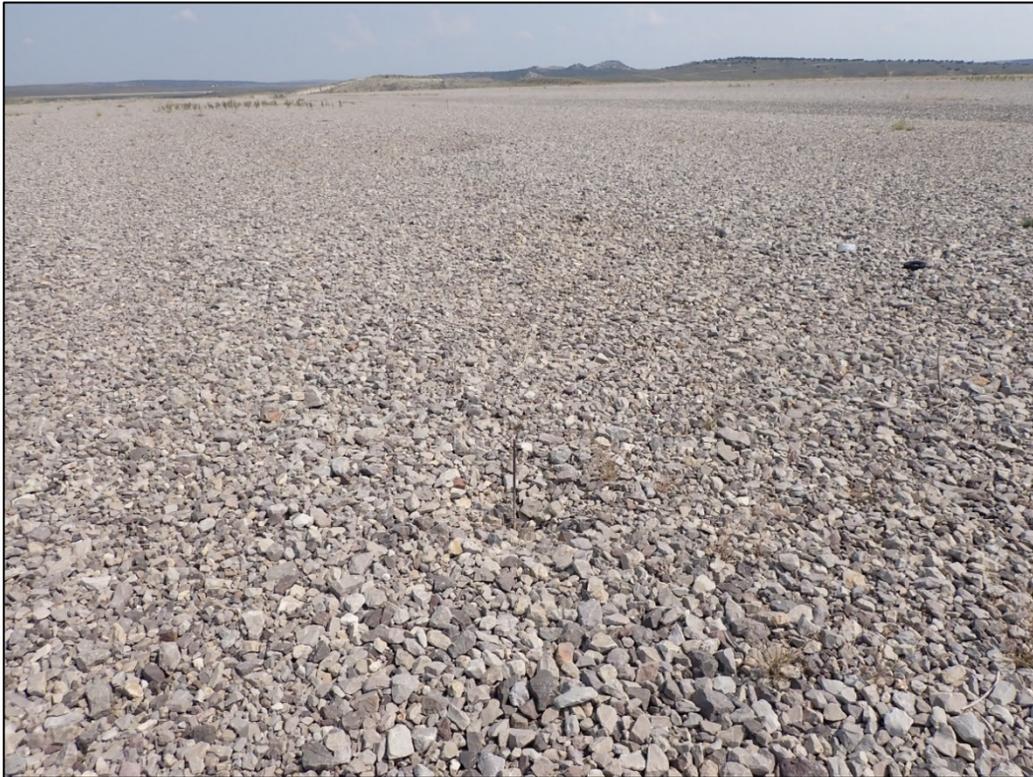
PL-9. Shallow Depression No. 3

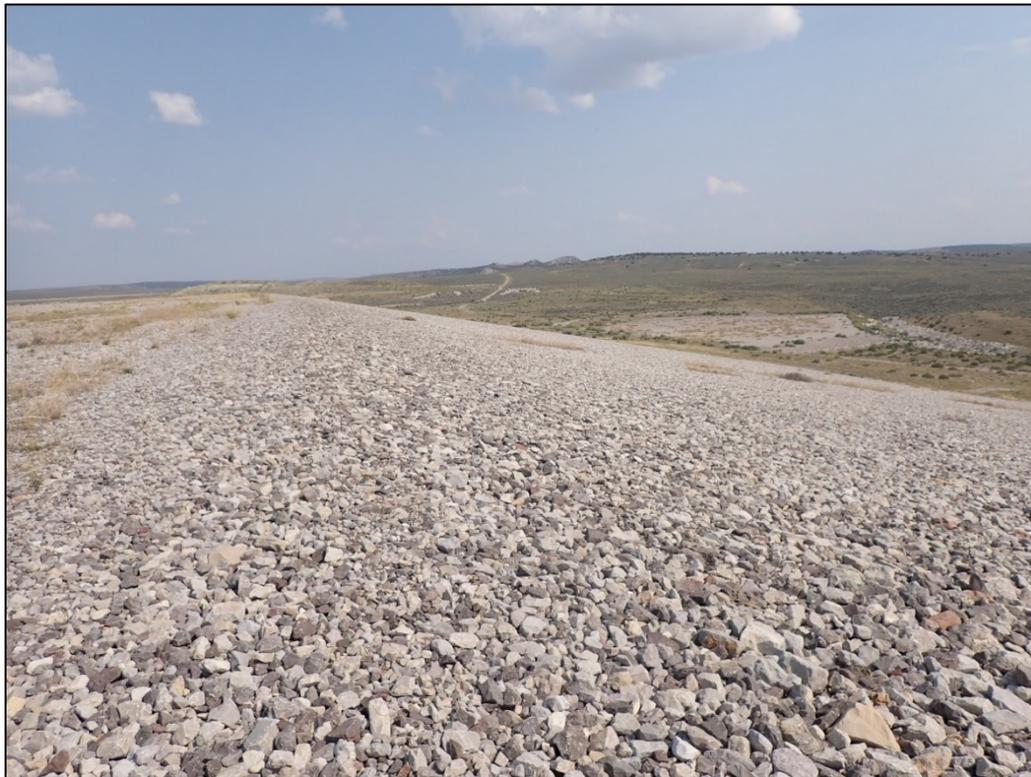
The disposal cell was designed to control surface water runoff resulting from a probable maximum flood event. The side slopes of the disposal cell were constructed with a 20% slope and are covered with a 1-foot-thick layer of riprap (PL-10). Minor sediment accumulation observed in the toe drain apron below the northwest side slope appears to be windblown (PL-11), and there was no evidence of side slope instability, erosion, or settlement. This area of sediment accumulation will continue to be monitored to ensure the toe drain and side slope are functioning properly.

PL-10. View Southeast of Southern Disposal Cell Side Slope

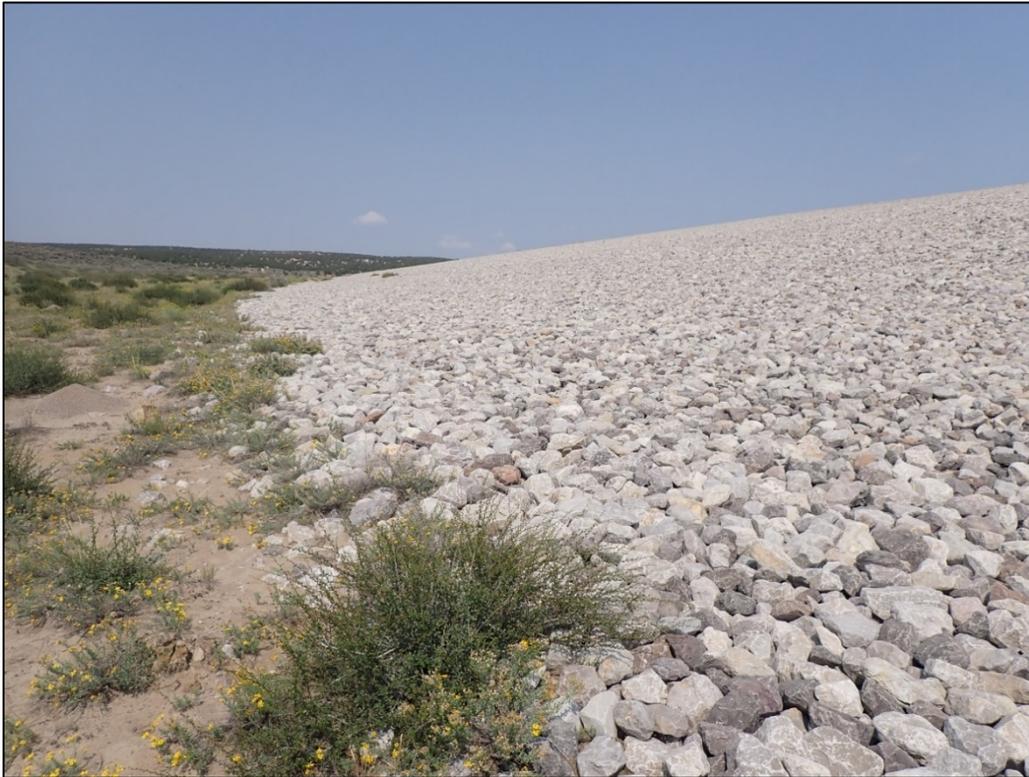
PL-11. Windblown Material Along Western Toe Slope of Disposal Cell

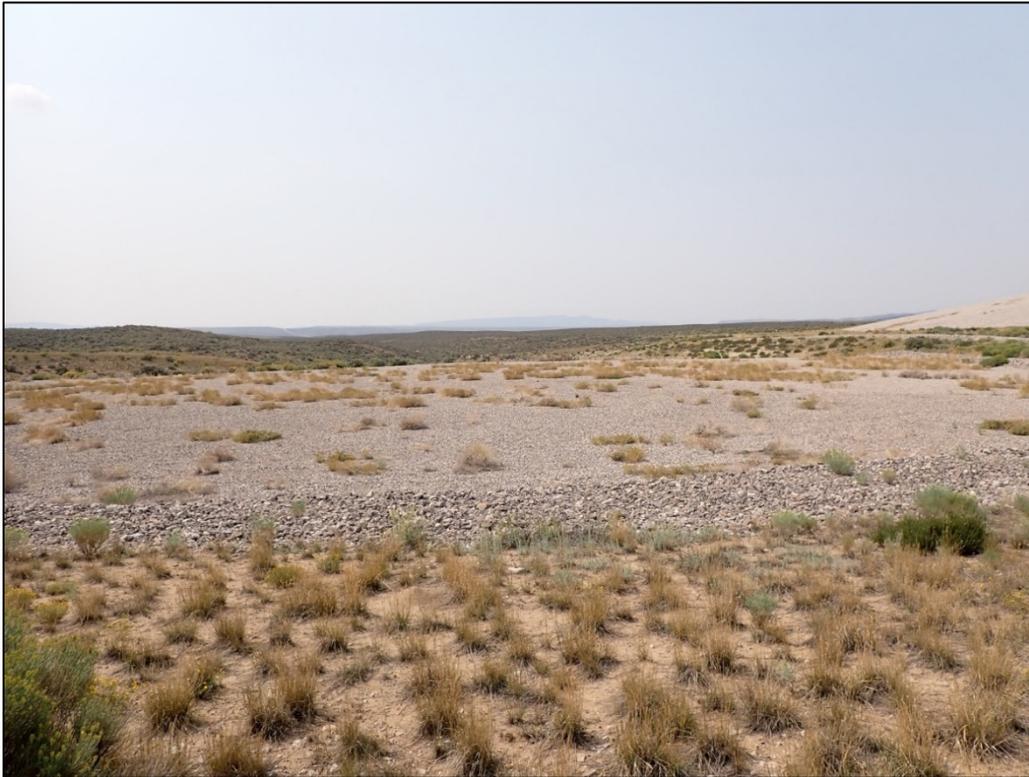
The ancillary cell (PL-13) was constructed to contain waste materials associated with the reclaimed evaporation pond area. It slopes gently toward the southwest. A rock berm wraps around its eastern and northern sides to protect it from surface water runoff. Small depressions observed on the west end of the ancillary cell top slope are not impacting the performance of the cell, but it will continue to be monitored (PL-14). Various species of plants were present on the top slope of the ancillary cell. Noxious weeds were also treated during the July 27, 2021, noxious weed treatment event.

PL-13. View West of Ancillary Cell Top Slope

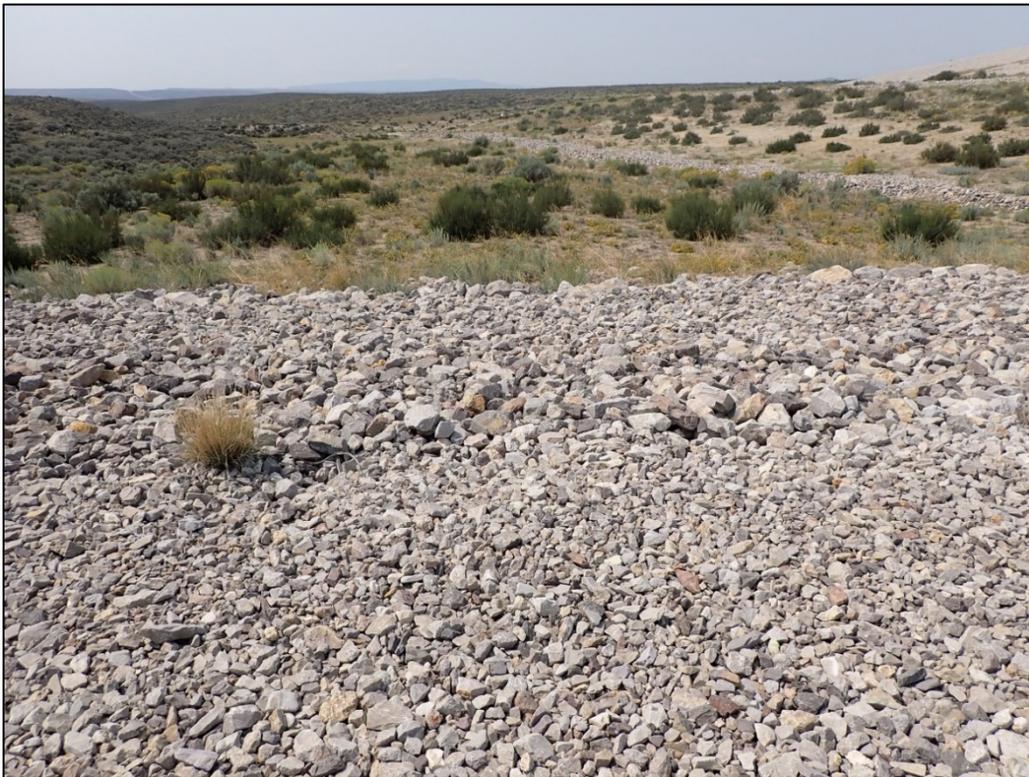
PL-14. Small Depressions on Ancillary Cell Top Slope

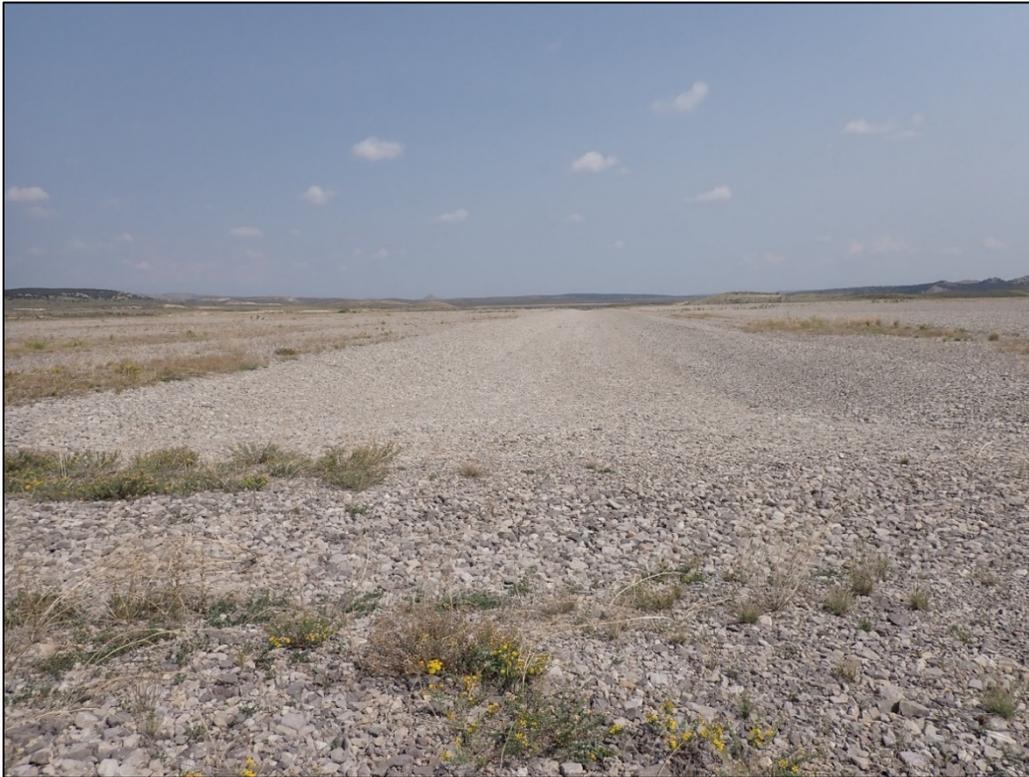
PL-15. View East of Diversion Channel No. 1

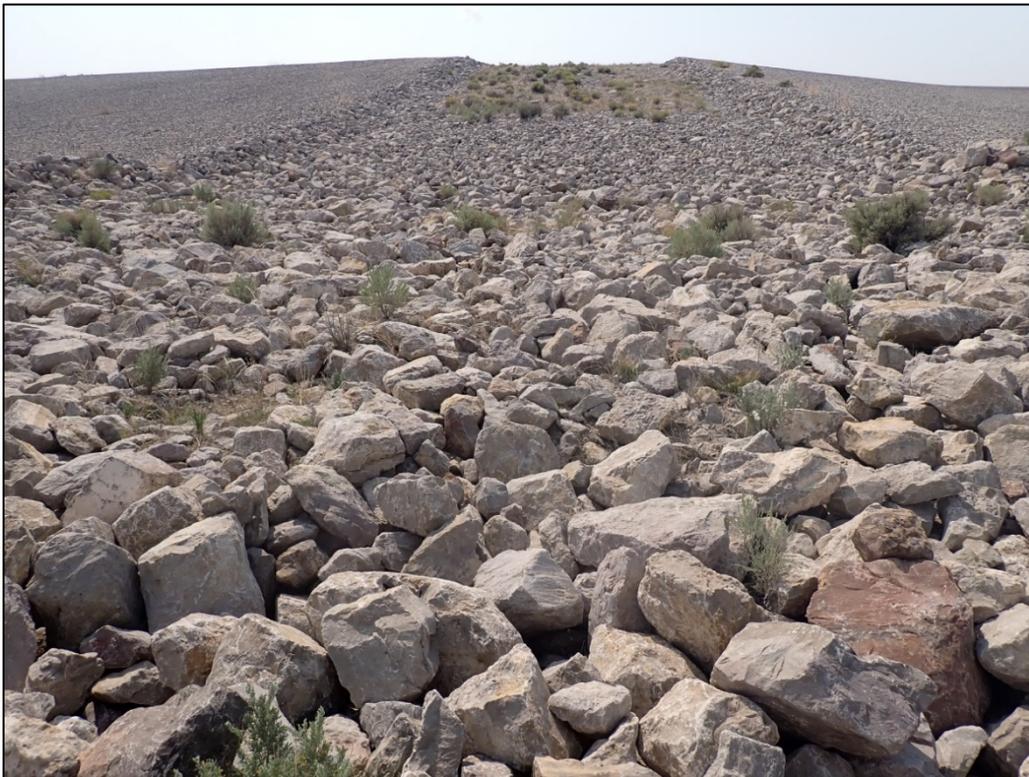
PL-16. View Southwest of the Launch Rock Erosion Protection Basin

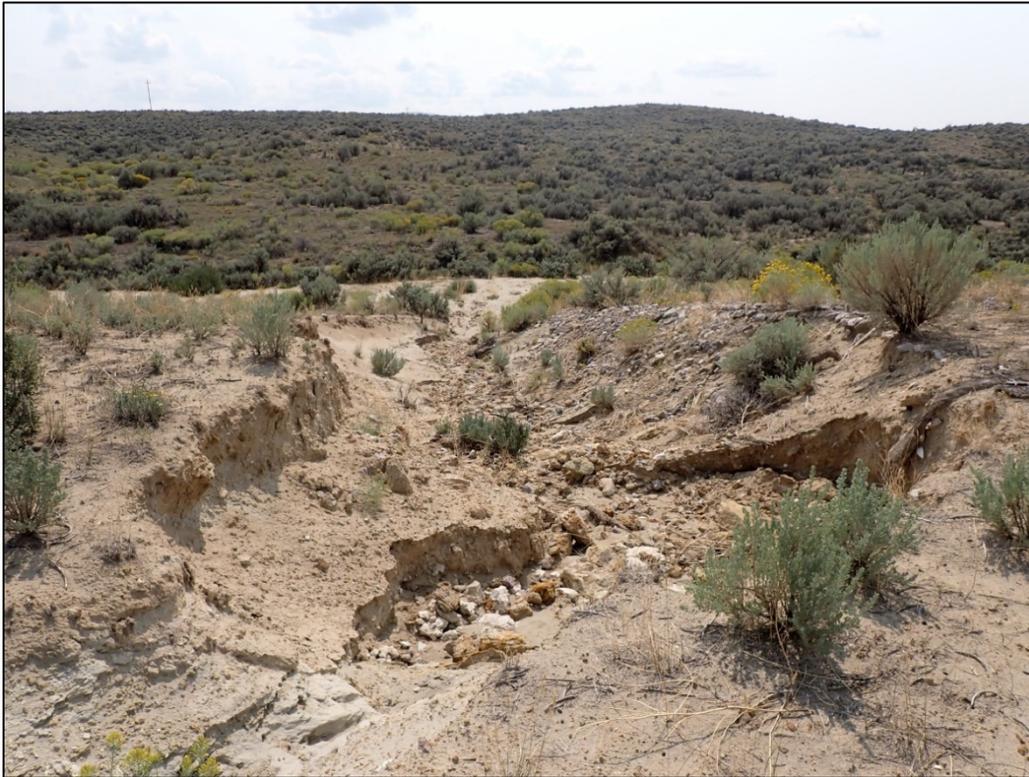
PL-17. Erosion South of Rock Berm Near Diversion Channel No. 2

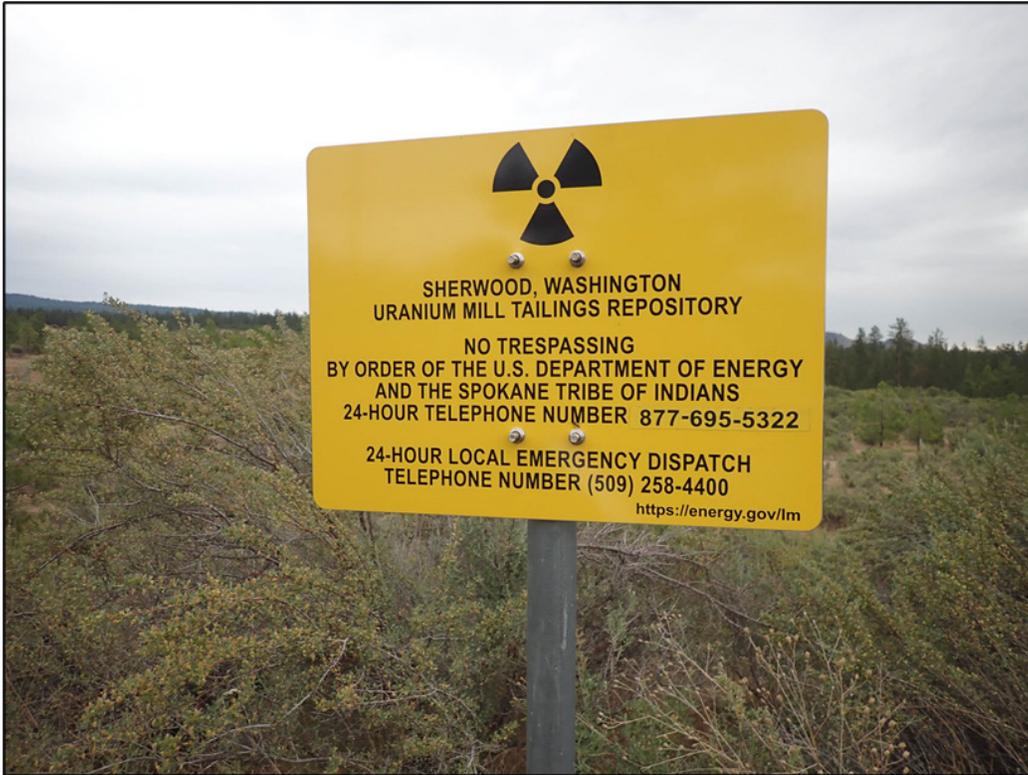
There are six warning or perimeter signs, attached to steel posts set in concrete, positioned along the site boundary at likely access points around the site (PL-1). Perimeter sign P2 was missing and was replaced during the subsequent groundwater sampling event in July 2021. No additional maintenance needs were identified.

PL-1. Perimeter Sign P6

Perimeter sign P2 was identified as missing and was replaced during the subsequent groundwater sampling event in July 2021. No additional routine maintenance needs were identified.

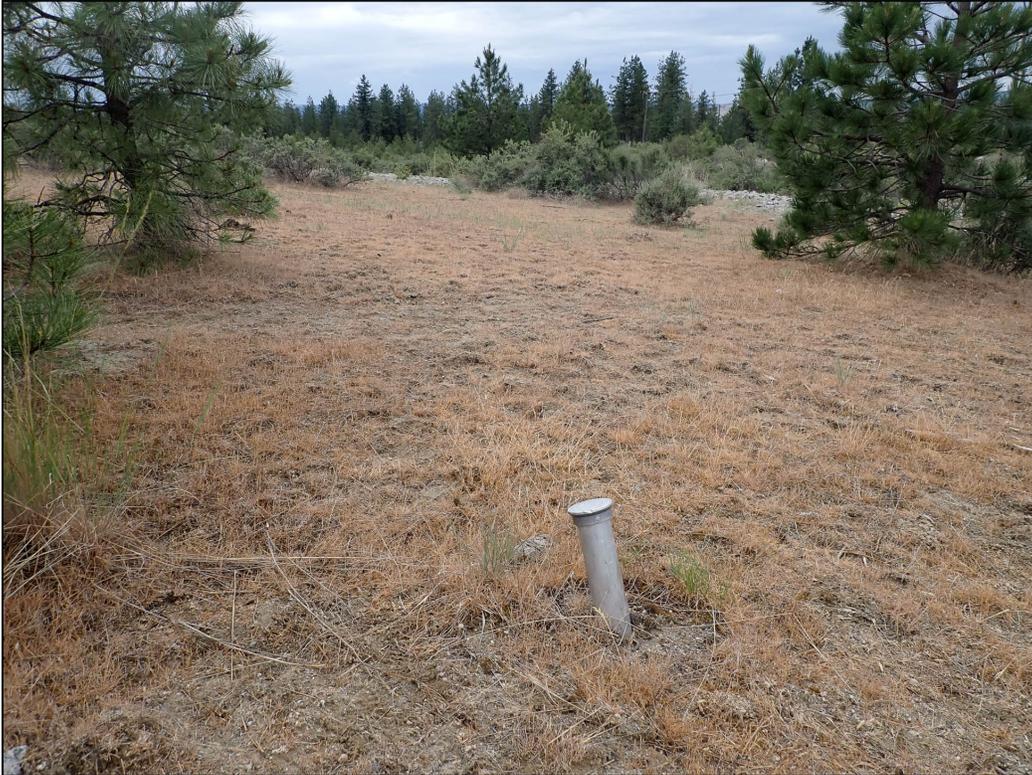
Six boundary monuments set in concrete define the site boundary. Because surrounding vegetation has made it difficult to locate some of the monuments, metal T-posts were installed at each monument location (PL-3). All boundary monuments were inspected. No maintenance needs were identified.

PL-3. Boundary Monument BM-3A

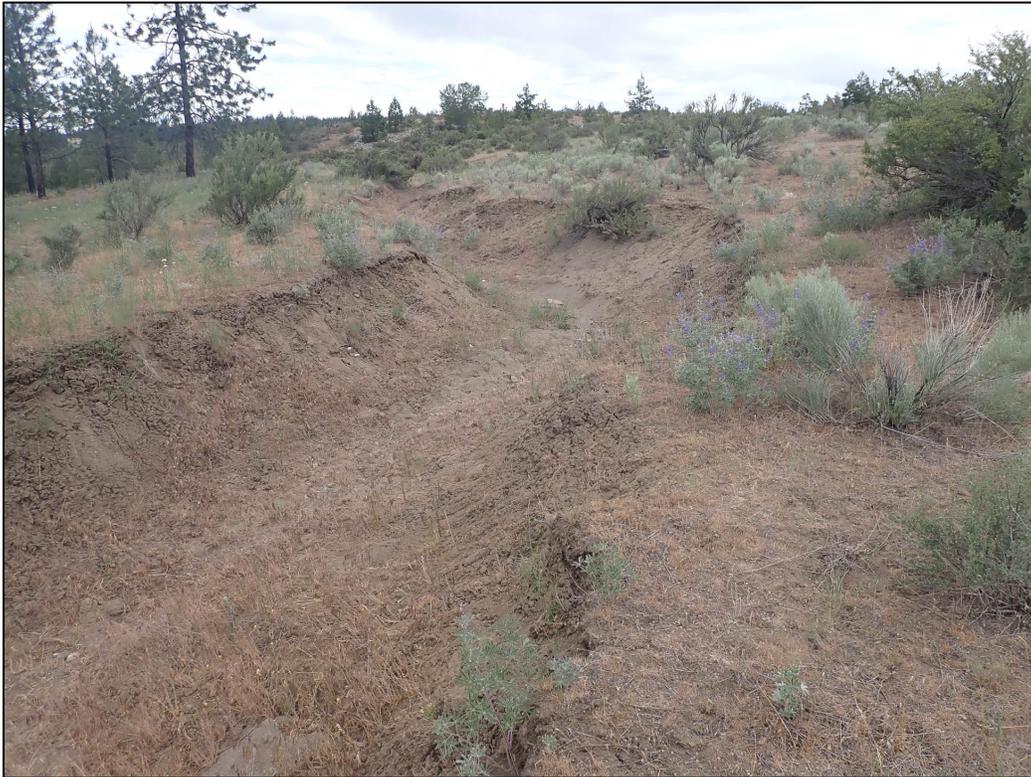
A gully offsite, downgradient of the riprap-armored swale near perimeter sign P1, was first observed in 2009. The gully is photographed periodically to monitor its development (PL-6). Although erosion continues to occur because of site drainage, the gully is not impacting site features or access but will continue to be monitored. Additionally, minor erosion was identified during the 2021 inspection adjacent the two-track on the southeast side of the cell near perimeter sign P2 (PL-7). The erosion areas are not impacting site features or access and will continue to be monitored. No maintenance needs were identified.

PL-6. Gully Downgradient of Riprap-Armored Swale Near Perimeter Sign P1

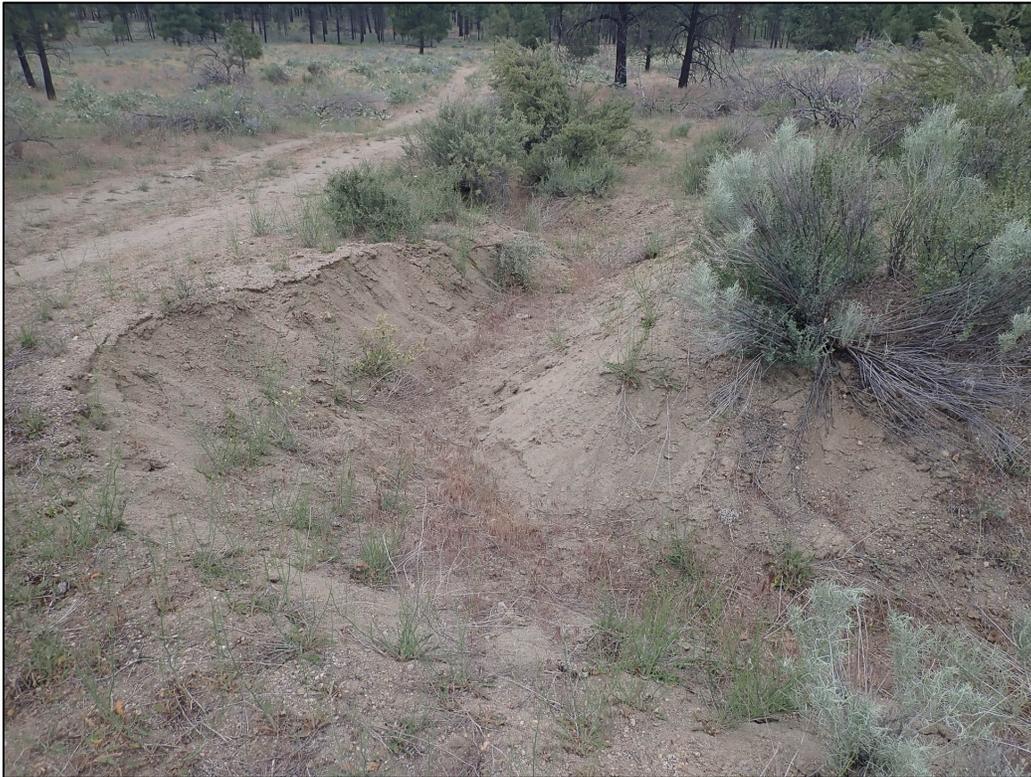
PL-7. Gully Near Perimeter Sign P2 (Stable)

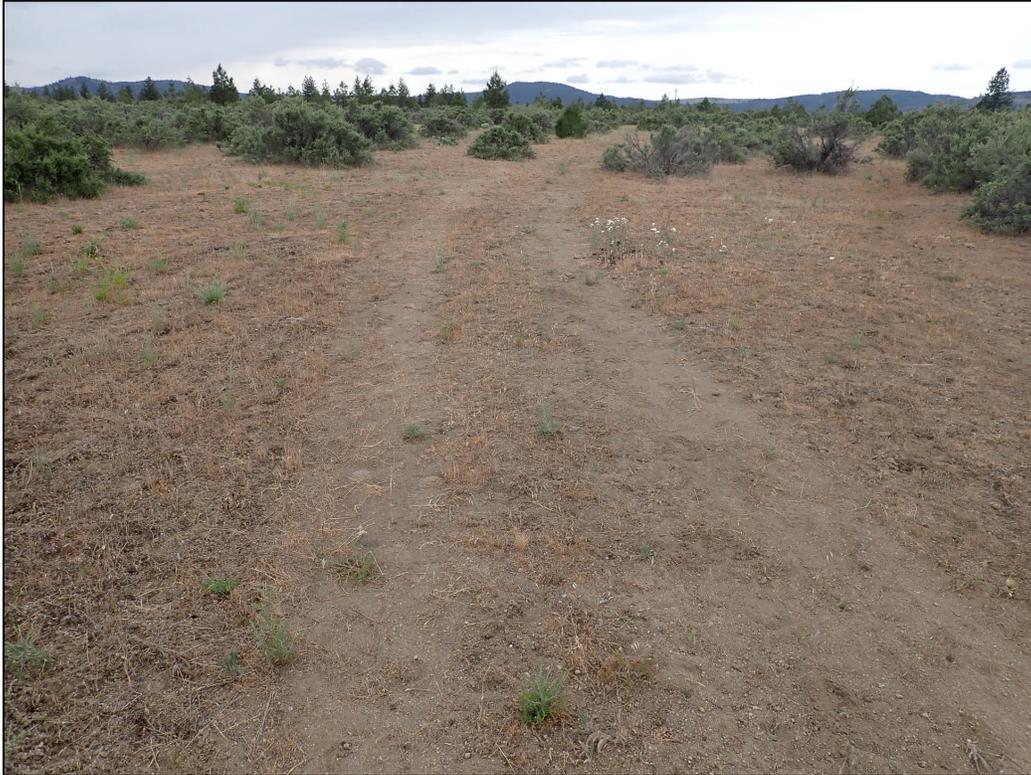
Evidence of vehicle travel was identified on the southwest side of the disposal cell. Minor vehicle tracks were observed from the road intersection near perimeter sign P5 to the edge of Pond 1 (PL-9). The area will continue to be monitored, and strategies to prevent unnecessary vehicle traffic on the cell will be evaluated in consultation with Spokane tribal leadership.

PL-9. Evidence of Vehicle Tracks to Disposal Cell Pond 1

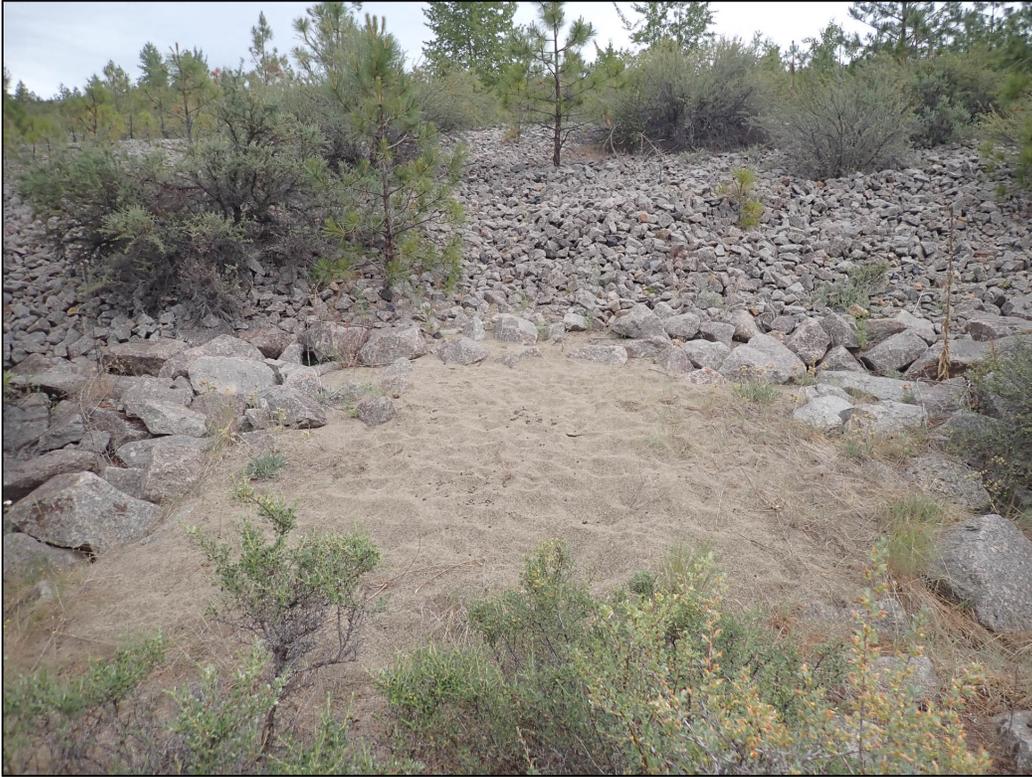
During the 2016 annual inspection, one location at the base of the rock-covered containment dam face was found to have a deposit of sand that had washed out from underneath the rock cover, as evidenced by a shallow rock-filled erosion feature upgradient of the deposit (Figure 5-1). A subsequent follow-up inspection and evaluation identified that the sandy material was the same as natural undisturbed material nearby. During reclamation, this area of the site was used as a source for fill material used to contour the area below the toe of the containment dam. Review of original reclamation and as-built drawings showed that the toe of the containment dam is upslope from the area of erosion, which was confirmed during the follow-up investigations. Therefore, it was concluded that the sand deposit location is in a portion of the dam defined as the outslope in the construction completion report and does not impact the containment dam (DOE 2018b).

The sand deposit location was examined during the inspection, and there was no apparent change in the deposit or the upgradient erosion feature (PL-11). The area will be visually monitored during future inspections and by periodic aerial remote sensing surveys. Repair options will be evaluated and implemented, in consultation with NRC, if the erosion area increases such that the containment dam could be affected.

PL-11. Sand Deposit at Toe of Containment Dam Outslope

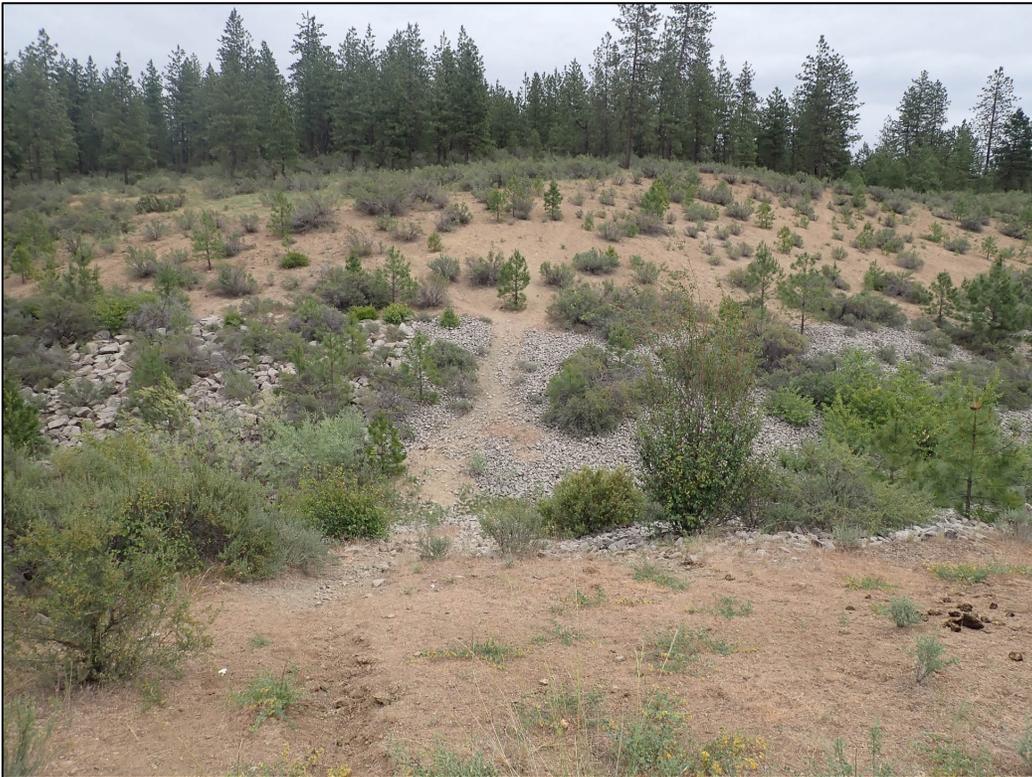
PL-12. Wildlife Trail Adjacent the Disposal Cell
