2021 Annual Site Inspection and Monitoring Report for Uranium Mill Tailings Radiation Control Act Title II Disposal Sites

December 2021

L-Bar, New Mexico, Disposal Site

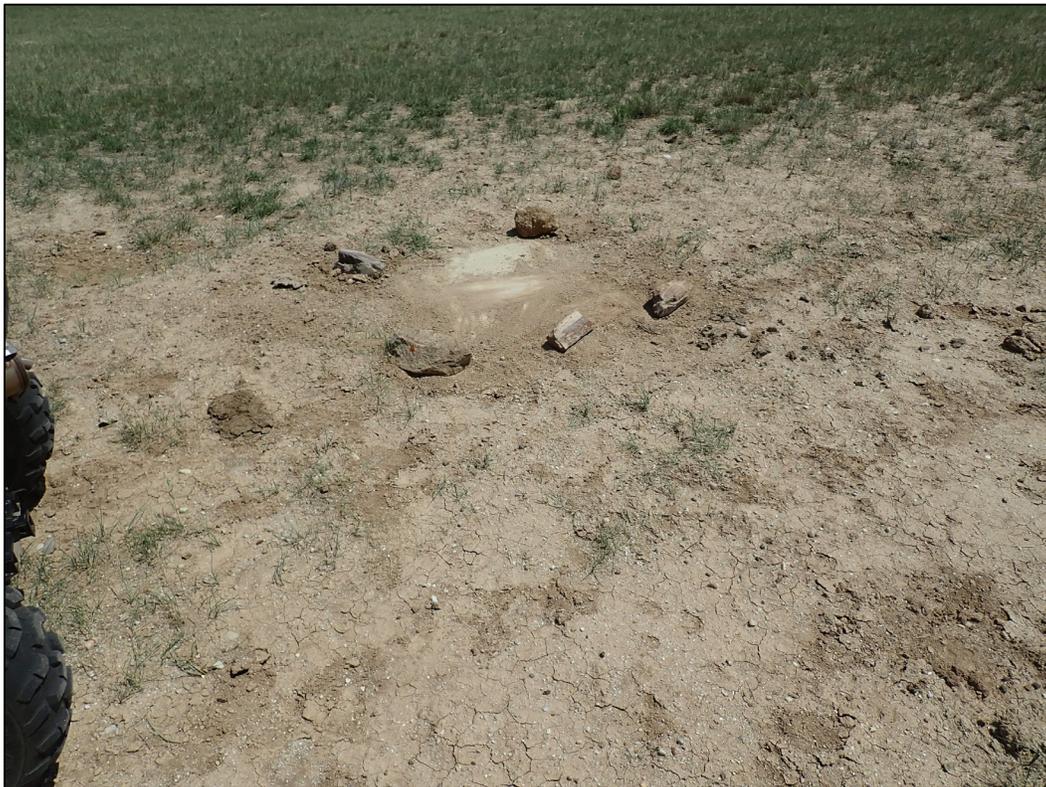
In July 2019, eight permanent quality control (QC) monuments were installed at the site in preparation for a baseline aerial survey of the disposal cell. The quality control monument locations are shown in Figure 6-1. Quality control monument QC-7 was unearthed for inspection and rocks were placed around it for easier identification (PL-4). A baseline aerial survey is tentatively scheduled for 2022. No maintenance needs were identified.

PL-4. Quality Control Monument QC7, Usually Buried Under Soil

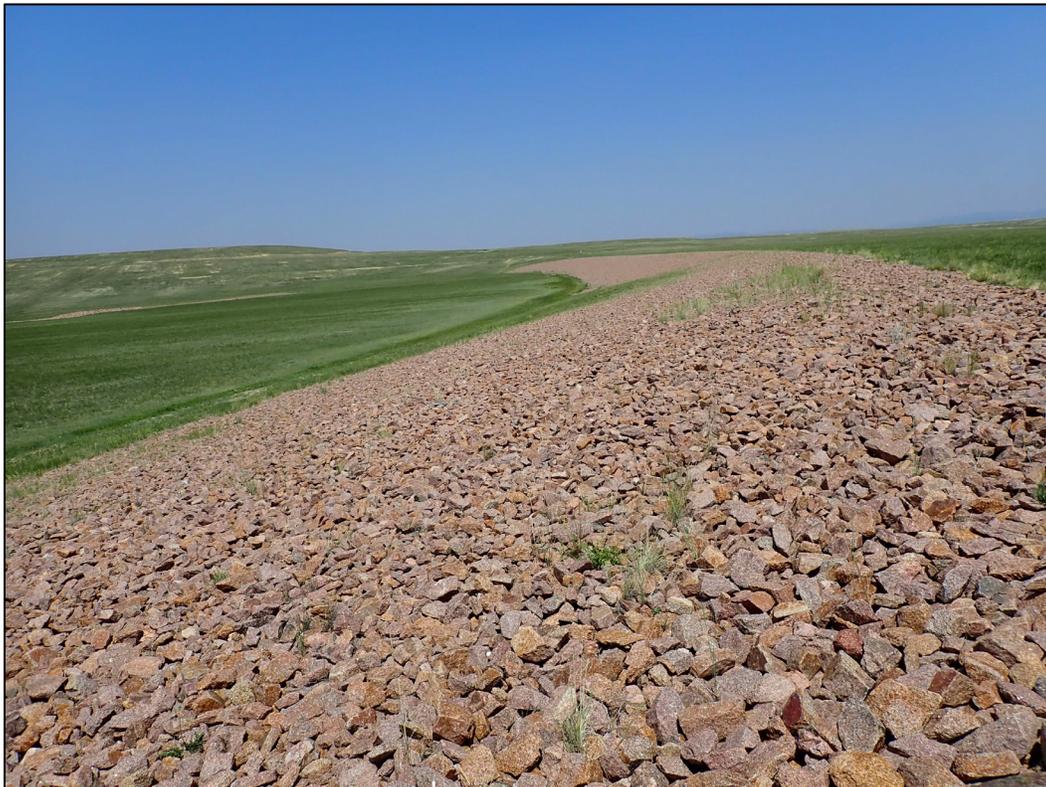
PL-6. Disposal Cell Riprap Between Upper and Lower Level

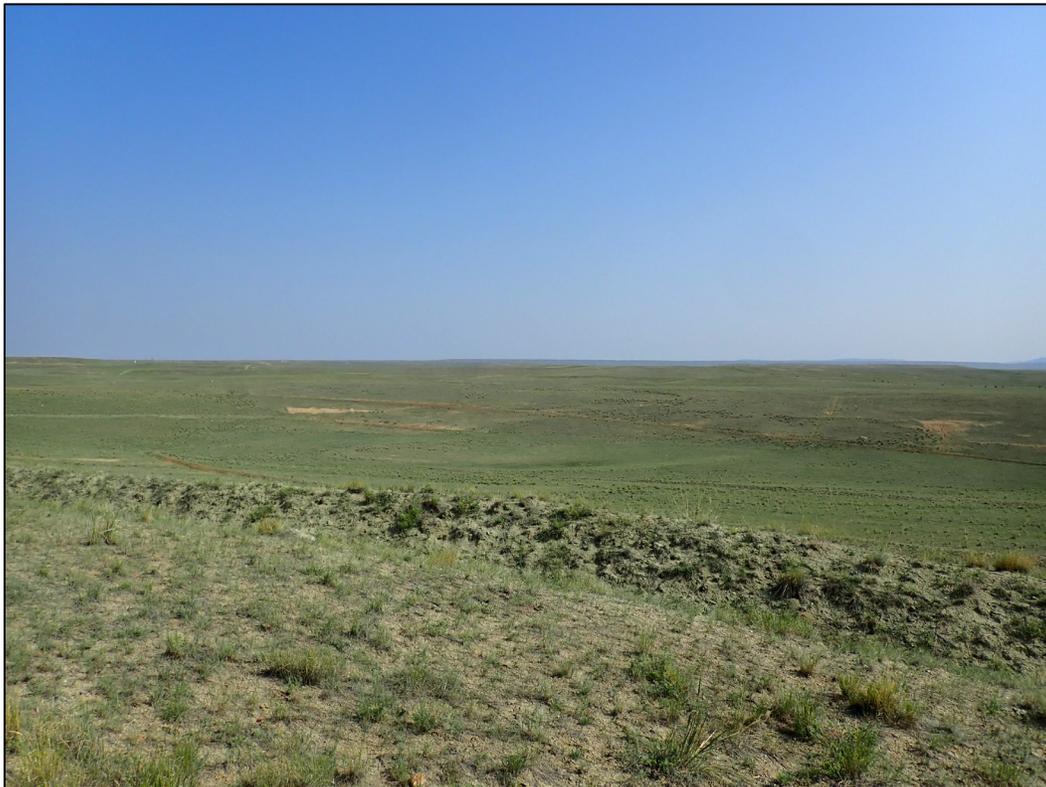
PL-8. Basin, Southeast Corner of Site

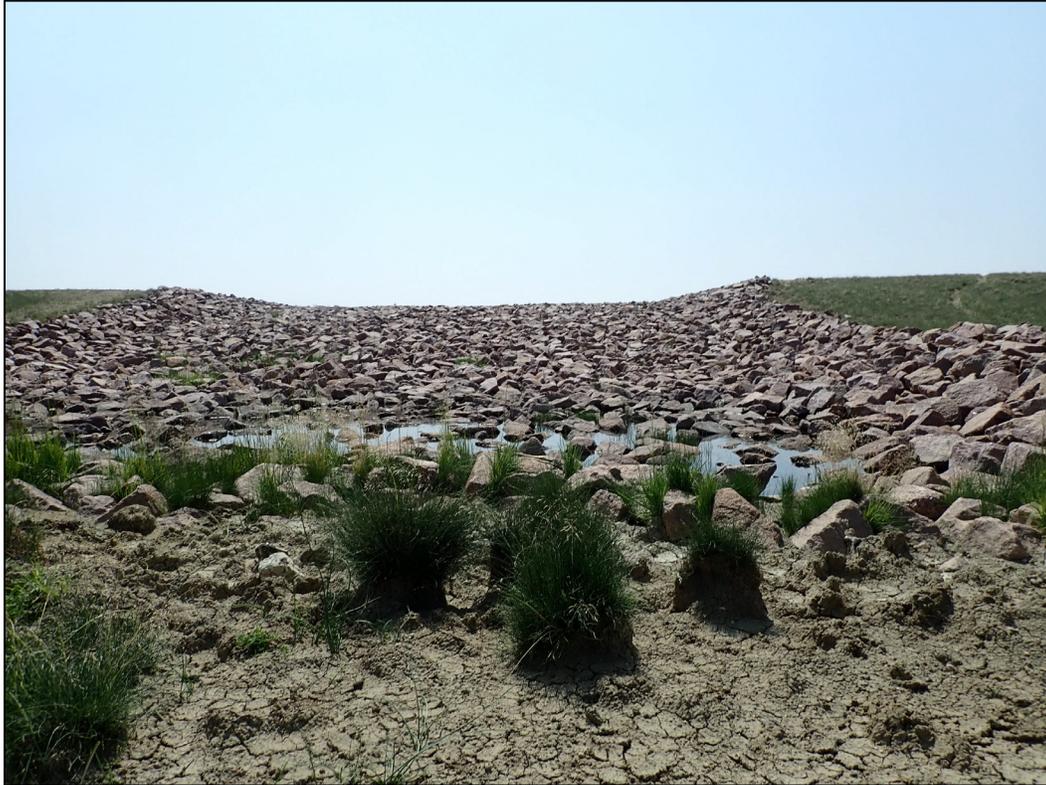
PL-9. Base of North Swale Discharge Point

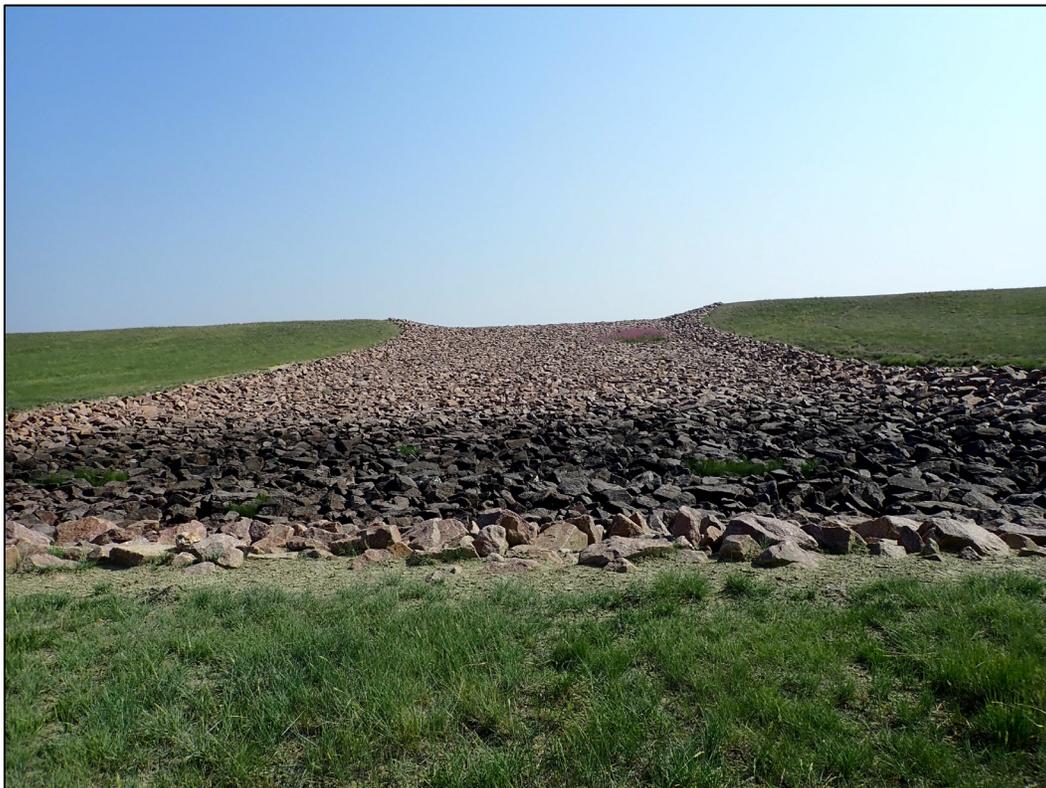
PL-10. Base of South Swale Discharge Point

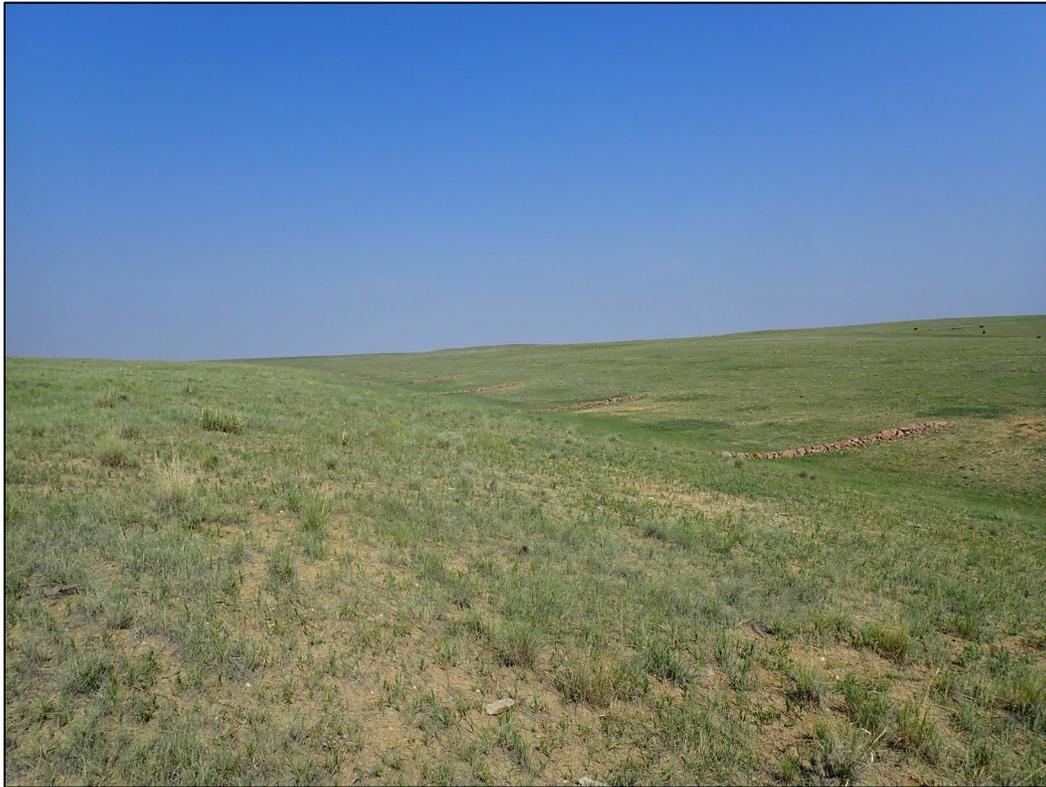
PL-11. Rock Check Dams, Southeast Corner of Site

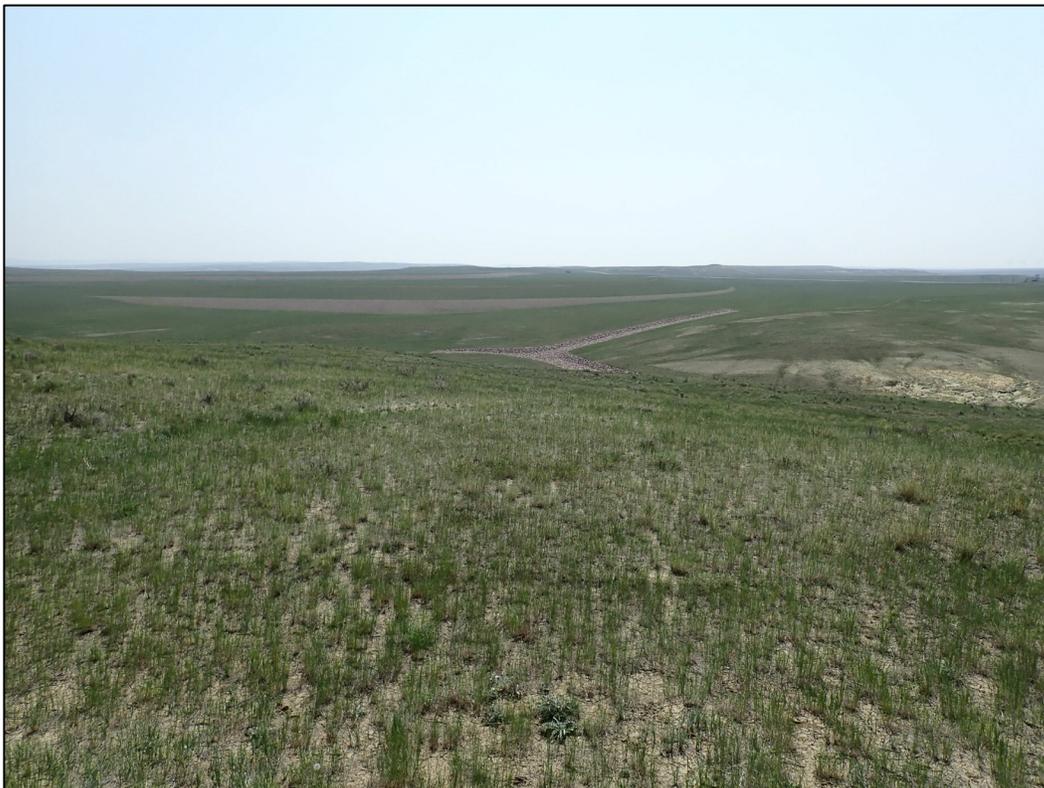
PL-12. Western Drainage Feature

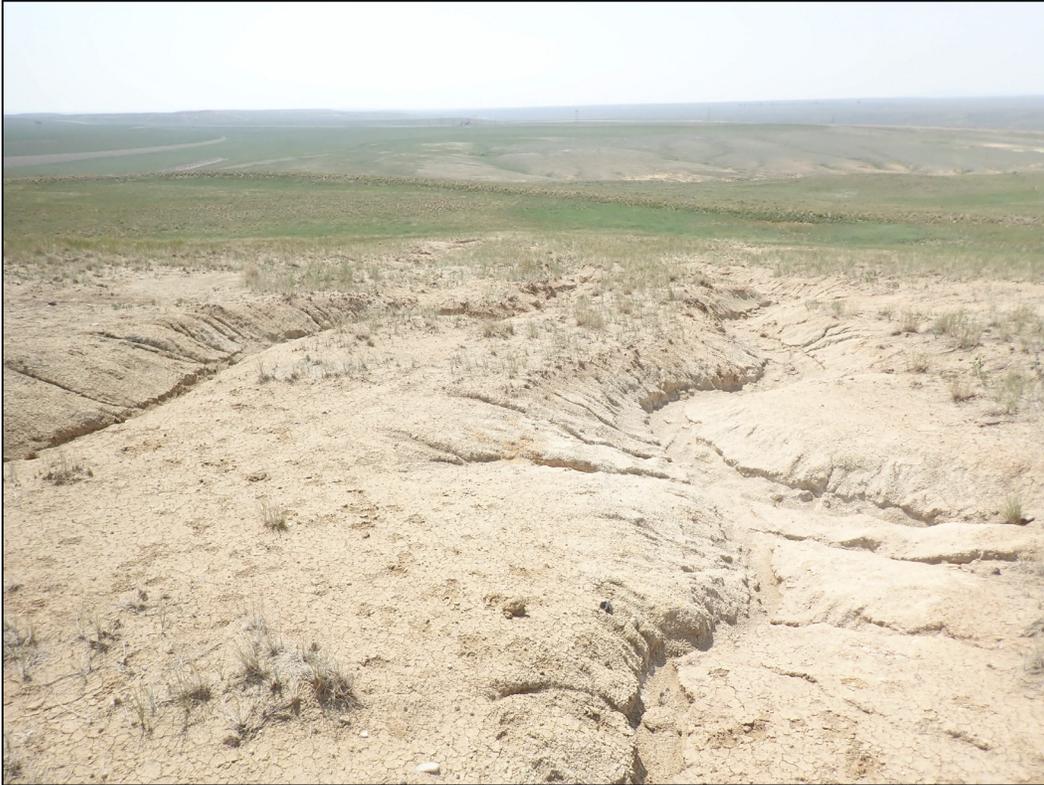
PL-13. Erosion Feature, Western Edge of Site

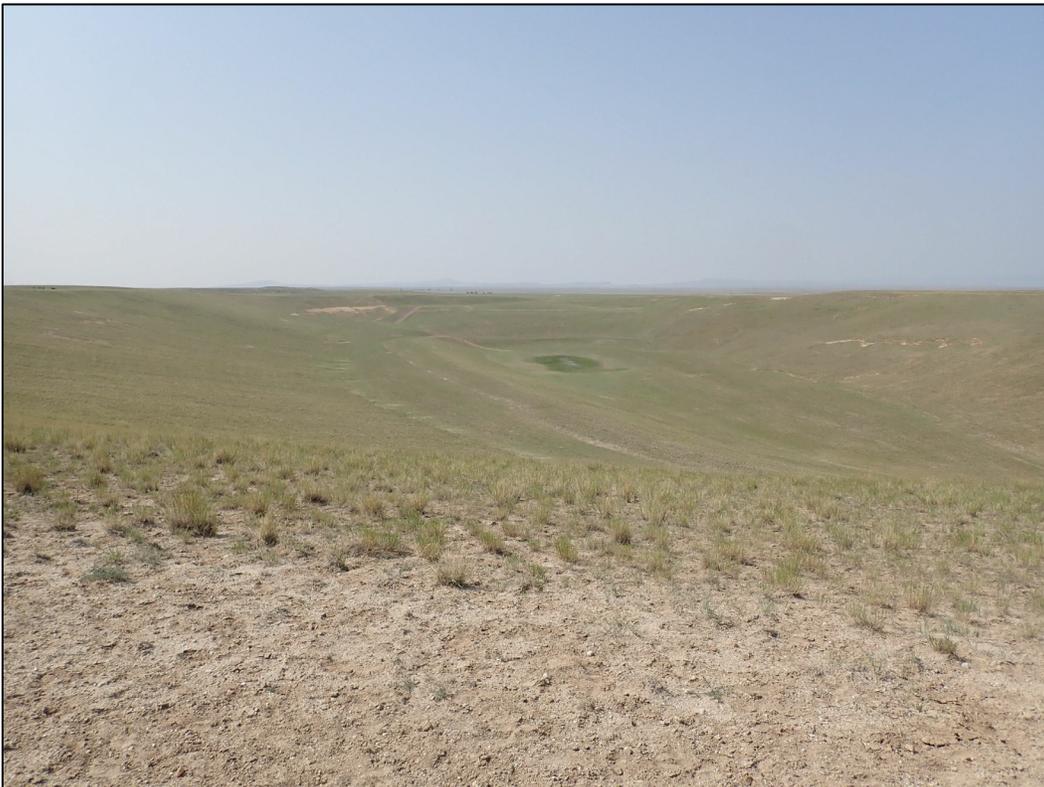
PL-14. Pit 4 and Wetland Area

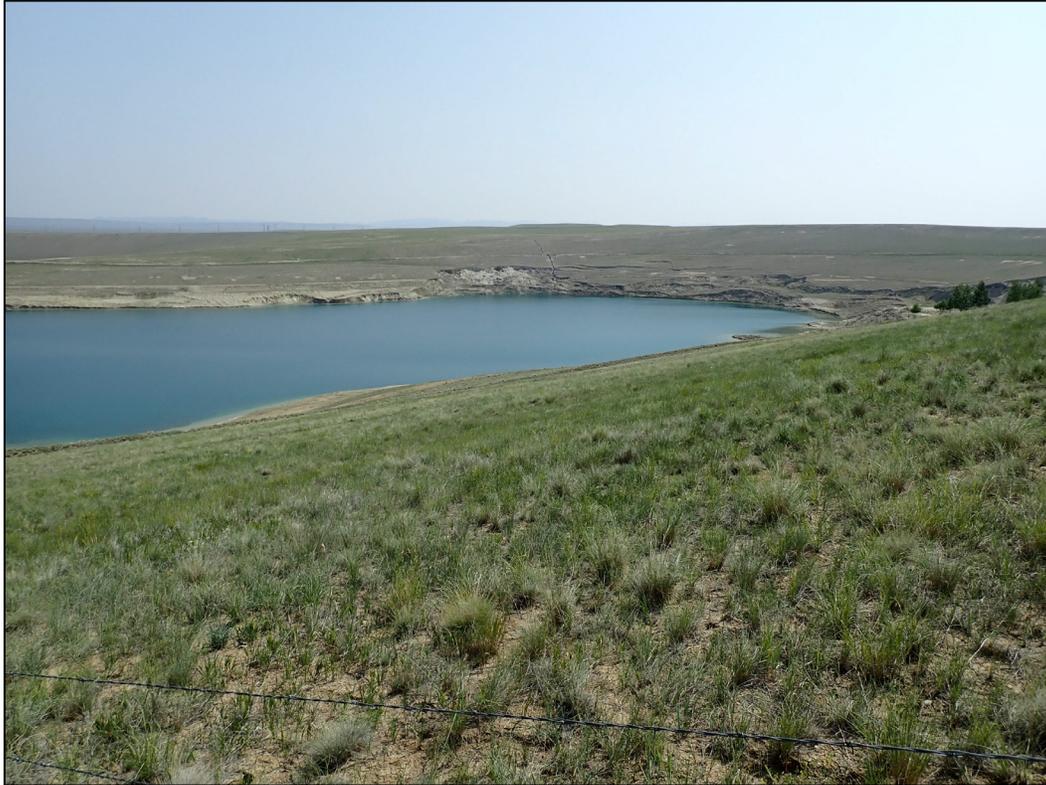
PL-15. Shirley Basin North Pit Lake
