# **INDIAN POINT 2 REACTOR COOLANT PUMP SEAL EVALUATIONS**

**M. Subudhi and J.H. Taylor**  
**Engineering Technology Division**  
**and**  
**J.H. Clinton, C.J. Czajkowski, and J.R. Weeks**  
**Materials Technology Division**

**August 1987**

**DEPARTMENT OF NUCLEAR ENERGY, BROOKHAVEN NATIONAL LABORATORY**  
**UPTON, LONG ISLAND, NEW YORK 11973**

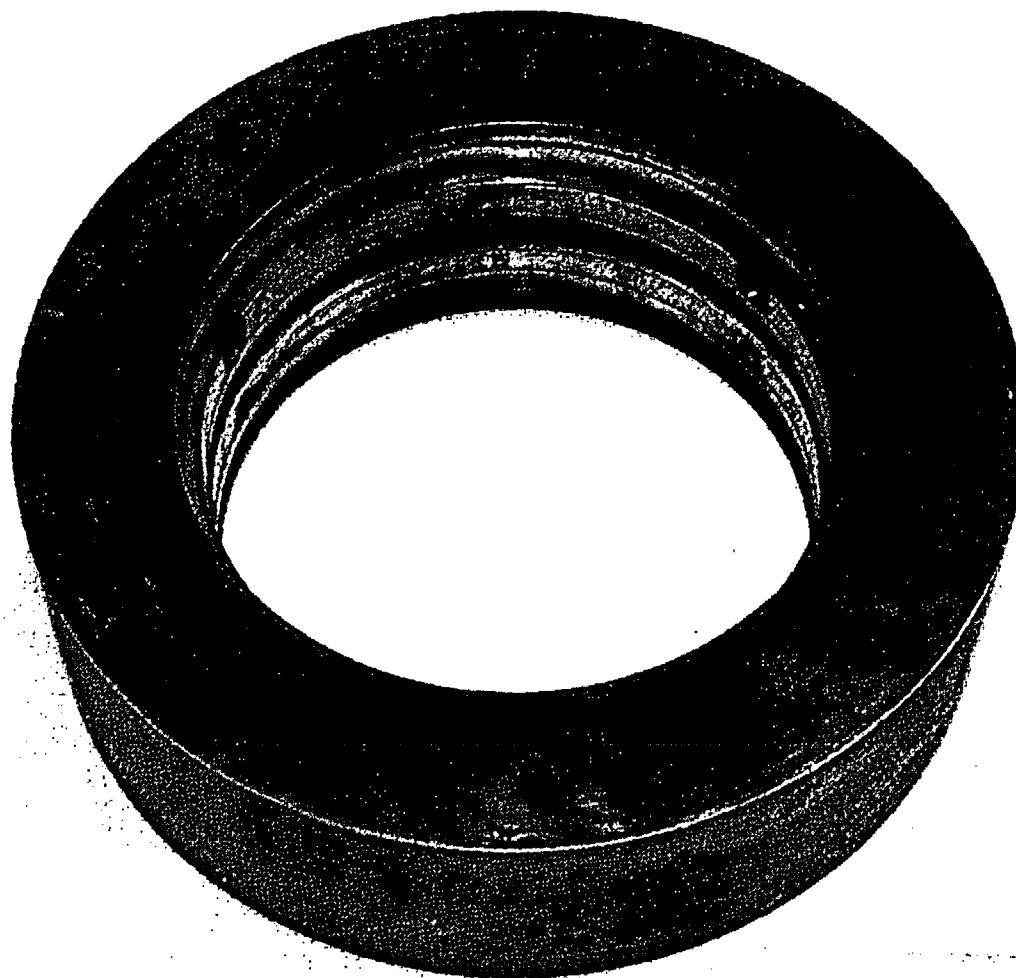
BNL ID: 2D-CN3-478-86

NO. 2 SEAL RUNNER

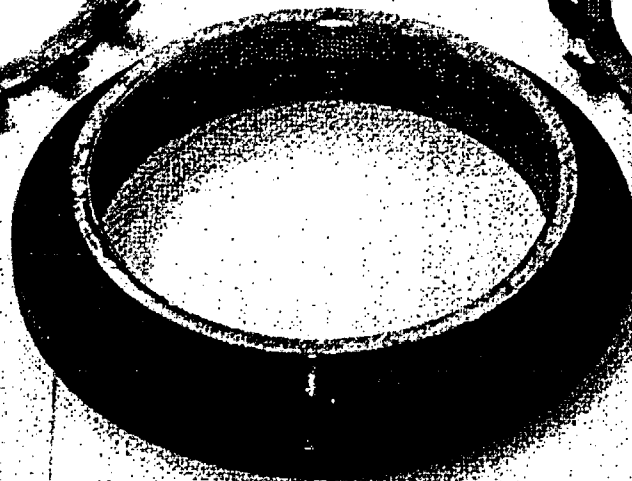
BNL ID: 3R/C/D-CN3-554-86

**Number 3 Seal Runner Assembly (BNL #3B/C/D-CN3-554-86 and BNL #3B/C/D-CN3-556-86).**  
The runner is flanked by two lock washers from the top of the seal assembly. Photographic enlargement is not sufficient to allow a close examination of the aluminum oxide insert on the runner. The lower surface of the runner assembly is deeply stained with oxide and crud.

NO. 3 SEAL RUNNER AND  
TWO LOCK WASHERS
